ENGINEERING INVESTIGATIONS AT INACTIVE HAZARDOUS WASTE SITES

PHASE I INVESTIGATION

Witmer Road

Site No. 932027

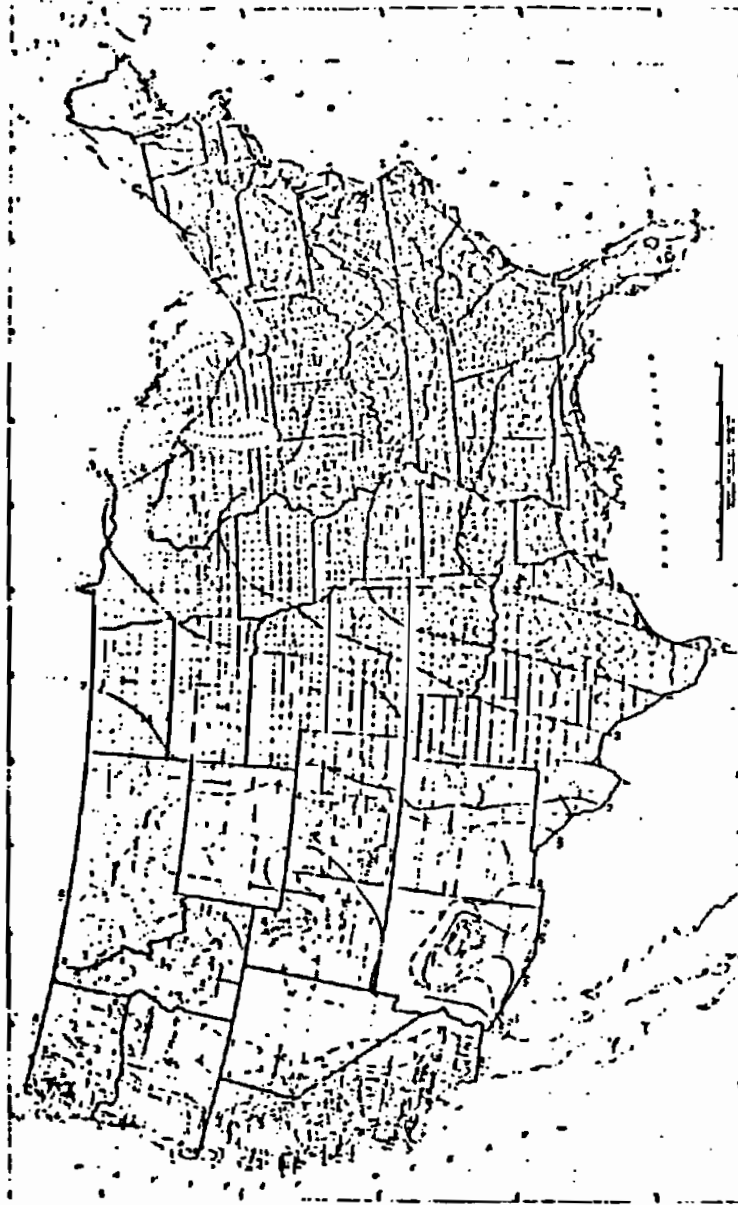
Figure 8

Source: Rainfall Frequency Atlas of the United States, Technical Paper No. 40, U.S. Department of Commerce, U.S. Government Printing Office, Washington, D.C., 1961.

1-Year 24-Hour Rainfall (Inches)

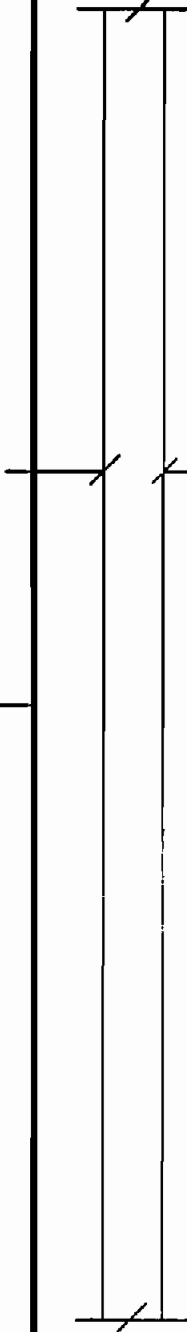
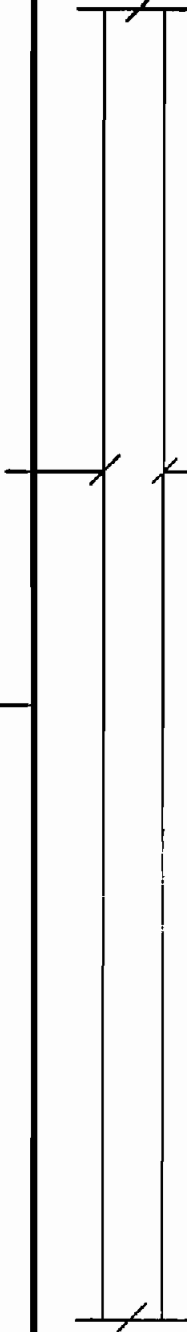
HOLE N°: F-6 Page 2 of 4
 DATE COMPLETED: MARCH 18, 1983
 GEOLOGIST/ENGINEER: W. CLARKE/J. KAY
 GROUND ELEVATION: 588.2
 TOP OF PIPE ELEVATION: _____

PROFILE		MONITOR INSTALLATION	SAMPLE			PENETRATION TEST BLOWS / FOOT			
DEPTH (ELEVATION)	STRATIGRAPHY DESCRIPTION & REMARKS		NUMBER	TYPE	BLOWS / FOOT				
550	Grey aphanitic to fine grained DOLOMITE

20	40	60	80
545									
540									
535									
530	Grey fine grained DOLOMITE

STRATIGRAPHIC AND INSTRUMENTATION LOG (Bergeson, 1984)

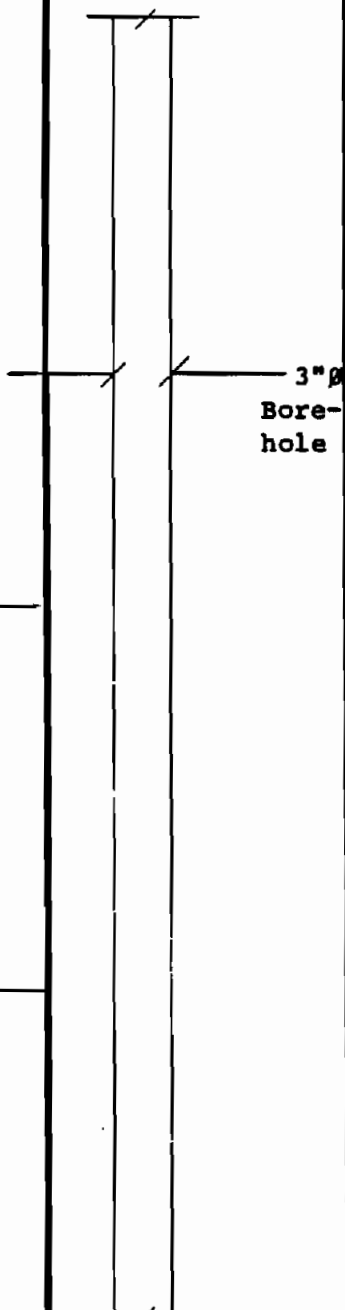
HOLE N°: F-6 Page 3 of 4
 DATE COMPLETED: MARCH 18, 1983
 GEOLOGIST/ENGINEER: W. CLARKE/J. KAY
 GROUND ELEVATION: 588.2
 TOP OF PIPE ELEVATION: _____

PROFILE		MONITOR INSTALLATION	SAMPLE			PENETRATION TEST BLOWS / FOOT										
DEPTH (ELEVATION)	STRATIGRAPHY DESCRIPTION & REMARKS		NUMBER	TYPE	BLOWS / FOOT											
510	Grey fine grained DOLOMITE

505																
500																
495																
490	Dark grey fine to medium grained DOLOMITE															
485	GASPORT MEMBER															
480	Grey aphanitic DOLOMITE DECEW MEMBER															
475																
470

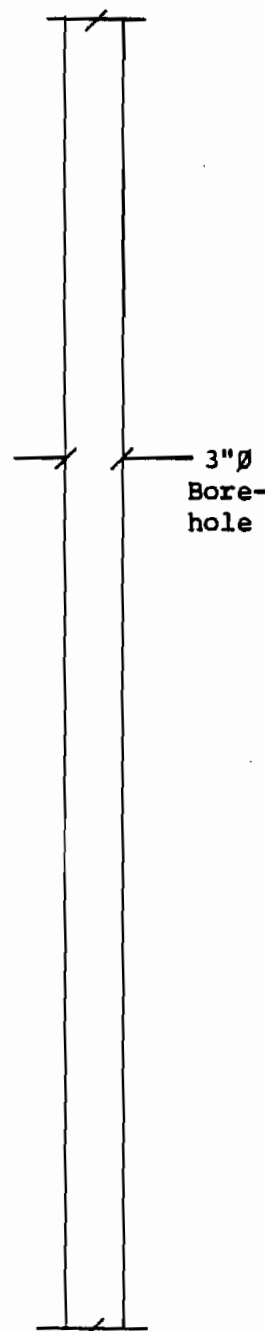
HOLE N° : F-7D Page 2 of 3
 DATE COMPLETED : May 11, 1983
 GEOLOGIST/ENGINEER : W. CLARKE/J. KAY
 GROUND ELEVATION : 578.3
 TOP OF PIPE ELEVATION : _____

PROFILE		MONITOR INSTALLATION	SAMPLE			PENETRATION TEST BLOWS / FOOT				
DEPTH (ELEVATION)	STRATIGRAPHY DESCRIPTION & REMARKS		NUMBER	TYPE	BLOWS / FOOT					
						20	40	60	80	
540	Gray aphanitic DOLOMITE

535										
530										
525										
520	Gray fine grained DOLOMITE									
515										
510										
505										
500	Gray aphanitic DOLOMITE

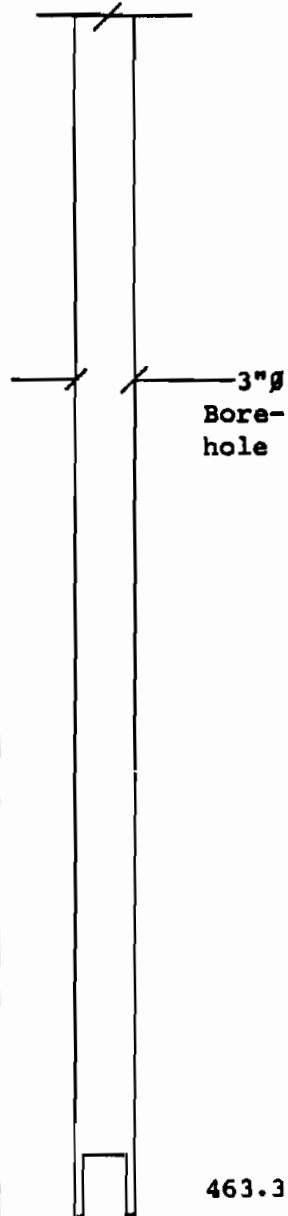
DEPTH (ELEVATION)	PROFILE STRATIGRAPHY DESCRIPTION & REMARKS	MONITOR INSTALLATION	SAMPLE			PENETRATION TEST BLOWS / FOOT			
			NUMBER	TYPE	BLOWS / FOOT	20	40	60	80
500	Gray aphanitic DOLOMITE

495									
490	Gray to medium gray fine grained DOLOMITE								
485	Medium gray fine to medium grained DOLOMITE								
480	GASPORT MEMBER								
475	Gray aphanitic DOLOMITE								
470	DECEW MEMBER								
465	Dark gray dolomitic SHALE								
	ROCHESTER FORMATION								
	Unrecovered core								
460
