# **ENGINEERING INVESTIGATIONS AT INACTIVE HAZARDOUS WASTE SITES IN THE STATE OF NEW YORK**

## **PRELIMINARY SITE ASSESSMENT TASK 1**

**TAM Ceramics, Inc. Site  
Site Number 932028  
Town of Niagara, Niagara County**

**August 1991**

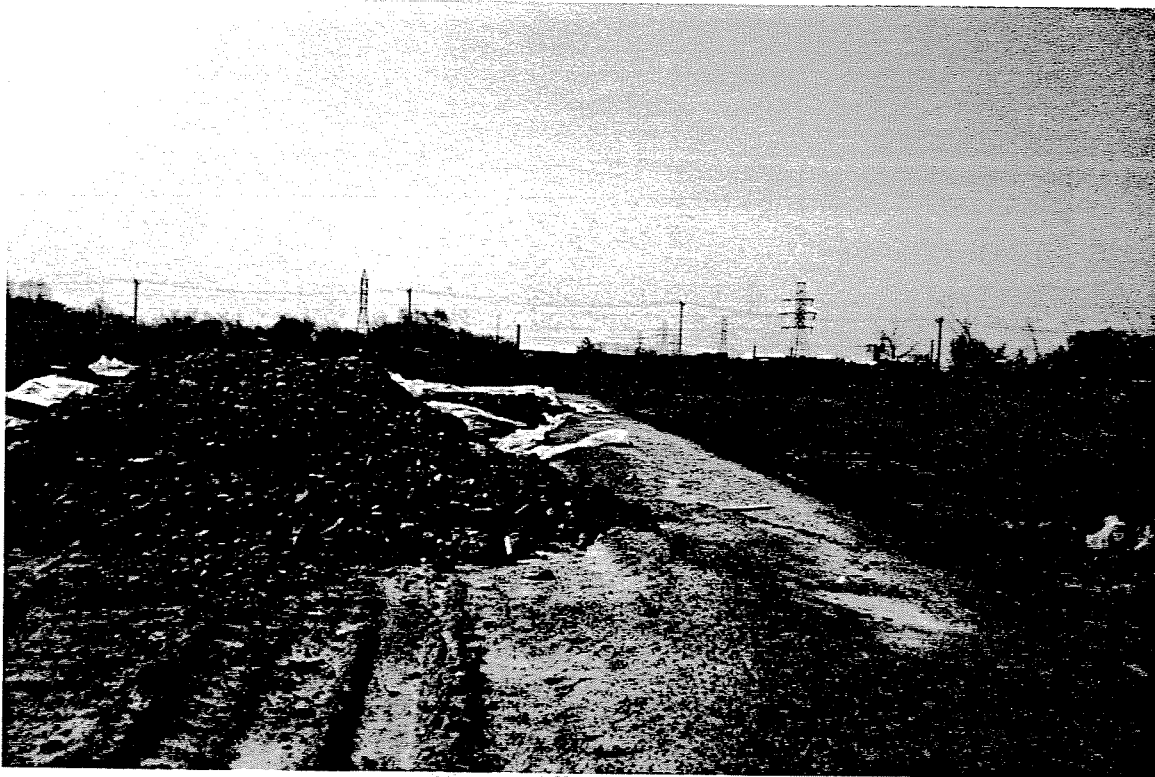
Comments\*: Direction south, debris pile and  
junkyard on south property line.

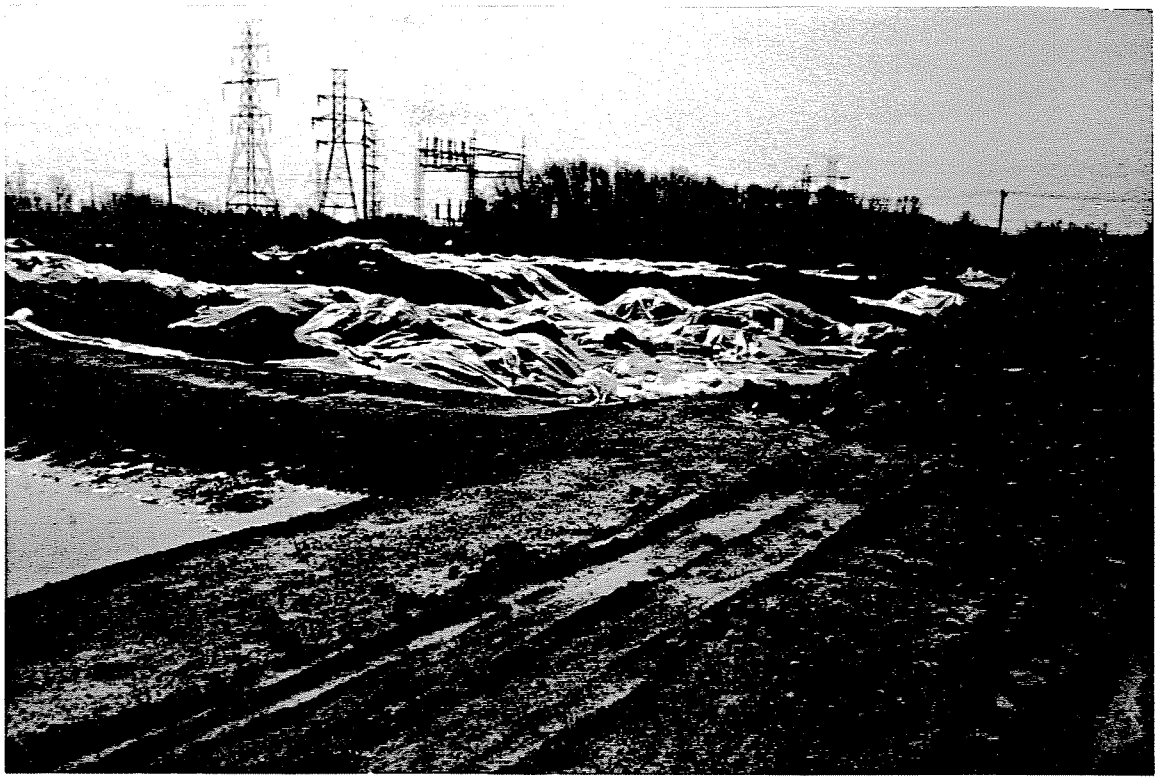
Client: NYSDEC	E & E Job No.: SB5222
Site: TAM Ceramics, Inc.	
Camera: Make      Kodak 35mm	SN      Disposable
Lens Type      --	SN      --
	Photographer: Scott Glinski      Date: 4/29/91
	Time: 10:45      Frame No.: 18
	Comments*: Berm with plastic lining, soil surrounding drums excavated in fall 1990.
*Comments to include location.

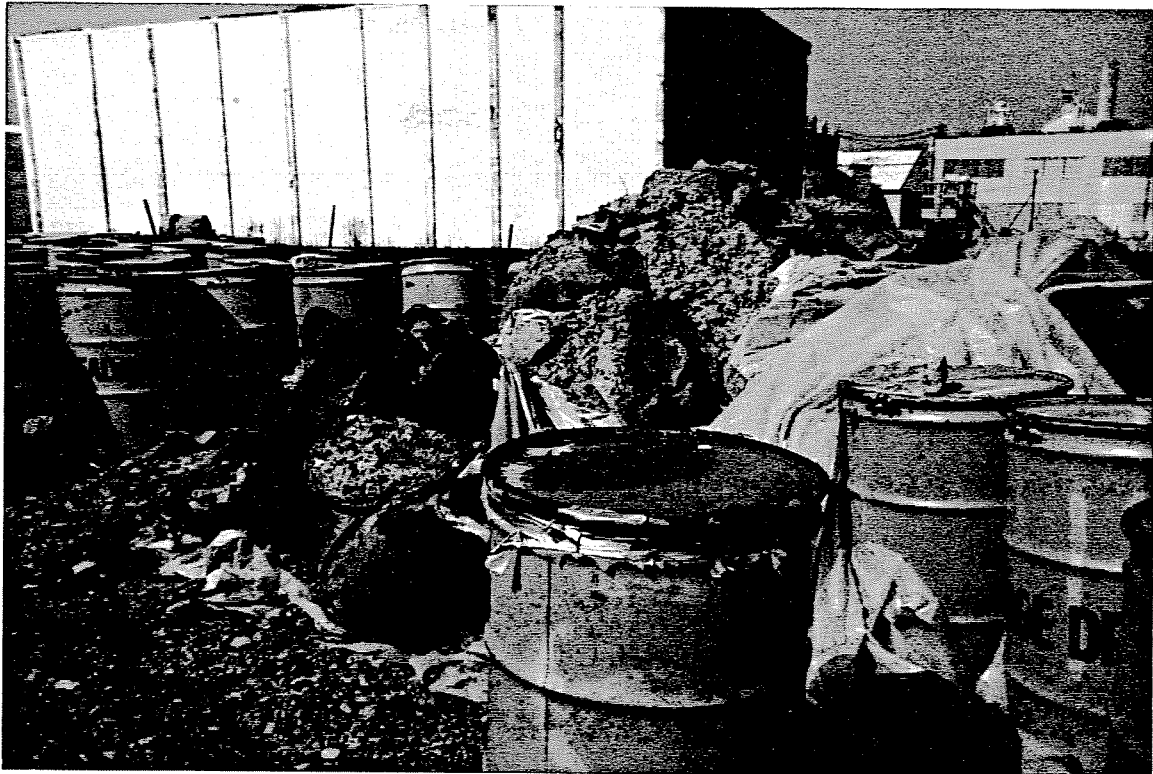
Comments\*: Overpack drums from excavation  
activities, fall 1990.

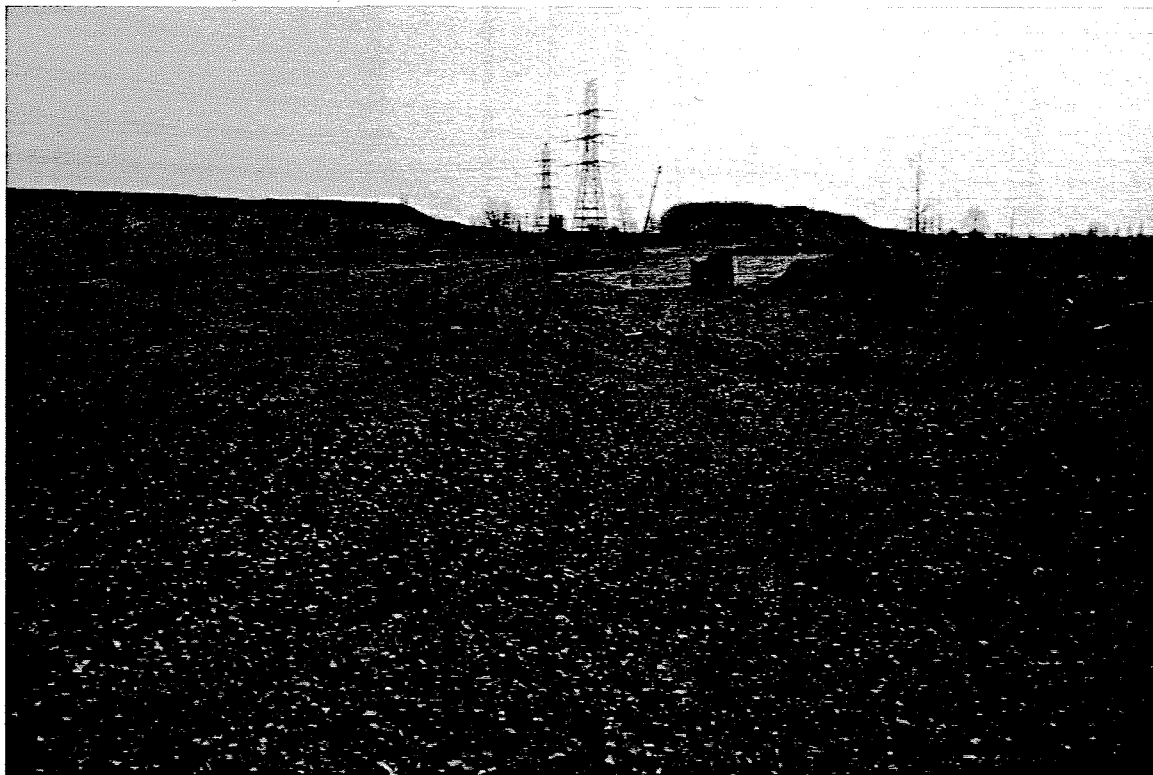
Comments\*: Direction northeast, excavated  
drum area.

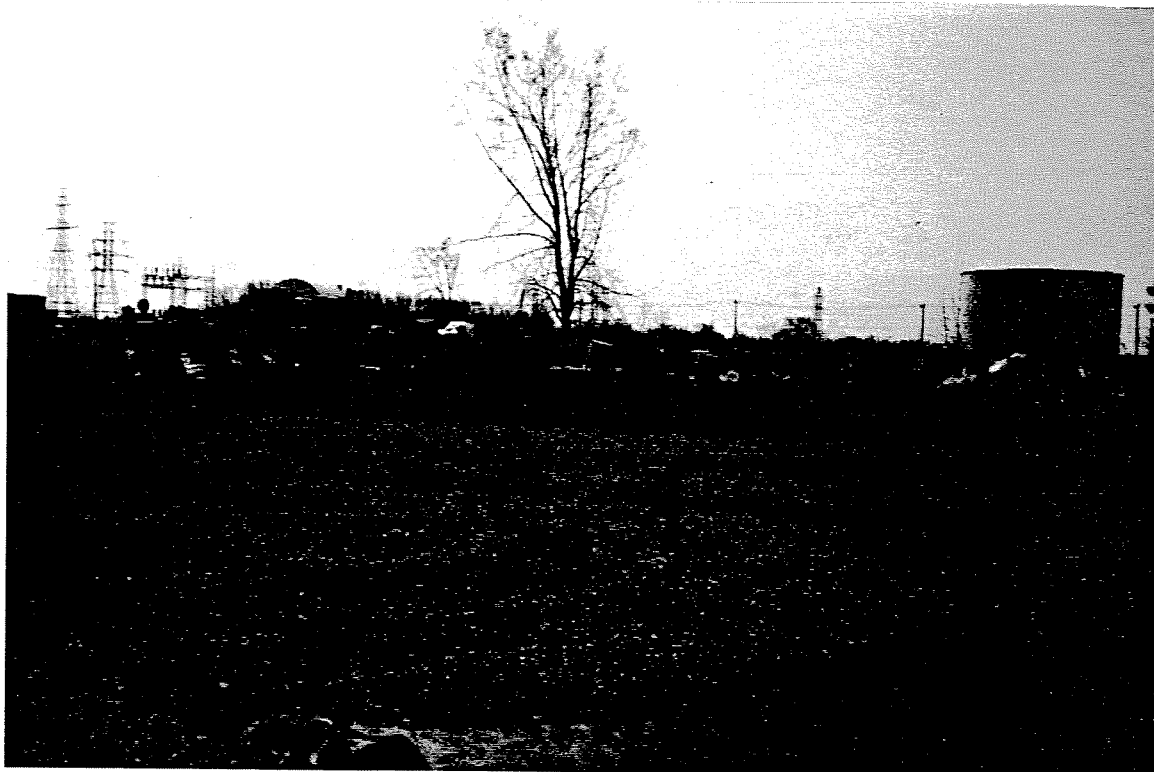
Comments\*: Direction southeast, berm area  
with overpack drums from excavation.

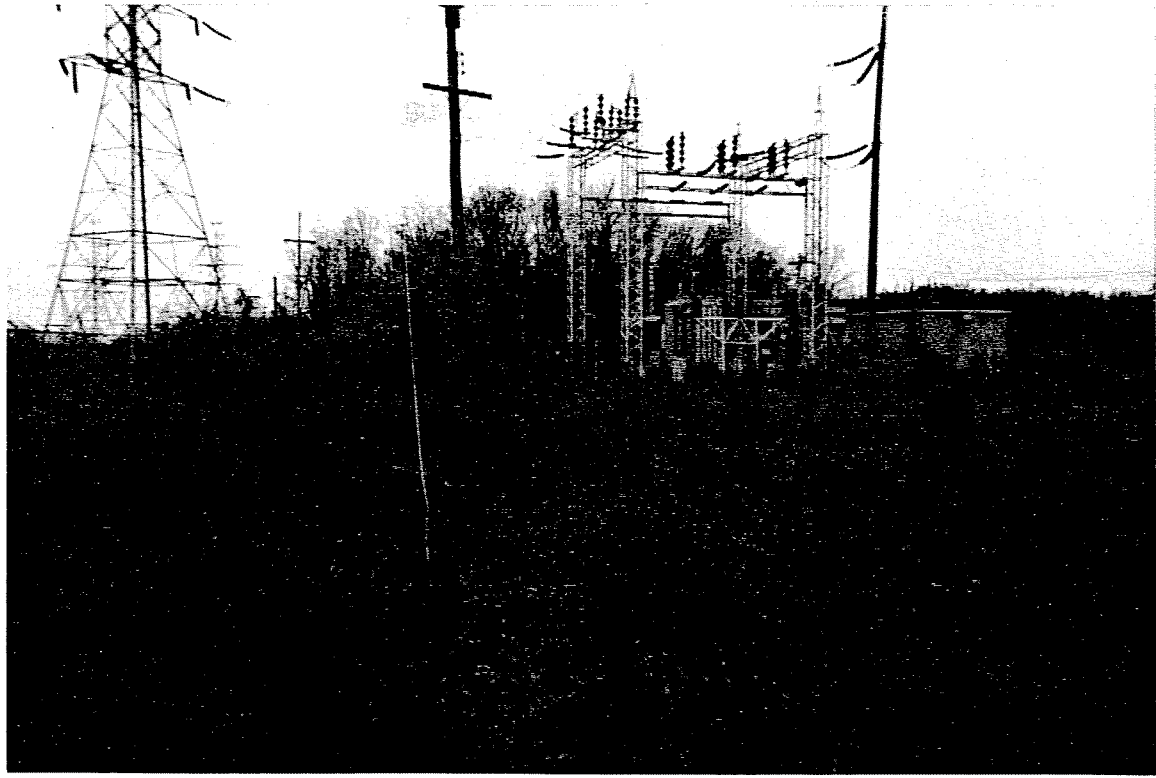
Client: NYSDEC	E & E Job No.: SB5222
Site: TAM Ceramics, Inc.	
Camera: Make Kodak 35mm	SN Disposable
Lens Type --	SN --
	Photographer: Linda Fischer Date: 5/6/91
	Time: 15:40 Frame No.: 20
	Comments*: Direction southeast, downed high voltage power line.
*Comments to include location.

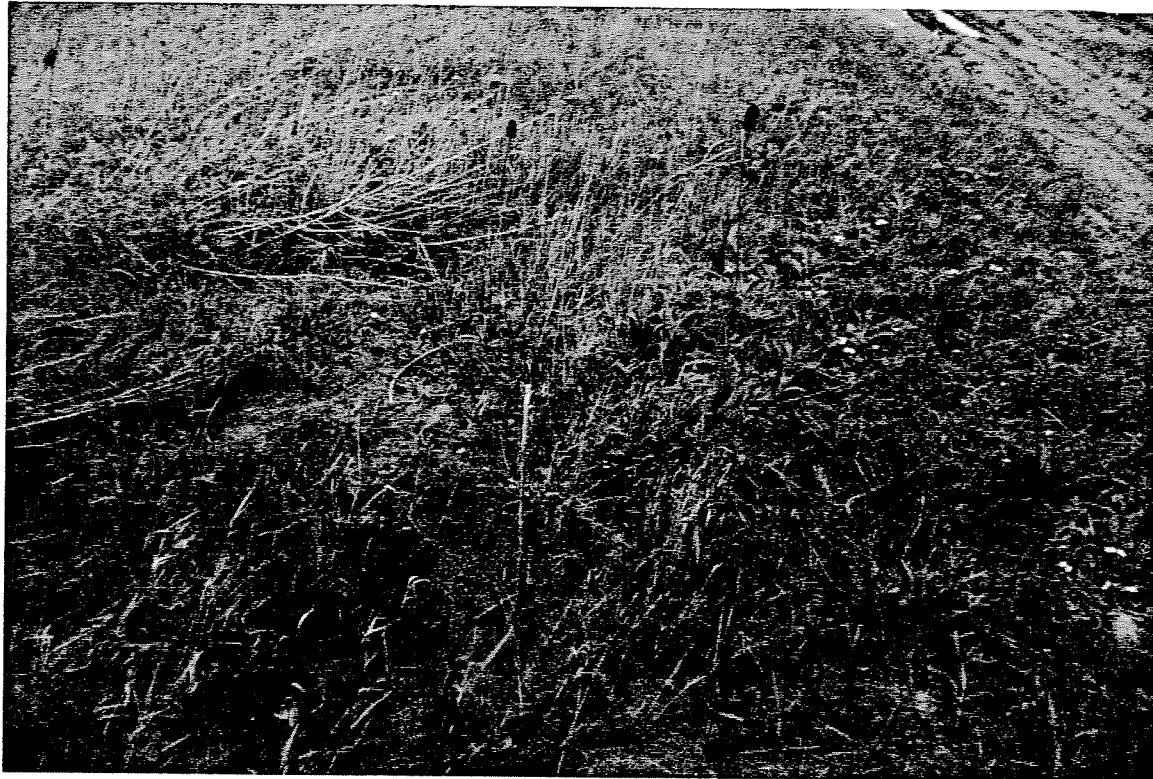
Comments\*: Direction northeast, area where  
oil/sludge was surfacing.

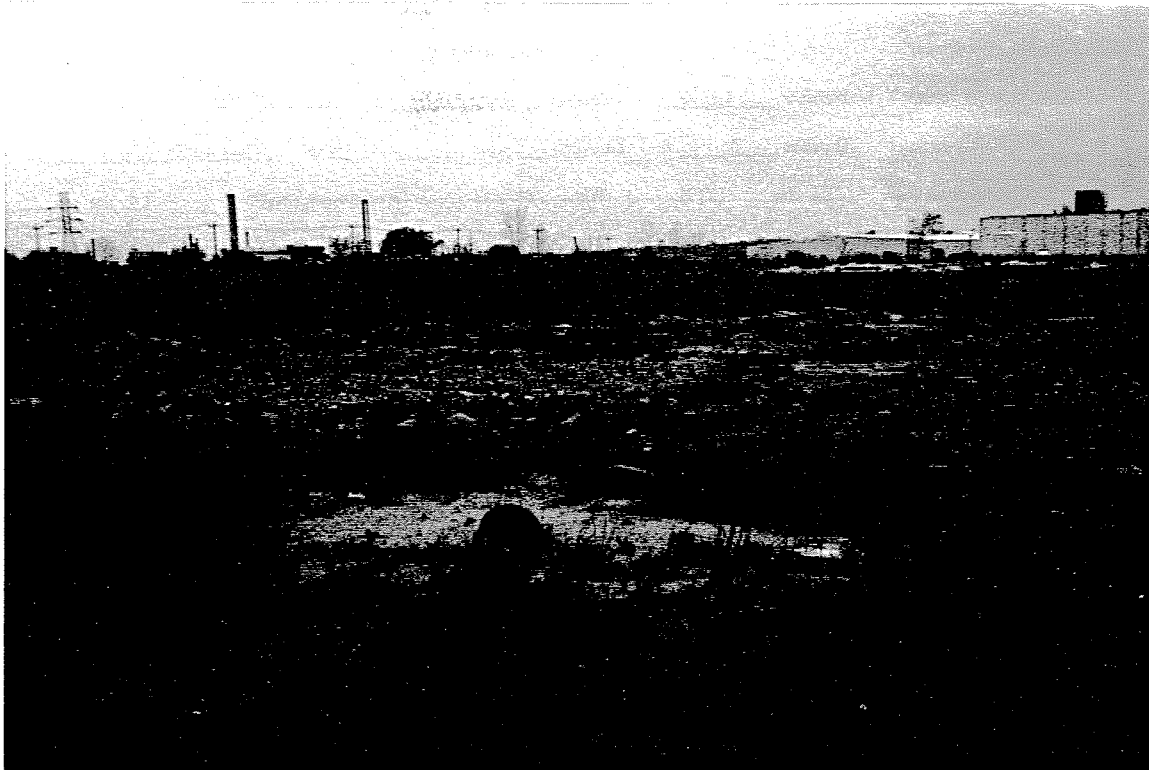
Comments\*: Direction southwest, blue-gray powder  
spread along east end of property.

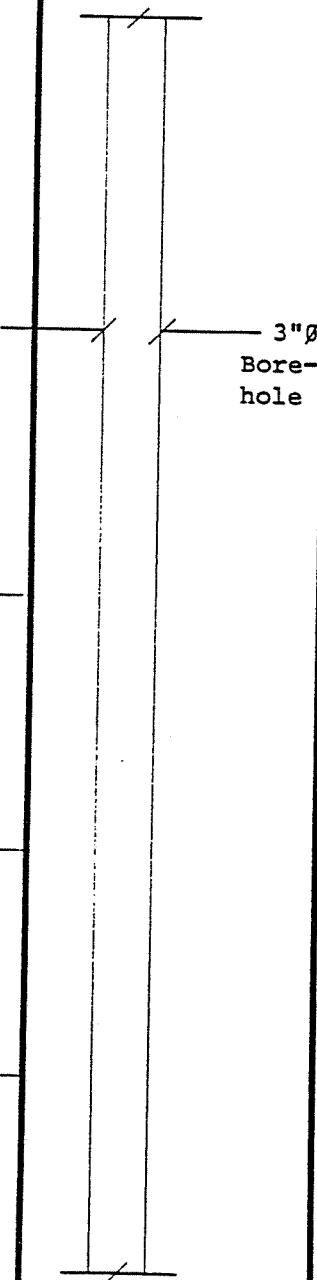
HOLE №: F-4 Page 3 of 4  
 DATE COMPLETED: MAY 25, 1983  
 GEOLOGIST/ENGINEER: W. CLARKE/J. KAY  
 GROUND ELEVATION: 601.4  
 TOP OF PIPE ELEVATION: \_\_\_\_\_

PROFILE		MONITOR INSTALLATION	SAMPLE			PENETRATION TEST BLOWS/FOOT				
DEPTH (ELEVATION)	STRATIGRAPHY DESCRIPTION & REMARKS		NUMBER	TYPE	BLOWS / FOOT					
						20	40	60	80	
525	Grey fine grained DOLOMITE

520										
515										
510										
505	Grey aphanitic DOLOMITE									
500	Medium grey fine to medium grained DOLOMITE									
495	GASPORT MEMBER									
490	Grey aphanitic DOLOMITE									
485	DECEW MEMBER

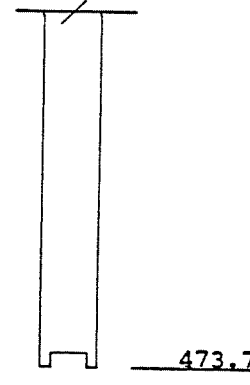
HOLE N° : F-4 Page 4 of 4  
 DATE COMPLETED : MAY 25, 1983  
 GEOLOGIST/ENGINEER : W. CLARKE/J. KAY  
 GROUND ELEVATION : 601.4  
 TOP OF PIPE ELEVATION : \_\_\_\_\_

PROFILE		MONITOR INSTALLATION	SAMPLE			PENETRATION TEST BLOWS / FOOT			
DEPTH (ELEVATION)	STRATIGRAPHY DESCRIPTION & REMARKS		NUMBER	TYPE	BLOWS / FOOT	20	40	60	80
485	Grey aphanitic DOLOMITE DECEW MEMBER

480	Dark grey dolomitic SHALE  ROCHESTER FORMATION								
475	Unrecovered Core		473.7						
470

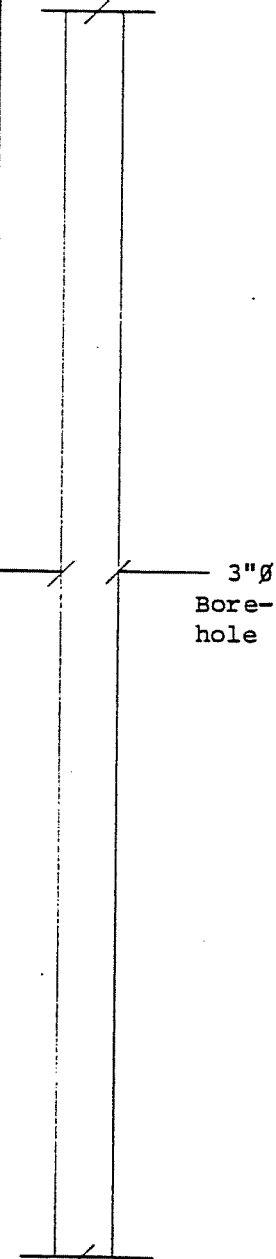
HOLE N<sup>o</sup> : G-3 Page 3 of 4  
 DATE COMPLETED : FEBRUARY 26, 1983  
 GEOLOGIST/ENGINEER : W. CLARKE/J. KAY  
 GROUND ELEVATION : 609.7  
 TOP OF PIPE ELEVATION : \_\_\_\_\_

DEPTH (ELEVATION)	PROFILE	MONITOR INSTALLATION	SAMPLE			PENETRATION TEST BLOWS/FOOT			
	STRATIGRAPHY DESCRIPTION & REMARKS		NUMBER	TYPE	BLOWS / FOOT				
						20	40	60	80
535	Grey aphanitic to medium grained DOLOMITE

530									
525	Grey fine grained DOLOMITE								
520									
515		<div style="text-align: right; margin-right: 20px;">3"Ø Bore- hole</div>							
510									
505	Grey aphanitic to fine grained DOLOMITE								
500									
495

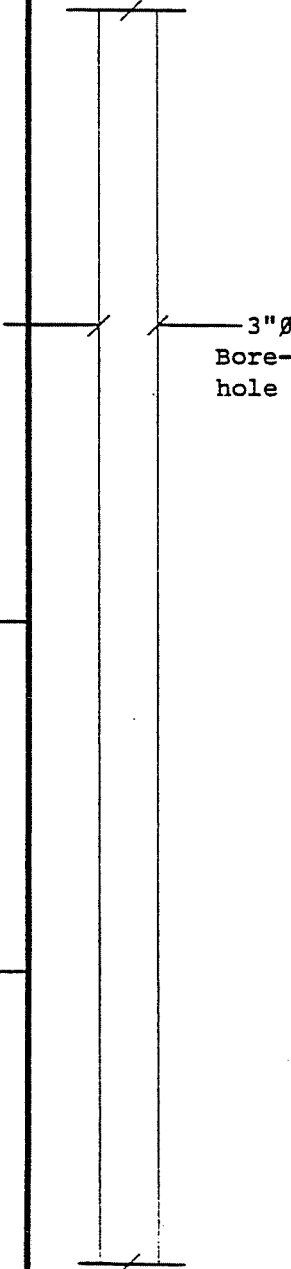
HOLE N° : H-3 Page 2 of 4  
 DATE COMPLETED : MAY 18, 1983  
 GEOLOGIST/ENGINEER : W. CLARKE/J. KAY  
 GROUND ELEVATION : 616.1  
 TOP OF PIPE ELEVATION : \_\_\_\_\_

PROFILE		MONITOR INSTALLATION	SAMPLE			PENETRATION TEST BLOWS / FOOT				
DEPTH (ELEVATION)	STRATIGRAPHY DESCRIPTION & REMARKS		NUMBER	TYPE	BLOWS / FOOT	20	40	60	80	
580	Grey aphanitic DOLOMITE

575										
570										
565	Grey fine grained DOLOMITE									
560										
555	Grey aphanitic DOLOMITE									
550										
545										
540

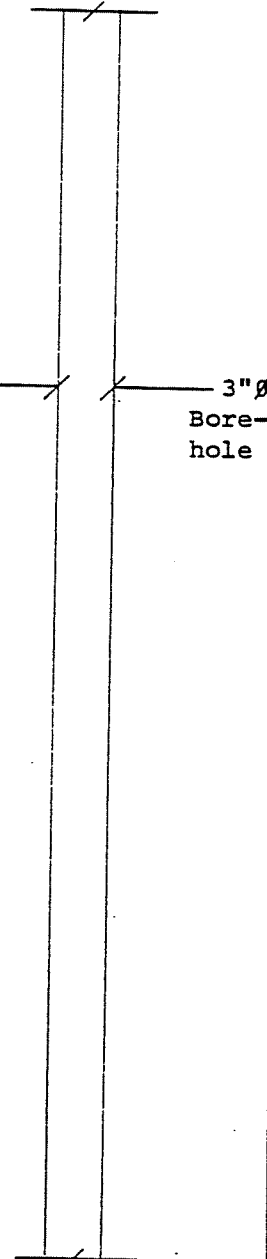
HOLE N<sup>o</sup> : H-3 Page 3 of 4  
 DATE COMPLETED : MAY 18, 1983  
 GEOLOGIST/ENGINEER : W. CLARKE/J. KAY  
 GROUND ELEVATION : 616.1  
 TOP OF PIPE ELEVATION : \_\_\_\_\_

PROFILE		MONITOR INSTALLATION	SAMPLE			PENETRATION TEST BLOWS / FOOT				
DEPTH (ELEVATION)	STRATIGRAPHY DESCRIPTION & REMARKS		NUMBER	TYPE	BLOWS / FOOT					
					20	40	60	80		
540	Grey aphanitic DOLOMITE

3" Ø Bore- hole								
535										
530										
525	Grey fine grained DOLOMITE									
520										
515										
510										
505										
500

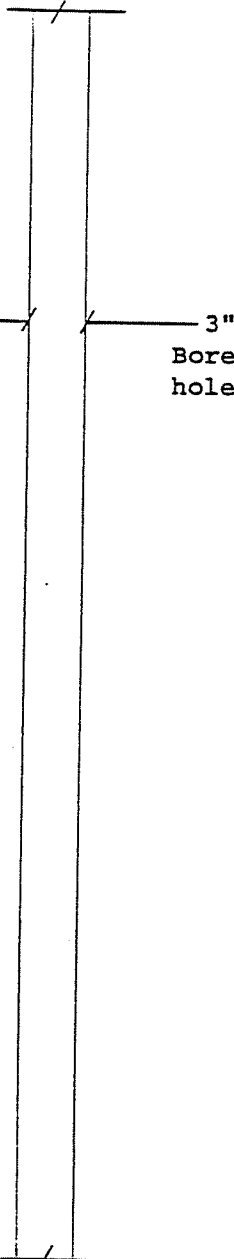
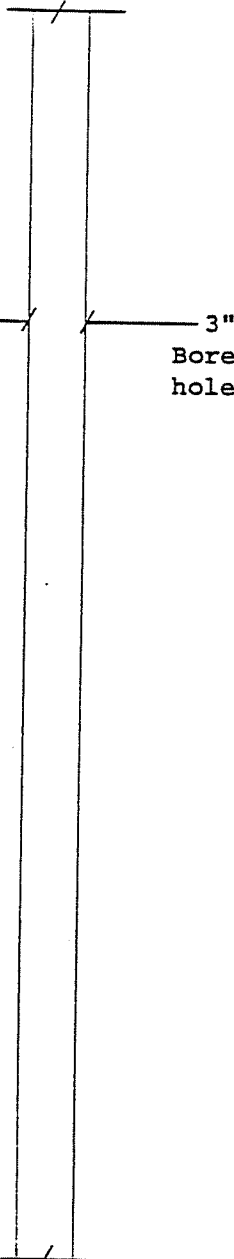
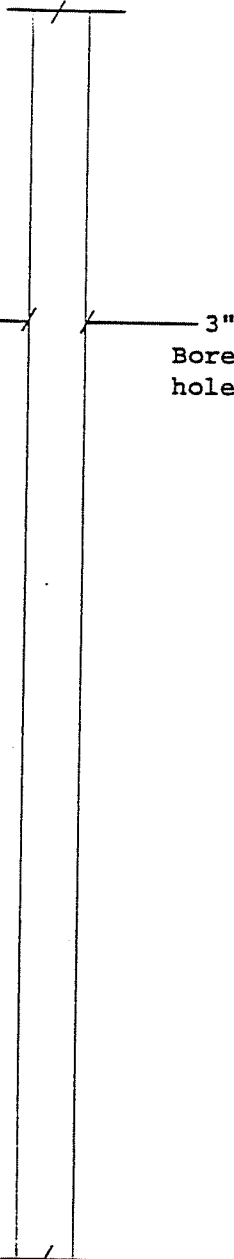
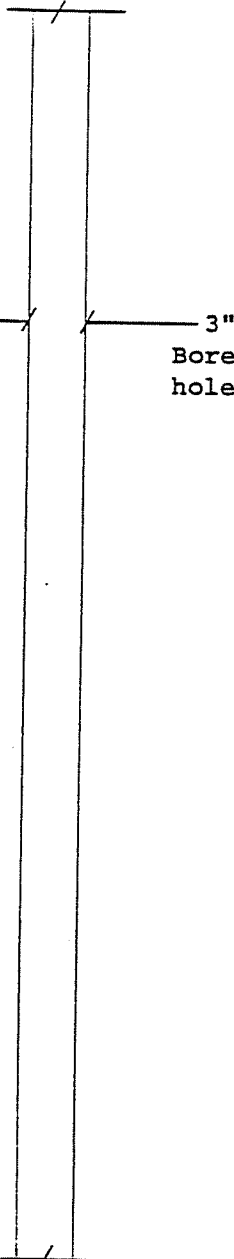
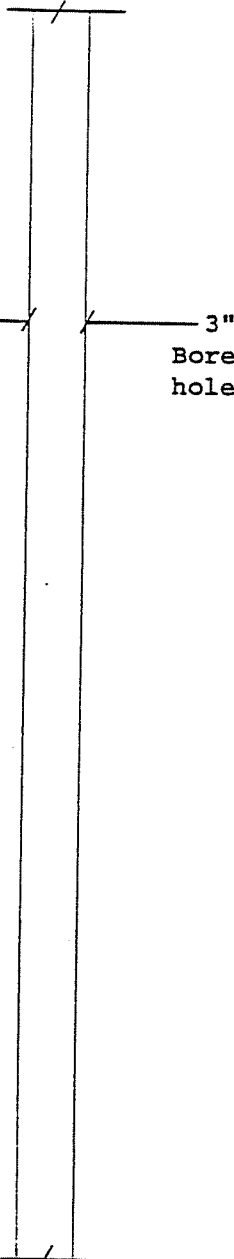
HOLE N<sup>o</sup> : H-4 Page 3 of 4  
 DATE COMPLETED : APRIL 6, 1983  
 GEOLOGIST/ENGINEER : W. CLARKE/J. KAY  
 GROUND ELEVATION : 611.9  
 TOP OF PIPE ELEVATION : \_\_\_\_\_

PROFILE		MONITOR INSTALLATION	SAMPLE			PENETRATION TEST BLOWS/FOOT			
DEPTH (ELEVATION)	STRATIGRAPHY DESCRIPTION & REMARKS		NUMBER	TYPE	BLOWS / FOOT	20	40	60	80
535	Grey fine grained DOLOMITE

530									
525	Grey aphanitic to fine grained DOLOMITE

520									
515	Grey fine grained DOLOMITE

510									
505	Grey fine grained DOLOMITE
