**ENGINEERING INVESTIGATIONS AT
INACTIVE HAZARDOUS WASTE SITES IN THE
STATE OF NEW YORK
PHASE II INVESTIGATIONS**

**HOLIDAY PARK
NORTH TONAWANDA, NIAGARA COUNTY, NEW YORK**

SITE CODE: 932033

June 1985

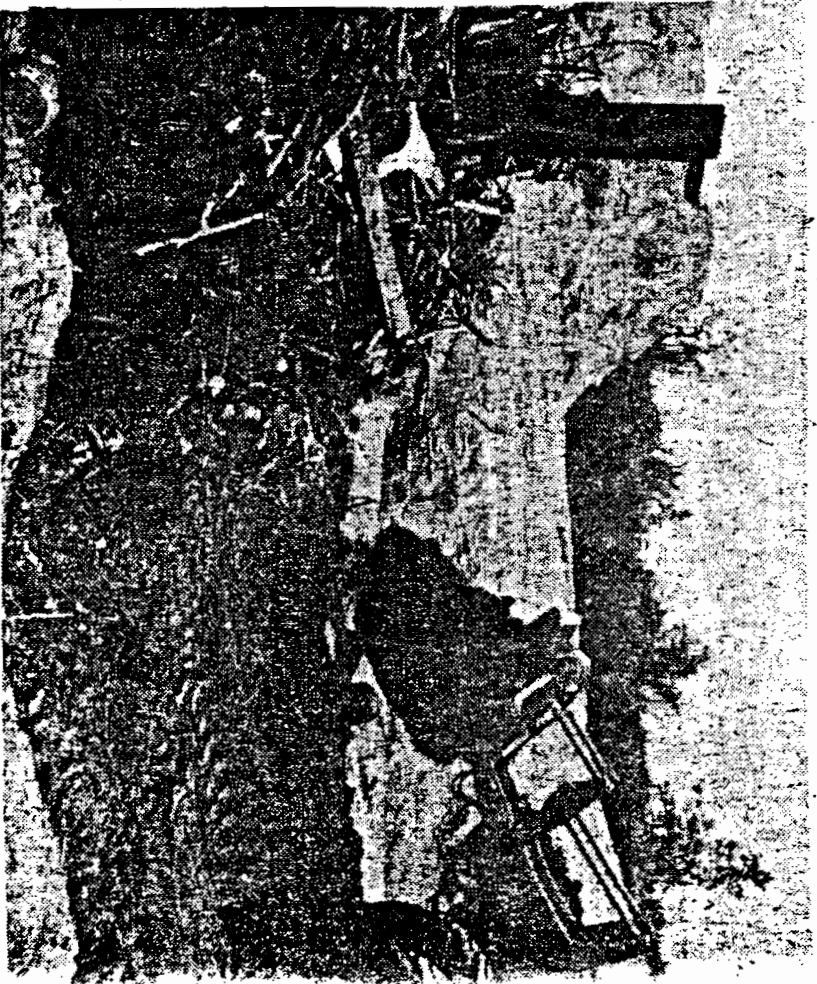
ILLEGAL DUMPING? — North brush, and other bulky trash in Tonawanda DPW equipment, at right, secluded spot inside the city's Holiday Park last summer.
