# ENGINEERING INVESTIGATIONS AT INACTIVE HAZARDOUS WASTE SITES IN THE STATE OF NEW YORK

## PHASE II INVESTIGATIONS

Wurlitzer Site  
Site Number 932041  
City of North Tonawanda, Niagara County

April 1992

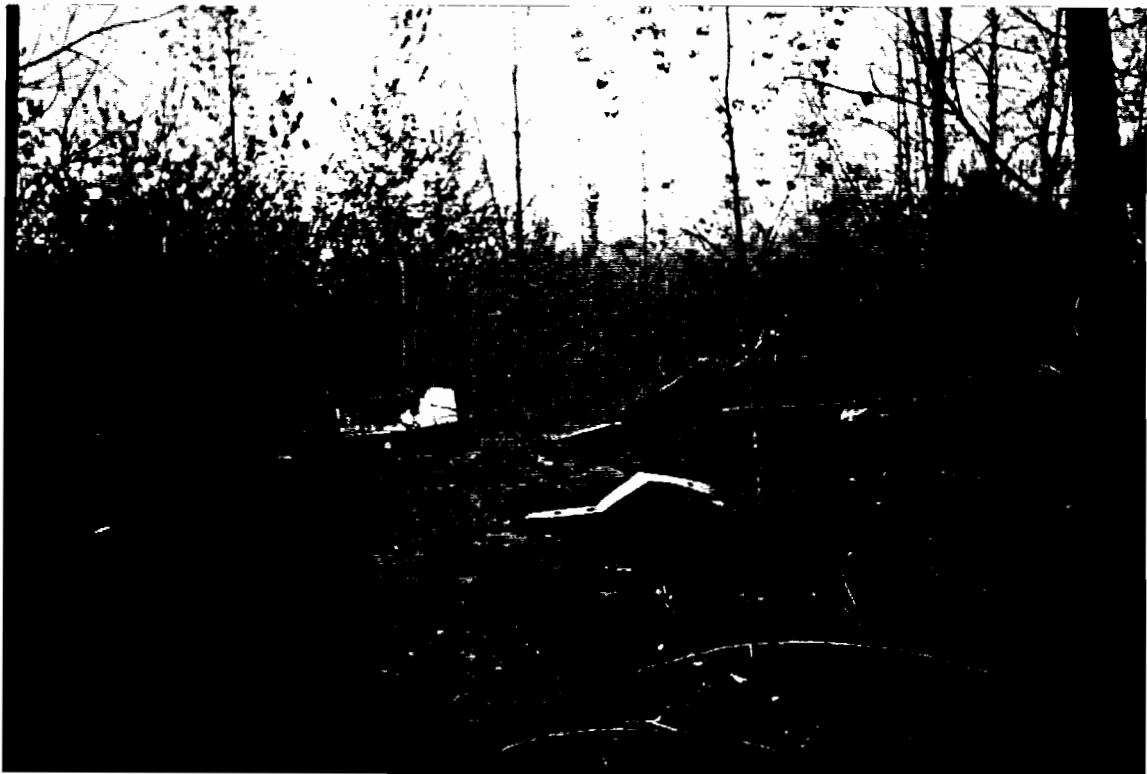
Lens: Type Auto Focus SN: NA Frame No.: 11

Comments: C&D debris in Area B. Front and back of photo show rusted steel. Center right is asphalt shingles. Soil sample S-8 taken in this area.

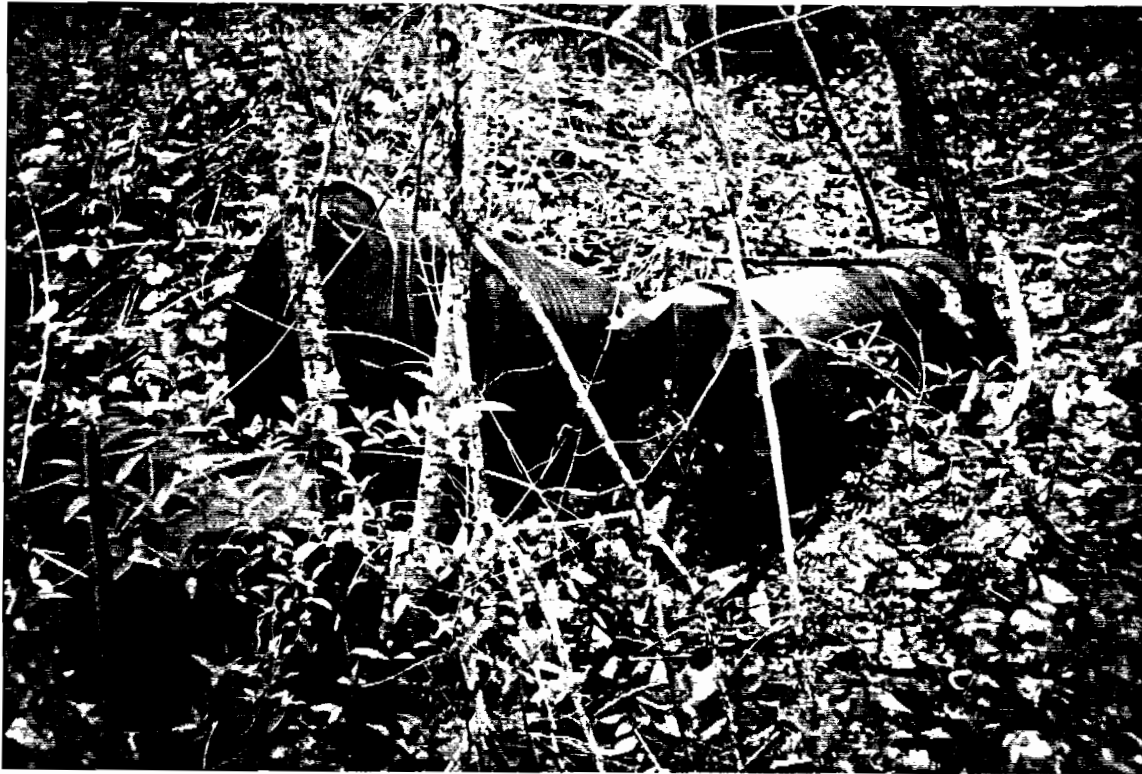
Lens: Type Auto Focus SN: NA Frame No.: 13

Comments: Rusted drums along footpath in Area B containing an unknown solid material. Soil sample  
S-6 collected at base of open drum.

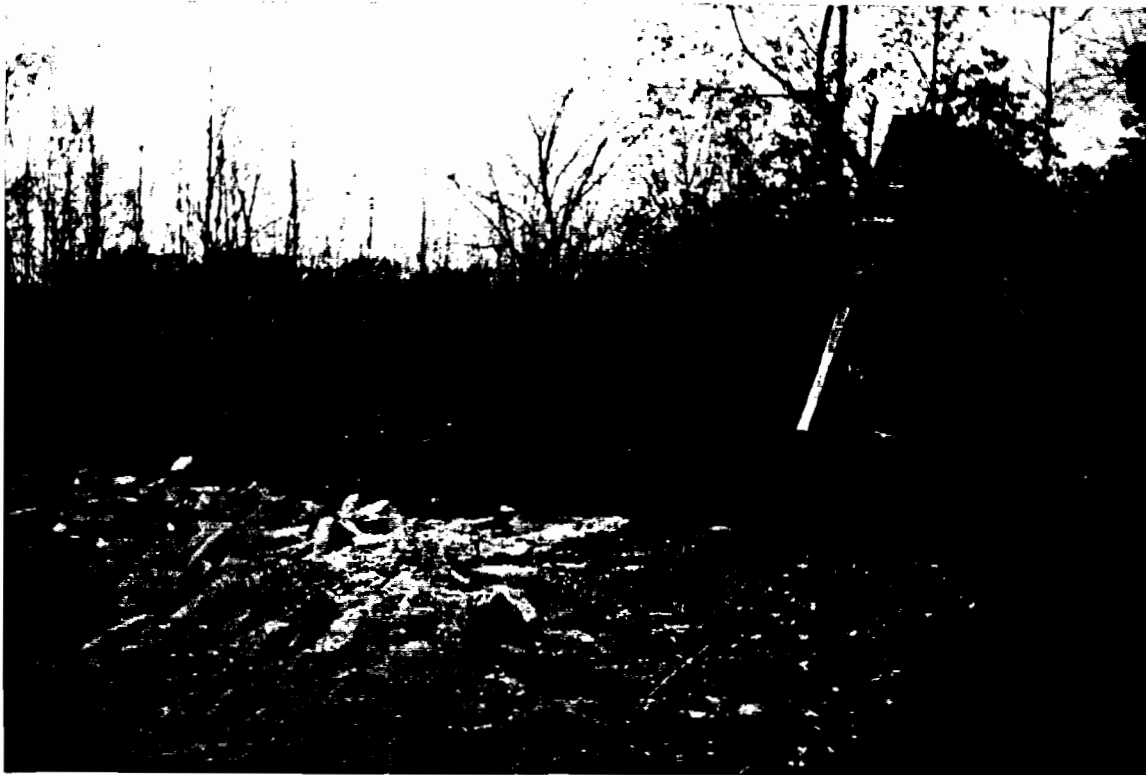
Lens: Type Auto Focus SN: NA Frame No.: 19

Comments: C&D debris in northeast corner of Area A. View is to the north.

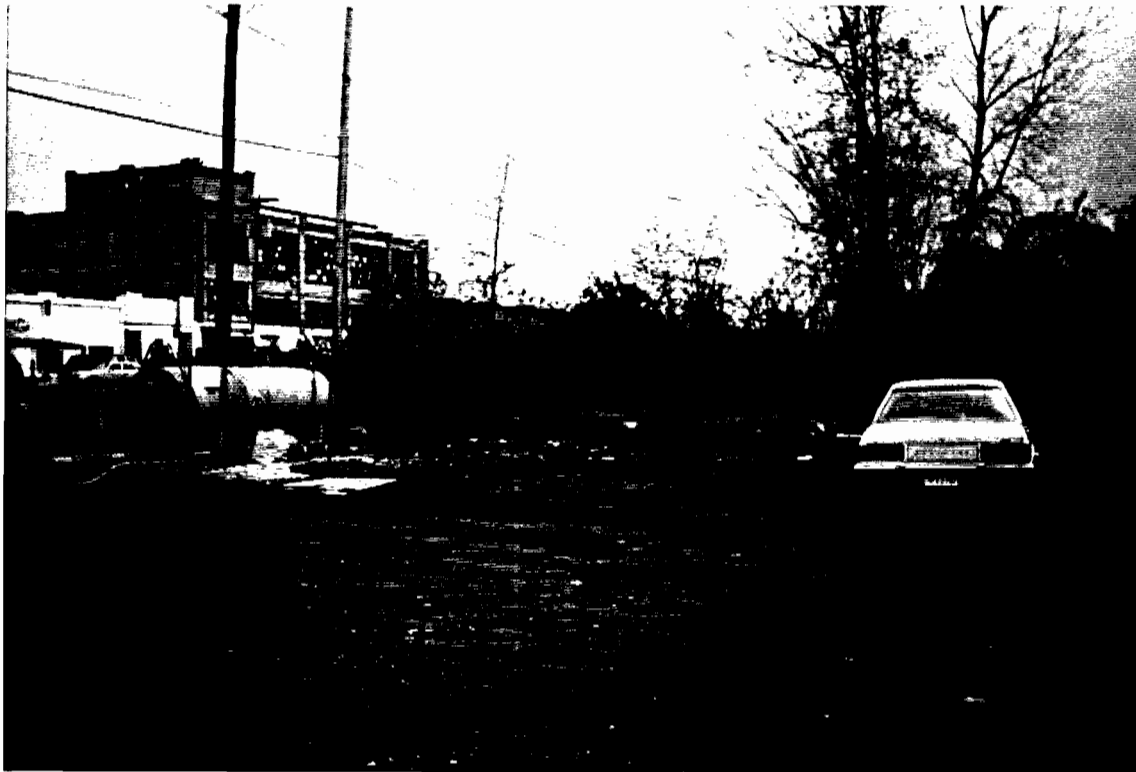
Comments: Diesel storage tank in southeast corner of Area A, with Wurlitzer building in background.

Tank was removed prior to the drilling of GW-3 which is nearby. View is to the south.

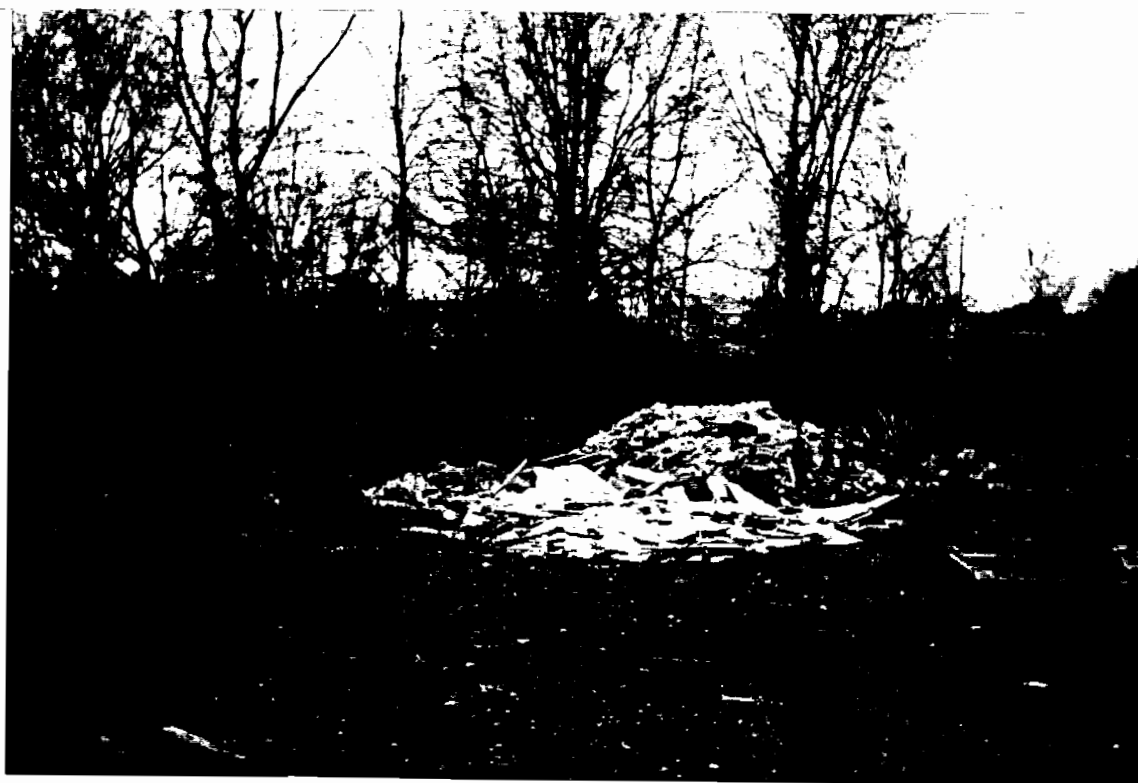
Lens: Type Auto Focus SN: NA Frame No.: 24

Comments: C&D debris piles just north of survey grid #4. View is to the west.

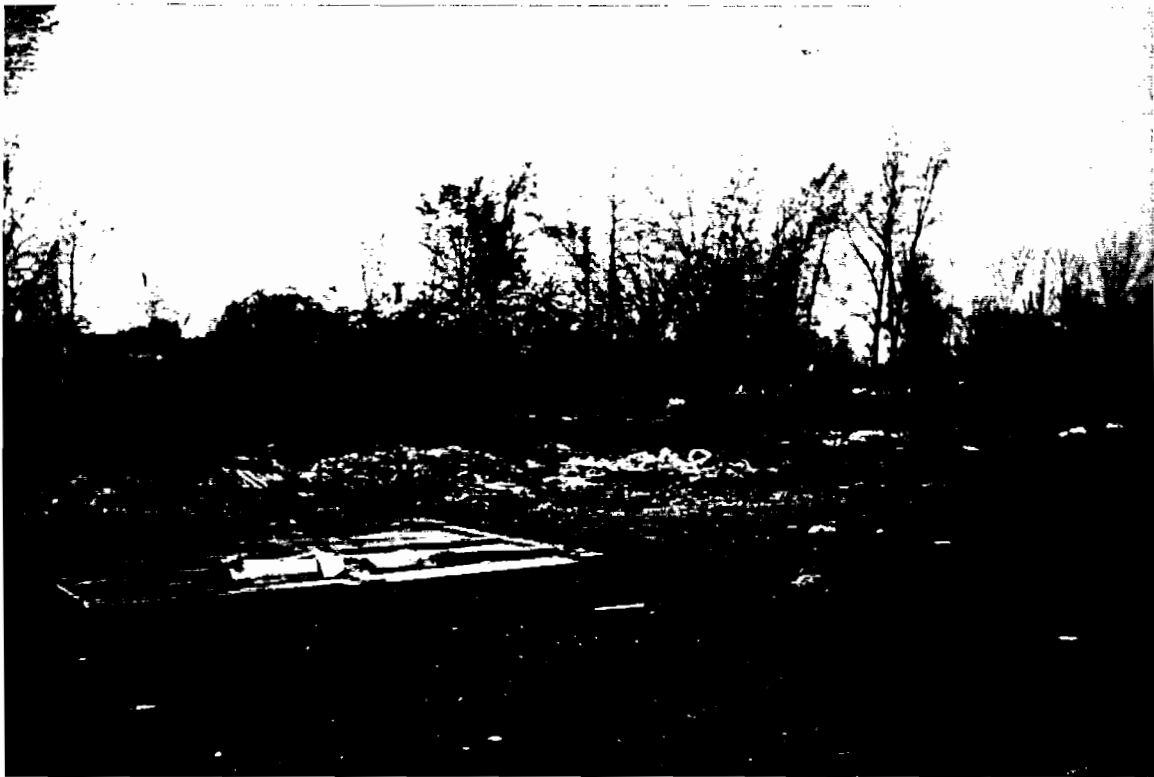
Lens: Type Auto Focus SN: NA Frame No.: 25

Comments: C&D debris and abandoned trailer in area just north of survey grid #4. View is to the north.
