# **ENGINEERING INVESTIGATIONS AT INACTIVE HAZARDOUS WASTE SITES**

## **PHASE I INVESTIGATION**

**CARBORUNDUM BUILDING 82, SITE NUMBER 932048B  
CITY OF NIAGARA FALLS, NIAGARA COUNTY**

**January 1990**

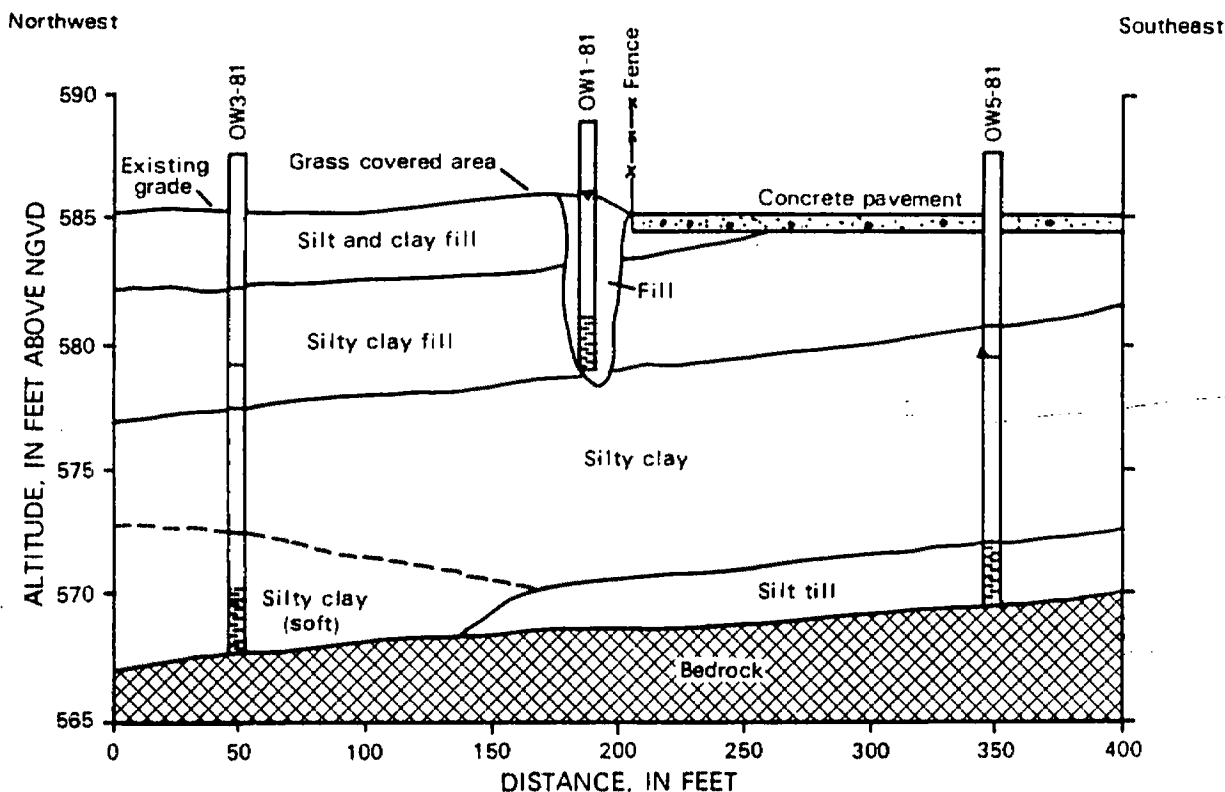
Figure C-4. Geologic cross section of formations underlying Carborundum-Abrasive Division, site 9, Wheatfield.  
(Modified from Conestoga-Rovers and Assoc., 1981.)

Geologic information.--The site consists of clay and silty fill underlain by a silty lacustrine clay, which is in turn underlain by a discontinuous layer of till. These units overlie bedrock of Lockport Dolomite. A geologic cross section is shown in figure C-4.

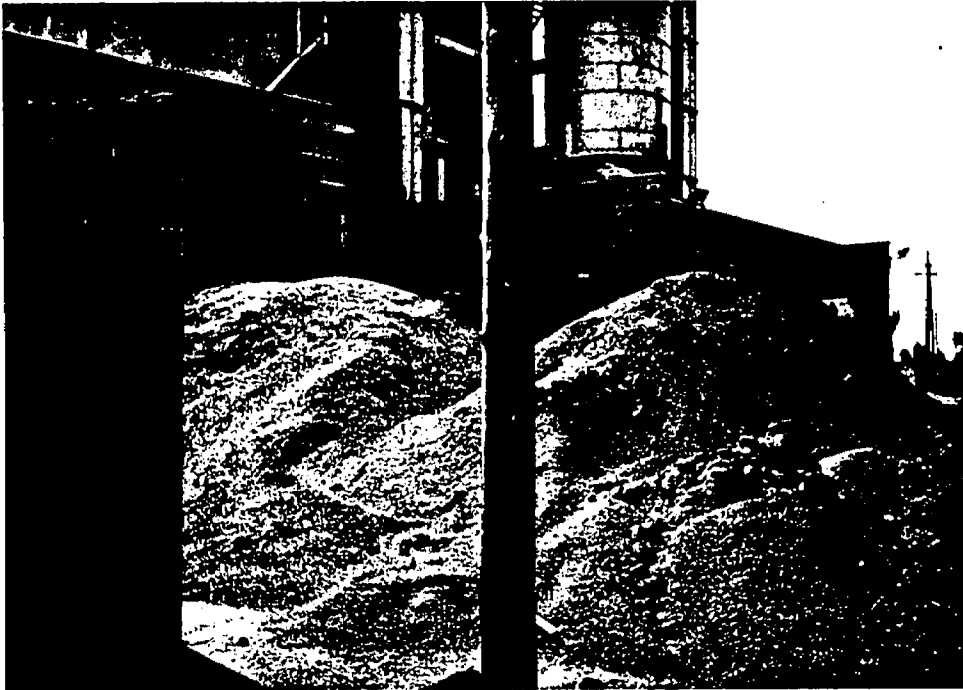
Frame No.: 1

Comments\*: Silicon carbide  
pile at west end of Building  
83, for eventual recycling.  
Electro Minerals (U.S.) Inc.

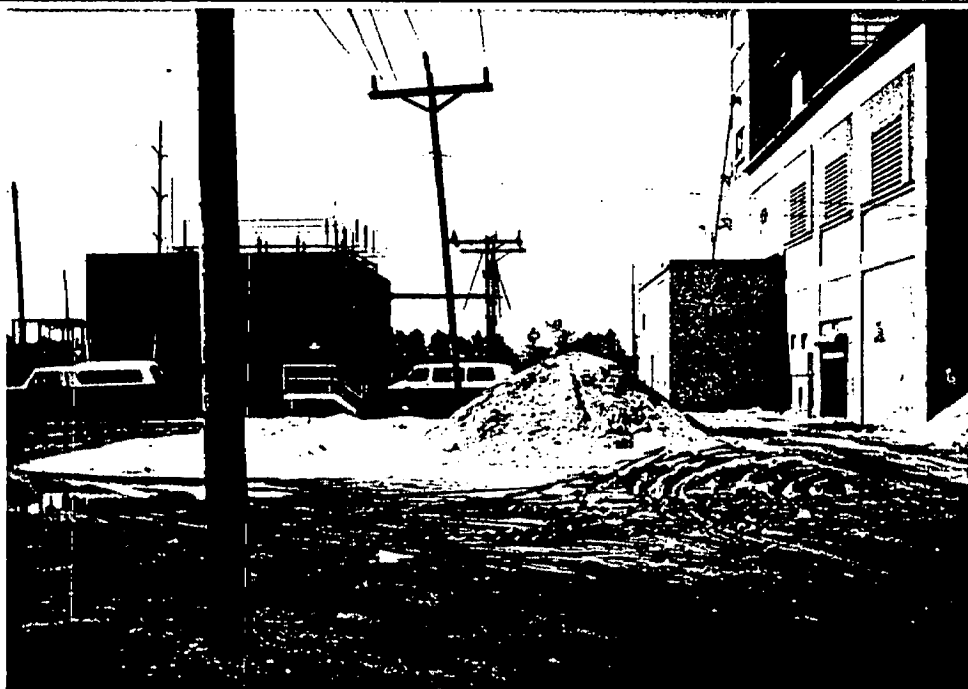
rainwater runoff. West of

Building 82.

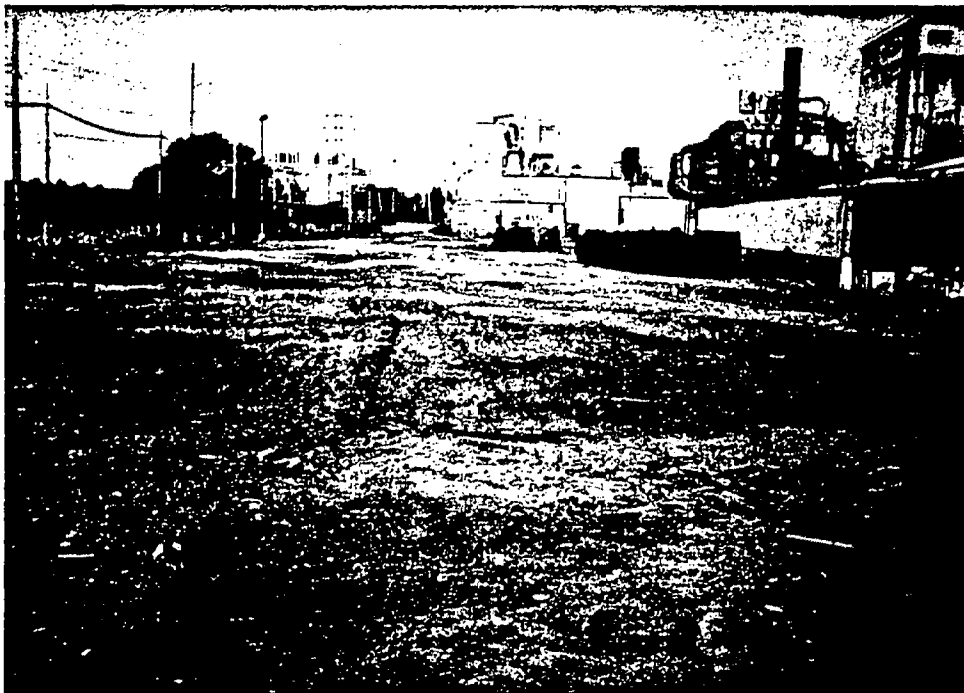
Frame No.: 5

Comments\*: Former waste storage area looking east toward Building 86. Trash has been removed, area is covered with fill.

In general, the site was free of stored waste. No landfill activity was noted and the former storage area was graded with crushed stone. All formerly stored waste appeared to be removed.
