**Re: Industrial Welding Site, Niagara Falls, New York  
Site No. 932050  
Annual Periodic Review Report – 2024  
Periodic Review Report – May 01, 2023 through May 01, 2024**

**Industrial Welding Site  
Site No. 932050  
2024 Periodic Review Report**

**Originally Submitted: May 31, 2024  
Revision 1: May 12, 2025**

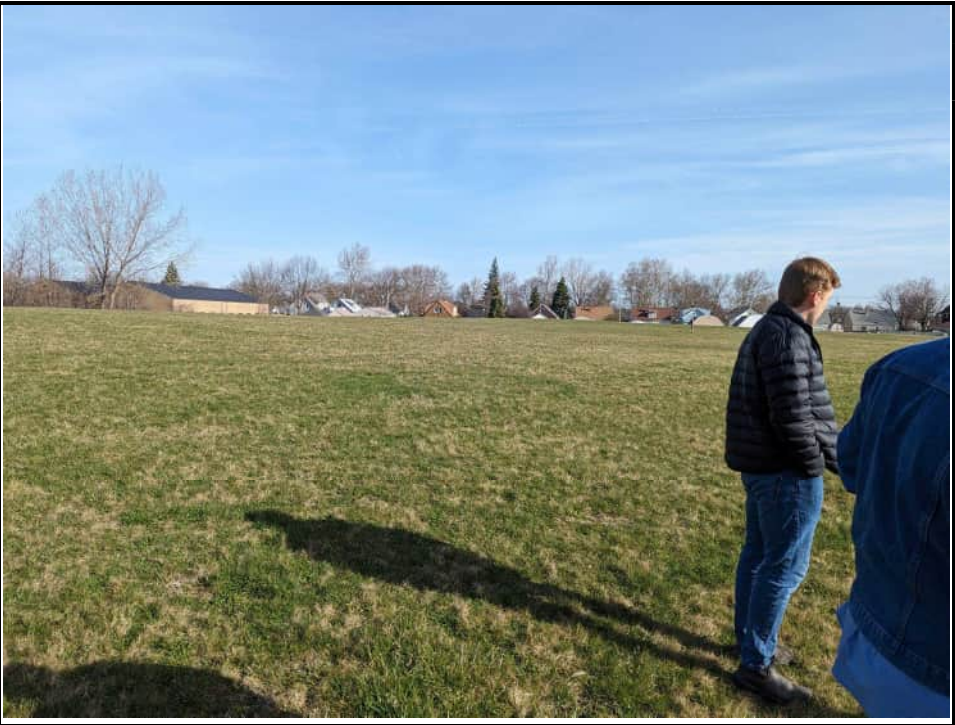
2	April 9, 2024	
Looking Northwest at vegetated cap of OU2.

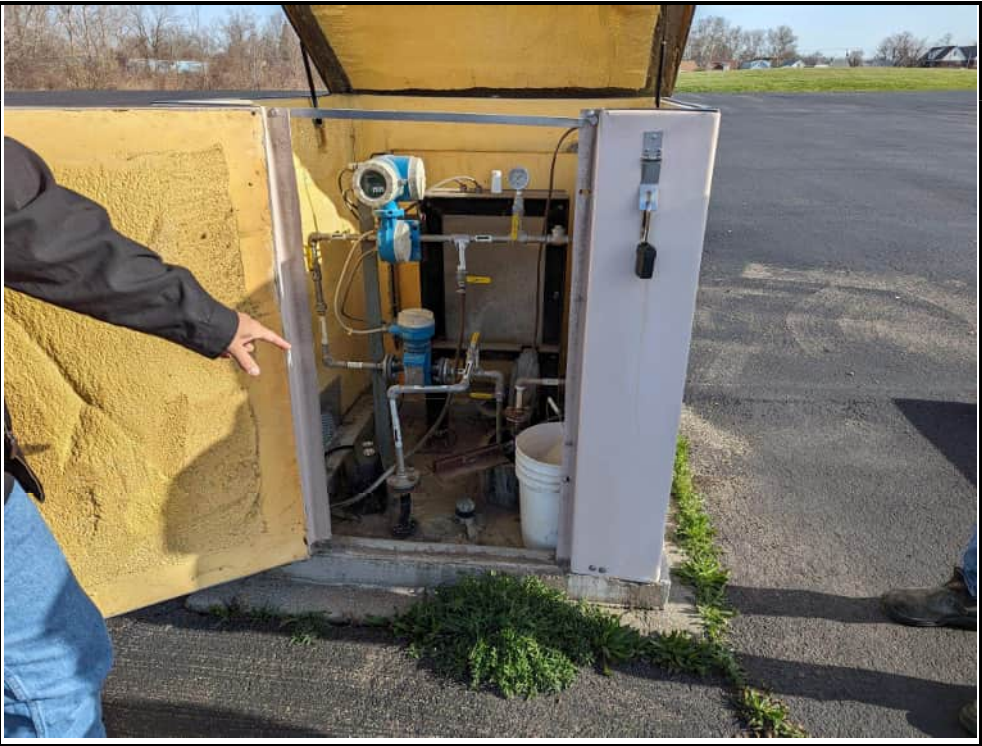
Photo No.	Date	
5	April 9, 2024	
Leachate Collection and Recovery System Well

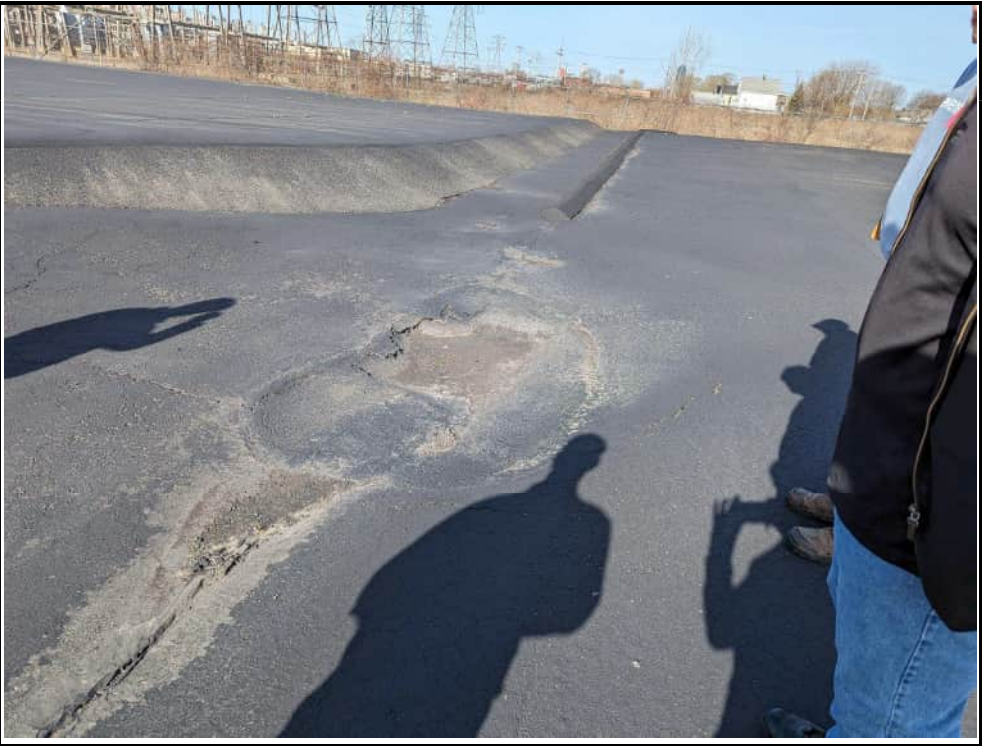
Photo No.	Date	
6	April 9, 2024	
Minor depression on the western side of OU3 - Cap
