**Re: Industrial Welding Site, Niagara Falls, New York**  
**Site No. 932050**  
**Annual Periodic Review Report – 2026**  
**Periodic Review Report – May 01, 2025 through May 01, 2026**

**Industrial Welding Site  
Site No. 932050  
2026 Periodic Review Report**

**Submitted: May 31, 2026  
Revision: July 8, 2026**

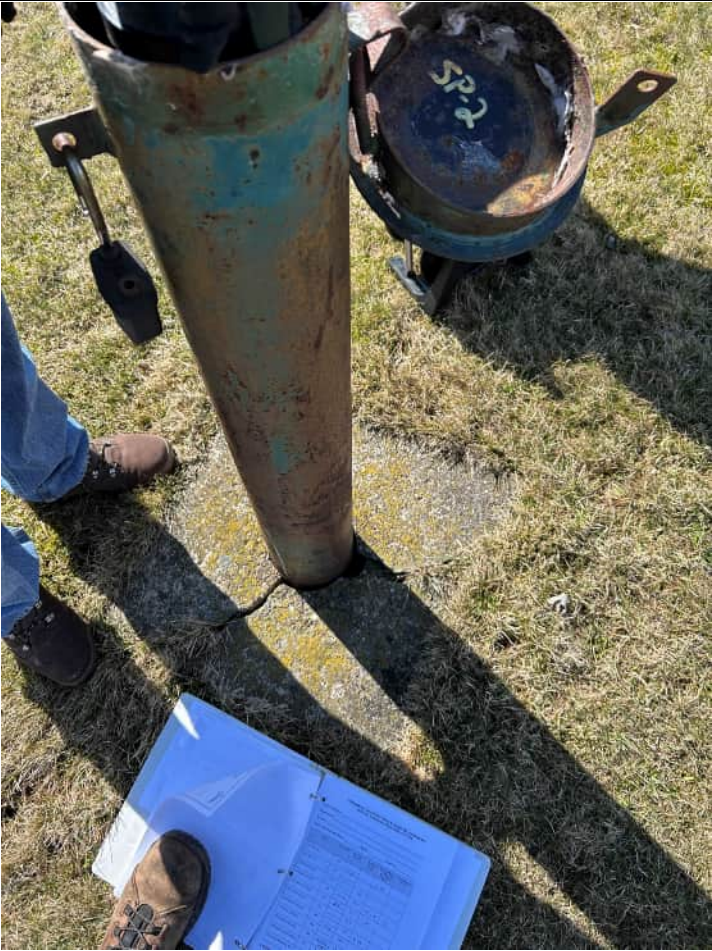
| Photo No. | Date | |
|---|---|---|
| 1 | 3/25/26 | |

| Photo No. | Date | |
|---|---|---|
| 3 cracks in pavement at SP-2 | | |

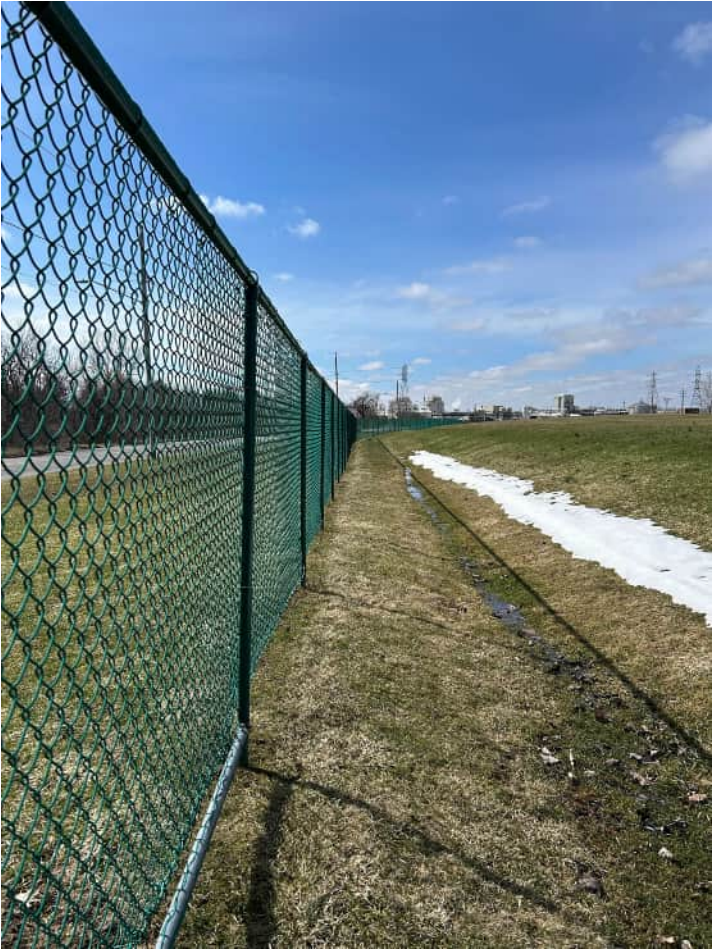
| Photo No. | Date | |
|---|---|---|
| 2 | 3/25/26 | |

| Photo No. | Date | |
|---|---|---|
| Eastern fence condition facing south | | |

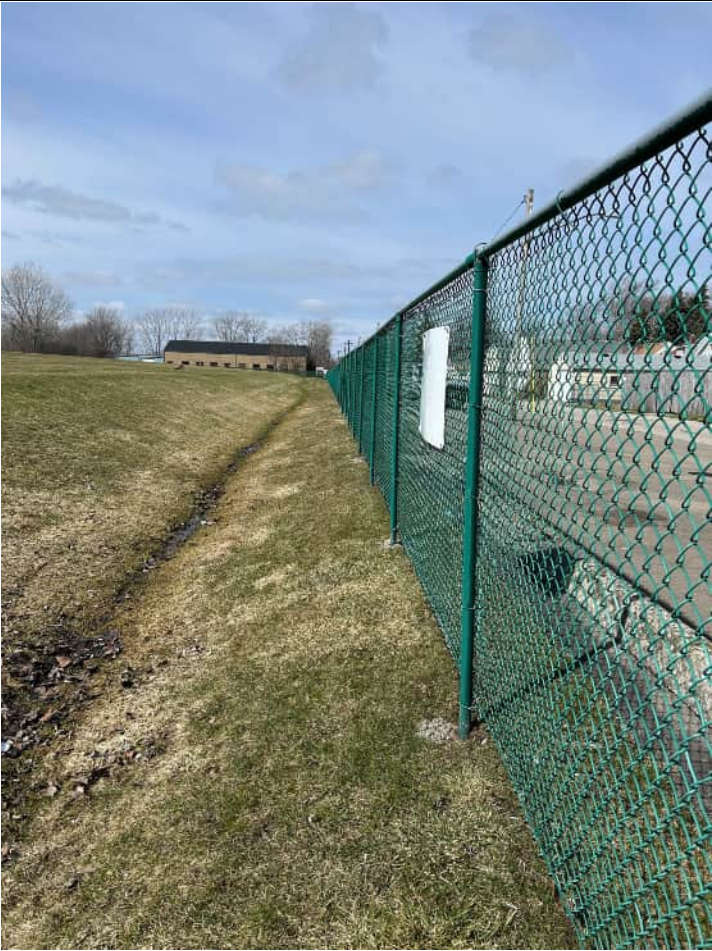
| Photo No. | Date | |
|---|---|---|
| 3 | 3/25/26 | |

| Photo No. | Date | |
|---|---|---|
| Northern fence condition facing west | | |

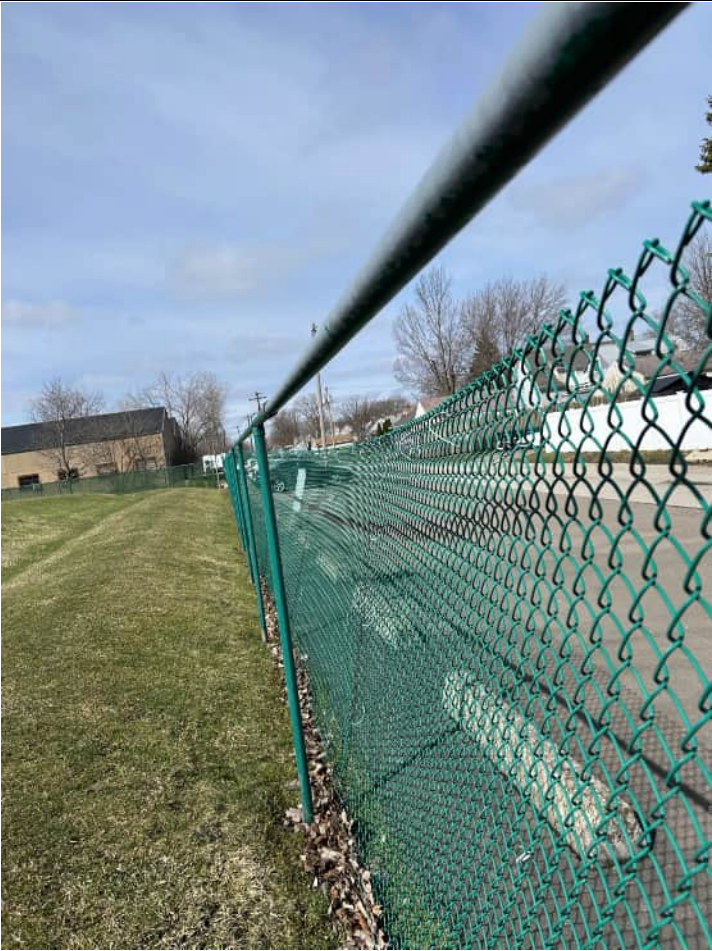
| Photo No. | Date | |
|---|---|---|
| 4 | 3/25/26 | |

| QUESTIONS | RESPONSE | | COMMENTS AND RECOMMENDATIONS |
|---|---|---|---|
| Is damage evident? If Yes, describe the type of damage(s), and indicate the location(s) the attached map. | ✓ | | top of fence not connected |

| Photo No. | Date | |
|---|---|---|
| Top of northern security fence not connected at the top near the north western corner | | |

As noted in section 4.2, minor engineering controls on site are in need of repair but are not compromising the effectiveness of the remedy. These deficiencies will be addressed during the next Certifying Period.

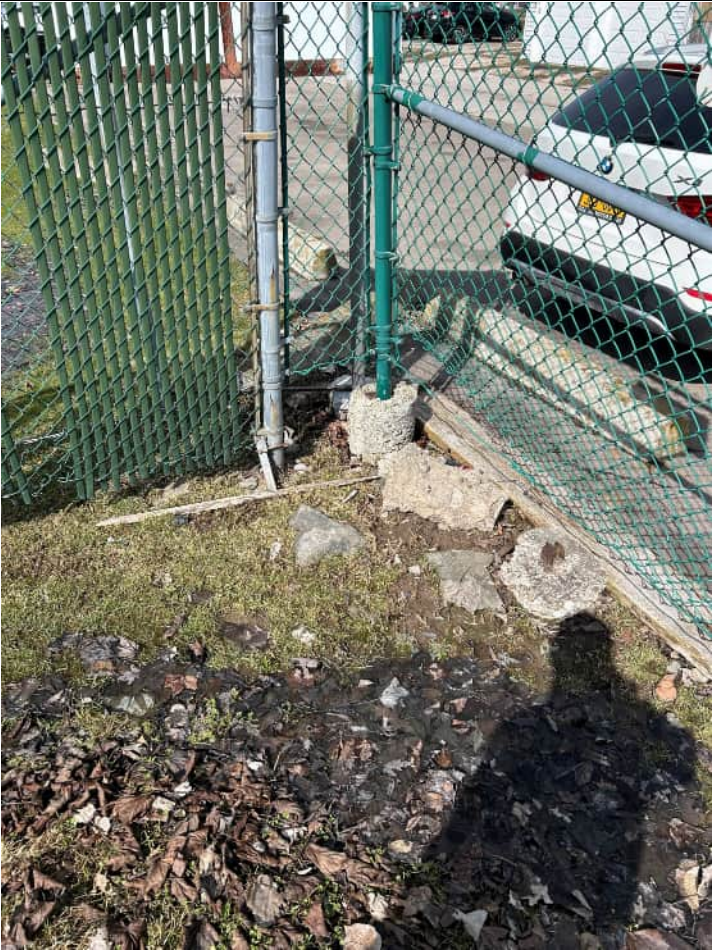
| Photo No. | Date | |
|---|---|---|
| 5 | 3/25/26 | |

| Photo No. | Date | |
|---|---|---|
| Northwestern corner of fence condition - small openings at the bottom close to entry gate | | |

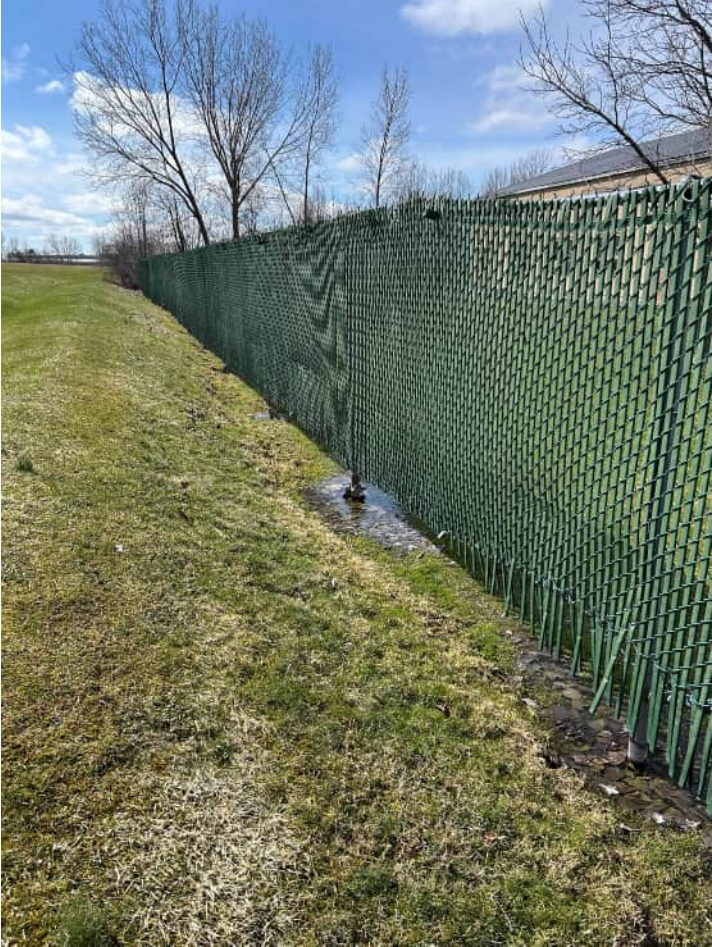
| Photo No. | Date | |
|---|---|---|
| 6 | 3/25/26 | |

| Photo No. | Date | |
|---|---|---|
| Condition of northwestern fence facing south | | |

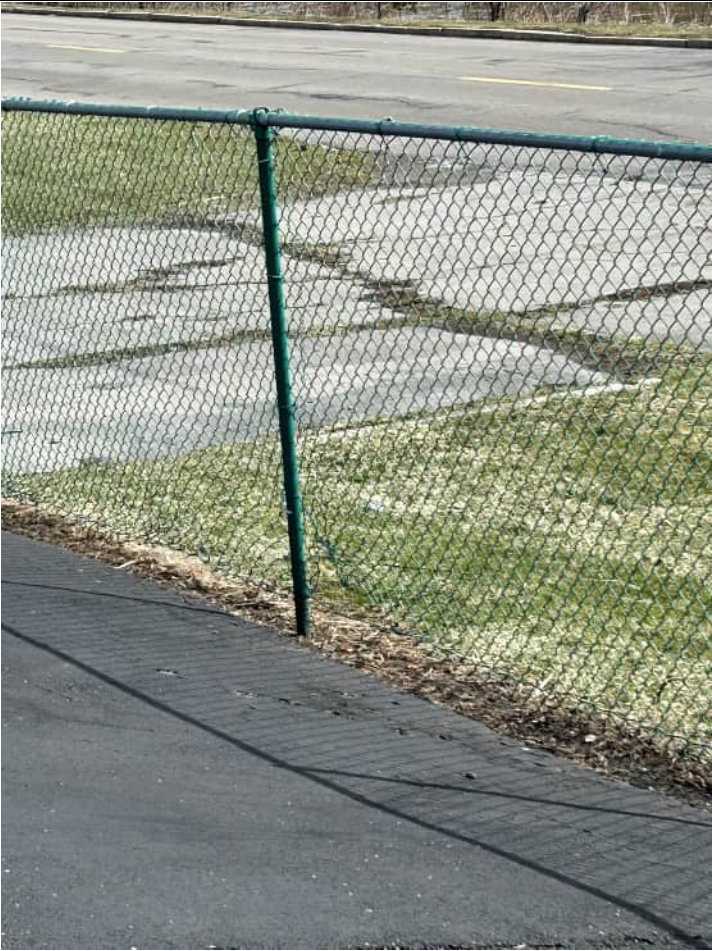
| Photo No. | Date | |
|---|---|---|
| 7 | 3/25/26 | |

| Photo No. | Date | |
|---|---|---|
| Small openings at the bottom of fence near large gate entrance on eastern fence. | | |

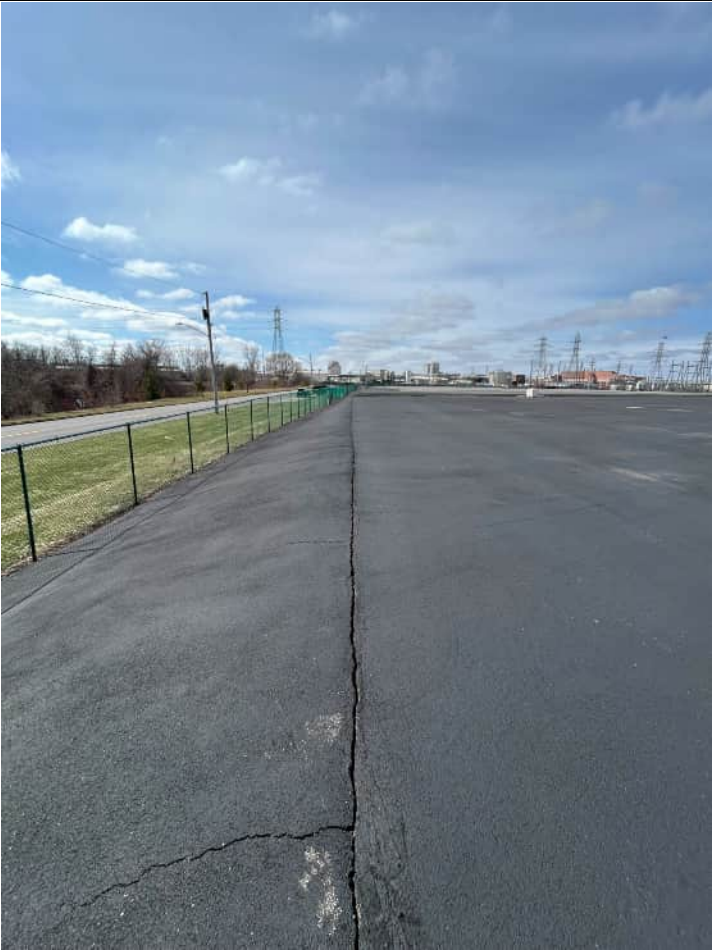
| Photo No. | Date | |
|---|---|---|
| 8 | 3/25/26 | |

| Photo No. | Date | |
|---|---|---|
| Cracks around the asphalt cover system on eastern end | | |

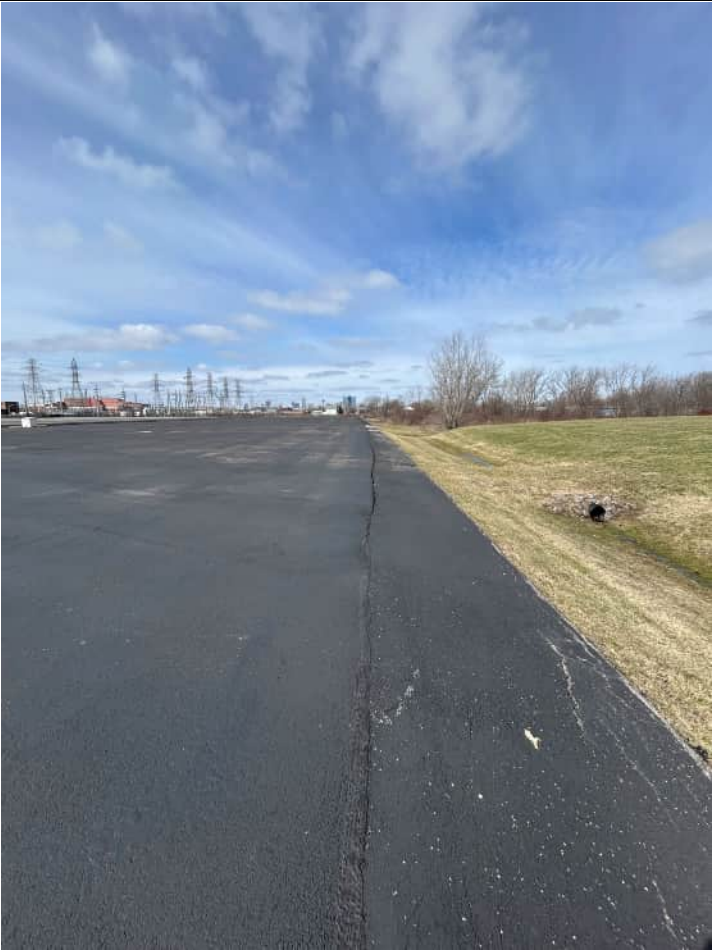
| Photo No. | Date | |
|---|---|---|
| 9 | 3/25/26 | |

| Photo No. | Date | |
|---|---|---|
| Cracks on the asphalt cover system on the northern edge of cover system | | |

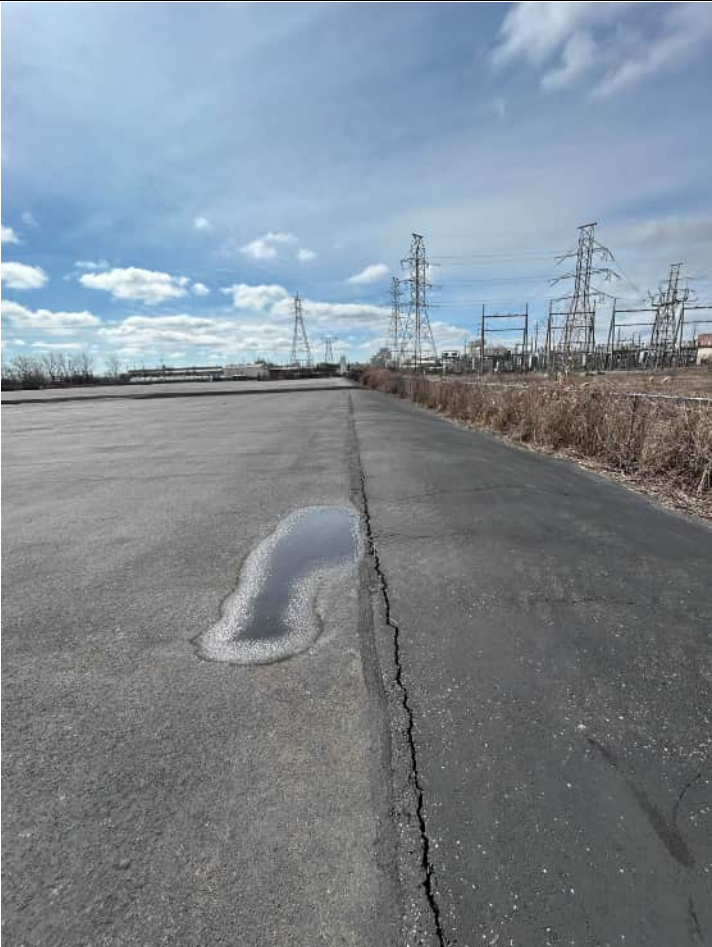
| Photo No. | Date | |
|---|---|---|
| 10 | 3/25/26 | |

| Photo No. | Date | |
|---|---|---|
| Cracks on the asphalt cover system on western end of site | | |

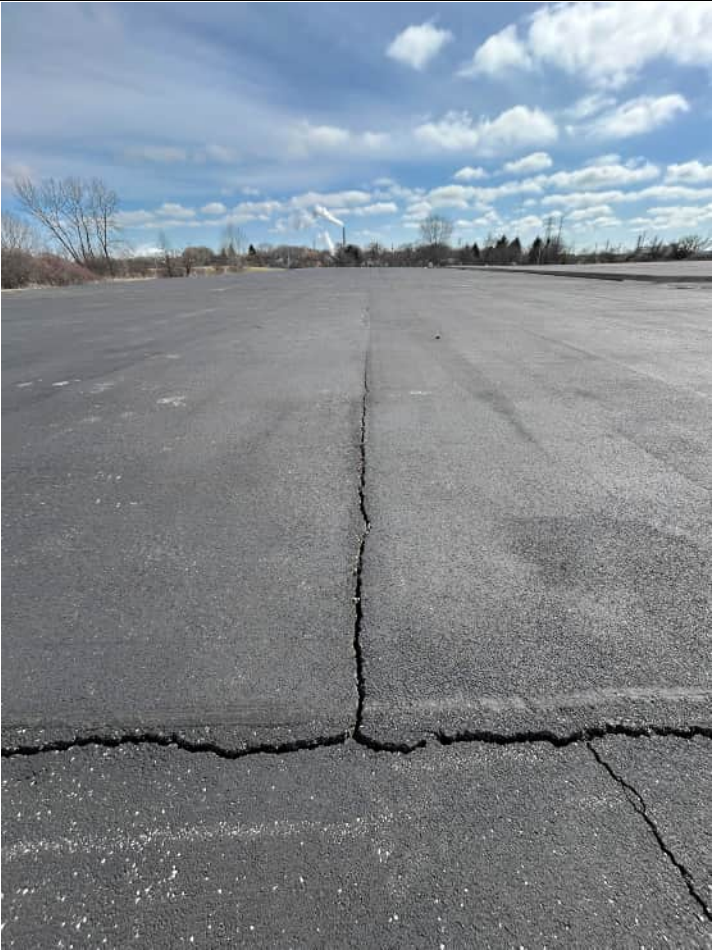
| Photo No. | Date | |
|---|---|---|
| 11 | 3/25/26 | |

| Photo No. | Date | |
|---|---|---|
| Moderate cracks on the asphalt cover system on the northwest corner of cover system | | |

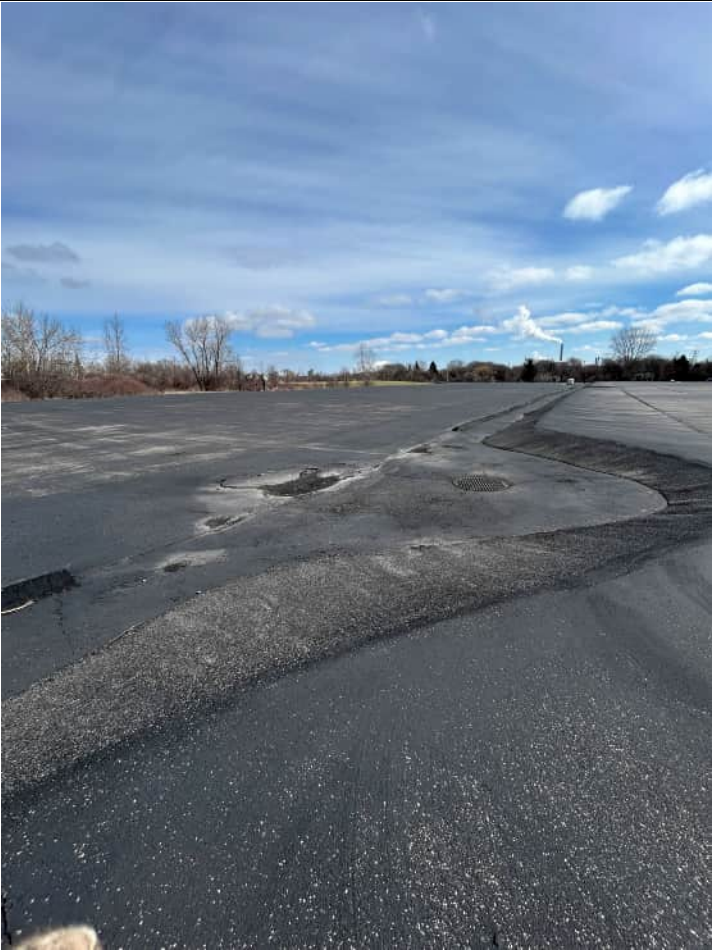
| Photo No. | Date | |
|---|---|---|
| 12 | 3/25/26 | |

| Photo No. | Date | |
|---|---|---|
| Condition of asphalt cover system near western drainages – evidence of pooling | | |

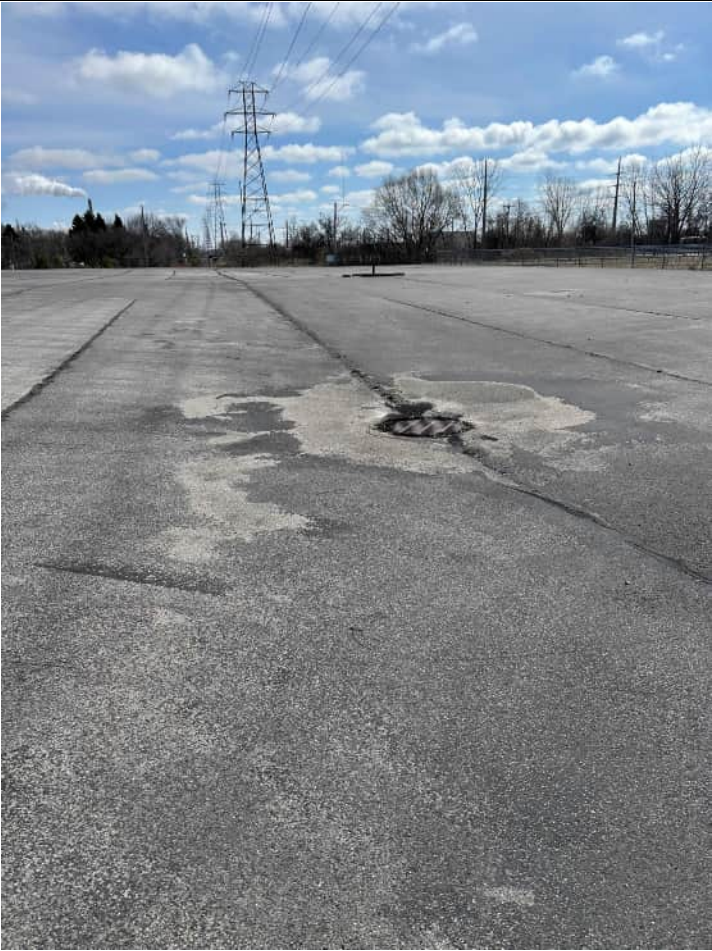
| Photo No. | Date | |
|---|---|---|
| 13 | 3/25/26 | |

| Photo No. | Date | |
|---|---|---|
| Condition of asphalt cover system - drainages | | |

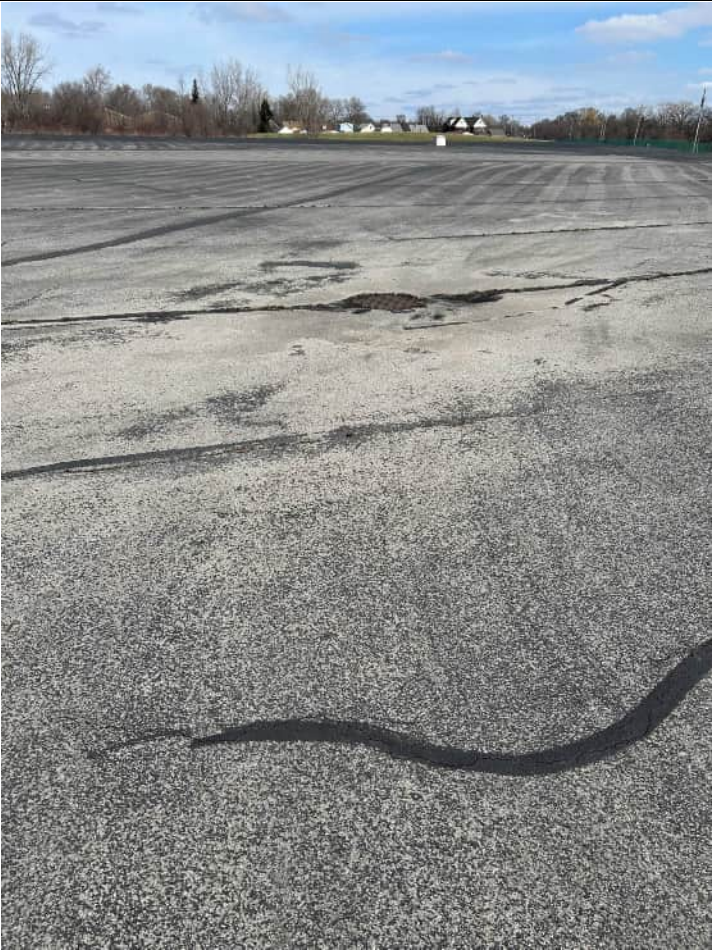
| Photo No. | Date | |
|---|---|---|
| 14 | 3/25/26 | |

| Photo No. | Date | |
|---|---|---|
| Condition of asphalt cover system - drainages | | |

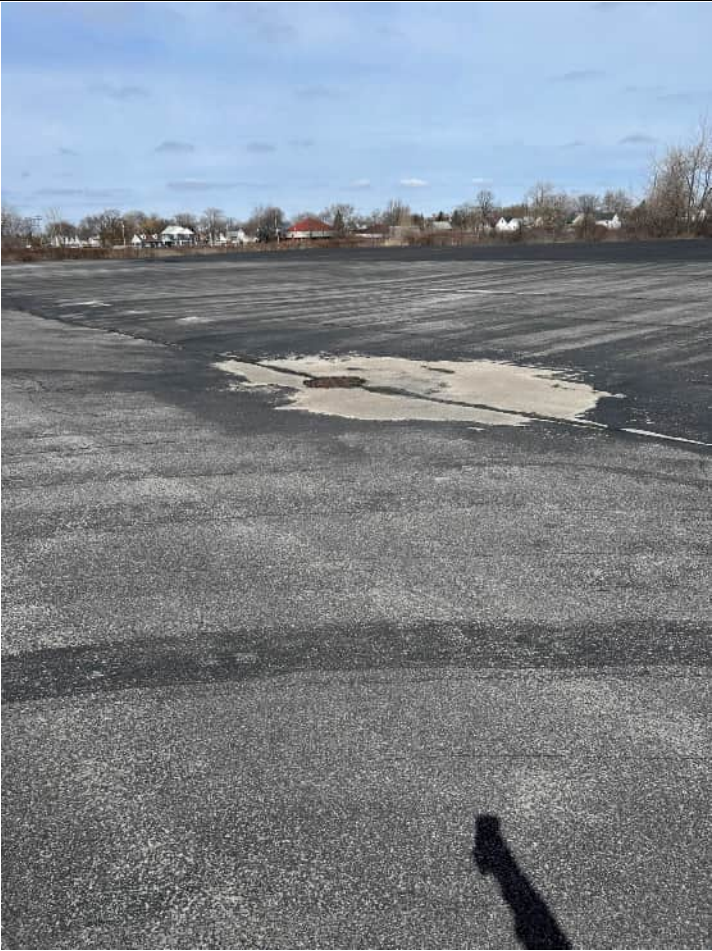
| Photo No. | Date | |
|---|---|---|
| 15 | 3/25/26 | |

| Photo No. | Date | |
|---|---|---|
| Condition of asphalt cover system - drainages | | |

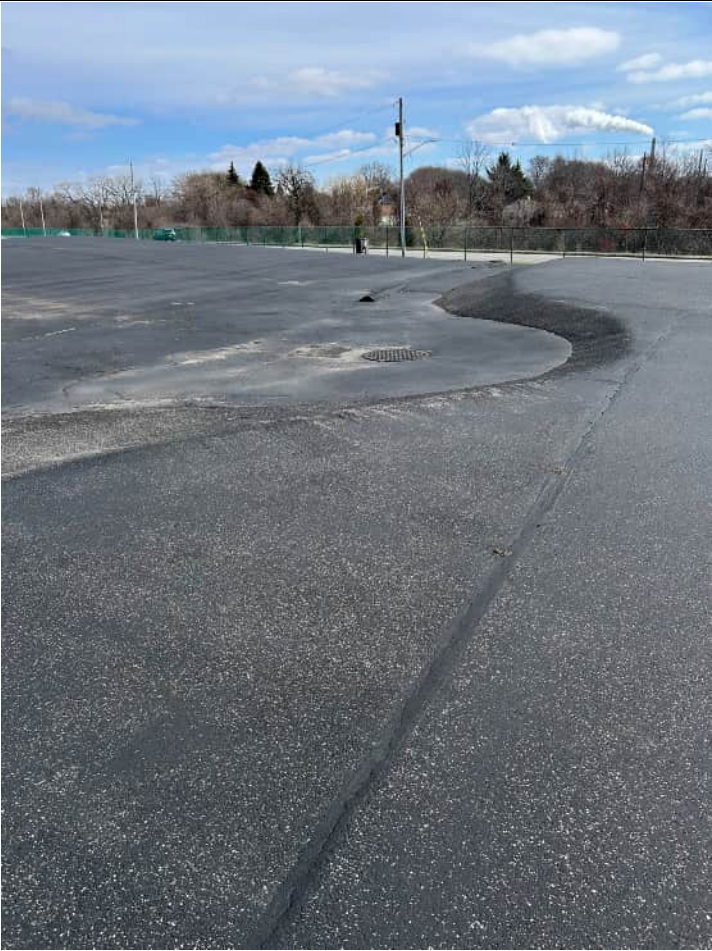
| Photo No. | Date | |
|---|---|---|
| 16 | 3/25/26 | |

| Photo No. | Date | |
|---|---|---|
| Condition of asphalt cover system - drainages | | |

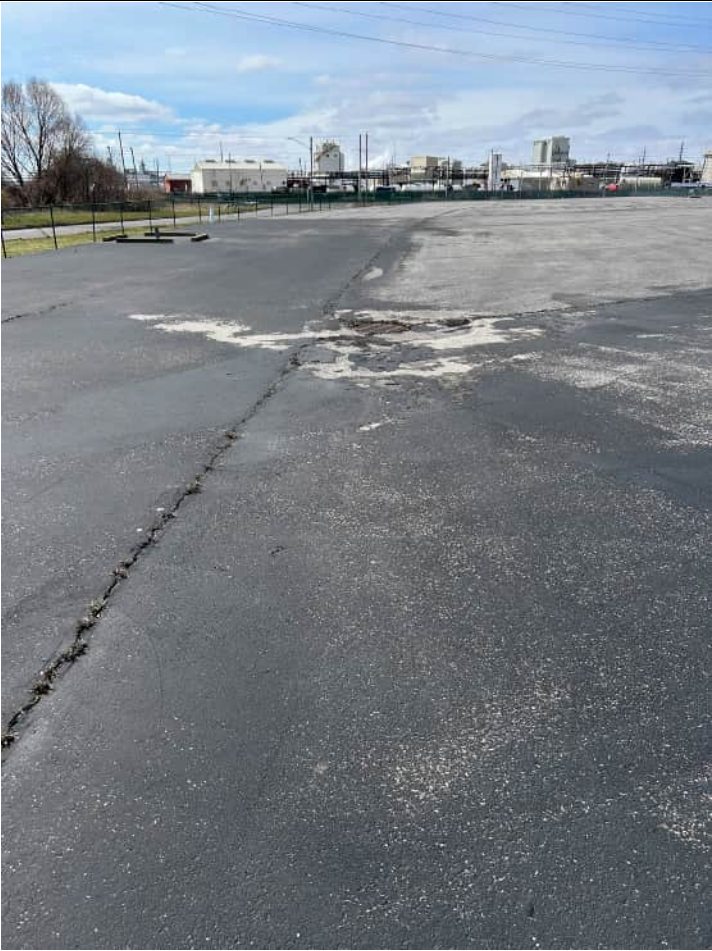
| Photo No. | Date | |
|---|---|---|
| 17 | 3/25/26 | |

| Photo No. | Date | |
|---|---|---|
| Moderate cracks on the asphalt cover system with some degradation around the drainage | | |

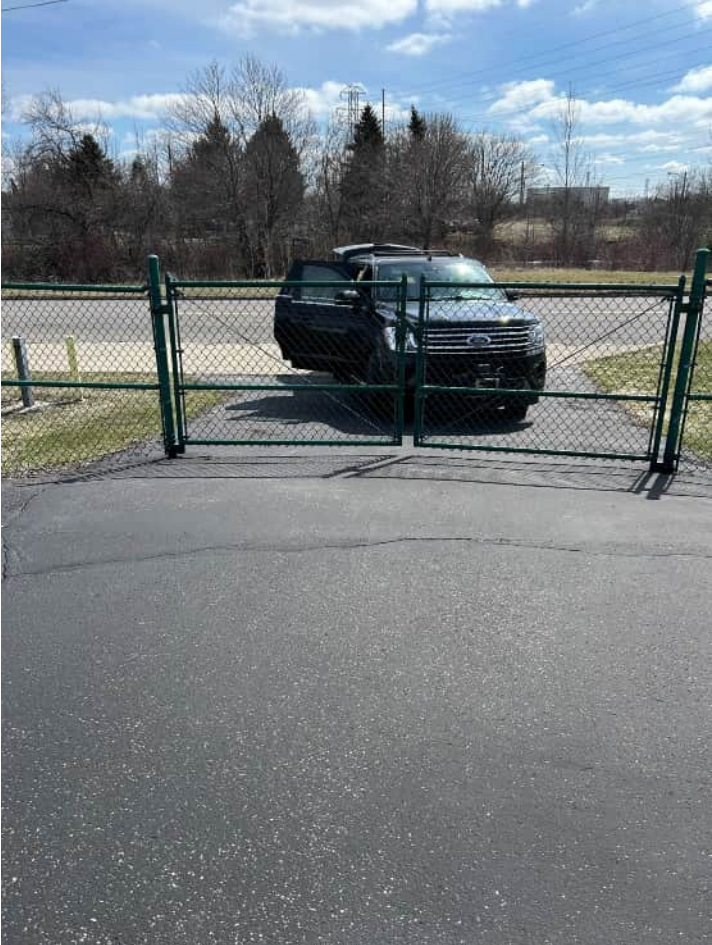
| Photo No. | Date | |
|---|---|---|
| 18 | 3/25/26 | |

| Photo No. | Date | |
|---|---|---|
| Condition of main gate on the eastern side of the site | | |

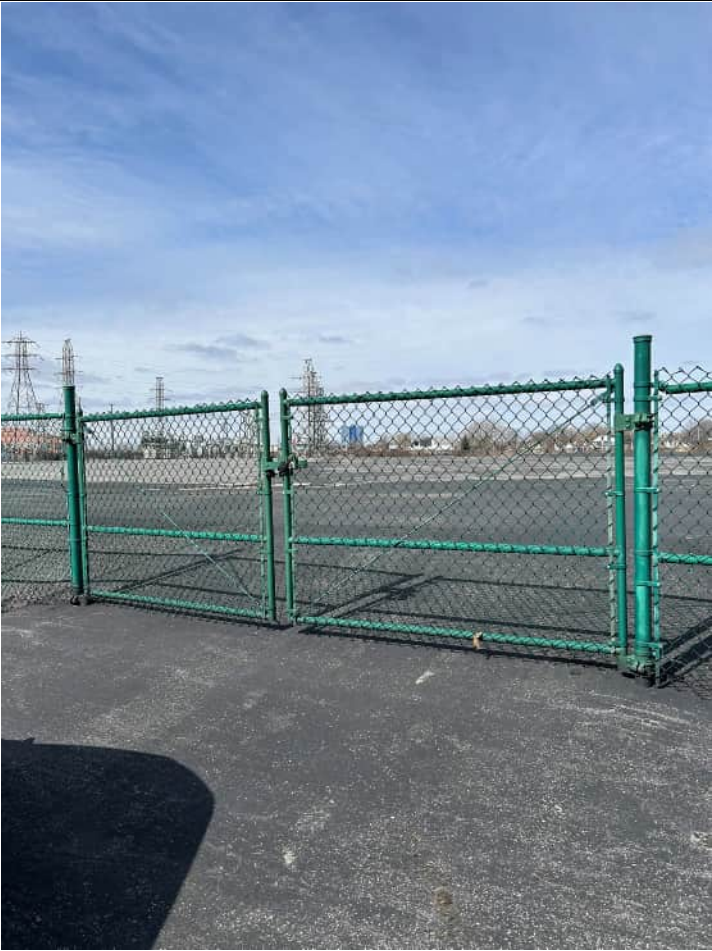
| Photo No. | Date | |
|---|---|---|
| 19 | 3/25/26 | |

| Photo No. | Date | |
|---|---|---|
| Condition of main gate on the eastern side of the site | | |
