Re: Joint Permit Application and Jurisdictional Determination for  
Former Nash Road Landfill  
NYSDEC Site #932054  
Town of Wheatfield, Niagara County, New York

AERIAL PHOTOGRAPH OF SITE  
INTERIM REMEDIAL MEASURES WORK PLAN  
NASH ROAD LANDFILL  
*Wheatfield, New York*

**WETLANDS PERMITTING PLAN**  
**INTERIM REMEDIAL MEASURE WORK PLAN**  
**NASH ROAD LANDFILL**  
*Wheatfield, New York*

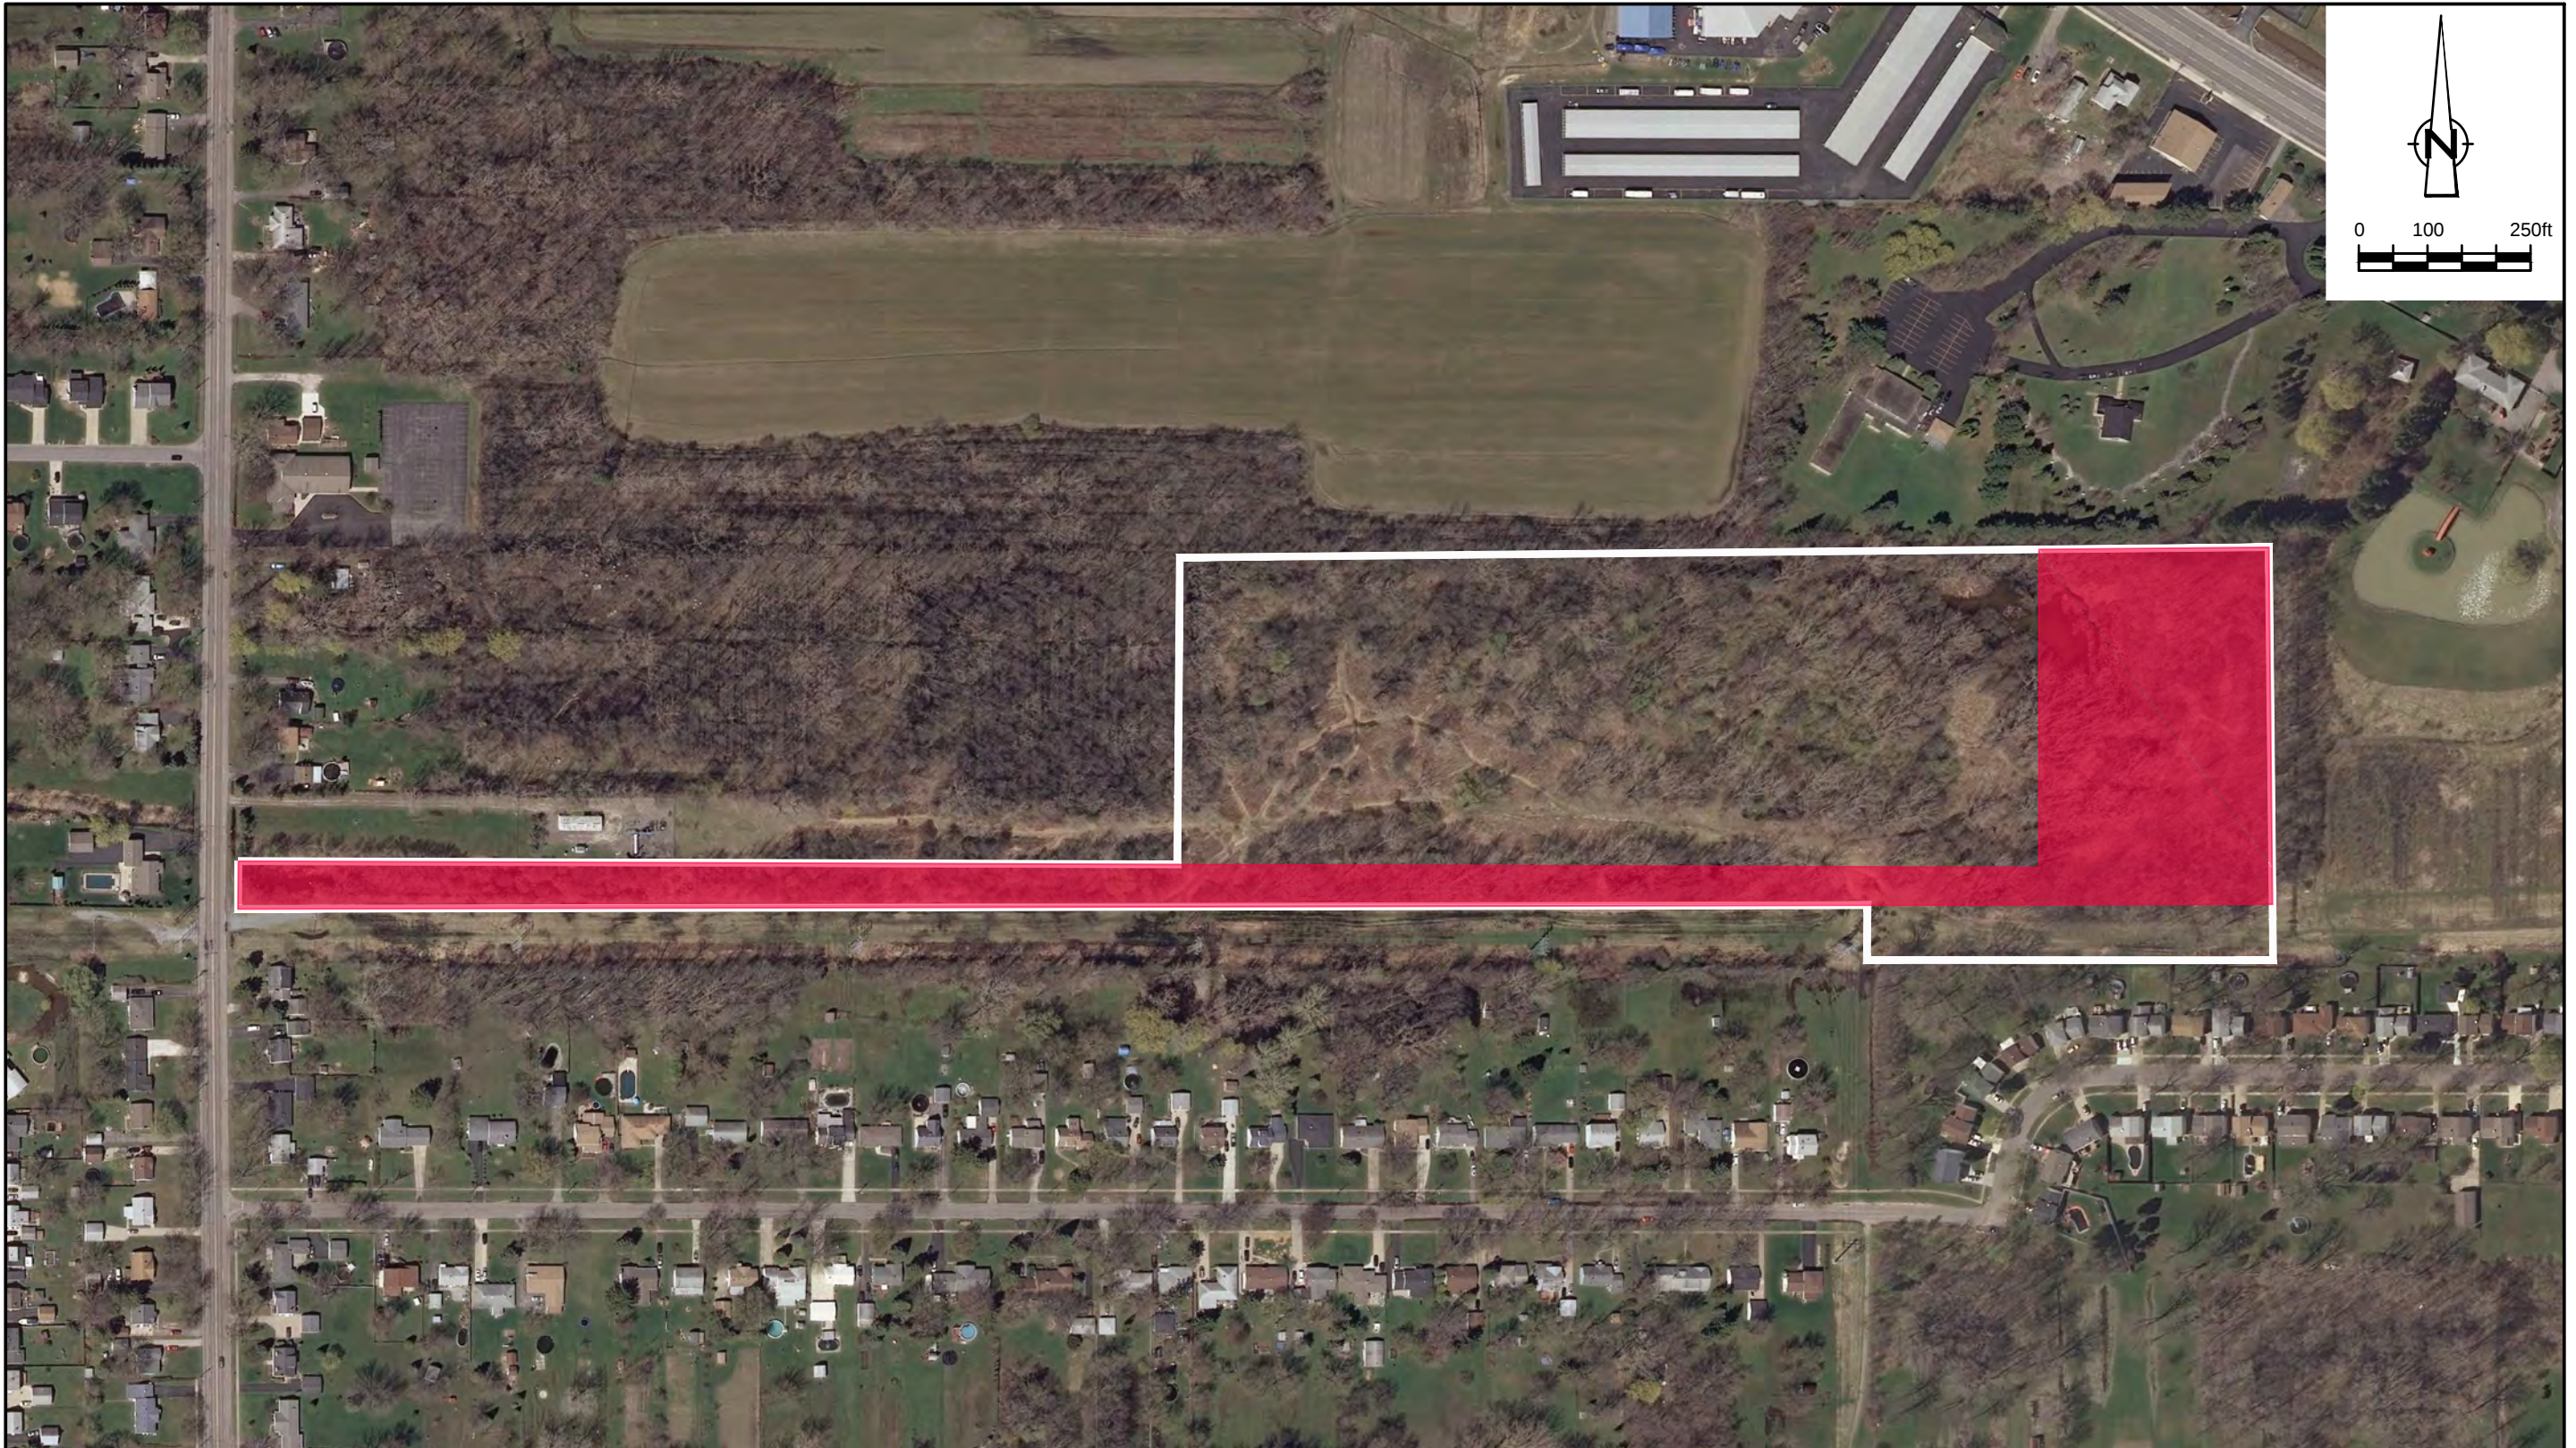
figure 3

A recent aerial photograph (Figure 3) shows the existing conditions within the Study Area. As shown on Figure 3, the Study Area is primarily woodlands with a series of dirt trails. There are two small open water features within the Study Area (along Nash Road and in the northeastern corner). The western portion of the Study Area contains a roadside swale that runs parallel to Nash Road and is fed by a culvert underneath Nash Road. The culvert pipe receives drainage from a roadside swale and a drainage ditch located west of Nash Road. The northeastern portion of the Study Area contains drainage ditches along the northern and eastern property lines. These drainage ditches appear to flow off-site via an 18-inch PVC pipe to a man-made pond on an adjacent property. The pond appears to be hydrologically connected to Sawyer Creek via a ditch and a culvert pipe underneath Niagara Falls Boulevard. Sawyer Creek flows in a southeasterly direction before discharging to the main stem of Tonawanda Creek, which ultimately discharges to the Niagara River.

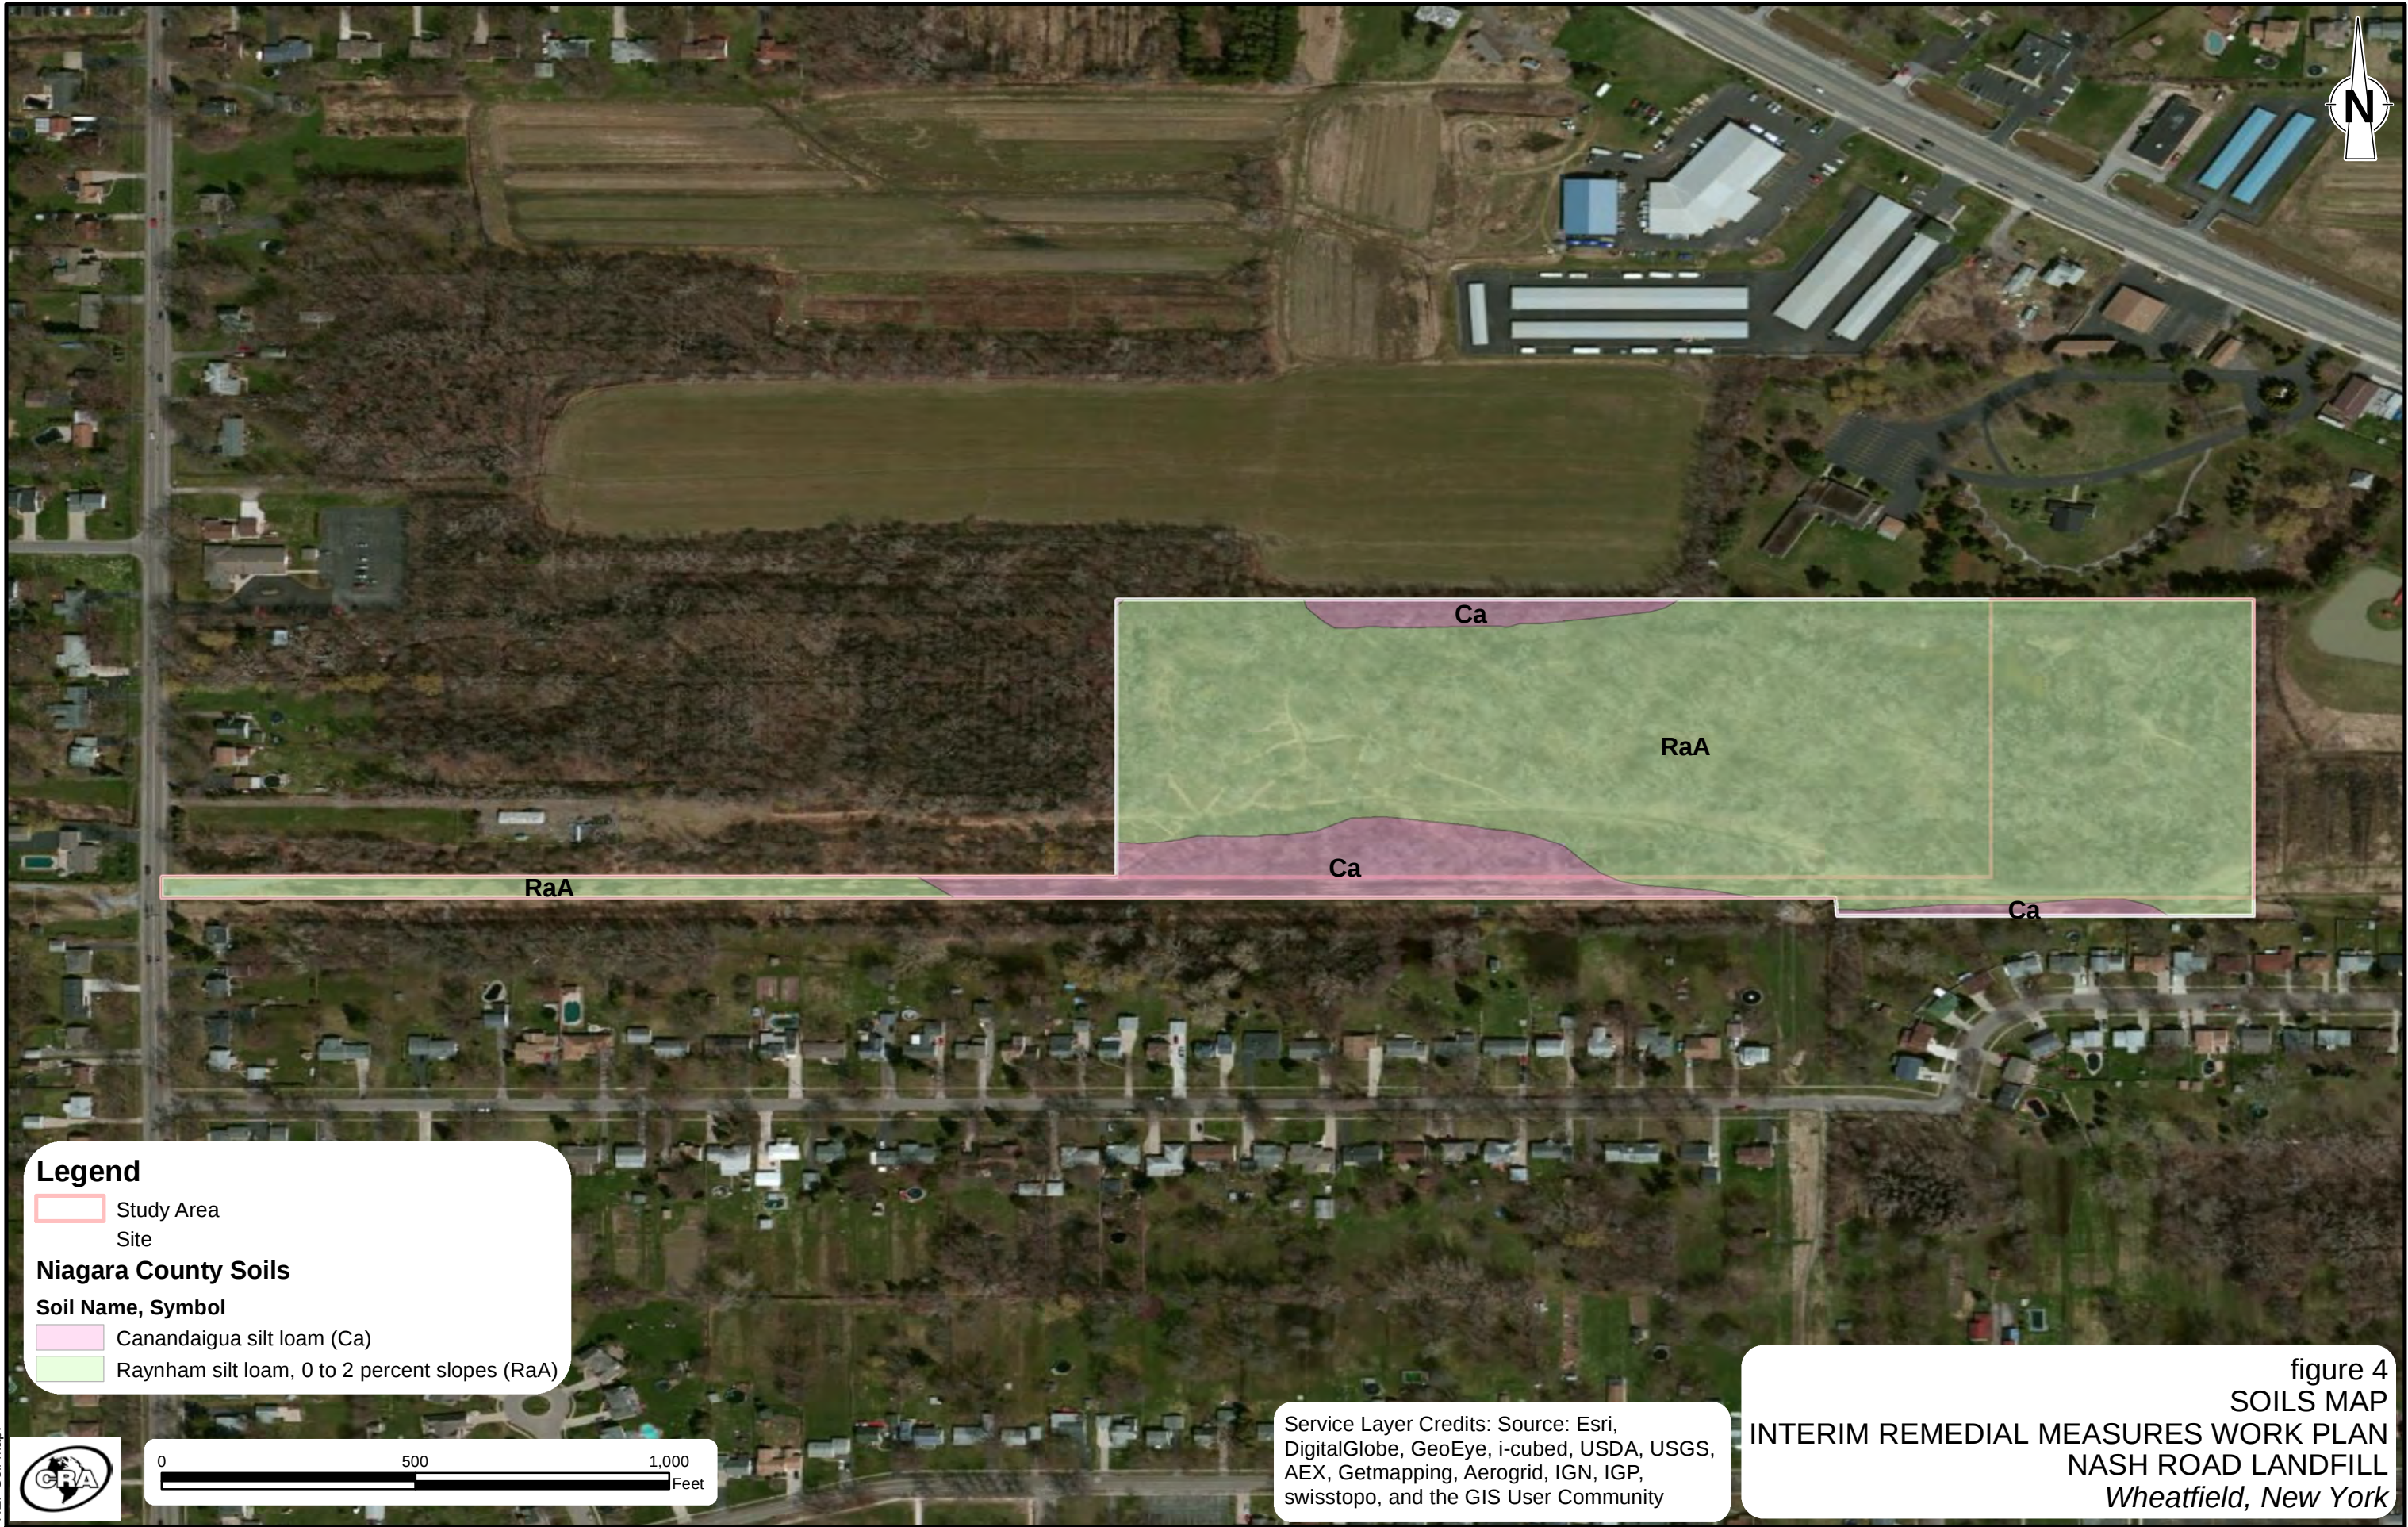
figure 4  
SOILS MAP  
INTERIM REMEDIAL MEASURES WORK PLAN  
NASH ROAD LANDFILL  
Wheatfield, New York

The soils within the Study Area were comprised of historical fill (possibly dredge material) used to cover the landfill. The soils within the wetlands in the Study Area are highly variable due to the use of fill and other historical disturbances. The soil from 0-18 inches was generally observed to be a mixture of black (10YR 2/1), very dark gray (10YR 3/1), dark gray (10YR 4/1), gray (10YR 5/1), very dark brown (10YR 2/2), dark grayish brown (10YR 4/2) and brown (10YR 5/2) clay loam with yellowish red (5YR 5/8), strong brown (7.5YR 5/8) and yellowish brown (10YR 5/6) concentrations. The majority of the Study Area primarily receives its hydrology from

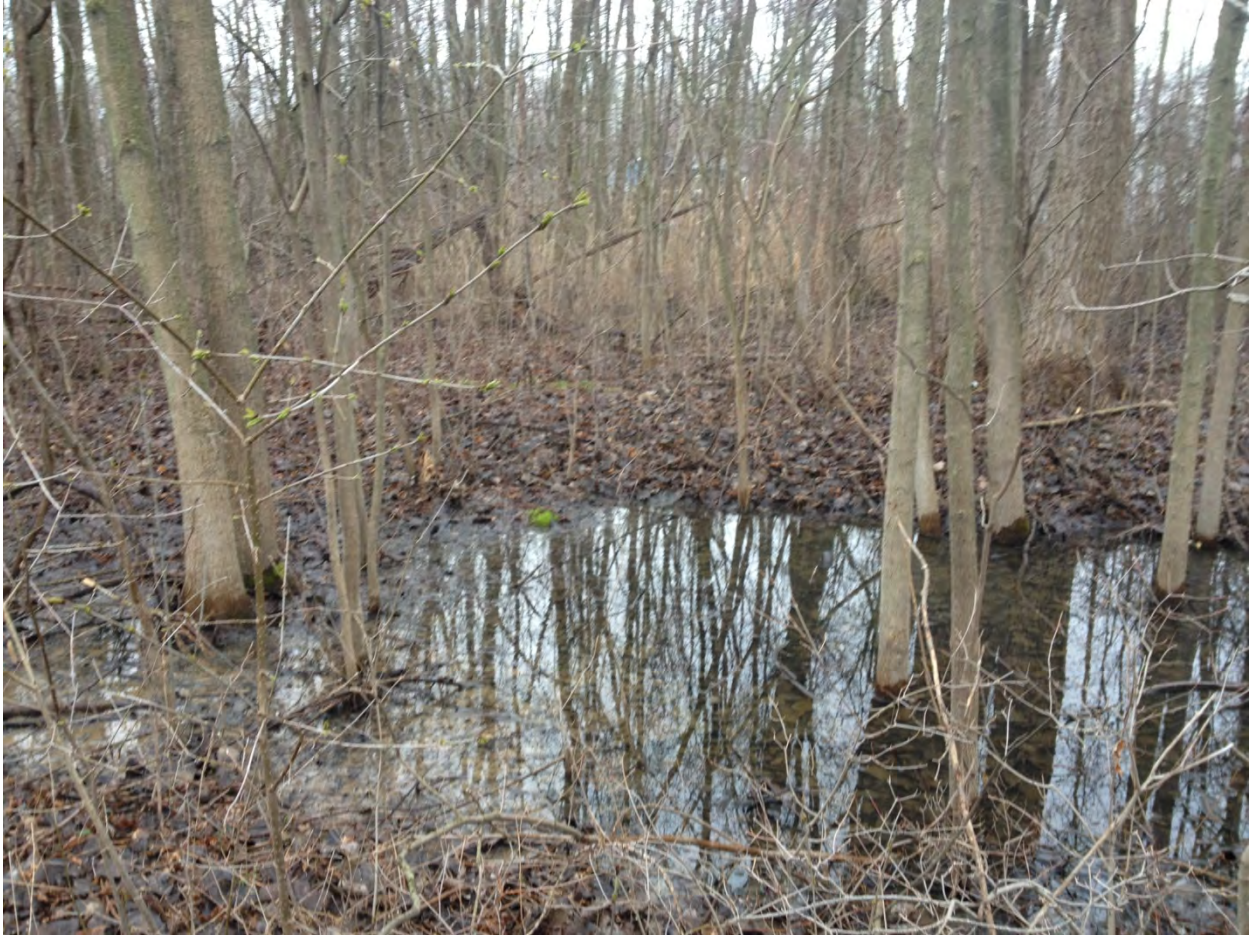
1. Looking south at forested wetlands located in the southwestern corner of the Study Area.

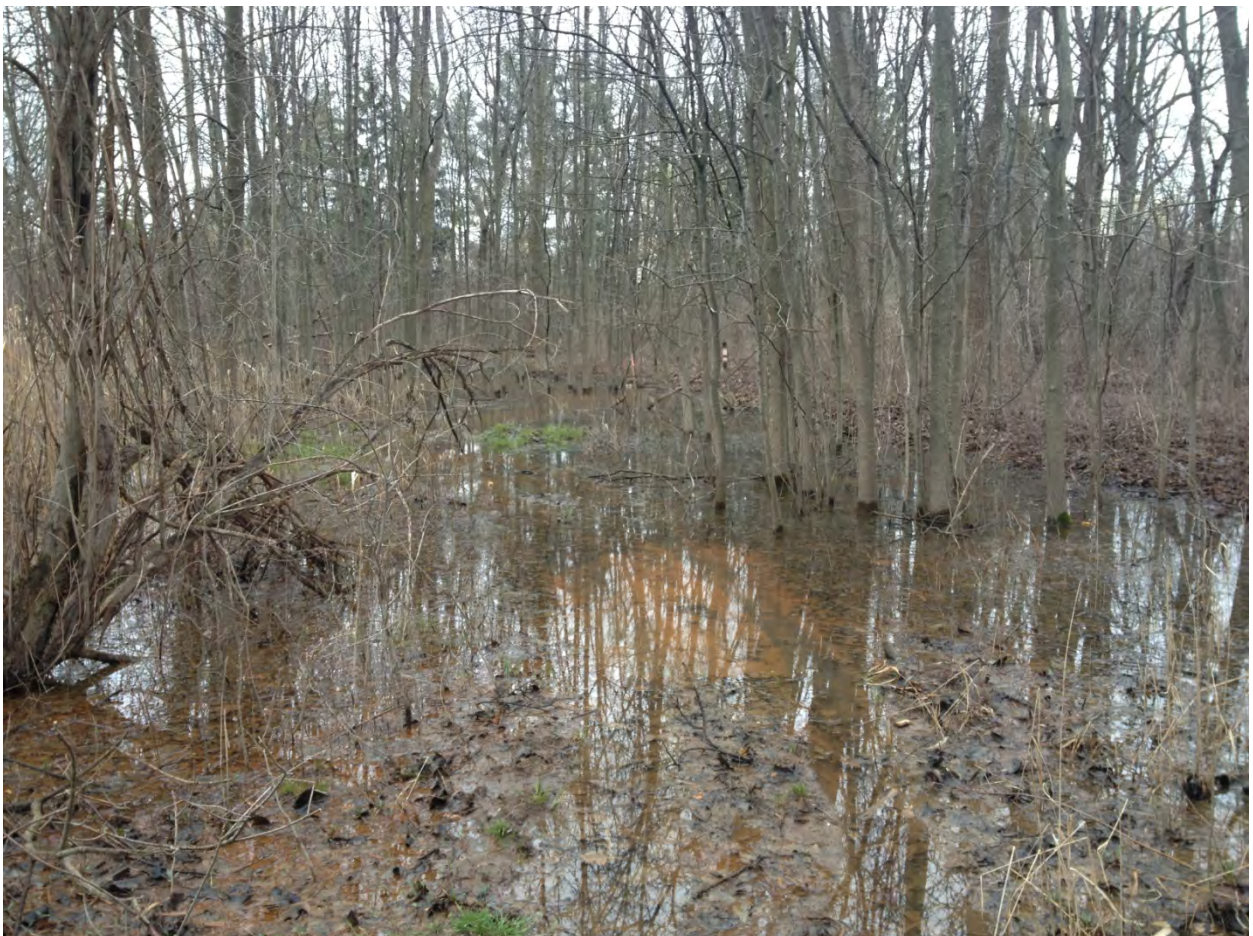
2. Looking north of the forested wetlands located in the central portion of the Study Area.

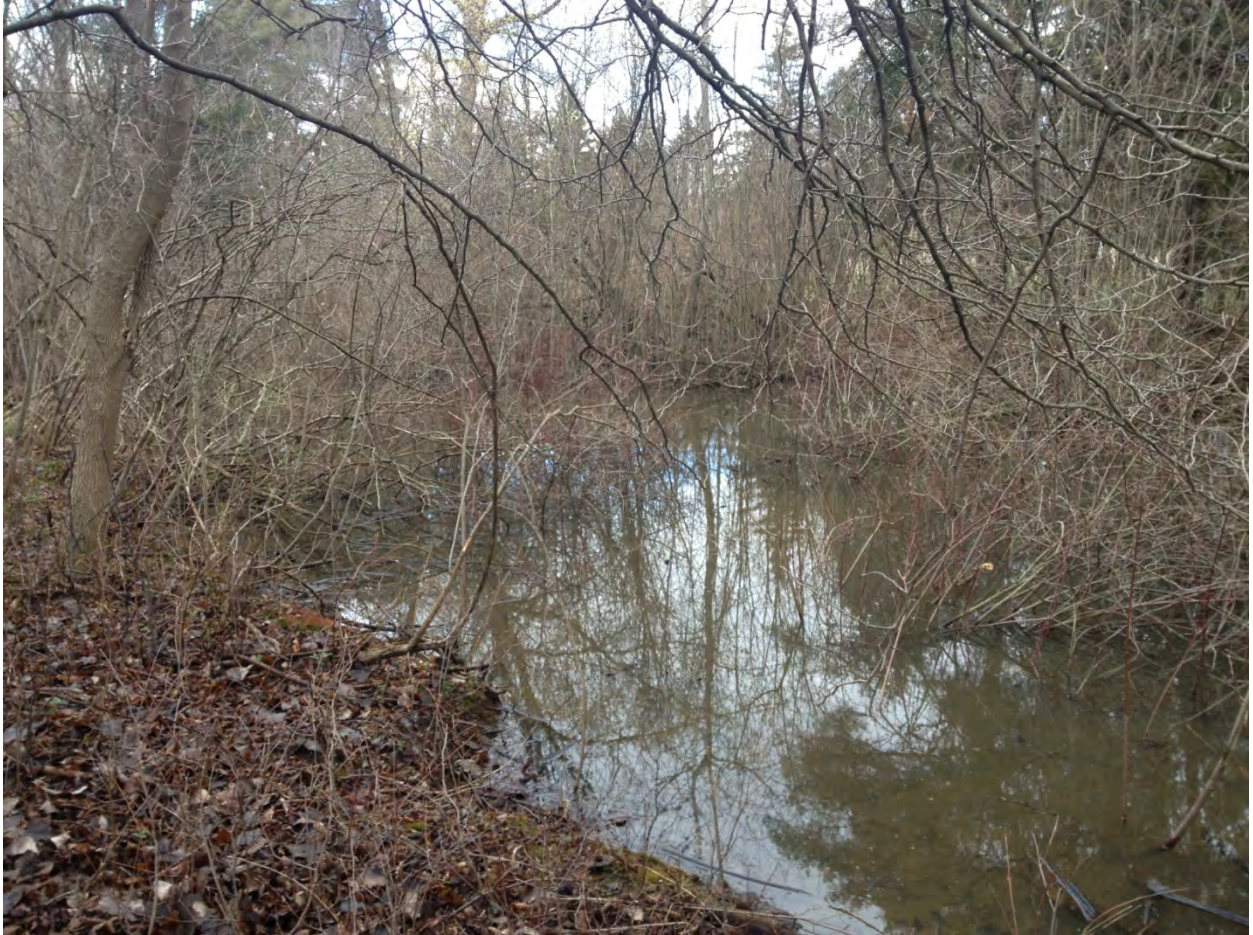
3. Looking west at forested wetland and drainage feature along the northern portion of the Study Area.

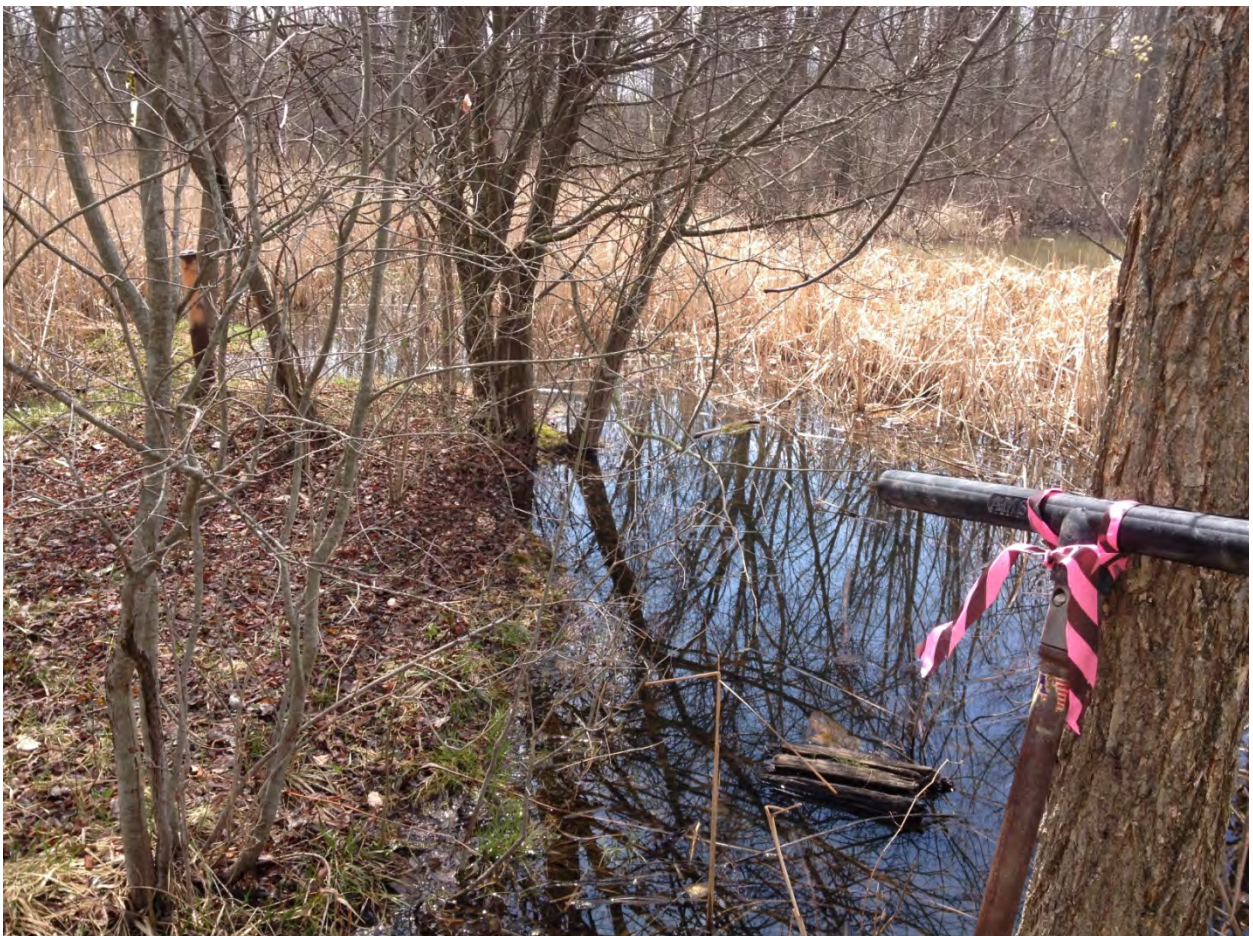
4. Looking south at an emergent wetland located in the northern portion of the Study Area adjacent to DP-101.

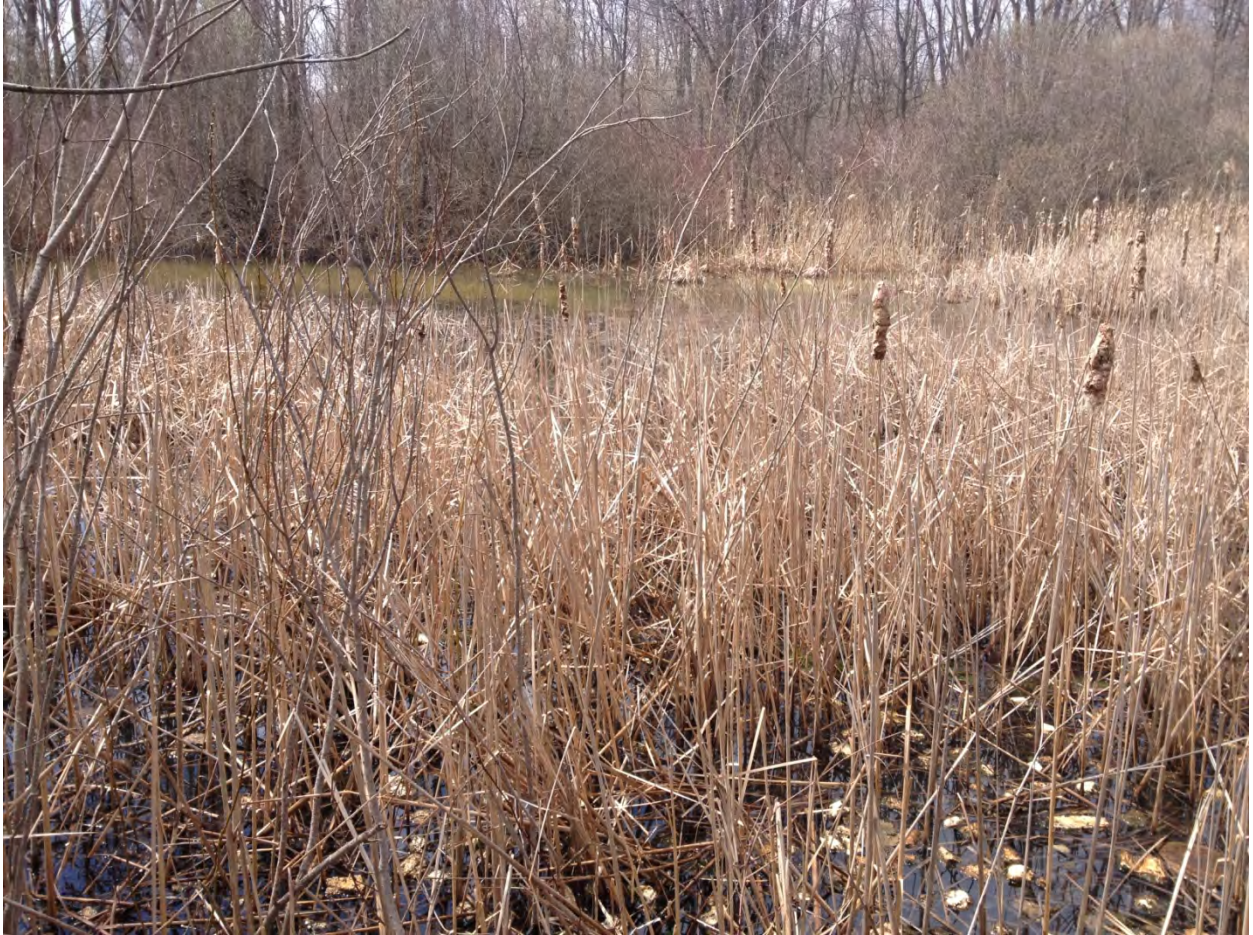
5. Looking west at an emergent wetland located in the northern portion of the Study Area adjacent to DP-101.

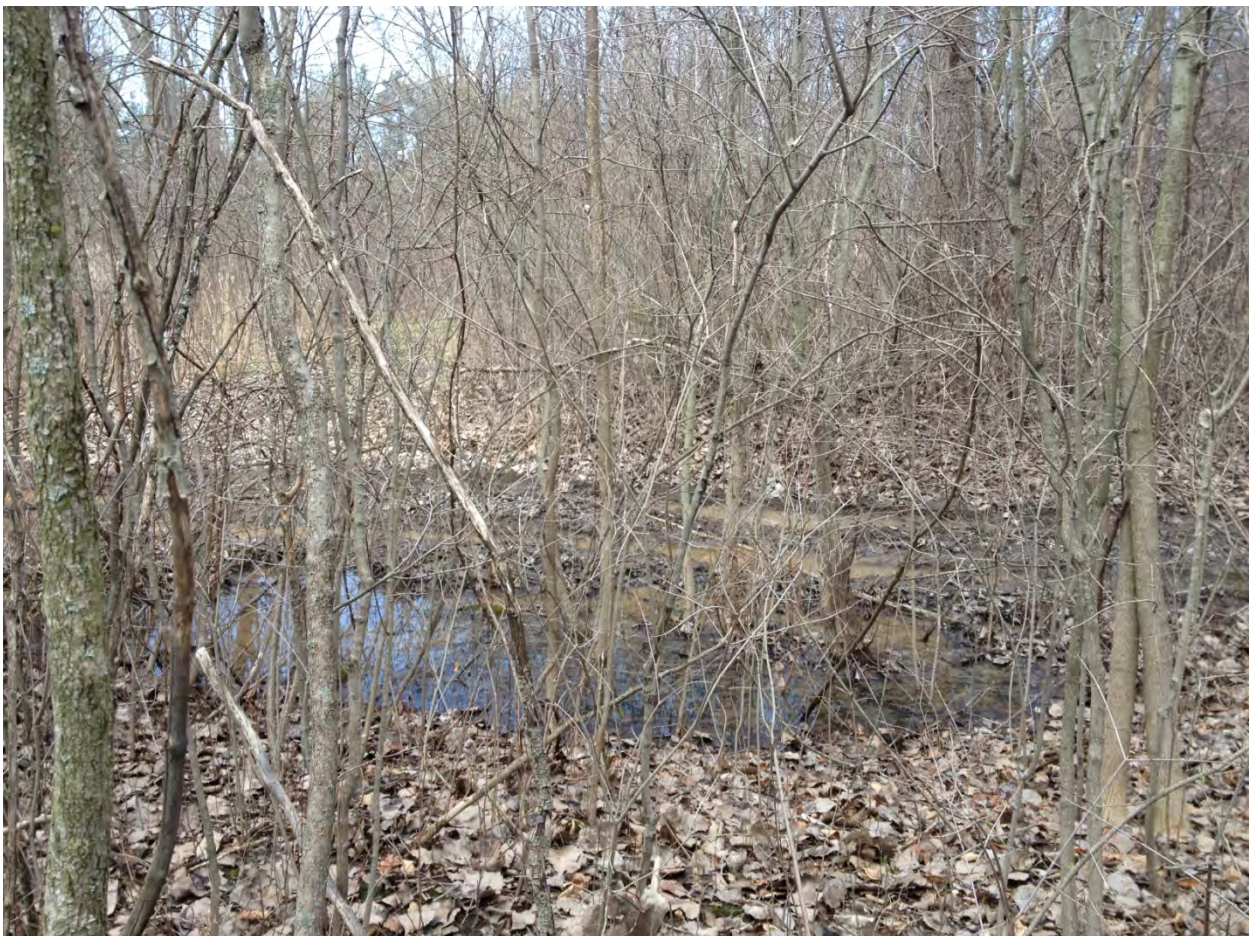
6. Looking south at forested wetlands and dirt trail located in the southwestern corner of the Study Area.

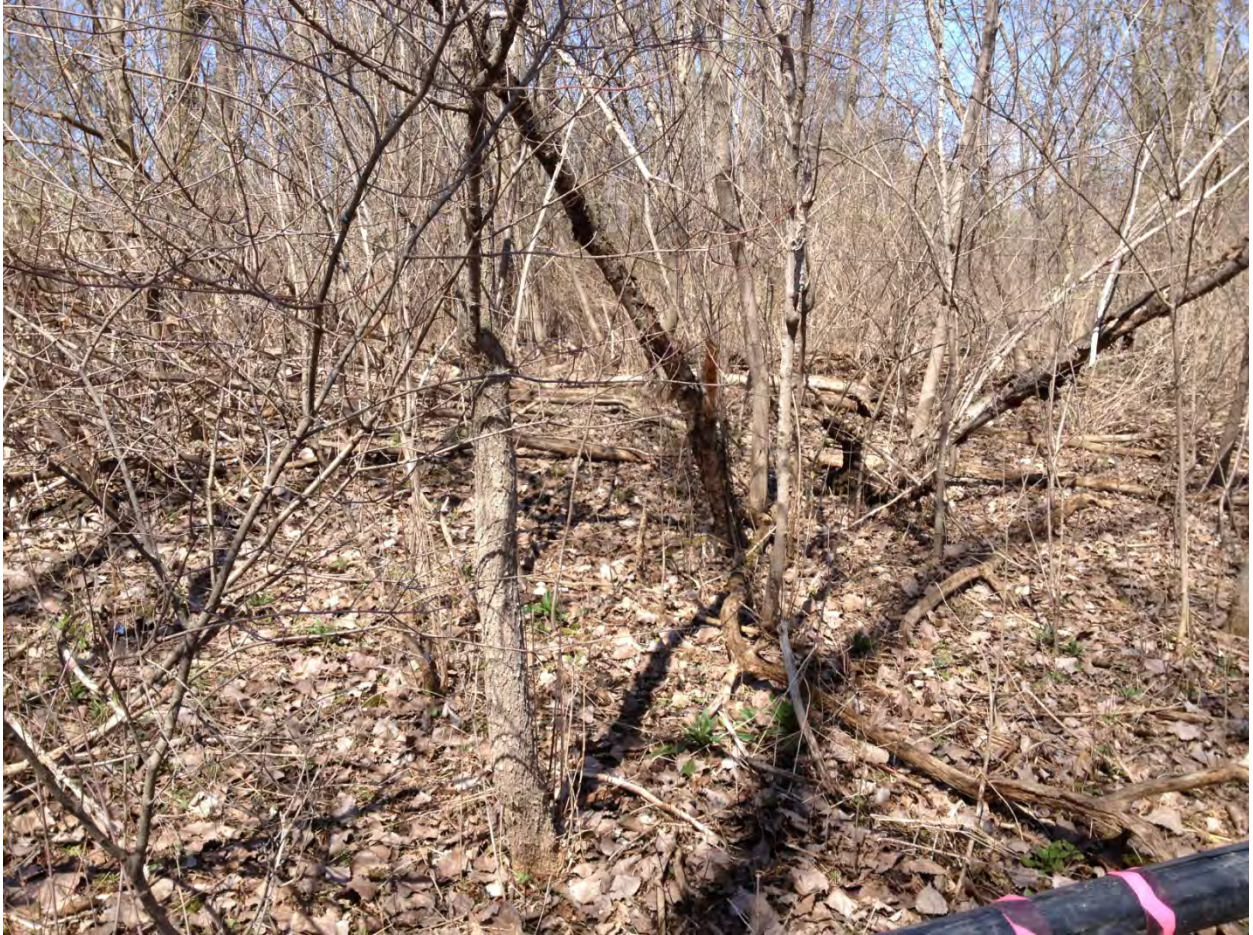
7. Looking north of typical uplands found northwest of the WB line.

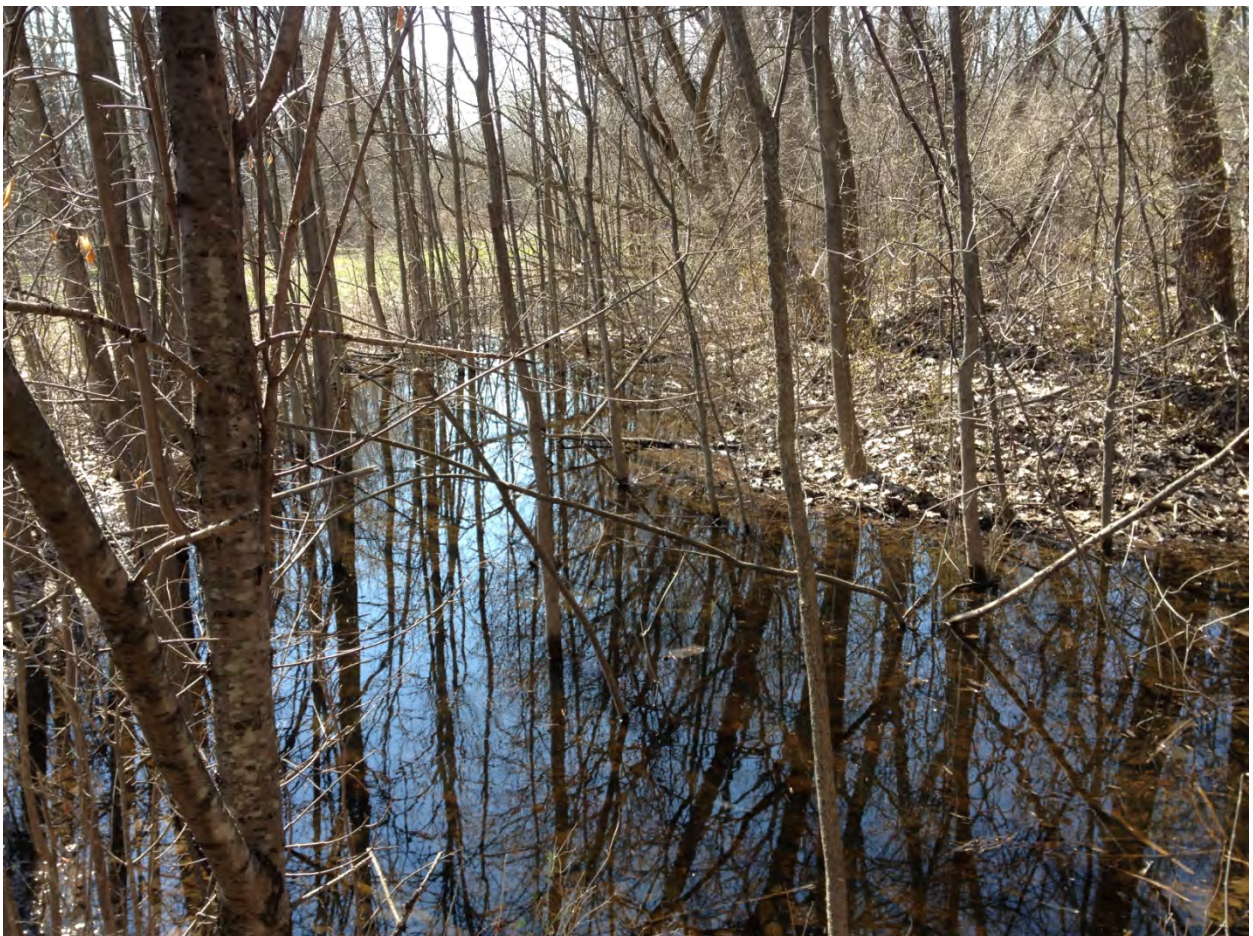
8. Looking southwest of forested wetlands adjacent to the overhead power line easement located south of the Study Area.

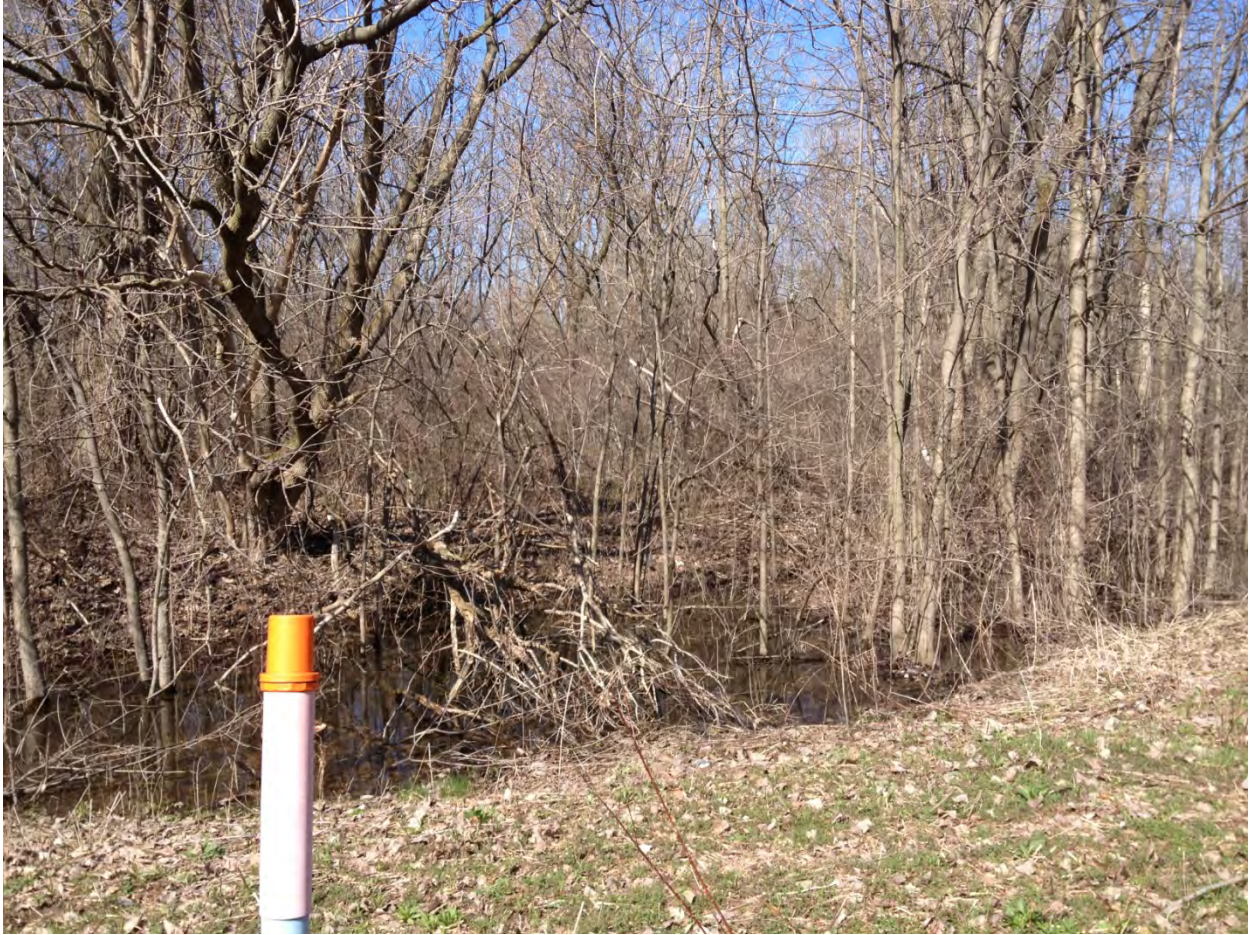
9. Looking southwest of forested wetlands adjacent to the gas easement located north of the Study Area.

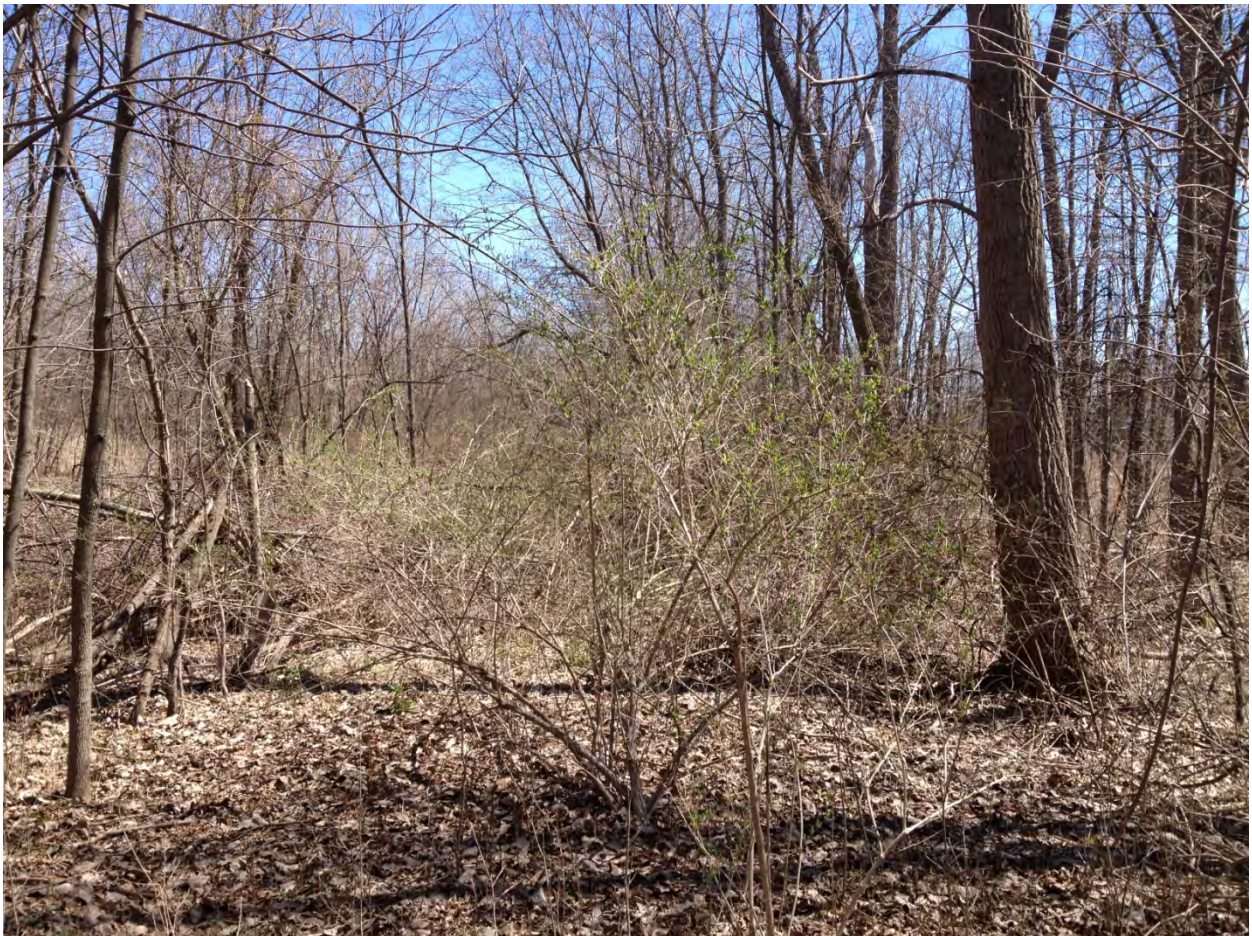
10. Looking east of upland area (WD line) within the Study Area. The upland area appears to be associated with a former access road to the Site.

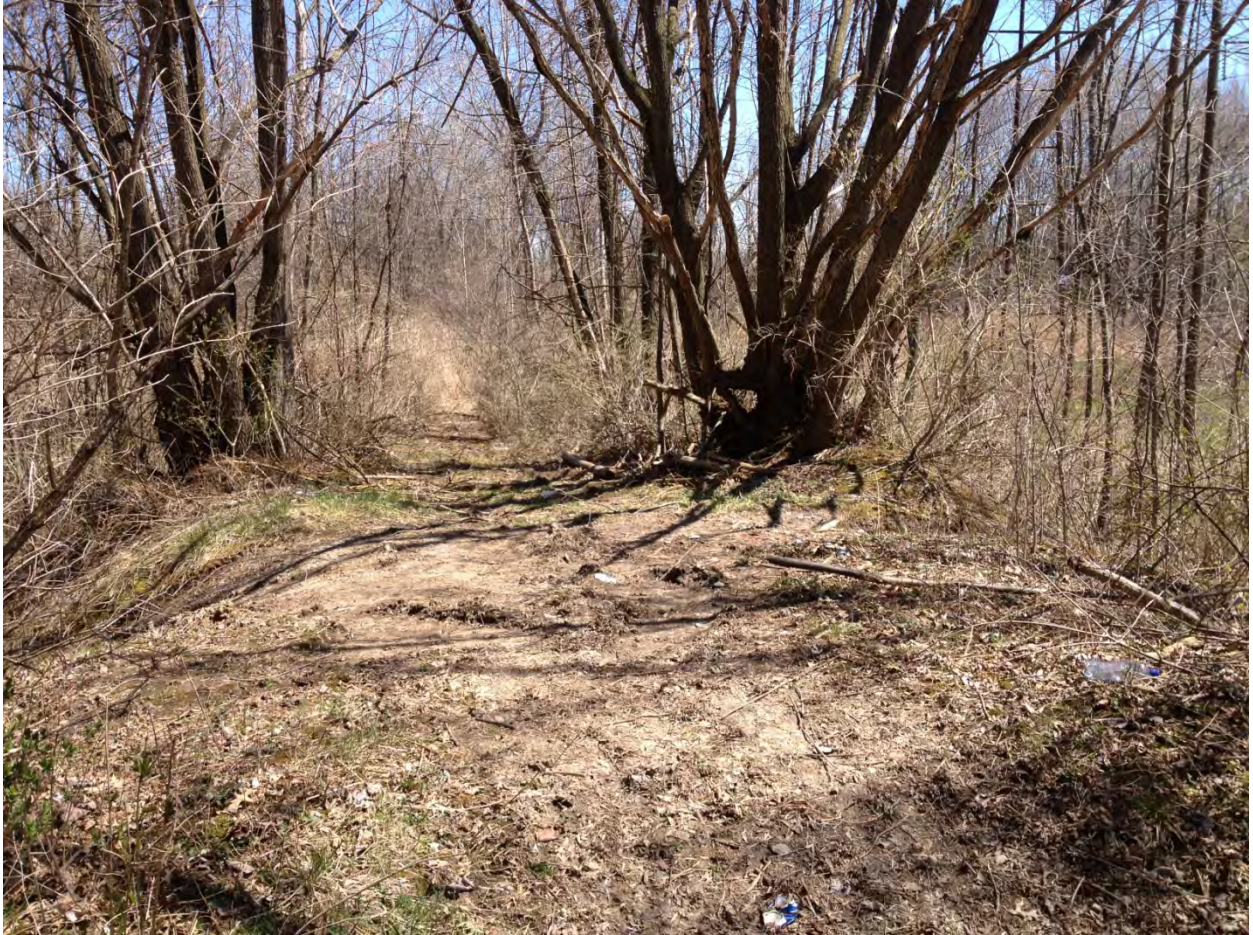
11. Looking east of upland area (WE line) within the Study Area. The upland area appears to be associated with a former access road to the Site.

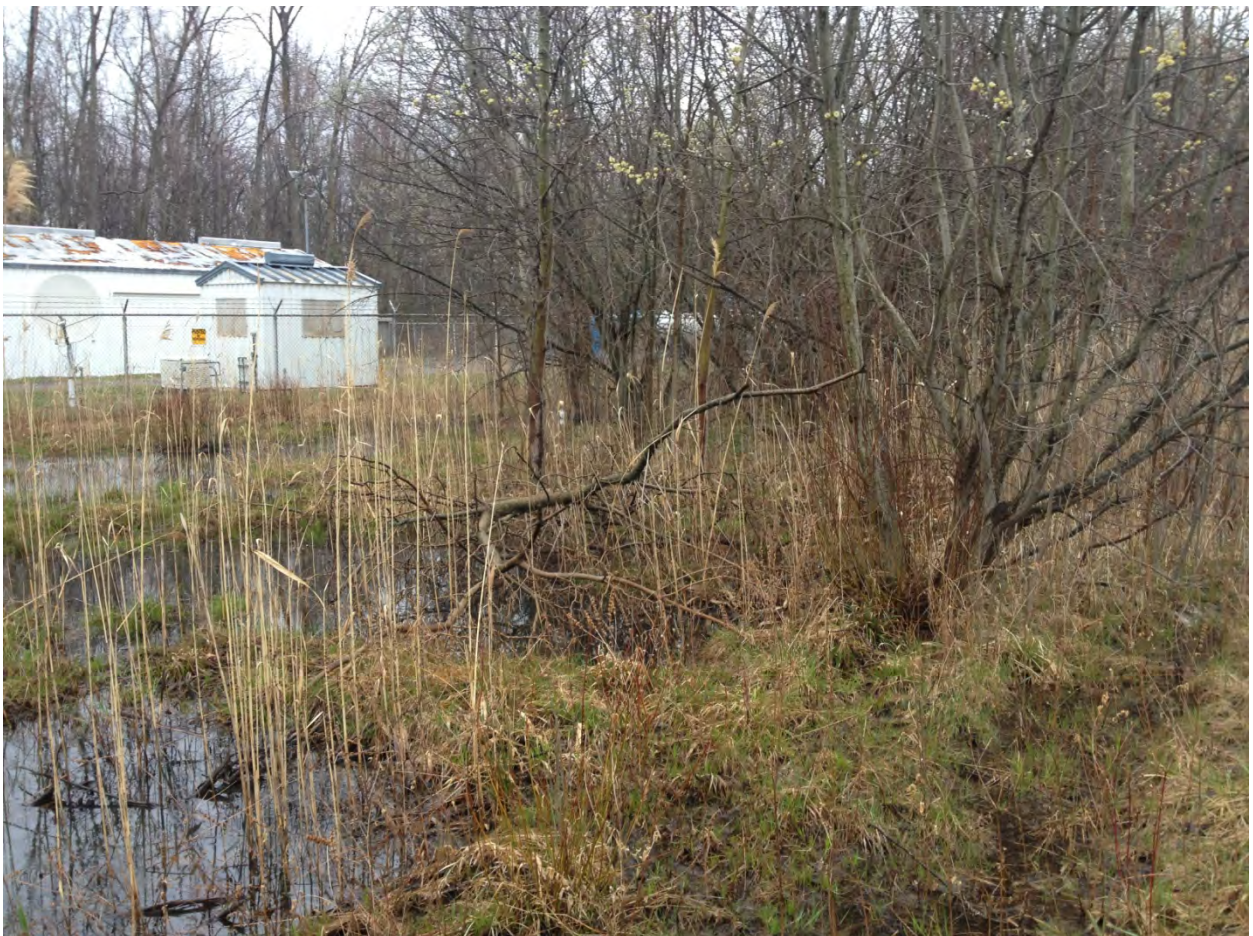
12. Looking northeast of forested/emergent wetlands adjacent to a gas line transfer station.
