Re: Joint Permit Application and Jurisdictional Determination for  
Former Nash Road Landfill  
NYSDEC Site #932054  
Town of Wheatfield, Niagara County, New York

AERIAL PHOTOGRAPH OF SITE  
INTERIM REMEDIAL MEASURES WORK PLAN  
NASH ROAD LANDFILL  
*Wheatfield, New York*

**WETLANDS PERMITTING PLAN**  
**INTERIM REMEDIAL MEASURE WORK PLAN**  
**NASH ROAD LANDFILL**  
*Wheatfield, New York*

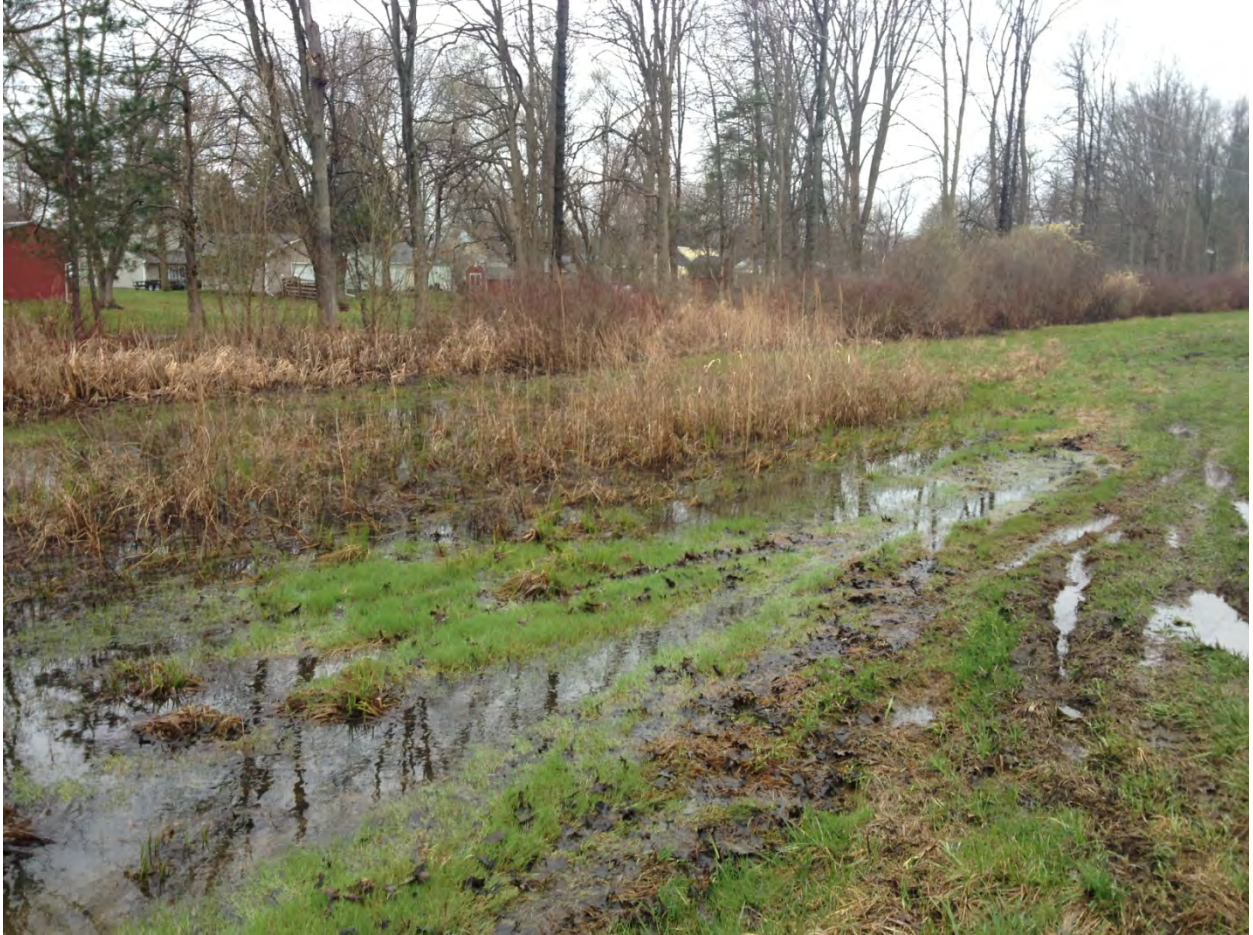
13. Looking southwest of emergent wetlands within the overhead power line easement located along the southern Site boundary.

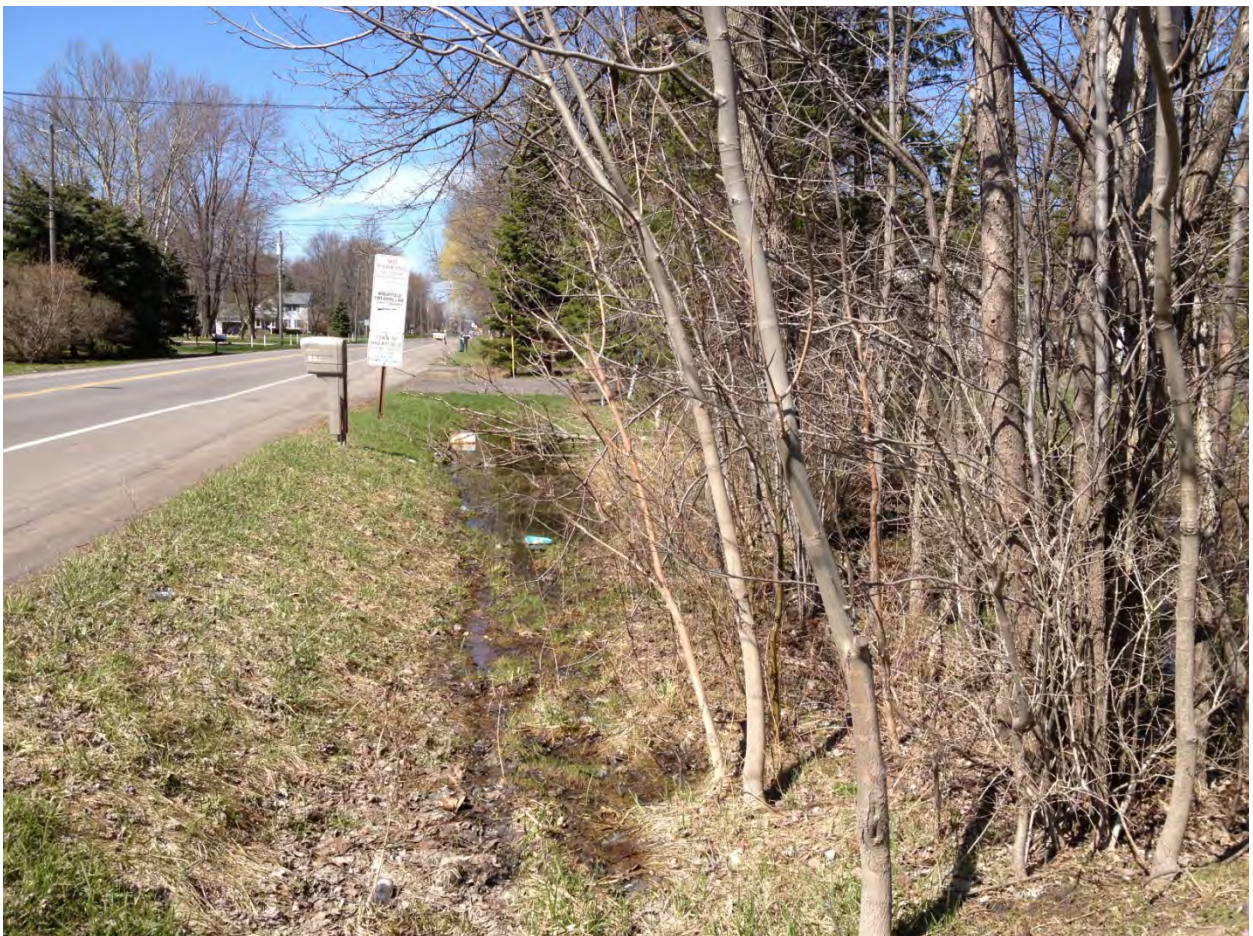
14. Looking northwest at a road side swale adjacent to Nash Road. The swale connects to the forested/emergent wetlands located within the Study Area.

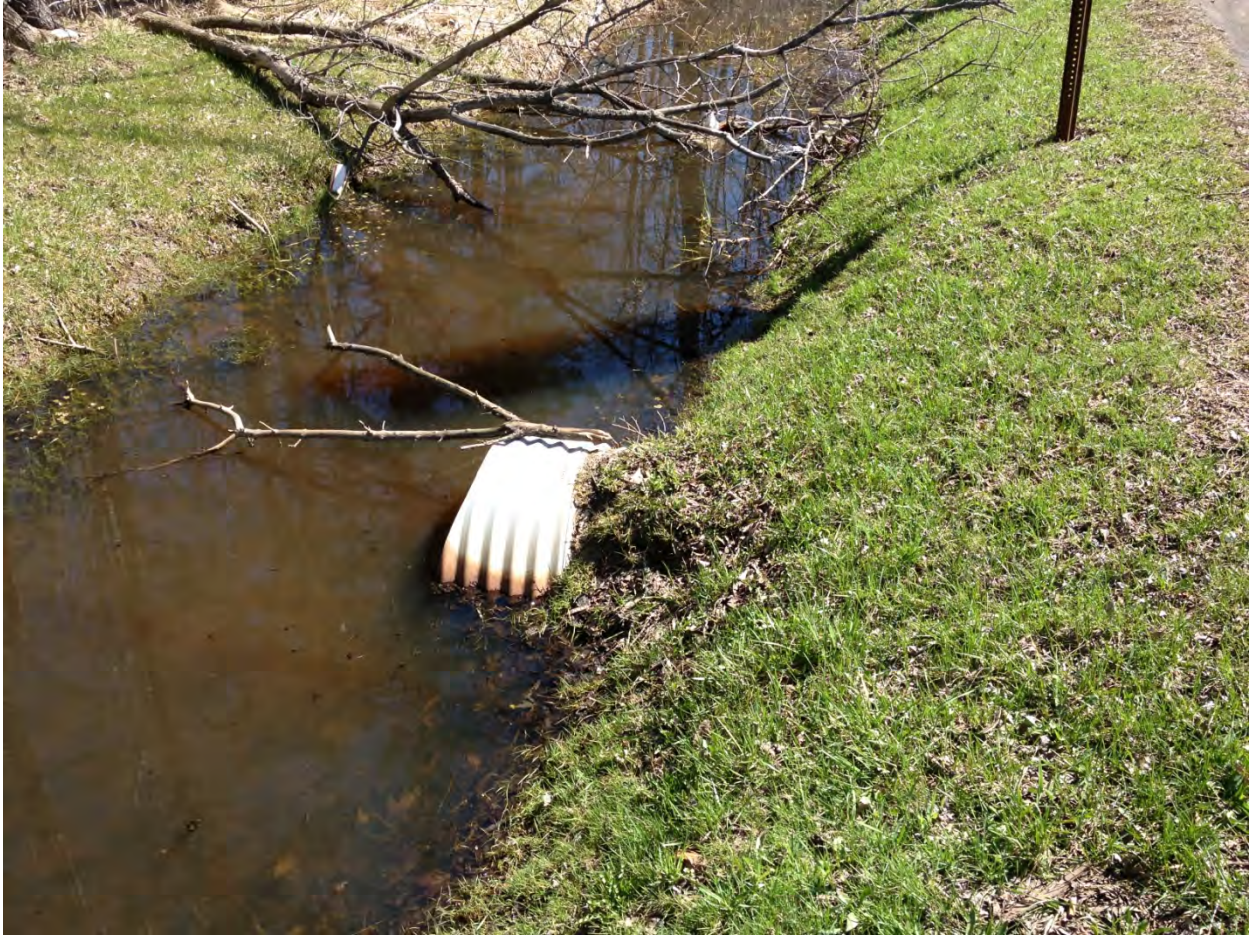
15. Looking south at a road side swale and culvert pipe adjacent to Nash Road. The swale connects to the forested/emergent wetlands located within the Study Area. The culvert pipe flows underneath Nash Road and connects to an off-site drainage ditch.

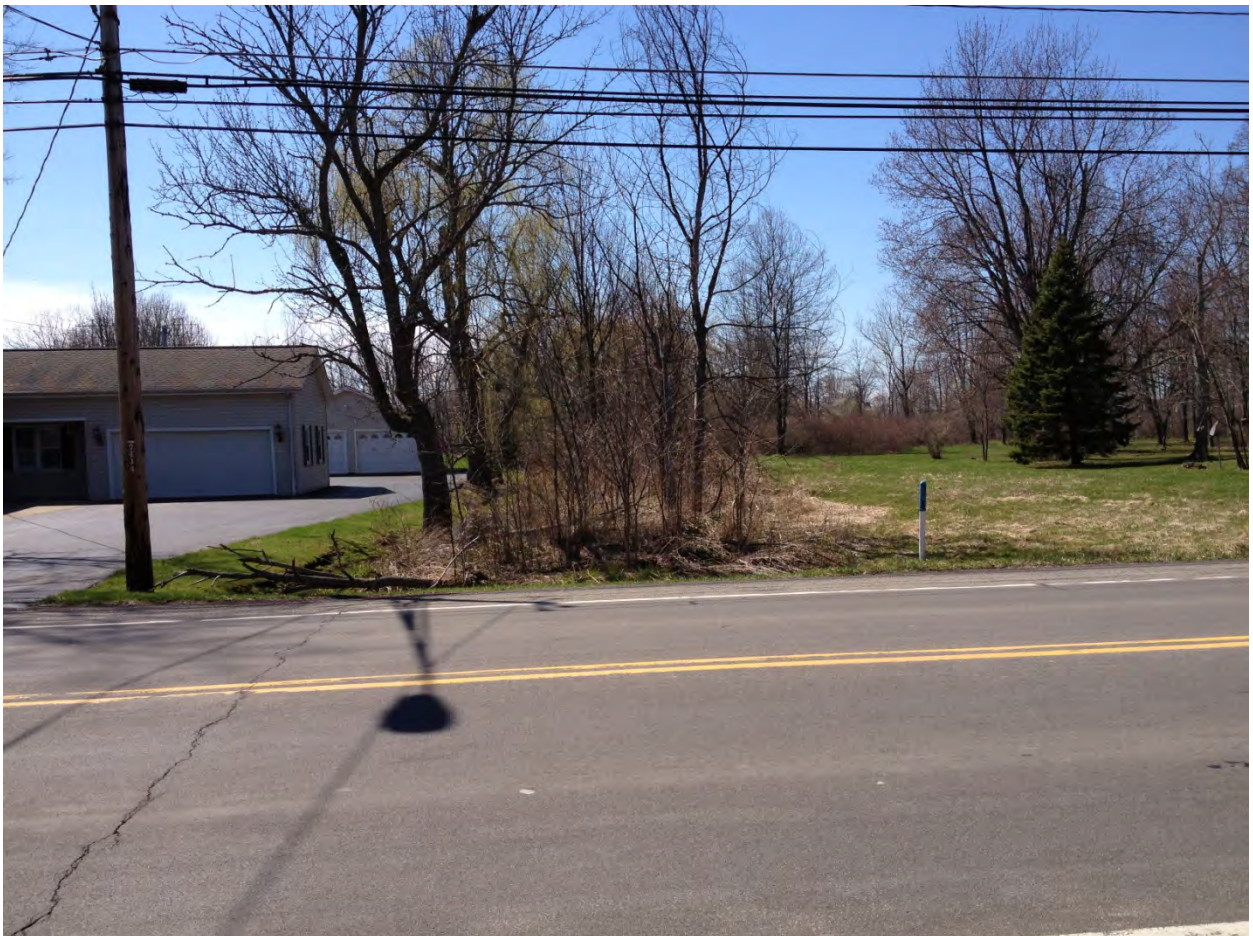
16. Looking west of the off-site drainage ditch along Nash Road.
