ENGINEERING INVESTIGATIONS AT INACTIVE HAZARDOUS WASTE SITES IN THE STATE OF NEW YORK

PHASE II INVESTIGATIONS

**Dibacco Site No. 1, Old Creek Site
Site Number 932056A
Town of Niagara, Niagara County**

February 1992

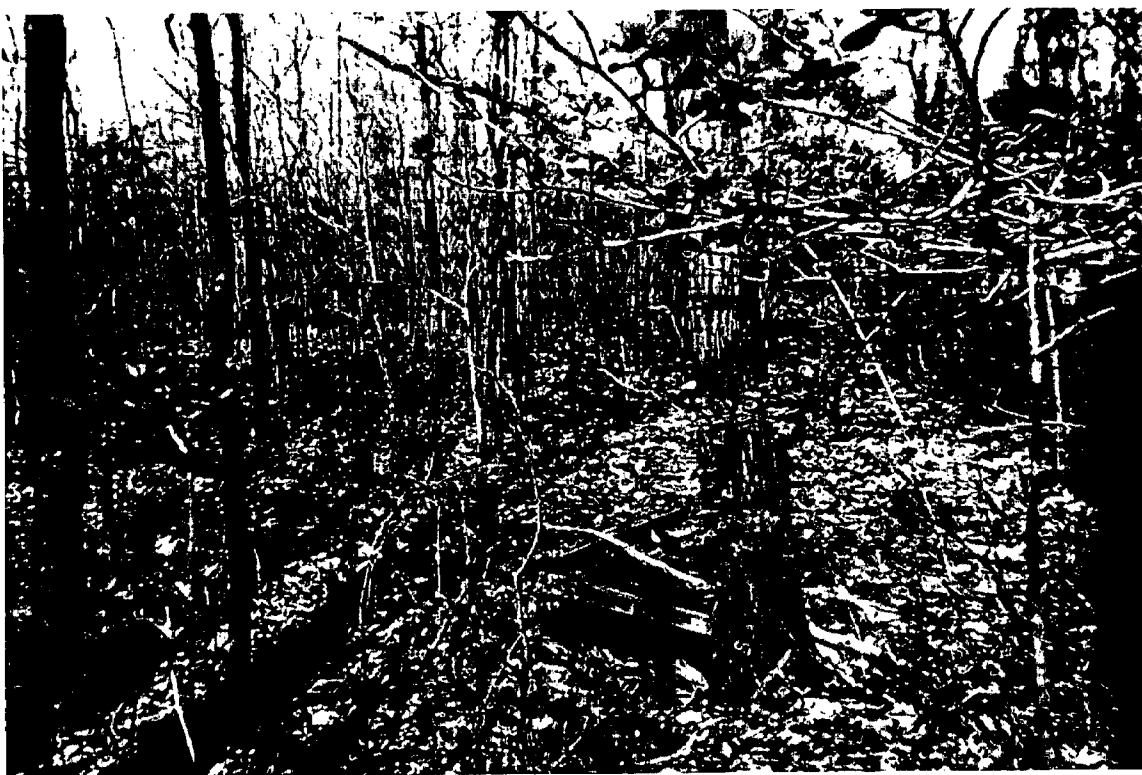
Frame No.: Roll 1-4

Comments: Geophysical survey grid for GW-2 on north side of the embankment looking east.

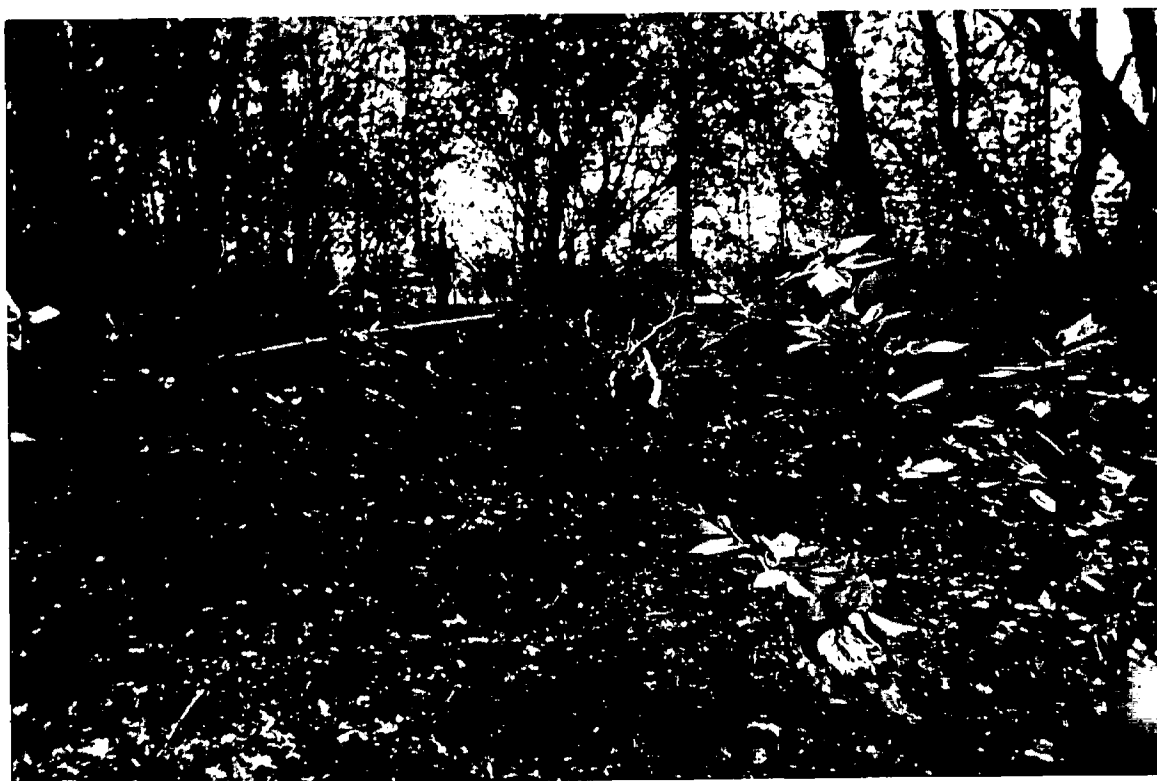
Frame No.: Roll 1-5

Comments: Geophysical survey grid for GW-3 facing east by Cayuga Creek showing the berm of the
existing creek with background.

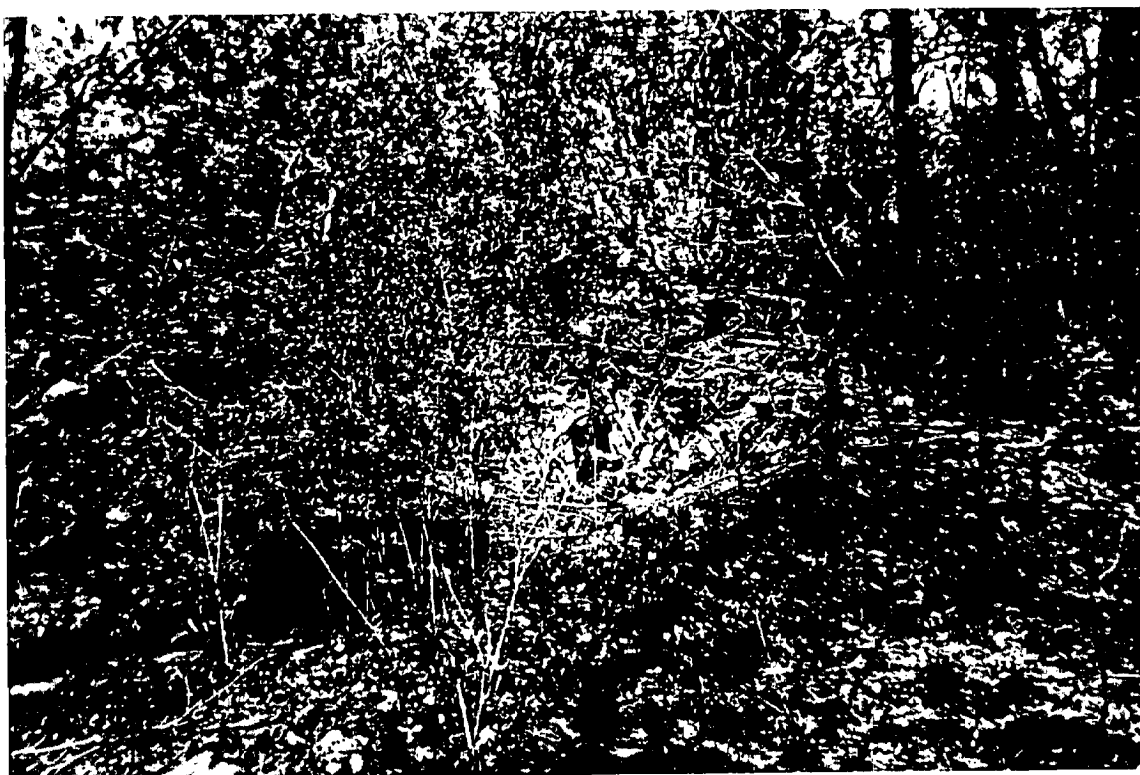
Frame No.: Roll 1-6

Comments: Geophysical survey grid for GW-3 facing north by Cayuga Creek showing the exposed debris
at the base of the pile.

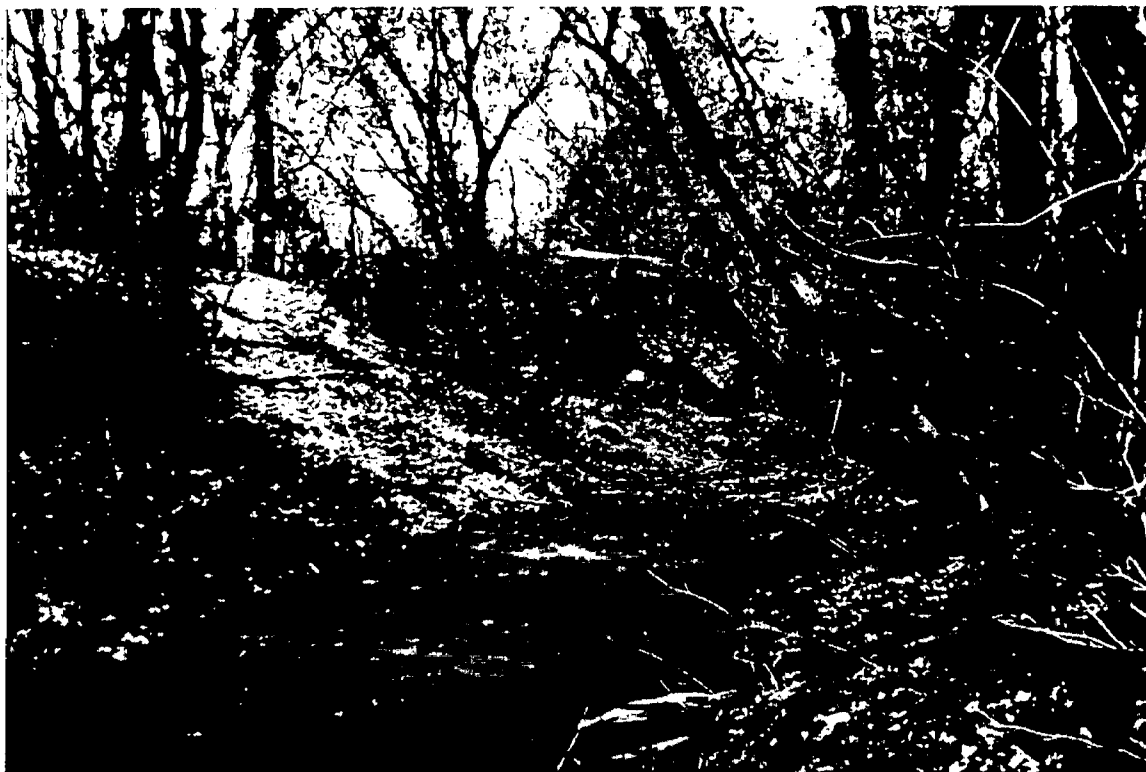
Frame No.: Roll 1-7

Comments: Looking northeast up Cayuga Creek showing the berm of the existing creek and intermittent nature of the creek.

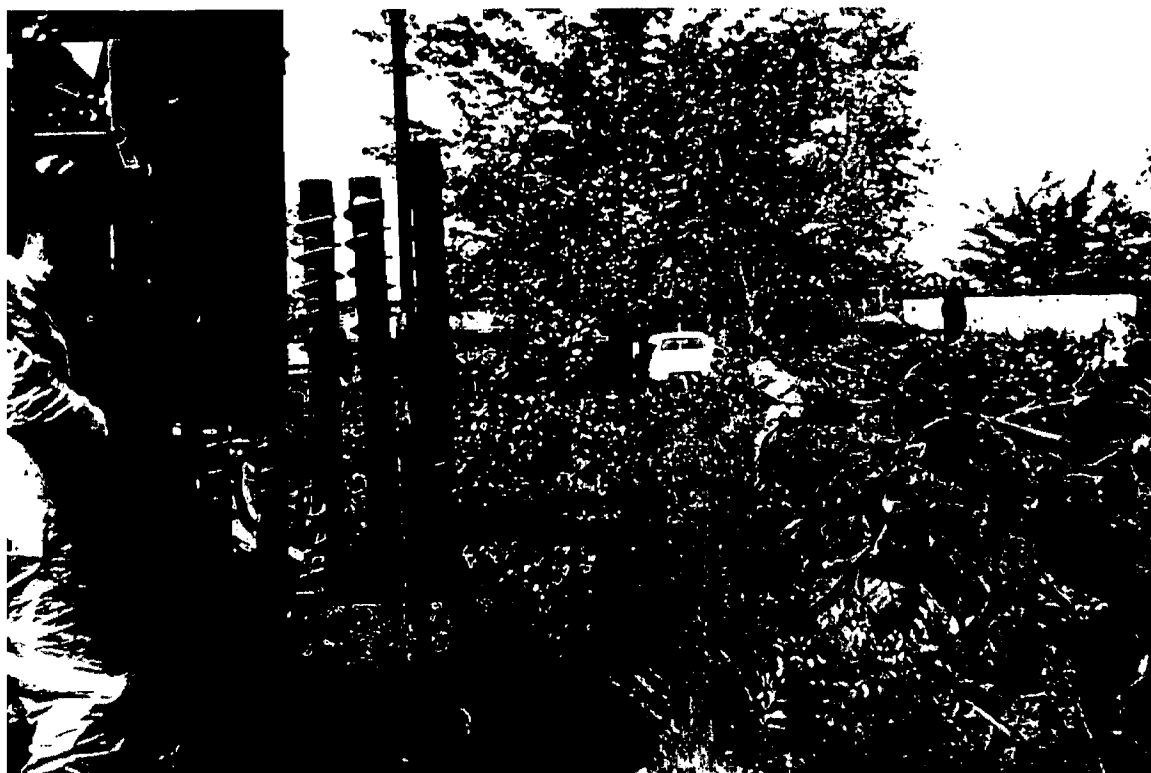
Frame No.: Roll 1-9

Comments: Drill rig positioned on BH-1 behind the gas station, looking north.
