**TEST PIT SUMMARY REPORT
BARRIER WALL CONSTRUCTION**

**Gratwick-Riverside Park Site
North Tonawanda, New York**

FEBRUARY 1997

REF. NO. 7987 (9)

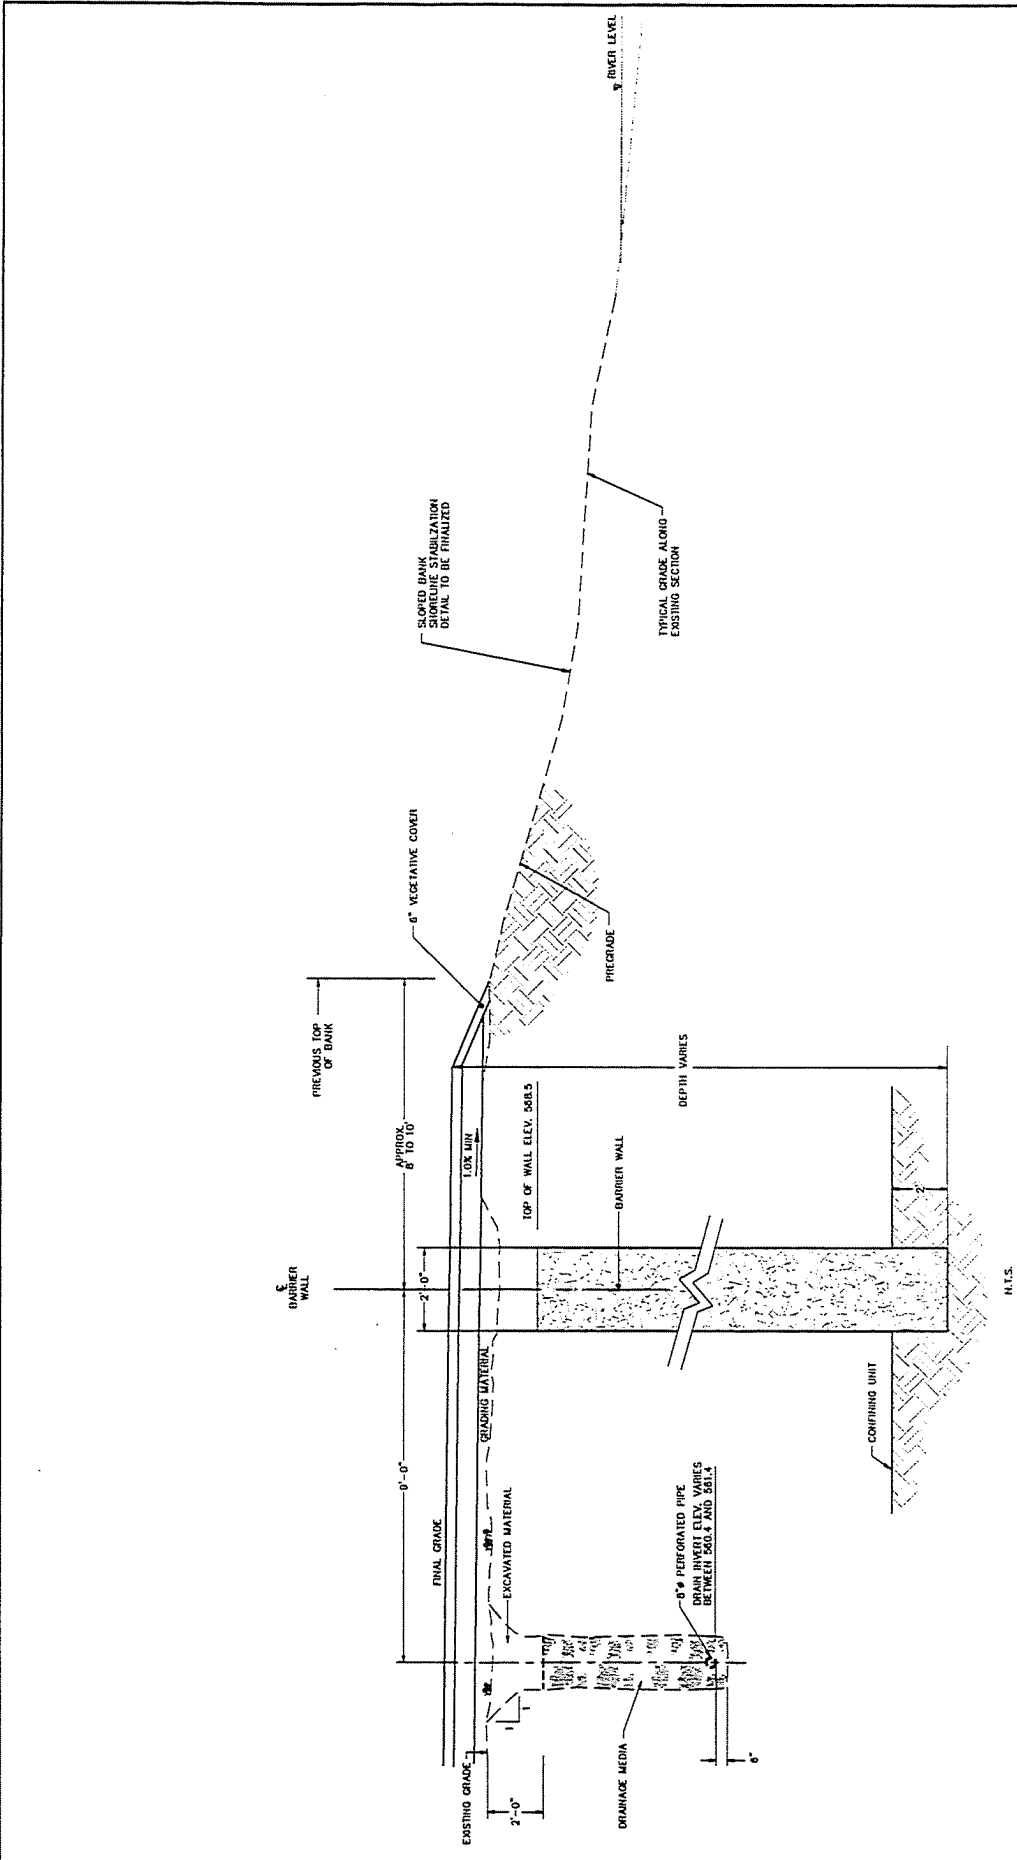
figure 1.2
 TYPICAL SLURRY WALL DETAIL
 TEST PIT SUMMARY REPORT
Gratwick-Riverside Park Site
Performing Parties

The traditional method of slurry wall construction involves the use of a backhoe to excavate a trench. The trench cavity is supported by a trenching slurry which is subsequently replaced with low permeability backfill materials. A typical detail of a slurry type barrier wall is presented on Figure 1.2. An HDPE barrier wall can be constructed either by driving HDPE wall panels or by placing the liner within the groundwater collection drain trench. A typical detail of an HDPE barrier wall is presented on Figure 1.3.

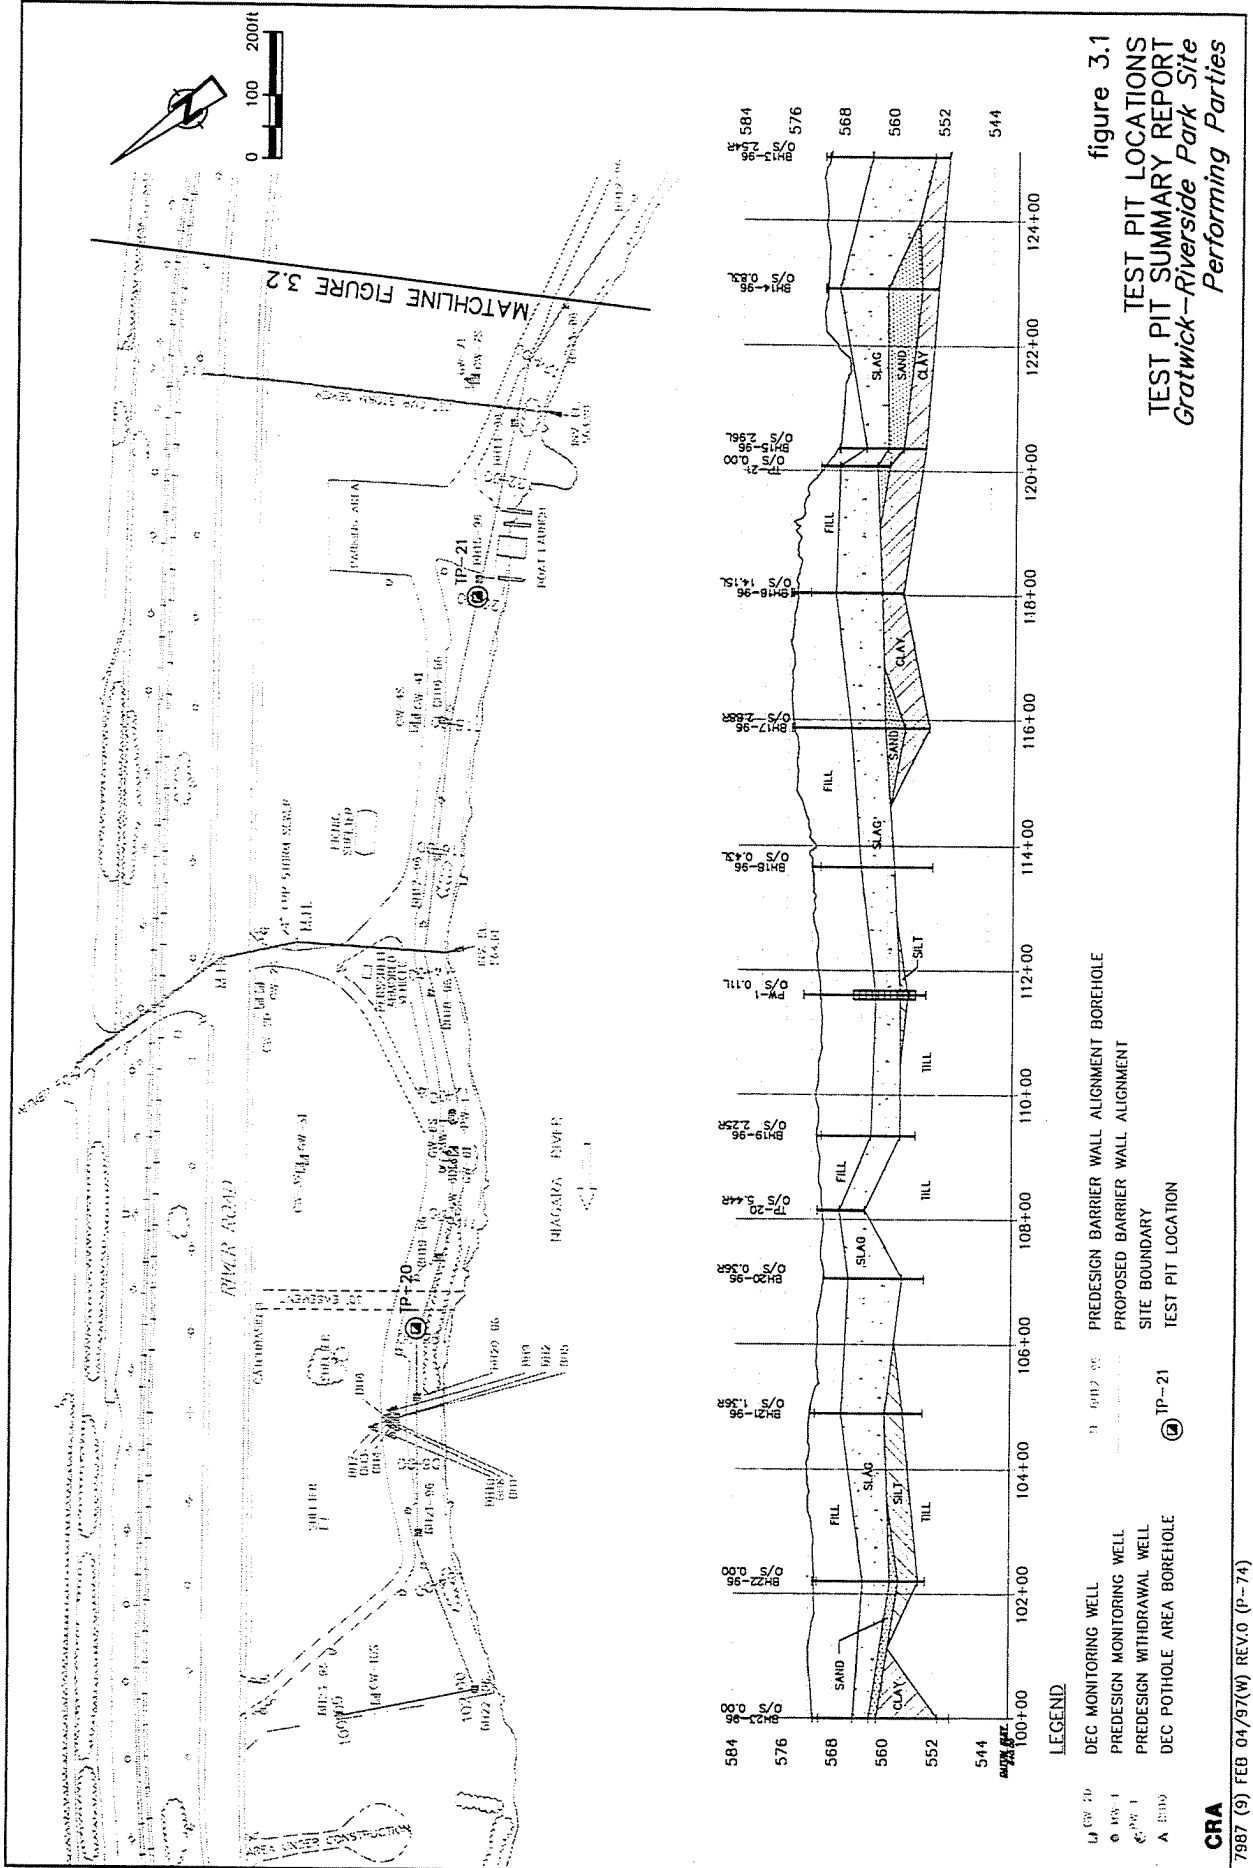
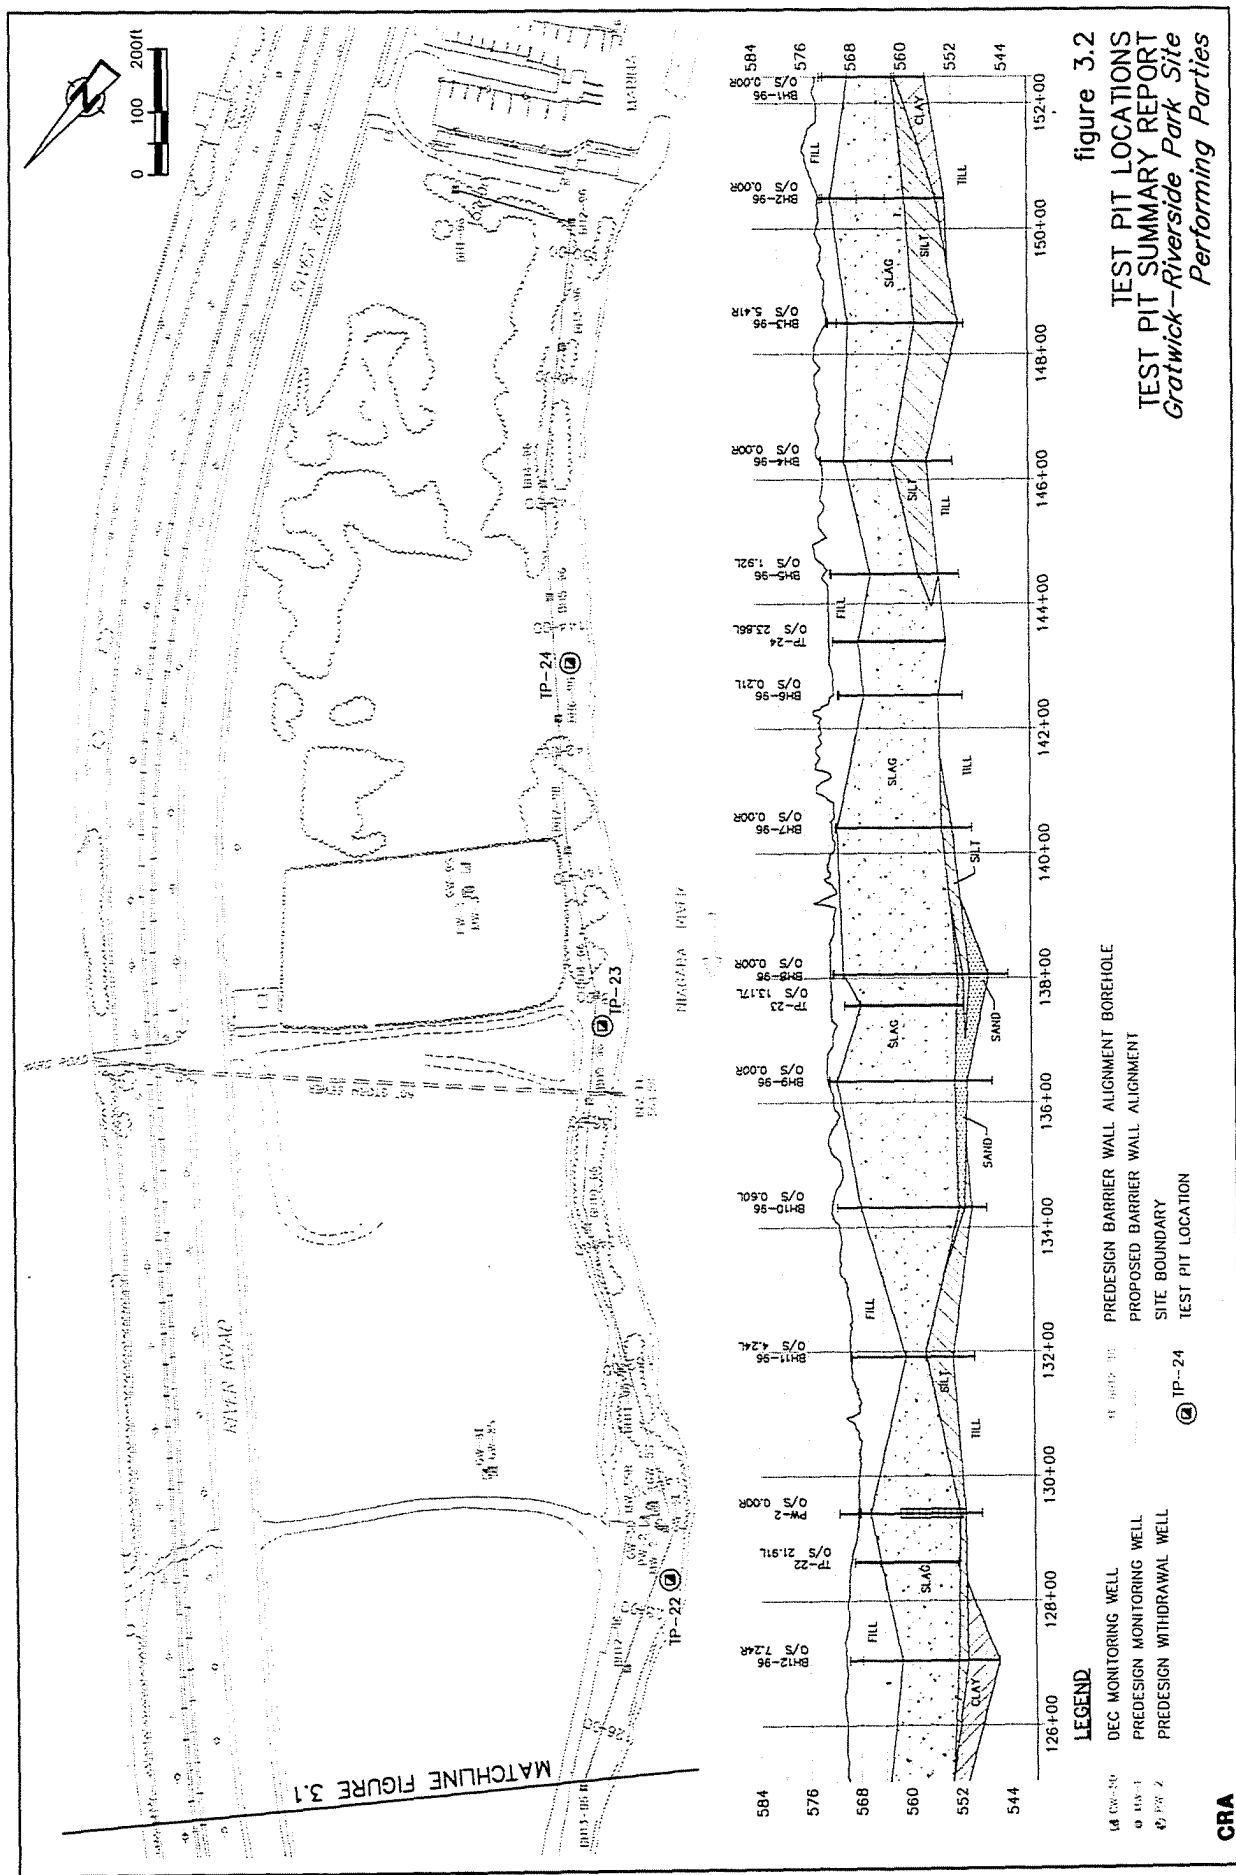
The purpose of the test pit program was to assist in determining the "constructability" of each type of barrier wall along the River shoreline at the Site. Figures 3.1 and 3.2 show the five test pit locations (TP-20, TP-21, TP-22, TP-23 and TP-24), the proposed barrier wall alignment, as well as the stratigraphy in cross-section through the 23 boreholes and two withdrawal wells. Specifically, the intent of the test pit program was to determine which technique or techniques are appropriate for construction of a barrier wall through areas of slag fill.

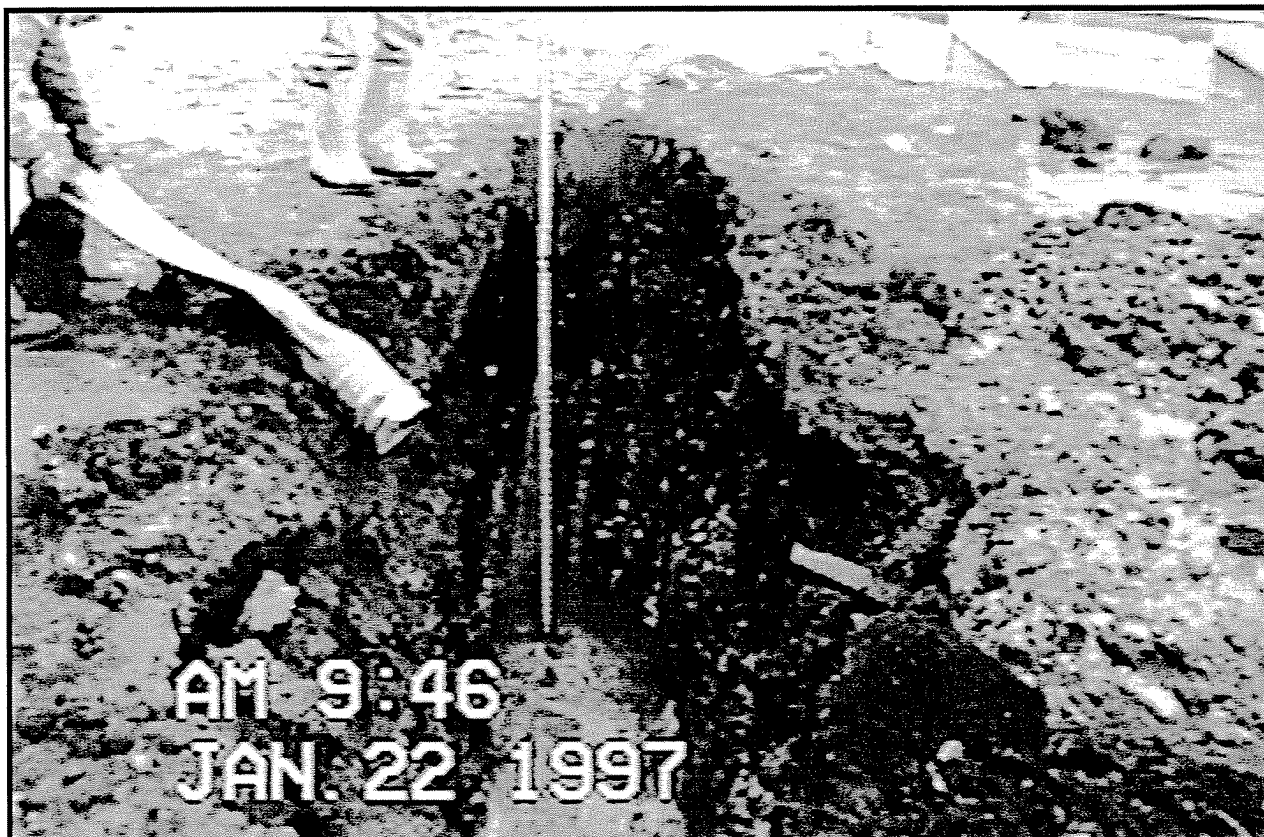
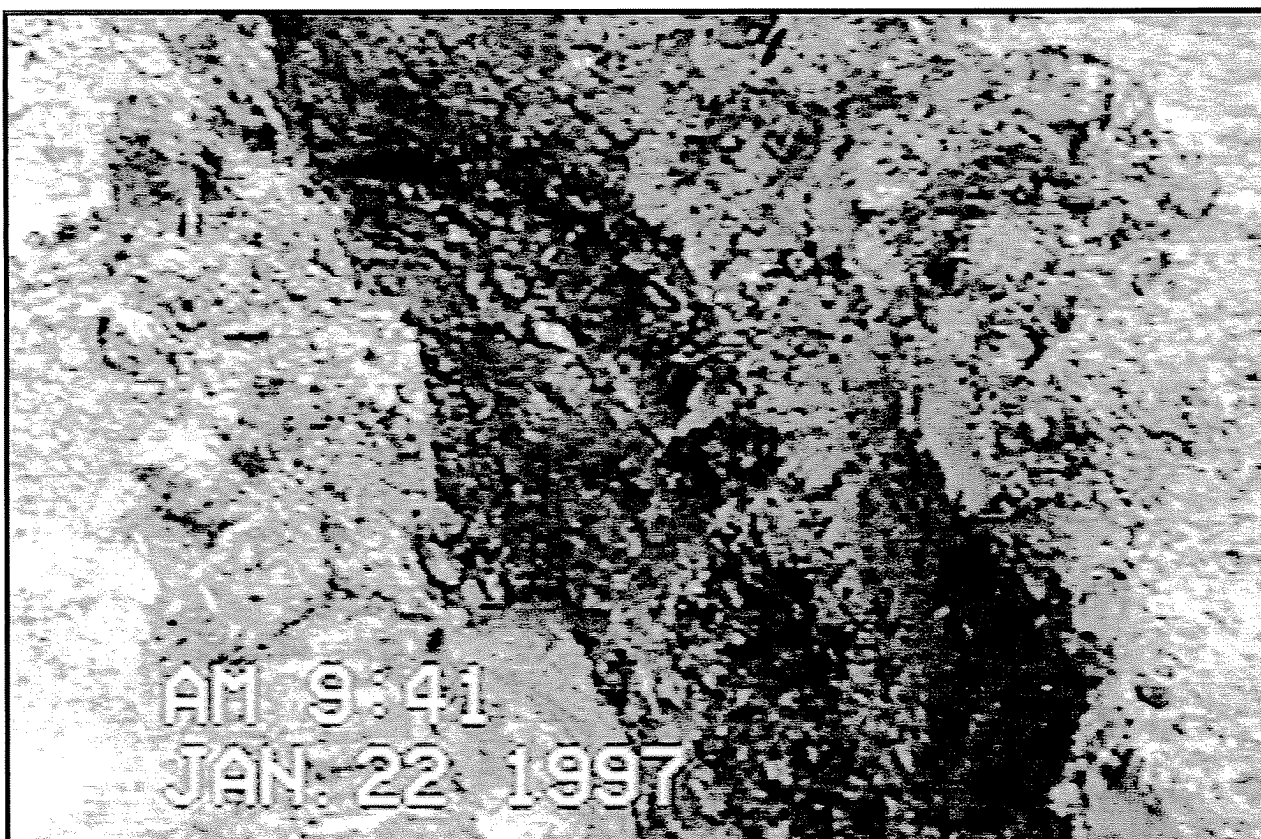
figure A.1

Test pit TP-20 was started and completed on January 22, 1997. The fill, composed primarily of clayey topsoil mixed with old bottles, was excavated to $3.5\pm$ feet below ground surface (BGS). The top of the groundwater surface was not contacted. The excavation was $13\pm$ feet long by $2\pm$ feet wide and contained no water. One foot of River water (approximately 195 gallons) was pumped into the excavation to conduct the test of the transmissive capabilities of the fill layer. The rate of water loss was observed for 5 minutes. A total of $3.6\pm$ inches of the pumped water ($12\pm$ gpm) was lost to the sidewalls in the five minute interval. This represents an approximate volume of 60 gallons or 30% of the volume of River water introduced to the excavation.

The slag was then excavated to the top of the confining unit, $7.5\pm$ feet BGS where till was contacted. The top of the groundwater surface was observed at approximately 5.5 feet BGS as the test pit was filled with water to this level. The excavation remained $13\pm$ feet long by $2\pm$ feet wide. Two feet of River water (approximately 390 gallons) was pumped into the excavation to conduct the test of the transmissive capabilities of the slag layer. The rate of water loss was observed for 10 minutes. A total of $10.5\pm$ inches was lost to the sidewalls in the 10 minute interval, $7\pm$ inches in the first 5 minutes ($22\pm$ gpm) and $3.5\pm$ inches in the final 5 minutes ($11\pm$ gpm). This represents an approximate volume of 170 gallons or 44% of the volume of River water introduced to the excavation. Sixty-seven percent of the total water loss was lost in the first five minutes of the test.

Test Pit TP-20

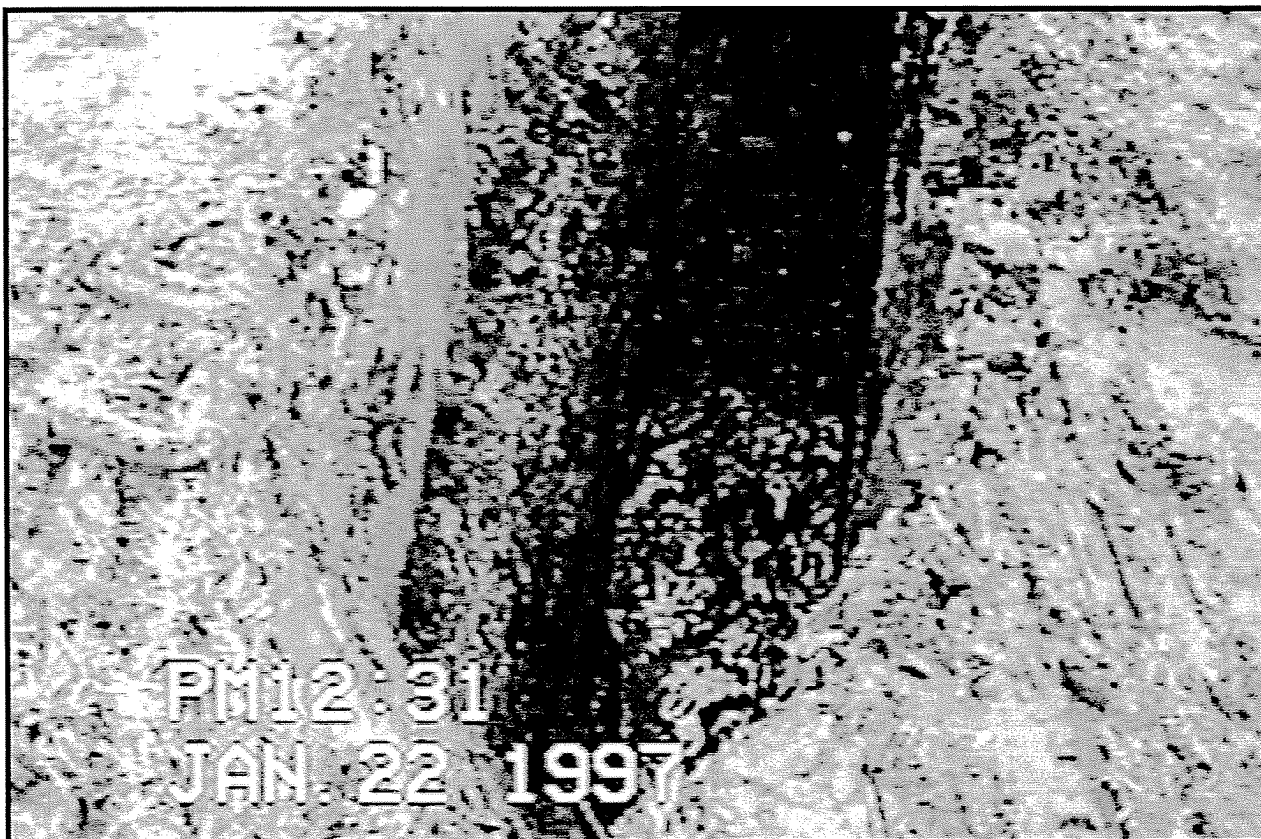
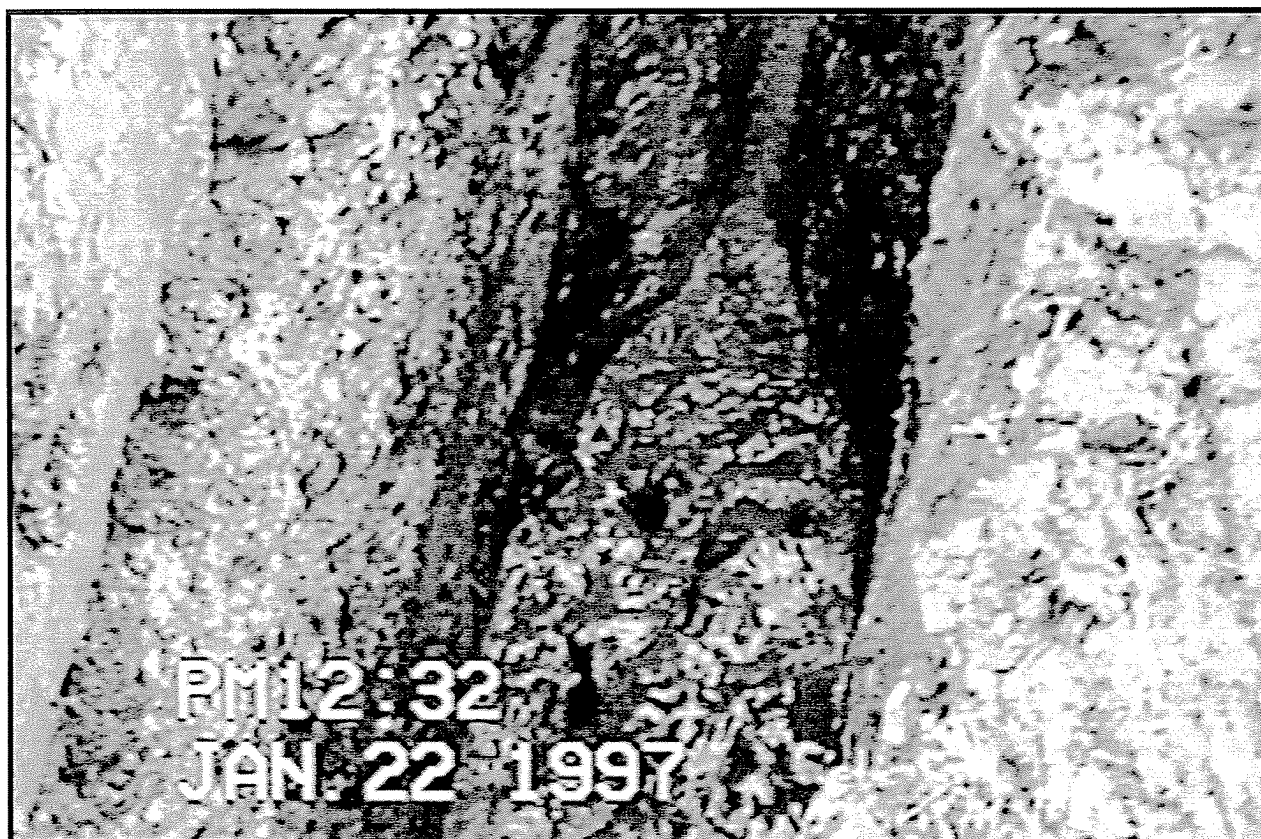
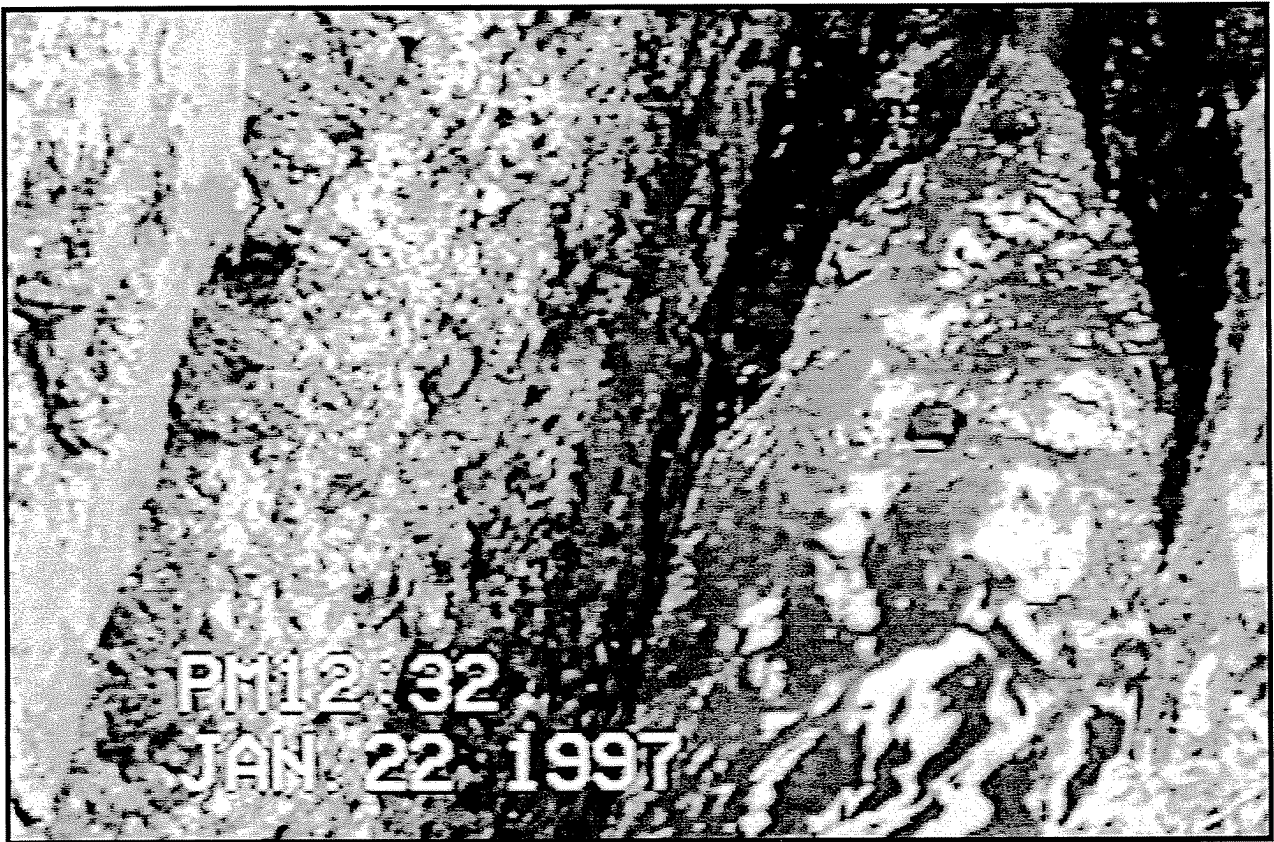
figure A.2

Test pit TP-21 was started and completed on January 22, 1997. The fill, composed primarily of topsoil mixed with foundry brick, was excavated to $3\pm$ feet BGS. The top of the groundwater surface was not contacted. The excavation was $11\pm$ feet long by $2\pm$ feet wide and contained no water. One and a half feet of River water (approximately 250 gallons) was pumped into the excavation to conduct the test of the transmissive capabilities of the fill layer. The rate of water loss was observed for 5 minutes. A total of $7.2\pm$ inches of the pumped water ($20\pm$ gpm) was lost to the sidewalls in the five minute interval. This represents an approximate volume of 100 gallons or 40% of the volume of River water introduced to the excavation.

The slag was then excavated to the top of the confining unit, $11.5\pm$ feet BGS. A layer of alluvial sand (9.0 to 11.0 feet BGS) was observed above the confining unit. The top of the groundwater surface was observed at approximately $7\pm$ feet BGS where groundwater was entering the excavation through the sidewalls. The water level was observed for 5 minutes to determine the rate of groundwater infiltration. The water level rose $0.6\pm$ feet during the interval. This equates to an infiltration of approximately 108 gallons ($22\pm$ gpm). The excavation for this portion of the test was $12\pm$ feet long by $2\pm$ feet wide. Seven feet of River water (approximately 1250 gallons) was pumped into the

excavation to conduct the test of the transmissive capabilities of the slag layer. The rate of water loss was observed for 10 minutes. A total of $6.0\pm$ inches was lost to the sidewalls in the 10 minute interval, 3.6 inches in the first 5 minutes ($11\pm$ gpm) and 2.4 inches in the final 5 minutes ($7\pm$ gpm). This represents an approximate volume of 90 gallons or 7% of the volume of River water introduced to the excavation. The rate of water loss to the sidewalls decreased with depth, similar to TP-20; 60% of the water loss was lost in the first five minutes of the test.

Test Pit TP-21

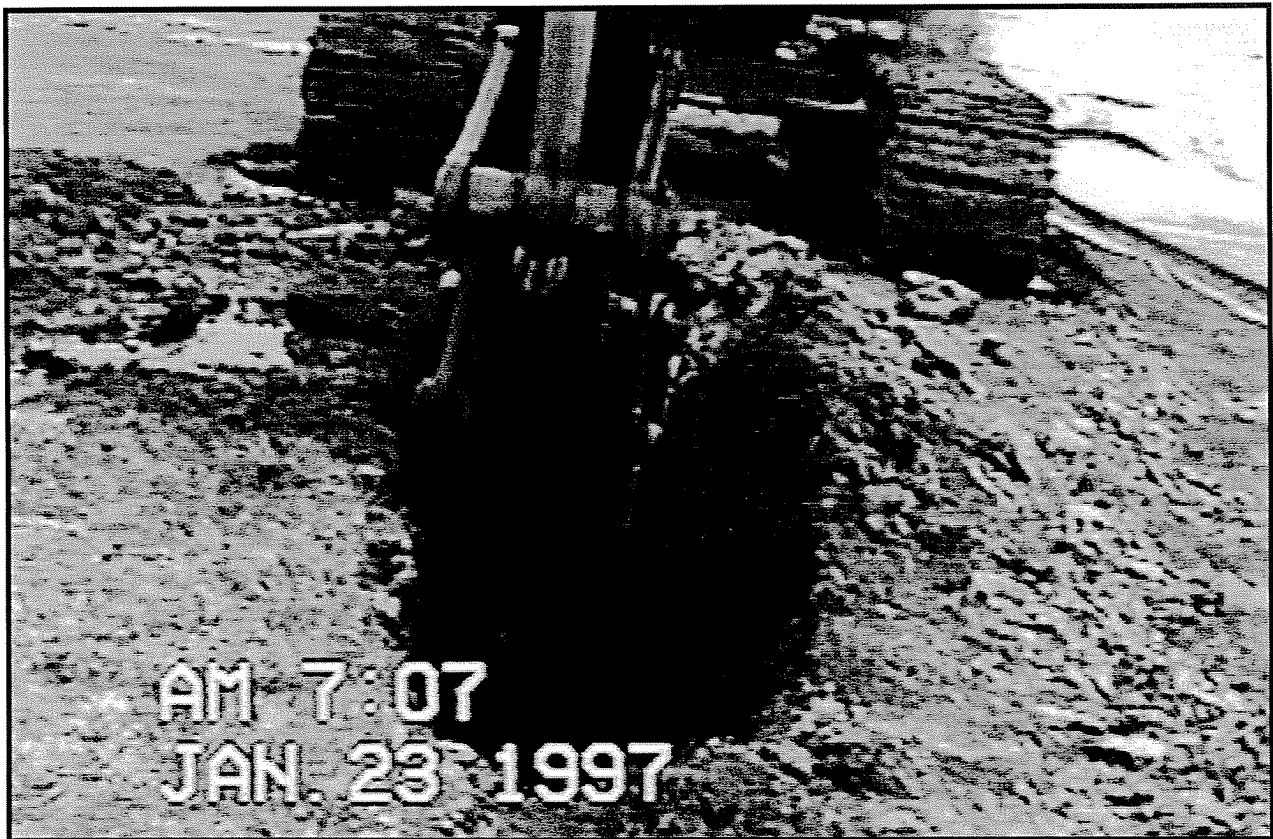
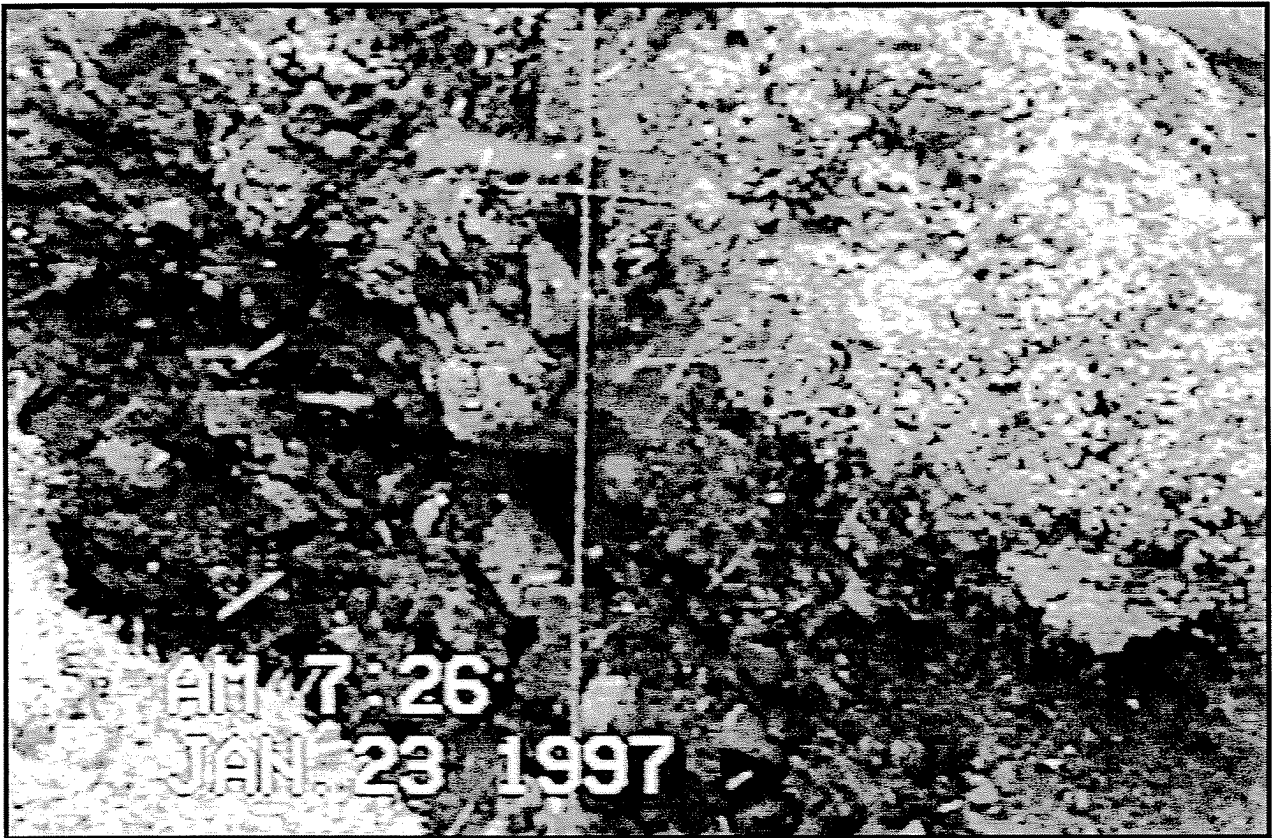
figure A.3

Test pit TP-22 was started and completed on January 23, 1997. The fill, composed primarily of sandy silt (very little debris), was excavated to $3\pm$ feet BGS. The top of the groundwater surface was not contacted. The excavation was $14\pm$ feet long by $2\pm$ feet wide and contained no water. One and a half feet of River water (approximately 315 gallons) was pumped into the excavation to conduct the test of the transmissive capabilities of the fill layer. The rate of water loss was observed for 5 minutes. A total of $4.8\pm$ inches of the pumped water was lost to the sidewalls in the five minute interval ($17\pm$ gpm). This represents an approximate volume of 85 gallons or 27% of the volume of River water introduced to the excavation.

The slag was then excavated to the top of the confining unit, $16.5\pm$ feet BGS where reddish clay was contacted. The top of the groundwater surface was observed within the excavation at approximately $5\pm$ feet BGS as the test pit was filled with water to that level. The excavation for this portion of the test was $15\pm$ feet long by $2.5\pm$ feet wide. Two feet of River water (approximately 560 gallons) was pumped into the excavation to conduct the test of the transmissive capabilities of the slag layer. The rate of water loss was observed for 10 minutes. A total of $13\pm$ inches was lost to the sidewalls in the 10 minute interval at the rates shown below:

This represents an approximate volume of 305 gallons or 55% of the volume of River water introduced to the excavation. The rate of water loss to the sidewalls decreased with depth; 90% of the water loss was in the first five minutes of the test. Given the fact that groundwater was present within the test pit during excavation (indicating slag with greater conductivity) it is to be expected that the rate of water loss would be greater than at either TP-20 or TP-21. This is confirmed by the higher exfiltration rates in TP-22.

Test Pit TP-22

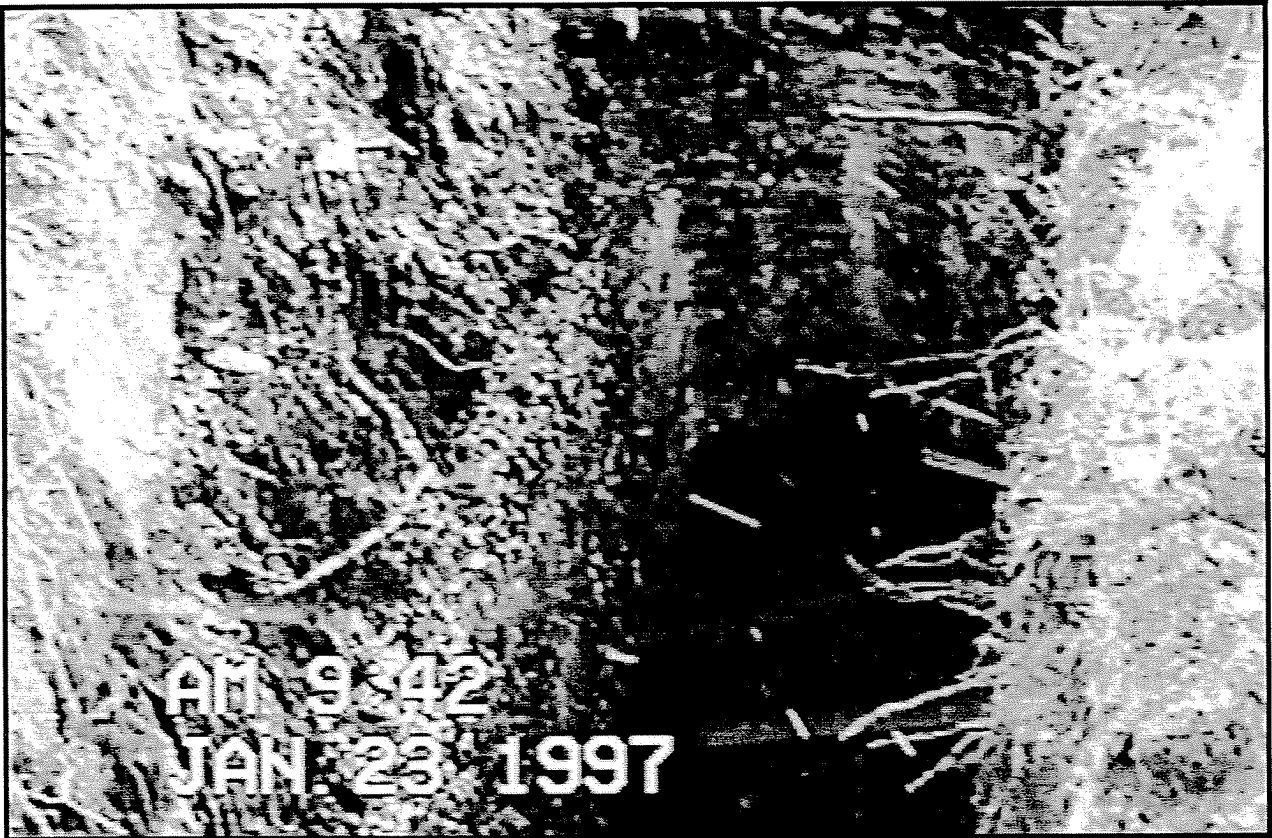
figure A.4

Test pit TP-23 was started and completed on January 23, 1997. The fill, composed primarily of topsoil (very little debris), was excavated to 2.5± feet BGS. The top of the groundwater surface was not contacted. The excavation was 13± feet long by 2± feet wide and contained no water. One and a half feet of River water (approximately 290 gallons) was pumped into the excavation to conduct the test of the transmissive capabilities of the fill layer. The rate of water loss was observed for 5 minutes. A total of 7.8± inches of the pumped water was lost to the sidewalls in the five minute interval, 4.8± inches in the first 2 minutes (42± gpm), 2.4± inches in the next two minutes (21± gpm) and 0.6 inches in the final minute (10± gpm). This represents an approximate volume of 135 gallons or 47 percent of the volume of River water introduced to the excavation.

The slag was then excavated to the top of the confining unit, 19± feet BGS where grey clay was contacted. Groundwater was observed entering the excavation through the sidewalls at approximately 8±± feet BGS. The rate of groundwater infiltration was small and a test to determine the

infiltration rate was not performed. The excavation for this portion of the test was $13\pm$ feet long by $2\pm$ feet wide. Fifteen feet of River water (approximately 2920 gallons) was pumped into the excavation to conduct the test of the transmissive capabilities of the slag layer. The rate of water loss was observed for 10 minutes. A total of $1\pm$ inch was lost to the sidewalls in the 10 minute interval, all in the first 3 minutes of the test ($3\pm$ gpm). This represents an approximate volume of 15 gallons or 0.5% of the volume of River water introduced to the excavation. The water level within the test pit remained constant for the final 7 minutes of the test. This minimal loss of water to the sidewalls is consistent with the observation that there was very little groundwater infiltrating into the open test pit during excavating, indicating a slag with a low hydraulic conductivity.

Test Pit TP-23

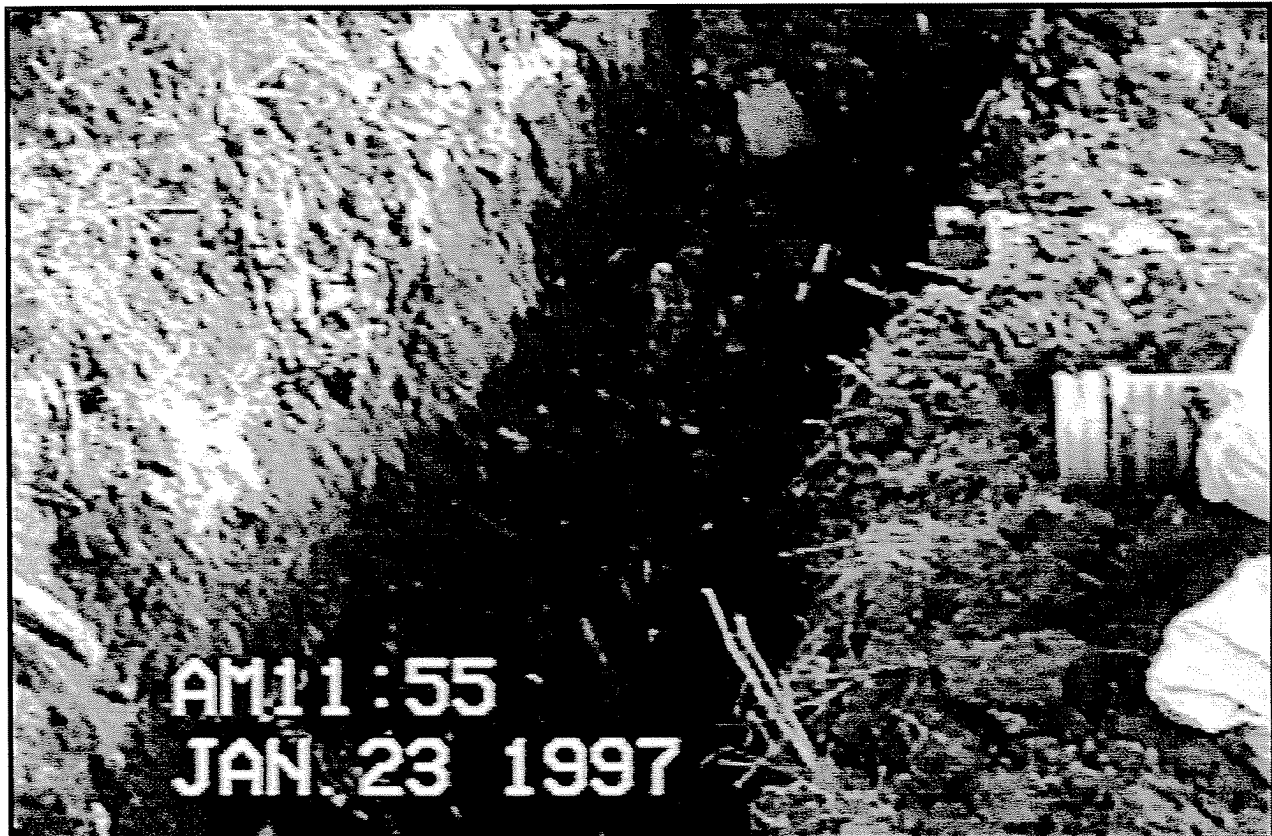
figure A.5

Test pit TP-24 was started and completed on January 23, 1997. The fill, composed primarily of topsoil mixed with a large quantity of old bottles, was excavated to $4\pm$ feet BGS. The top of the groundwater surface was not contacted. The excavation was $13\pm$ feet long by $2\pm$ feet wide and contained no water. Two feet of River water (approximately 390 gallons) was pumped into the excavation to conduct the test of the transmissive capabilities of the fill layer. The rate of water loss was observed for 5 minutes. A total of $9.6\pm$ inches of the pumped water was lost to the sidewalls in the five minute interval ($31\pm$ gpm). This represents an approximate volume of 155 gallons or 40% of the volume of River water introduced to the excavation.

The slag was then excavated to the top of the confining unit, $18\pm$ feet BGS where grey clay was contacted. Groundwater was observed entering the excavation through the sidewalls at approximately 8.5 feet BGS. The rate of groundwater infiltration was negligible and a test to determine the infiltration rate was not performed. The excavation for this portion of the test was $13\pm$ feet long by $2\pm$ feet wide. Two and three quarters of a foot of River water (approximately 535 gallons) was pumped into the excavation to conduct the test of the transmissive capabilities of the slag layer. The rate of water loss was observed for 10 minutes. A total of $6\pm$ inches was lost to the sidewalls in the

10 minute interval, $3 \pm$ inches in the first 3 minutes of the test ($17 \pm$ gpm) and $3 \pm$ inches in the last 7 minutes of the test ($7 \pm$ gpm). This represents an approximate volume of 100 gallons or 19 percent of the volume of River water introduced to the excavation. This minimal loss of water to the sidewalls is consistent with the observation that there was very little groundwater infiltrating into the open test pit during excavating, indicating a slag with a low conductivity.

Test Pit TP-24
