**Re: Charles Gibson Site, Niagara Falls, New York  
Site No. 932063  
Annual Periodic Review Report – 2018  
Post Closure Operation, Maintenance, and Monitoring Activities**

**Charles Gibson Site  
Site No. 932063  
Periodic Review Report**

**February 22, 2019**

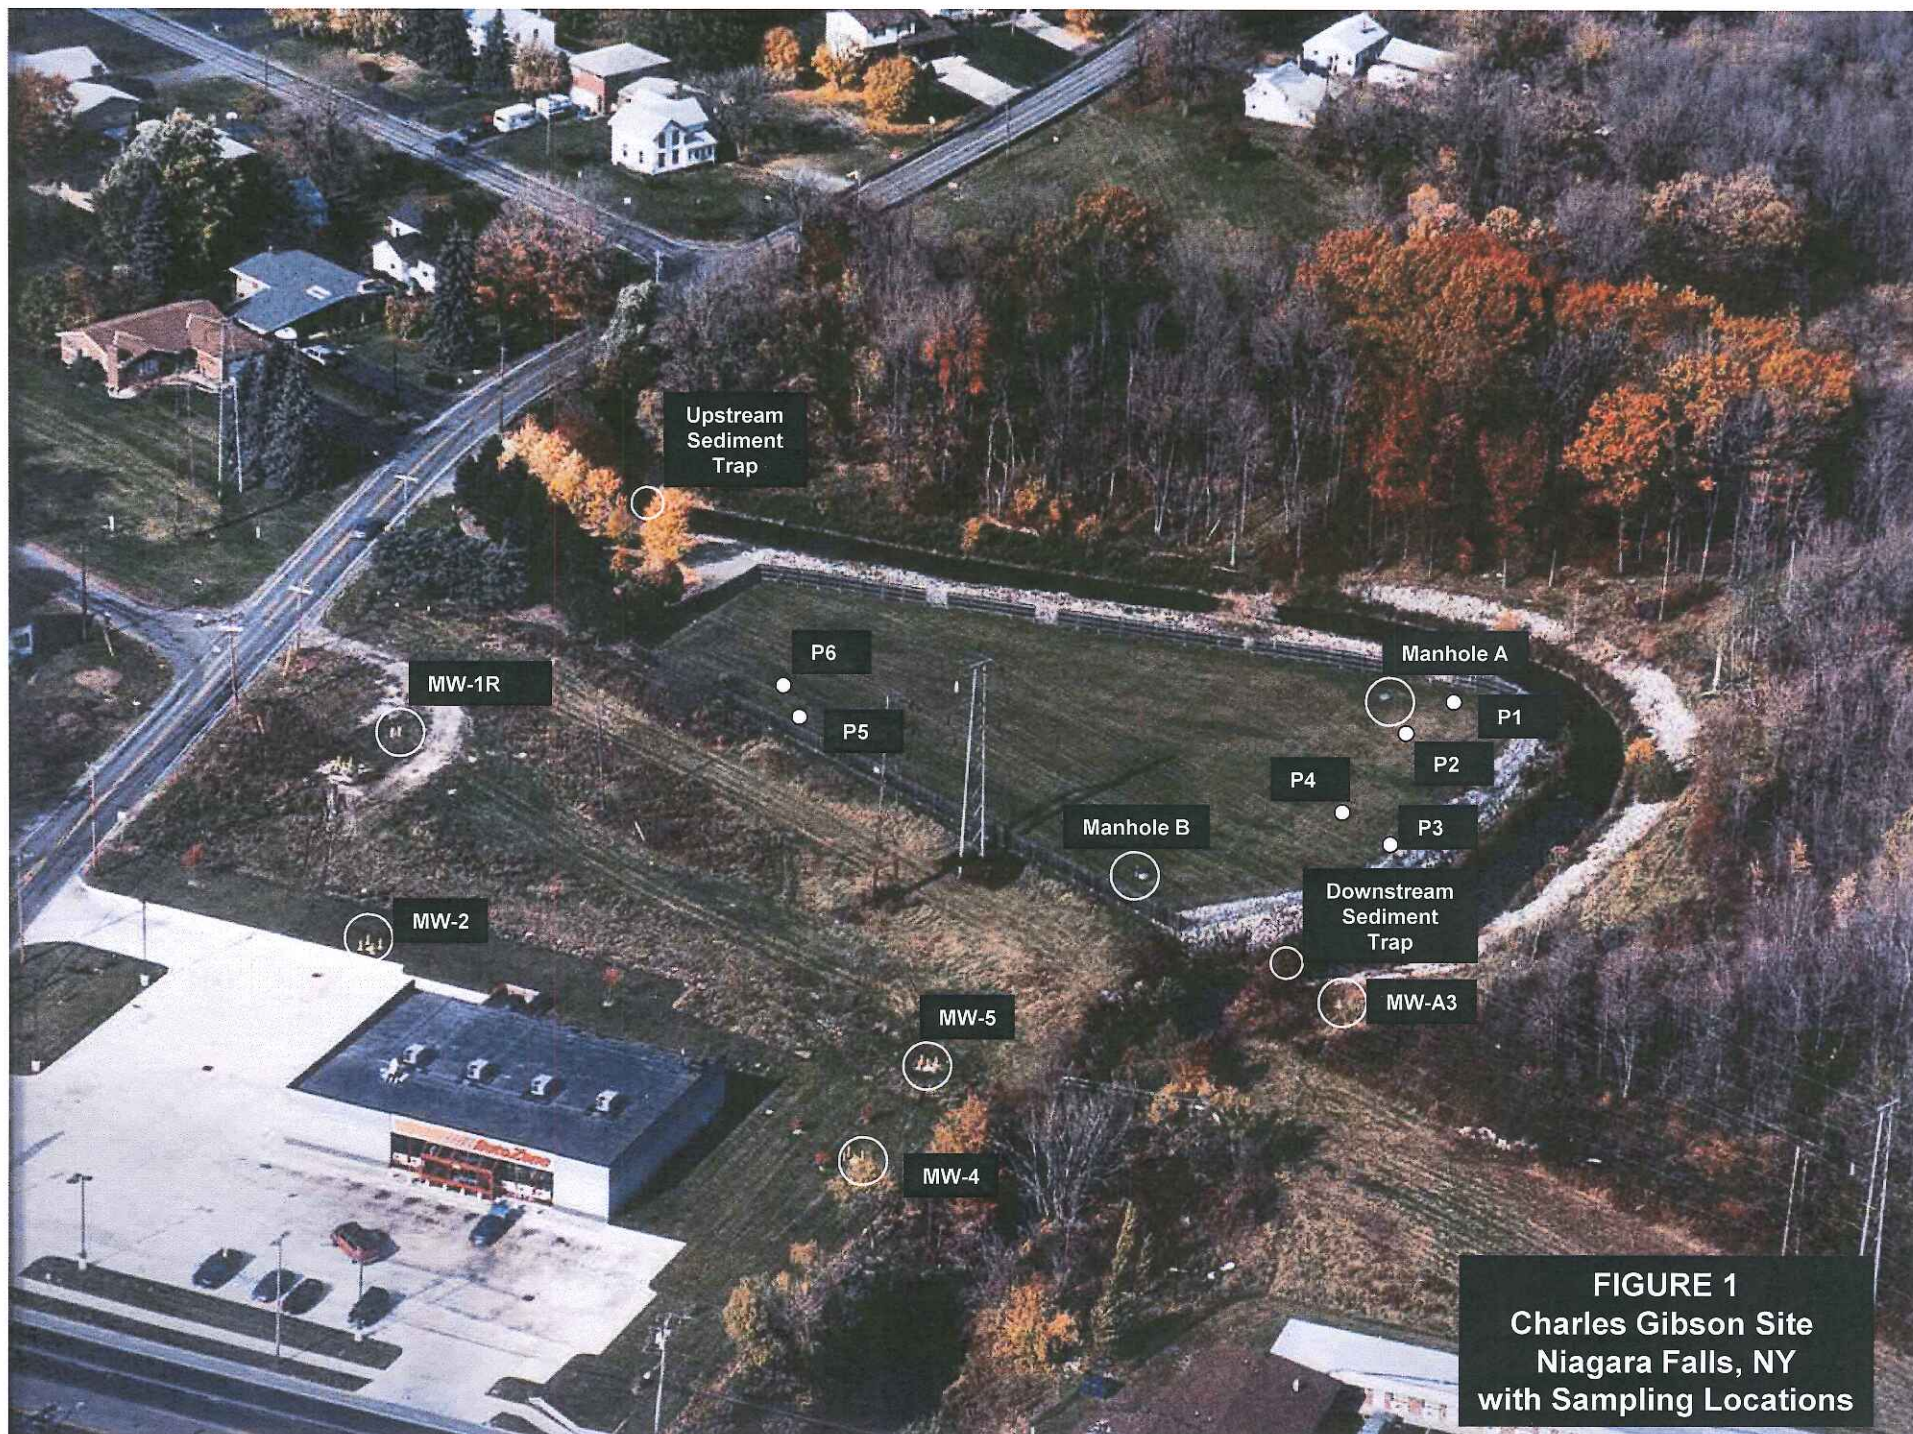
**Site Features Map  
Figure 1**

- The current groundwater level monitoring system for the Site consists of six piezometers (P-1 through P-6) and two manholes (A and B). Piezometers P-1, P-2 and Manhole A are located in the northeast section of the Site; P-3, P-4, and Manhole B are located in the southeast section; and P-5 and P-6 are located toward the southwest (see *Attachment B*).

**FIGURE 1**  
Charles Gibson Site  
Niagara Falls, NY  
with Sampling Locations
