Former Lockport Air Force Station, NY

HISTORICAL PHOTO ANALYSIS (FUDS C02NY0868)

FORMER LOCKPORT AIR FORCE STATION || MARCH 2019
Prepared for USACE – New England District

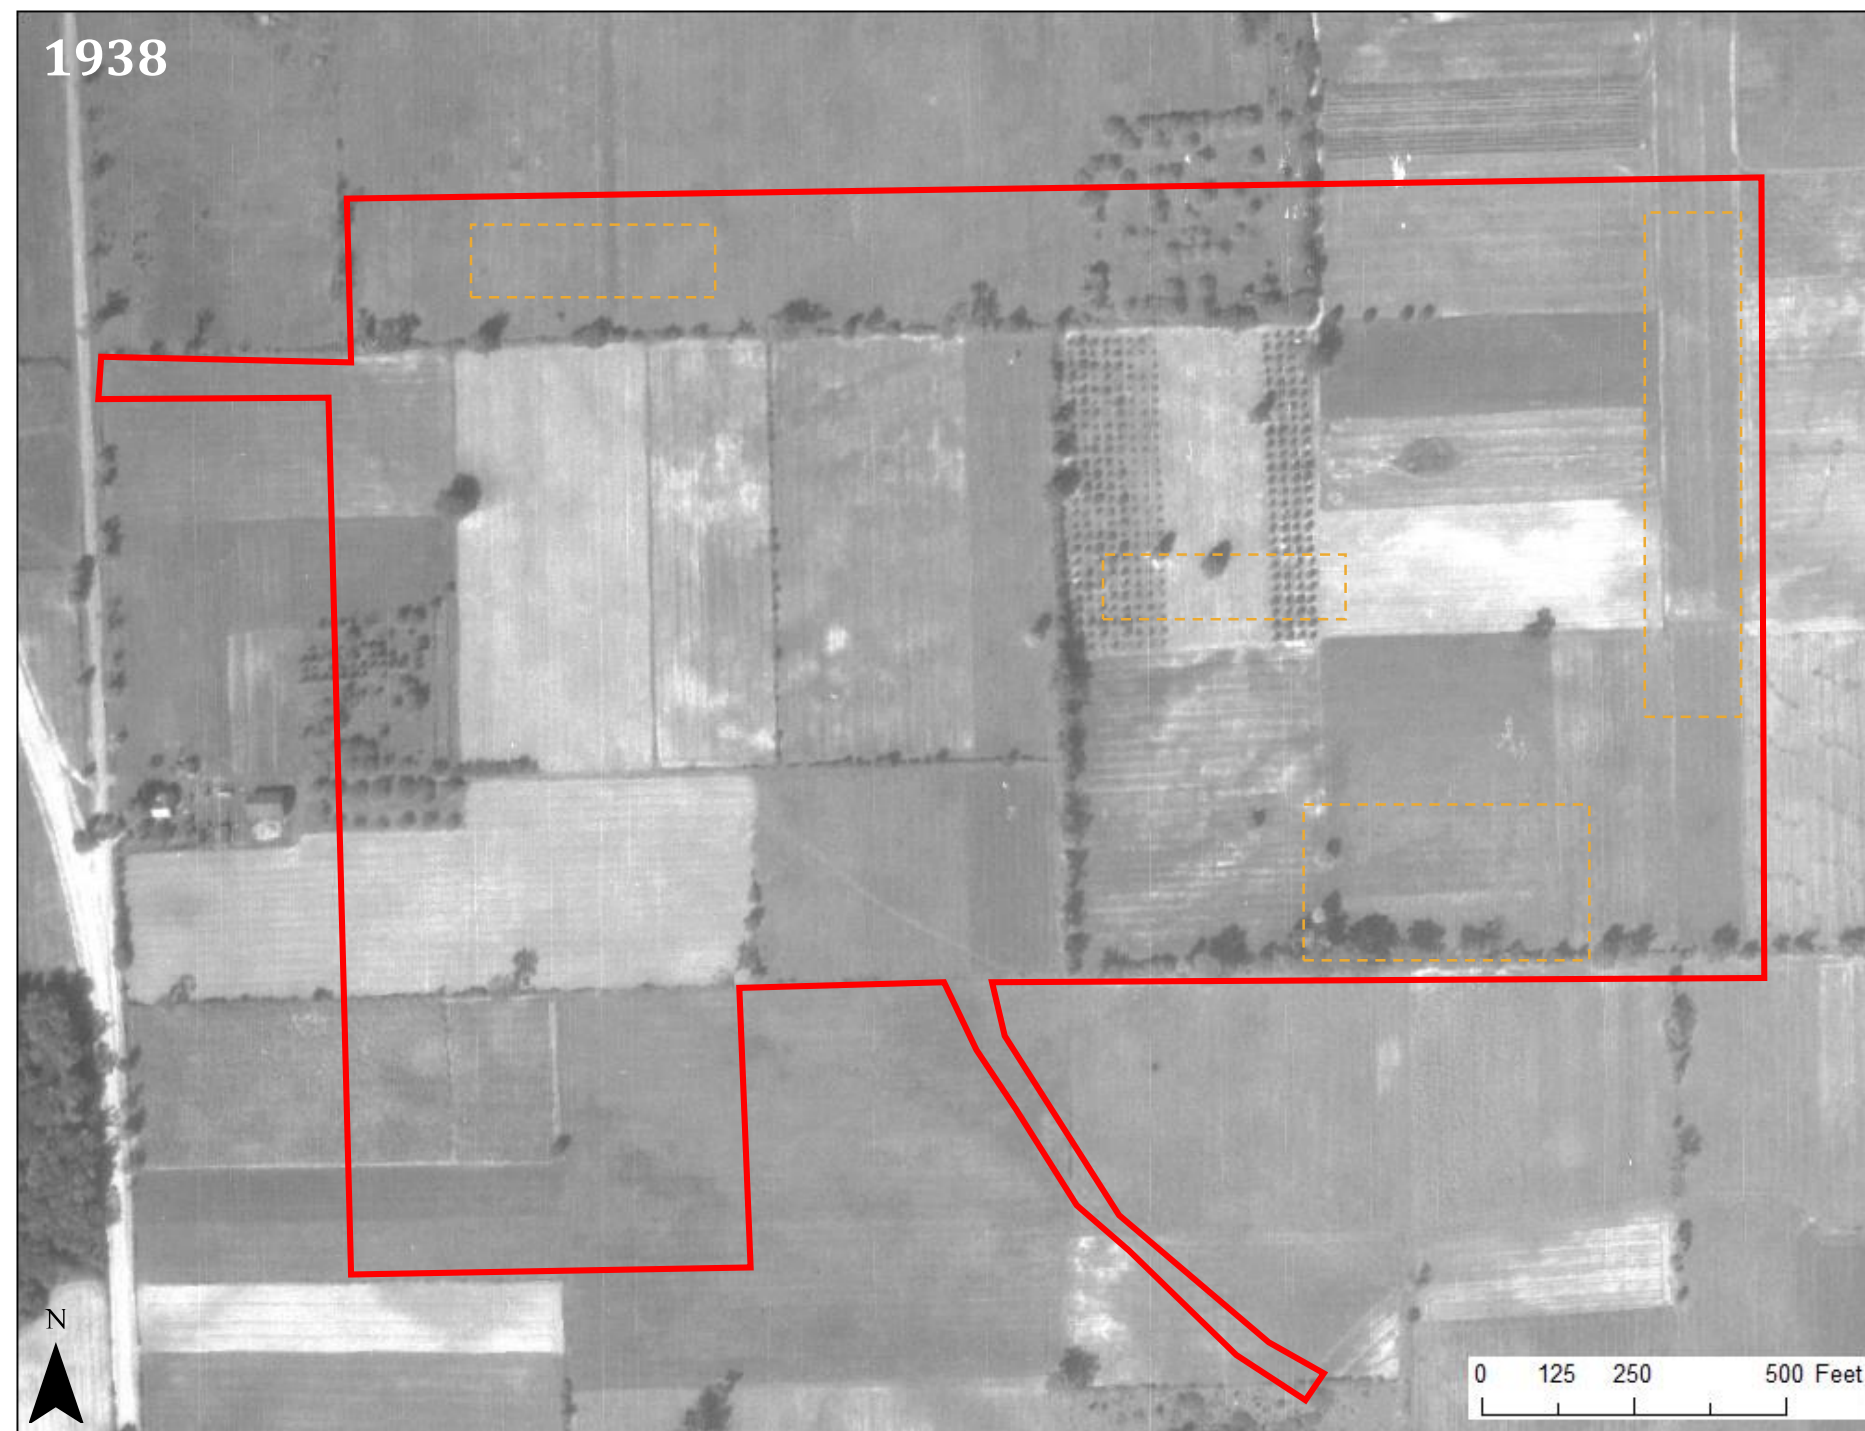
September 25, 1938

In 1938 the site was primarily agricultural land.

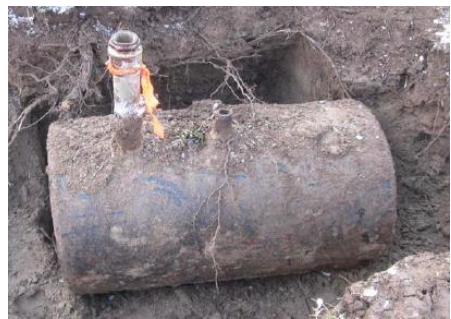
55 gallon UST recovered from this location next to a small concrete foundation.
Source: Green Seal Environmental, Inc. (2011)

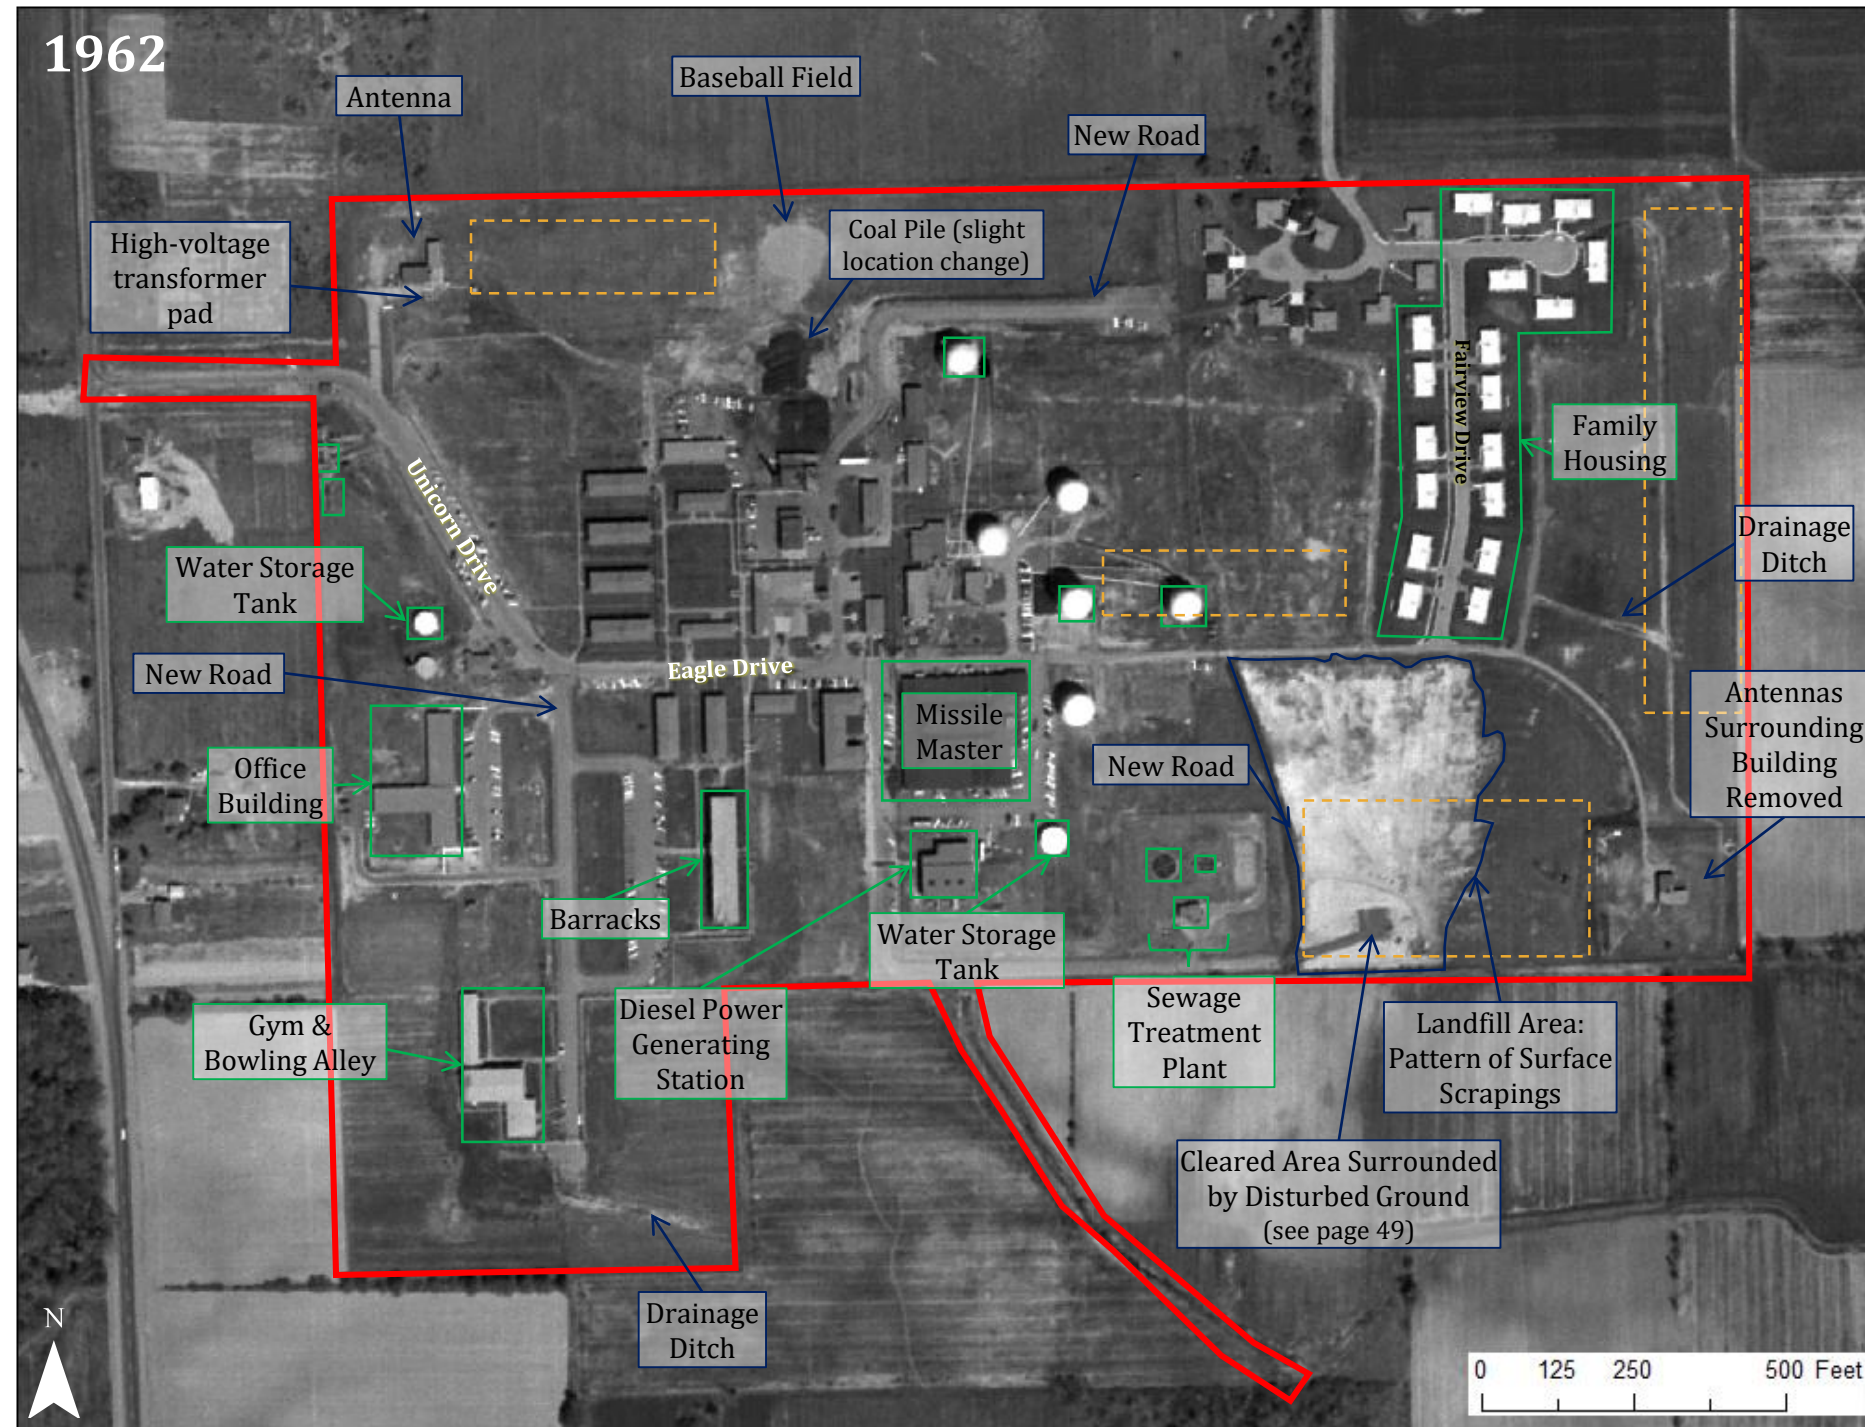
May 09, 1962

Development continued on the site between 1958 and 1962, with the expansion of the housing development. A high-voltage transformer pad (referenced in TVGA Consultants, 2009) is observed south of the dispensary.

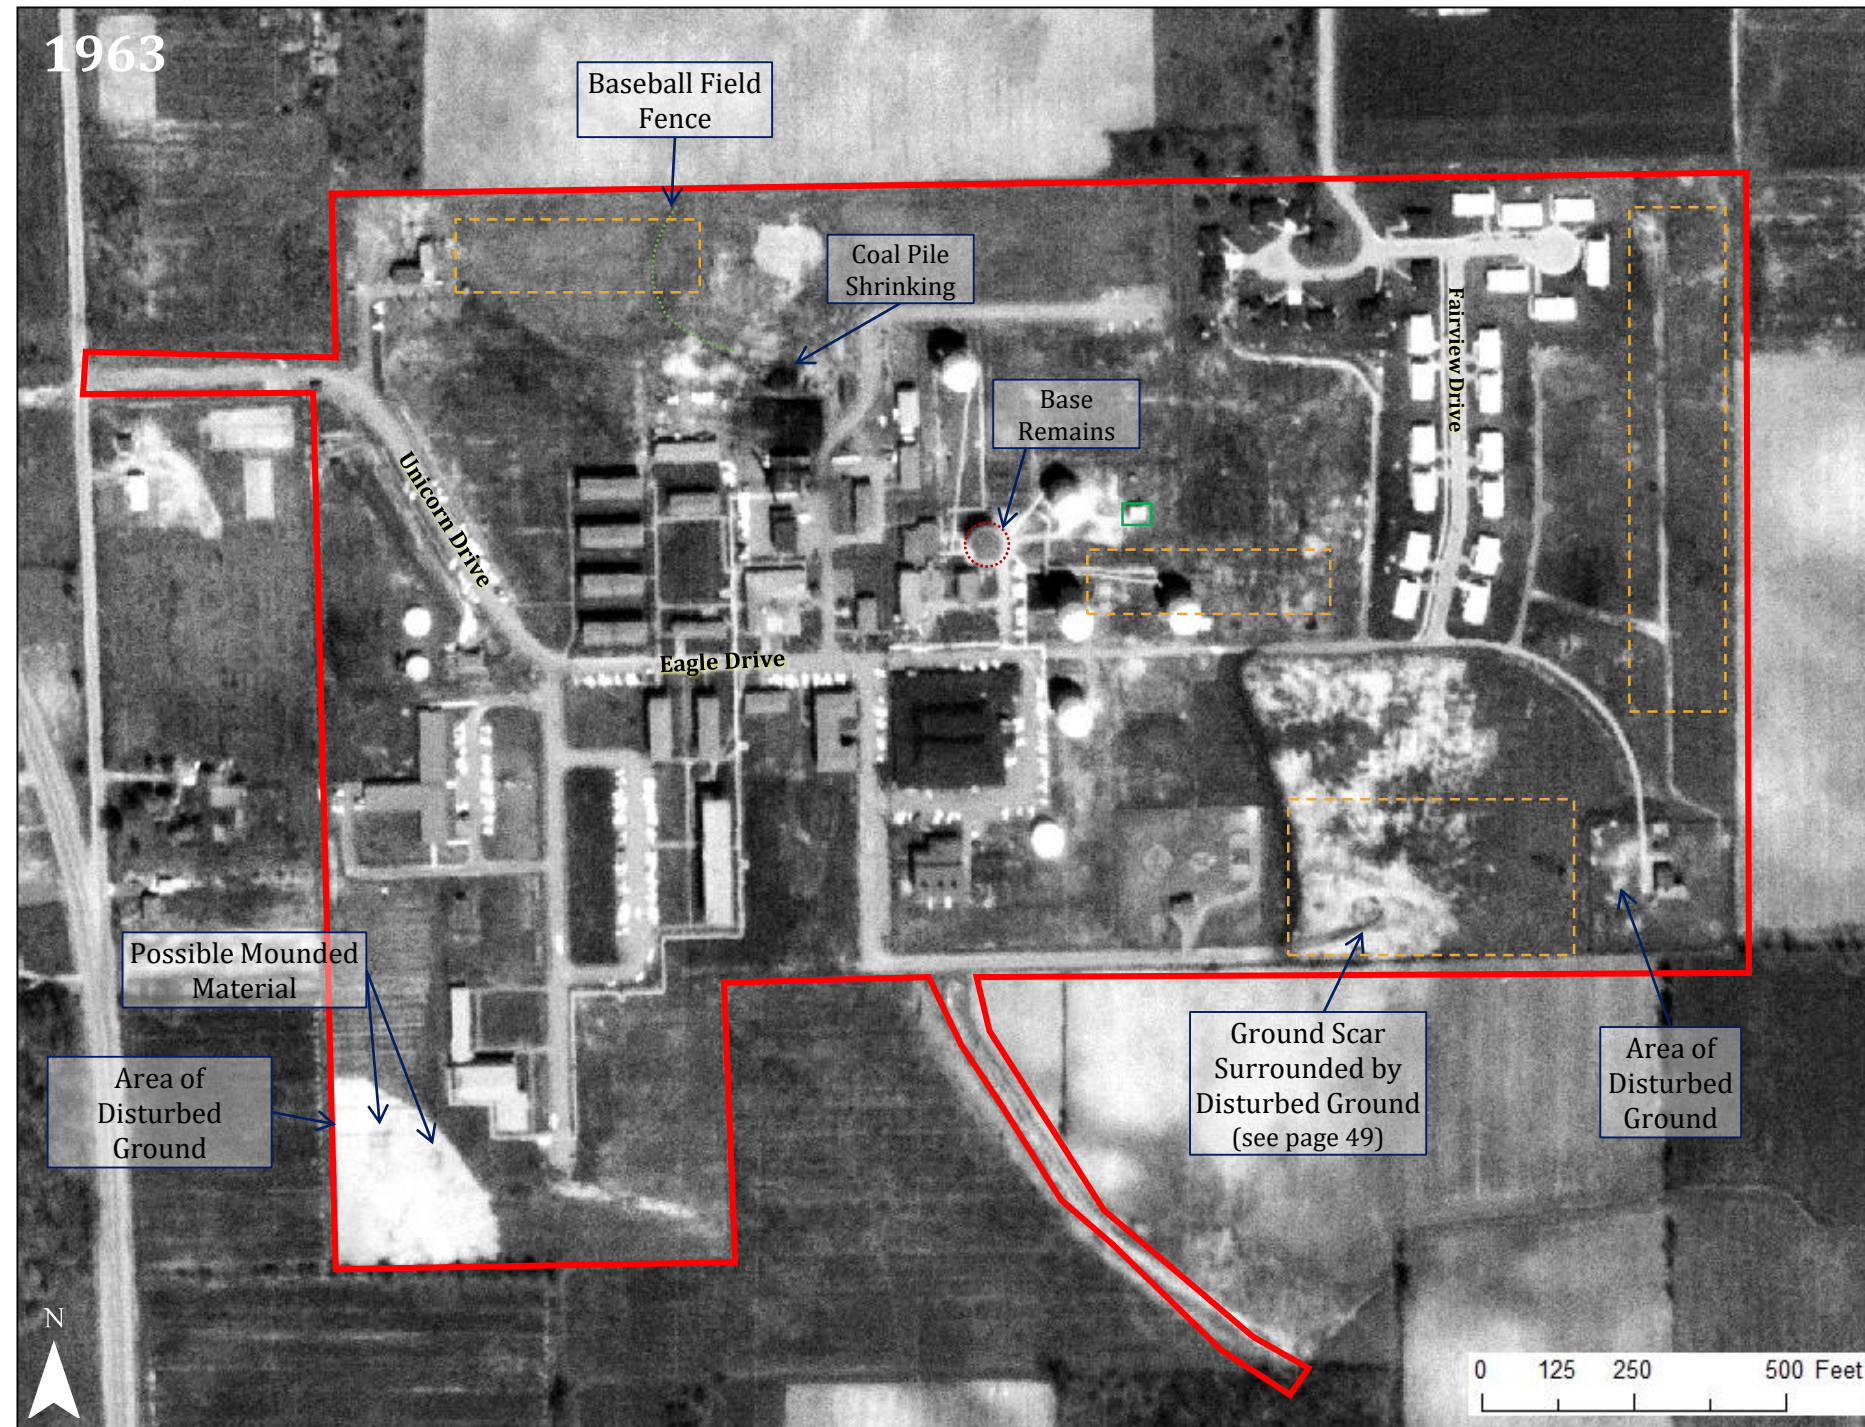
May 07, 1963

A large amount of disturbed ground is present between 1962 and 1963 in the southwestern corner of the area of analysis. This area has had increased activity since 1962 and contains possible mounded material or temporary structures. Development of the site includes the removal of one of the radomes (west of Area 2) and the construction of a baseball field fence (inside Area 1).

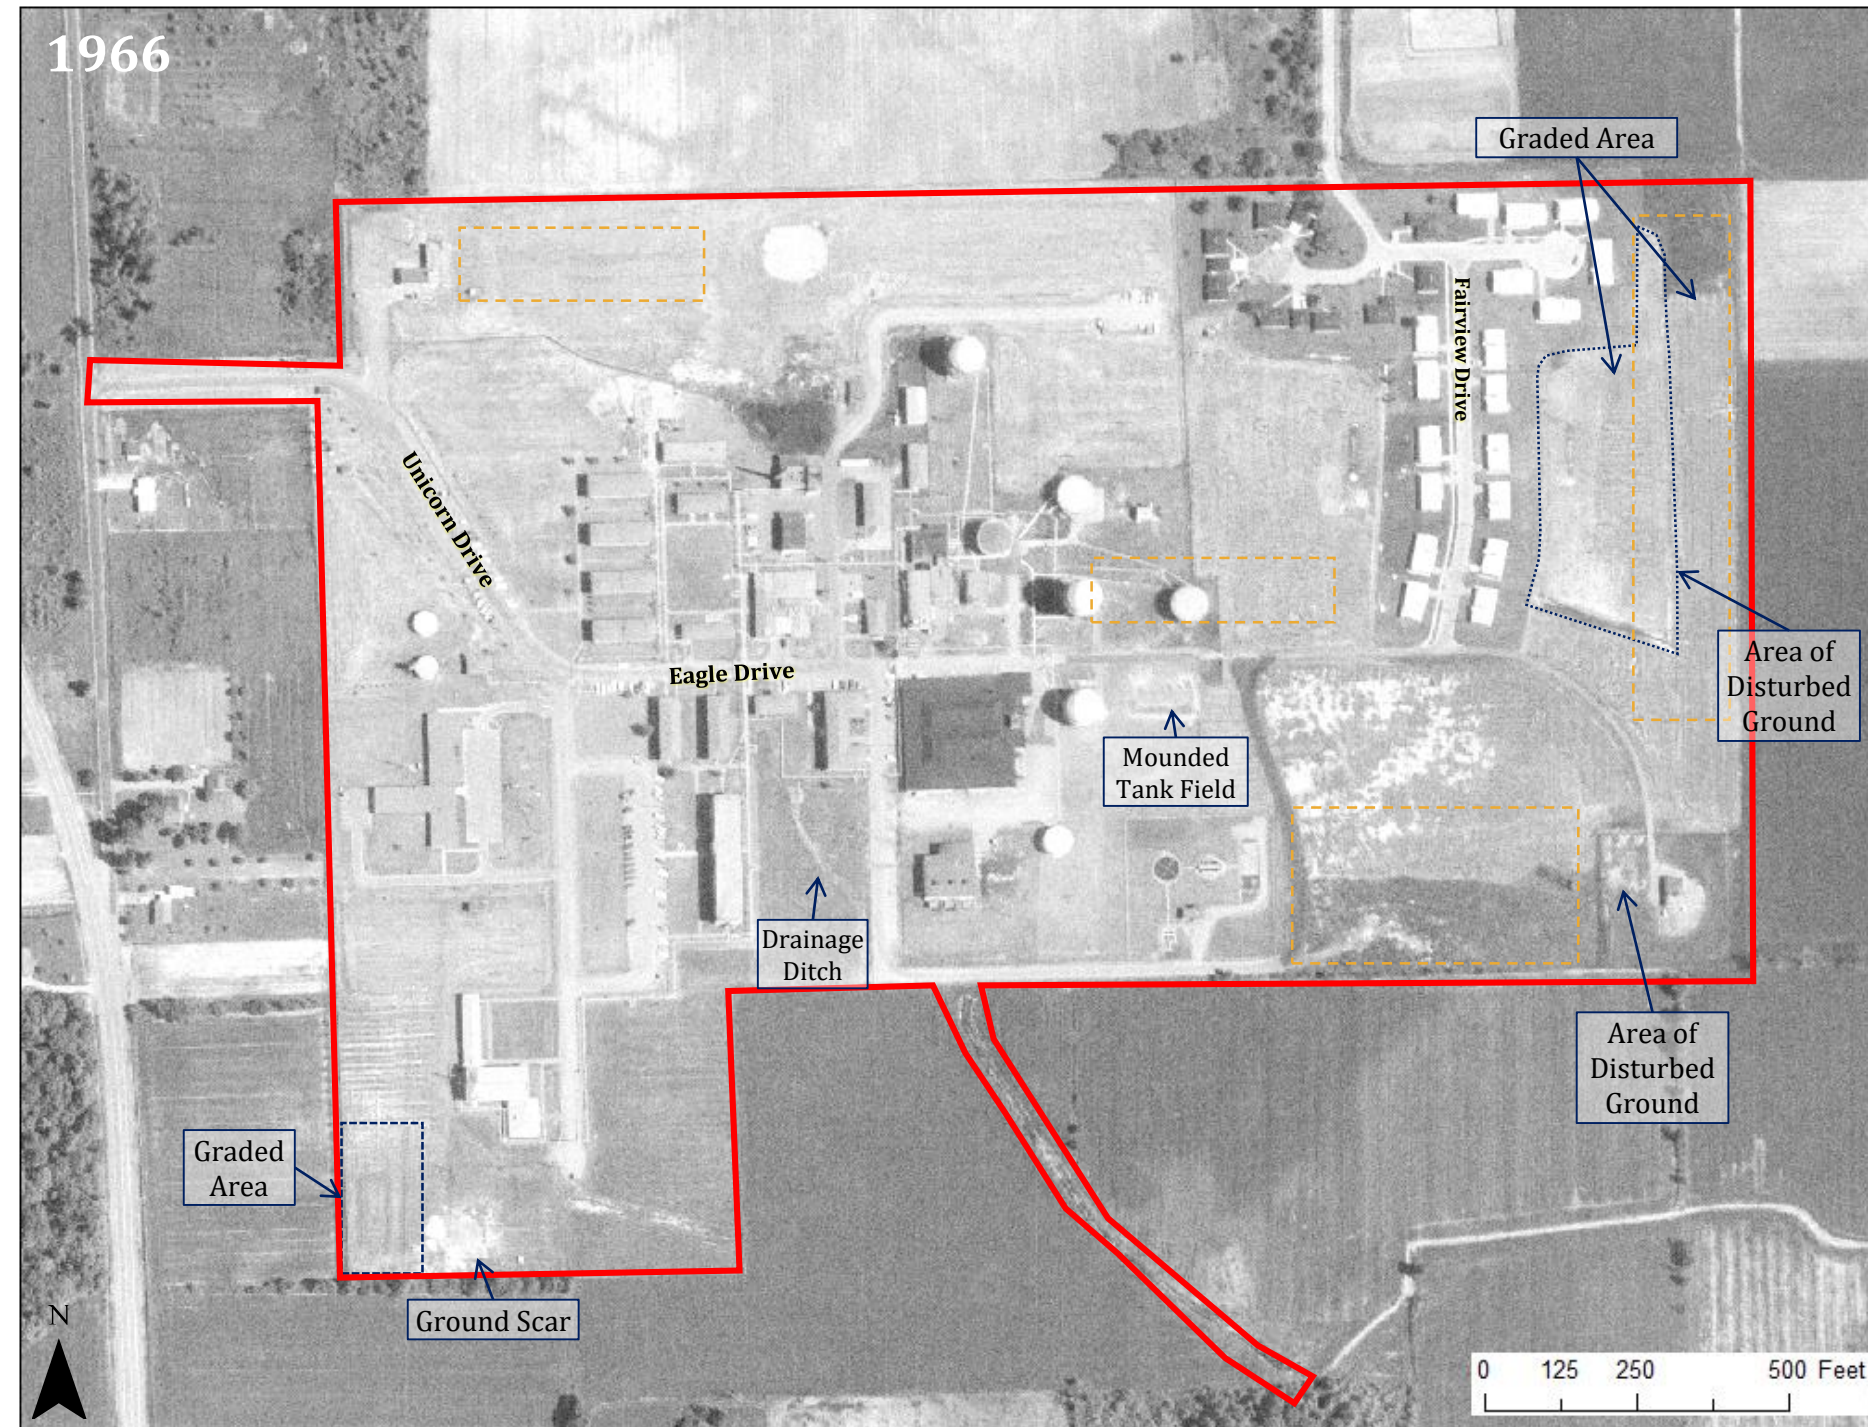
June 12, 1966

Most of the area of disturbed ground noted in the 1963 photograph (southwest corner) has become a graded area. Given the possible mounded material from 1963 and the graded area present in 1966, it is possible something was buried in this area. There is a large area of disturbed ground east of the family housing.

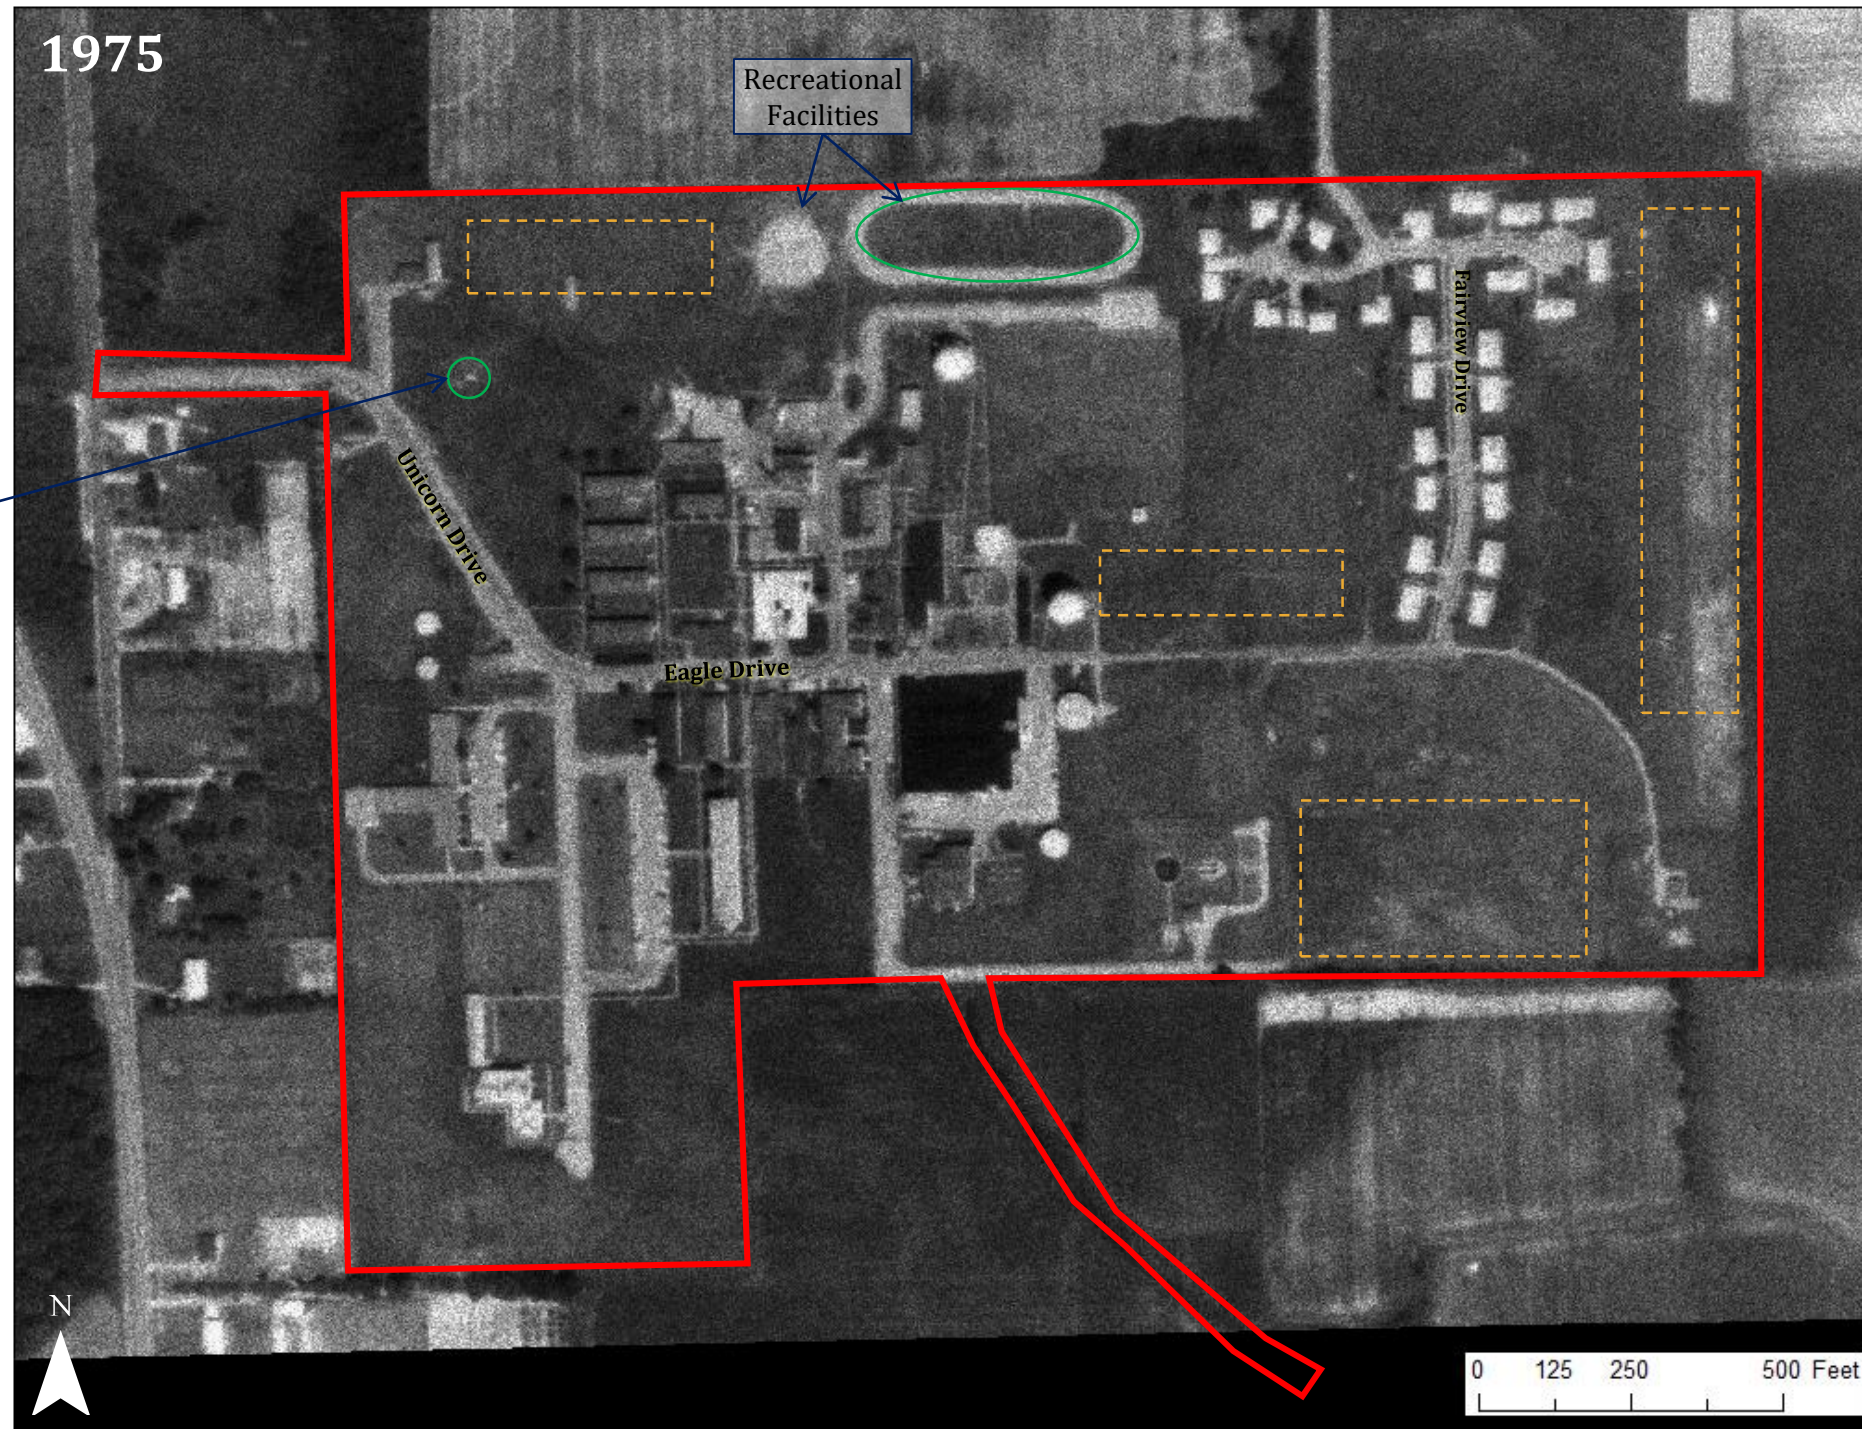
June 30, 1975

By 1975, a plane has been displayed by the main entrance of the Lockport Air Force Station. Athletic facilities (a track and baseball field) are observed in the northern part of the area of analysis. The baseball field existed prior to 1975, but appears to be revived from several years of disuse.

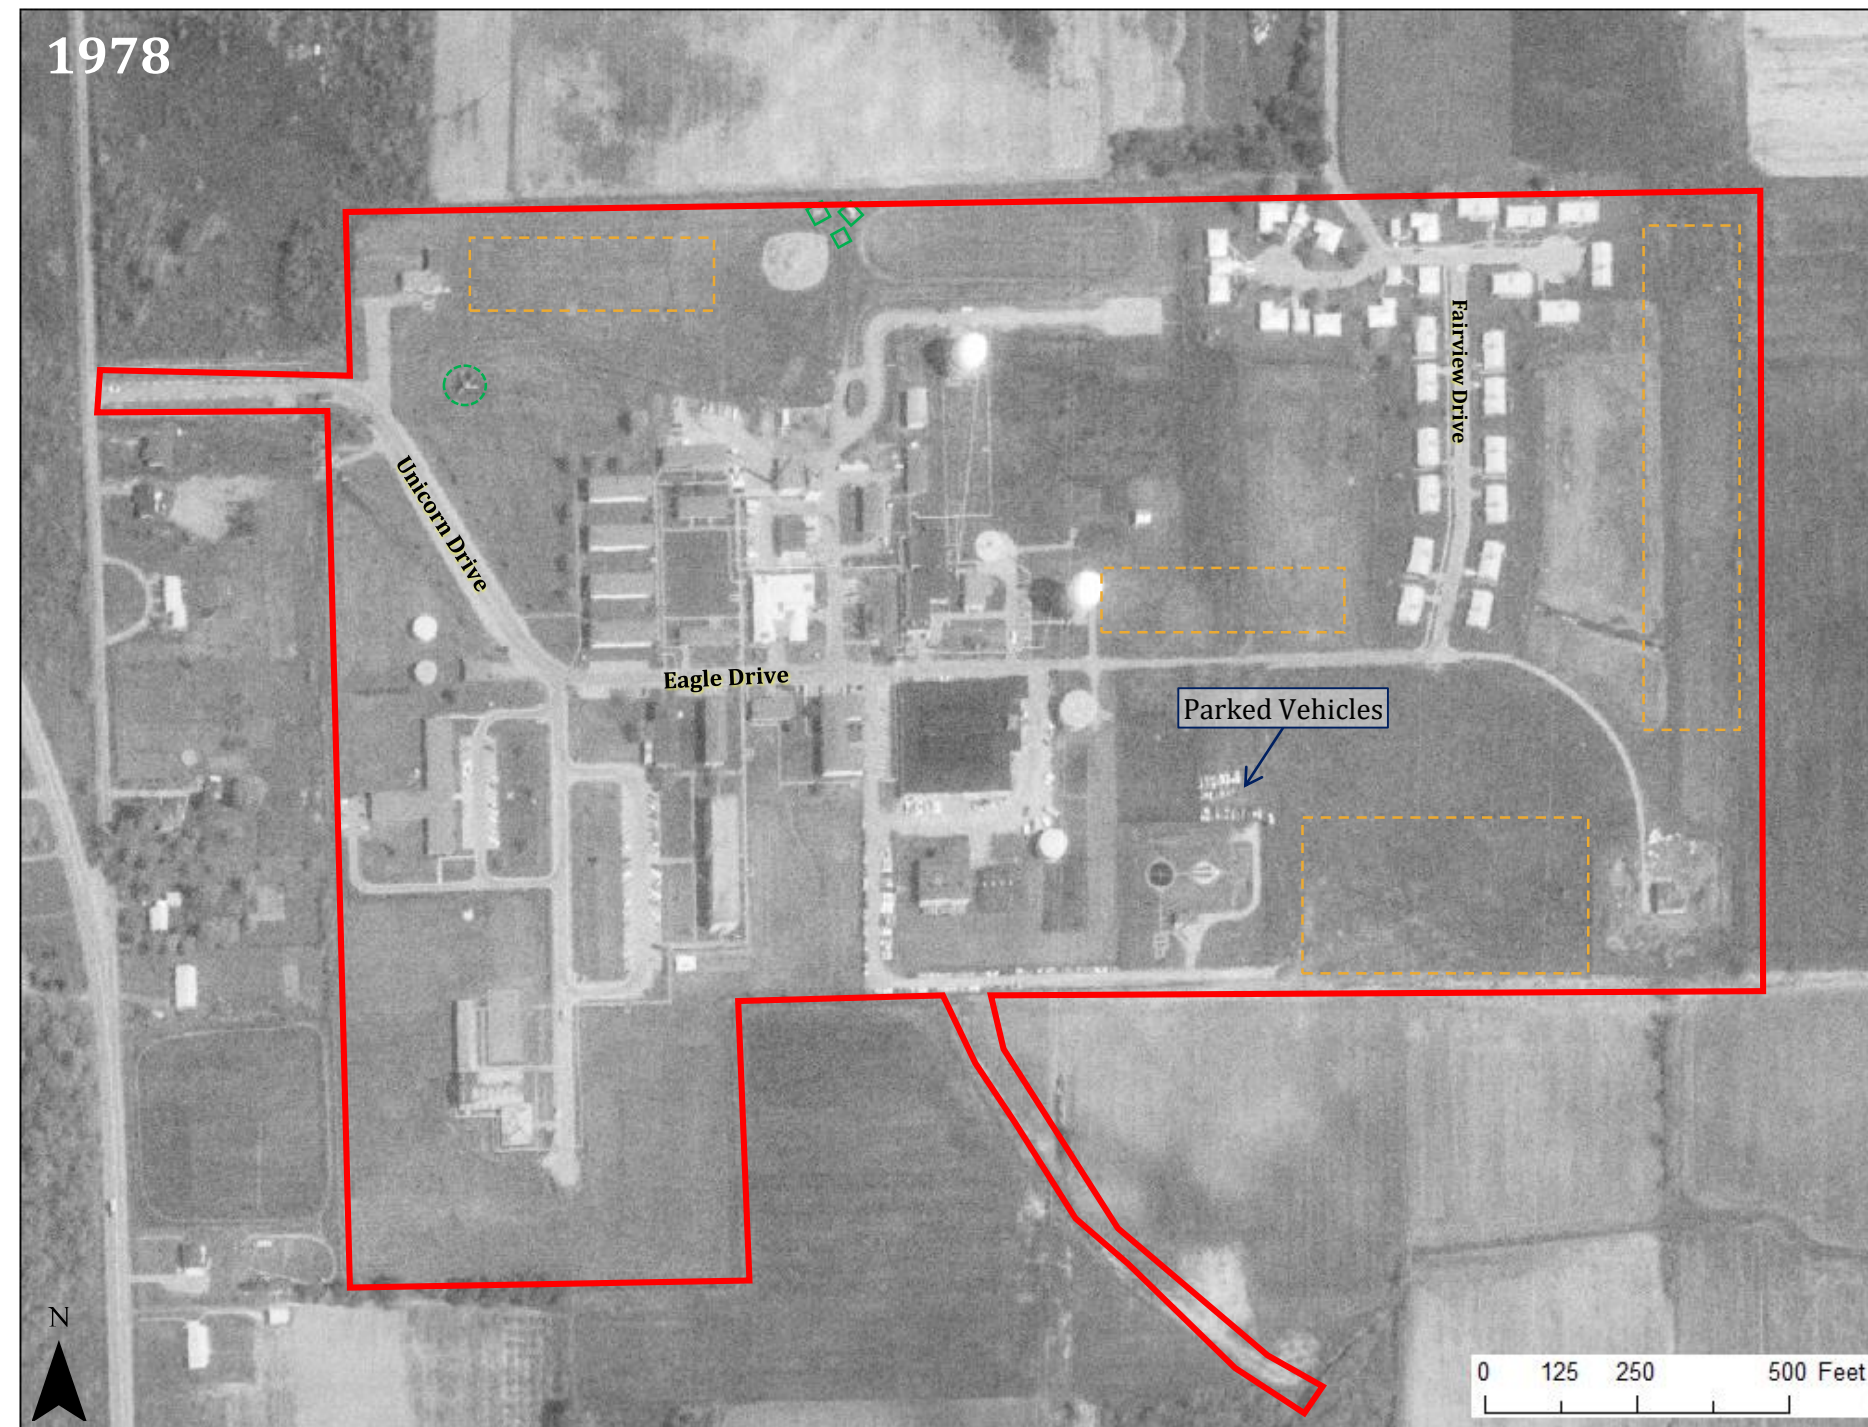
May 22, 1978

Two small structures, presumably related to the athletic facilities, were constructed between 1976 and 1978. The stationary plane, first noted in the 1975 analysis, is very discernable in the 1978 photograph.

An area of parked vehicles is observed north of the sewage treatment plant. This is the only year with parked vehicles present in this location.

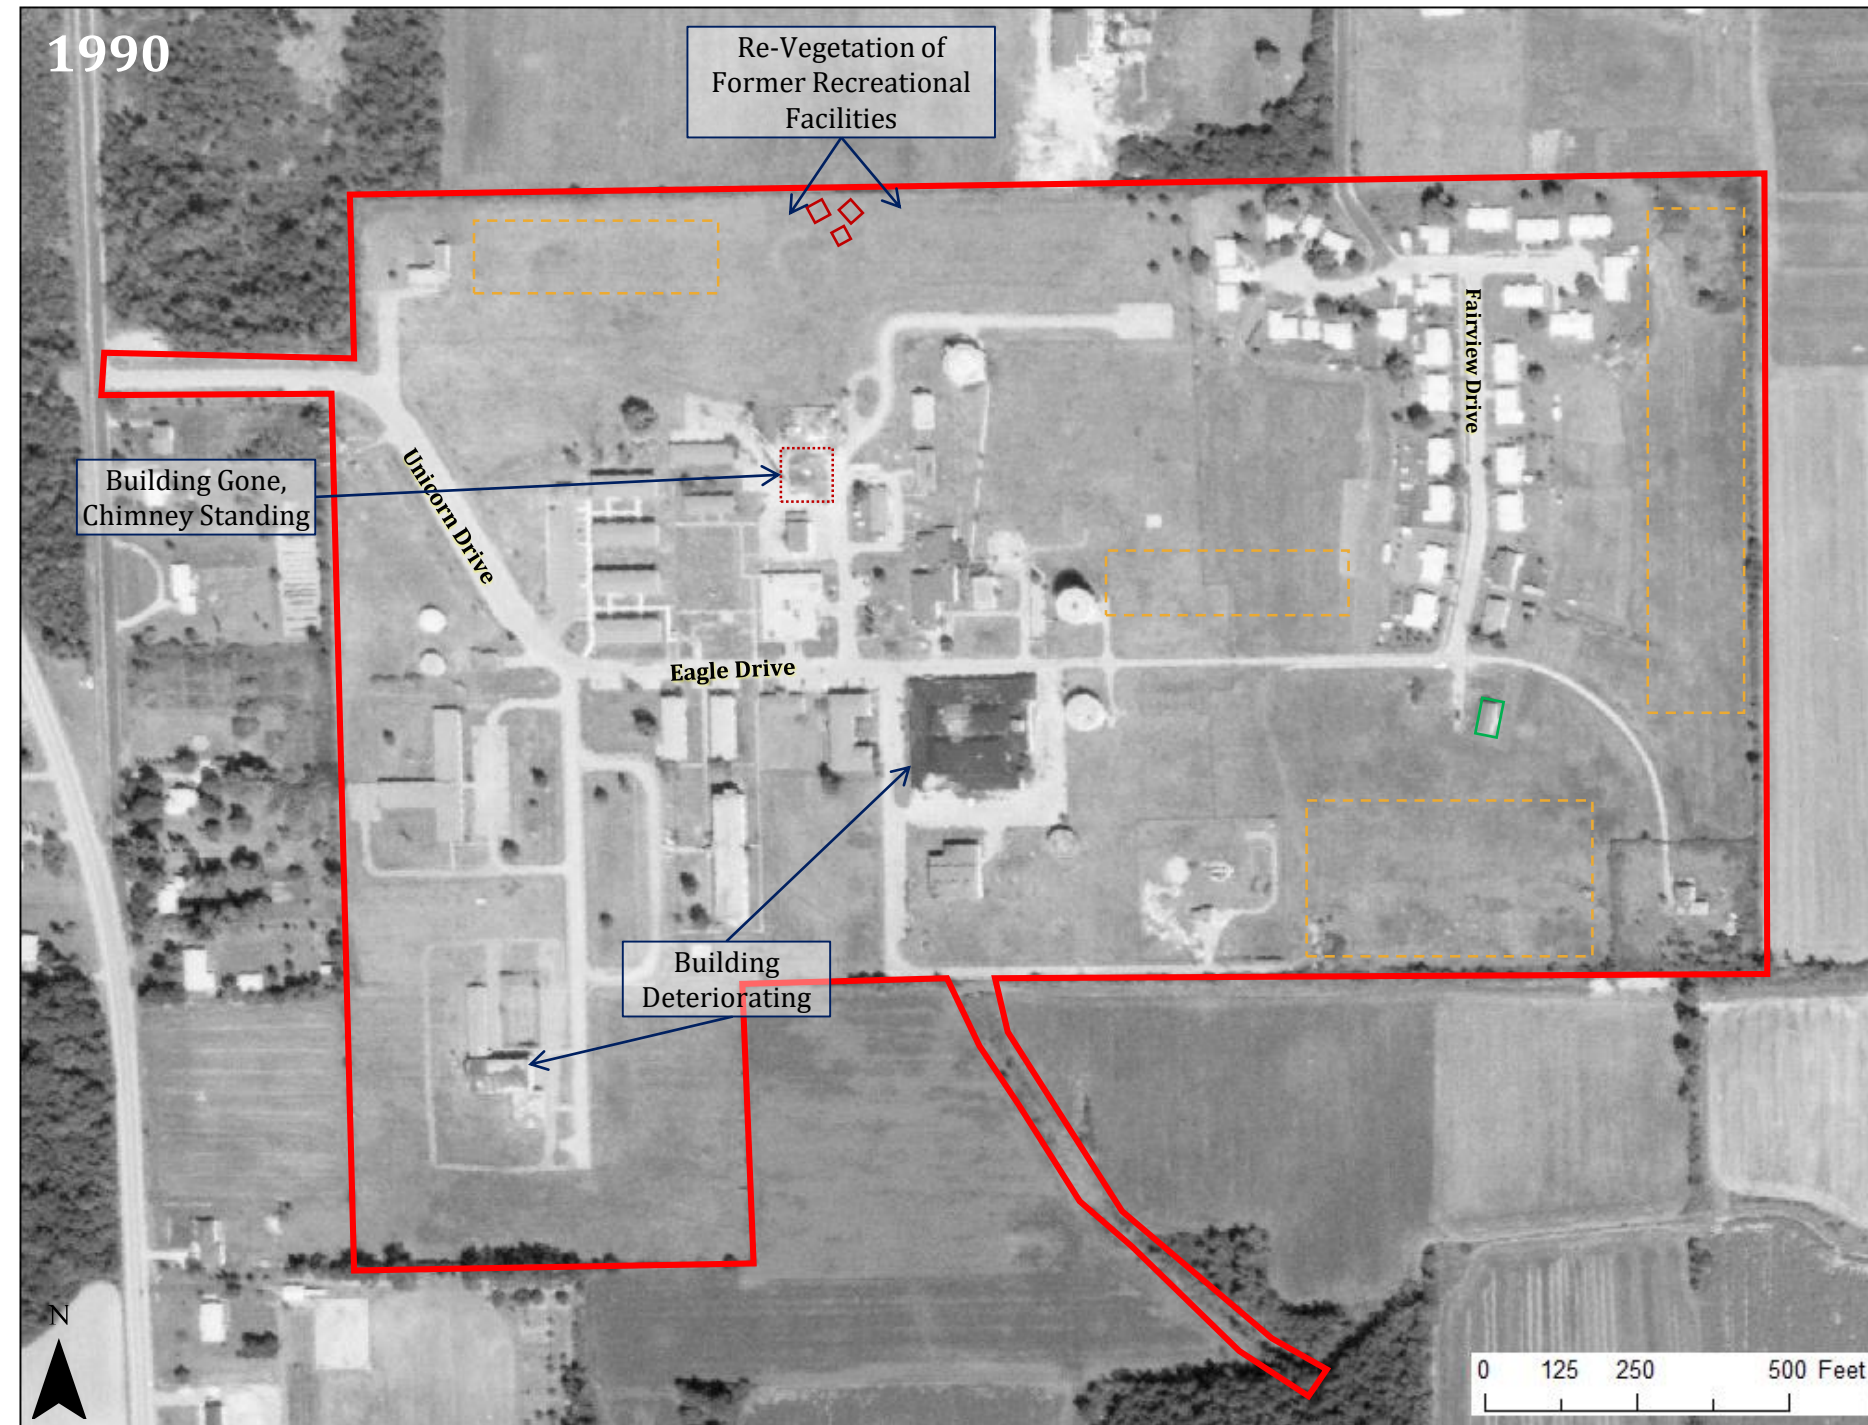
August 31, 1990

In 1990, most of the structures were still observed intact. The former Missile Master building and gym appear to be deteriorating. The heating plant building is gone (or severely deteriorated), but its chimney is still present. By 1990 a residential home was built to the south of the existing neighborhood, at the intersection of Fairview Drive and Eagle Drive.

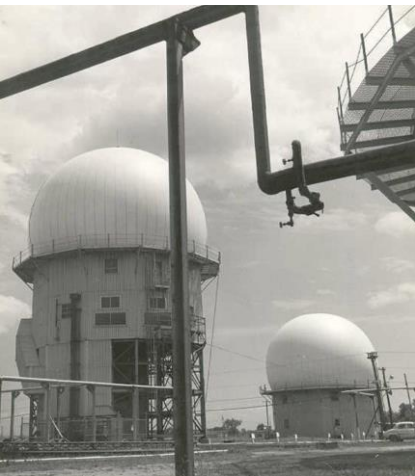
Radomes Onsite Throughout the Years

Above: Undated photograph of radomes at Lockport AFS.
Below: Photograph of Radomes at Lockport AFS ca 1967
Source: National Air Defense Radar Museum

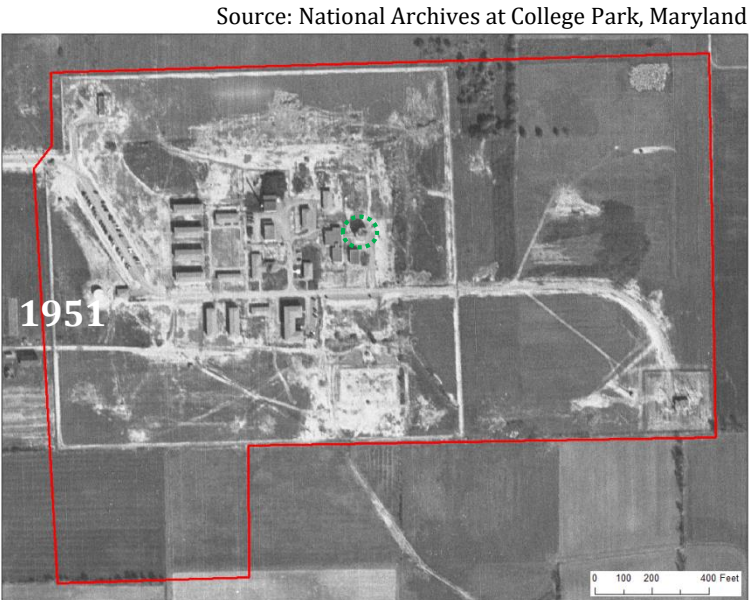
At the end of 1951, a pair of AN/CPS-6Bs systems began operating at this site.

In 1960 the site started operating an AN/FPS-7 radar on the site, in addition to the two AN-FPS 6s used as height finding radar. In 1962, one of the AN-FPS 6s was replaced by an AN/FPS-26. The AN/FPS-7 was later modified to an AN/FPS-107.

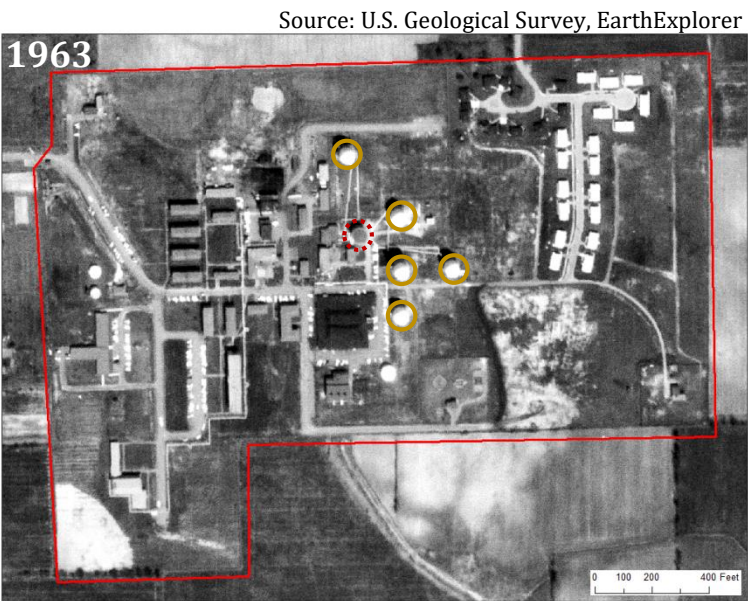
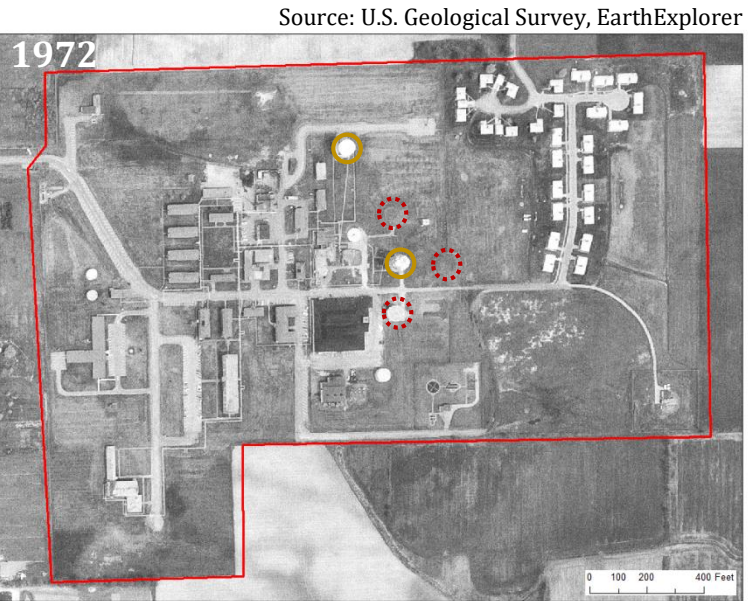
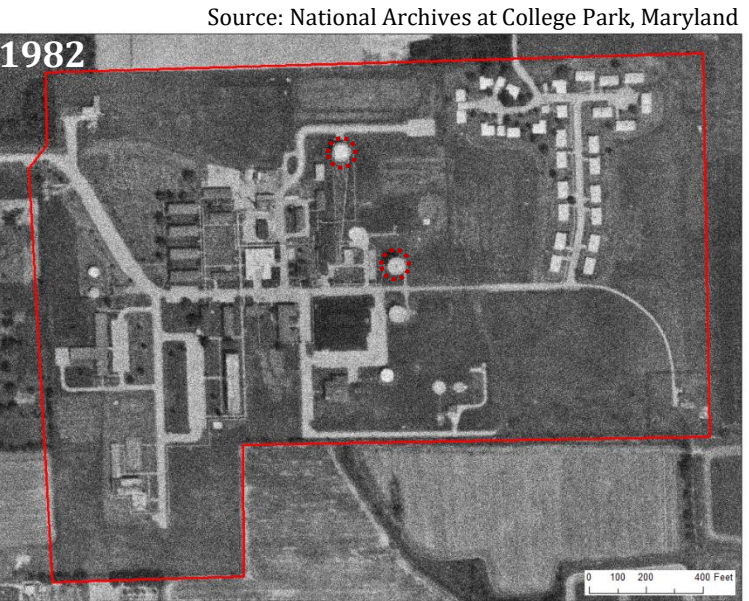
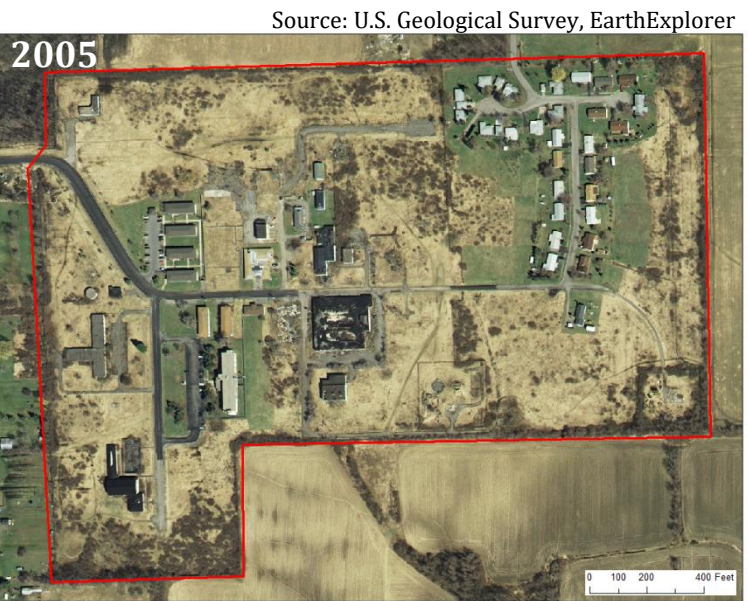
By 2005, the all of the radome bases have been removed from the site.

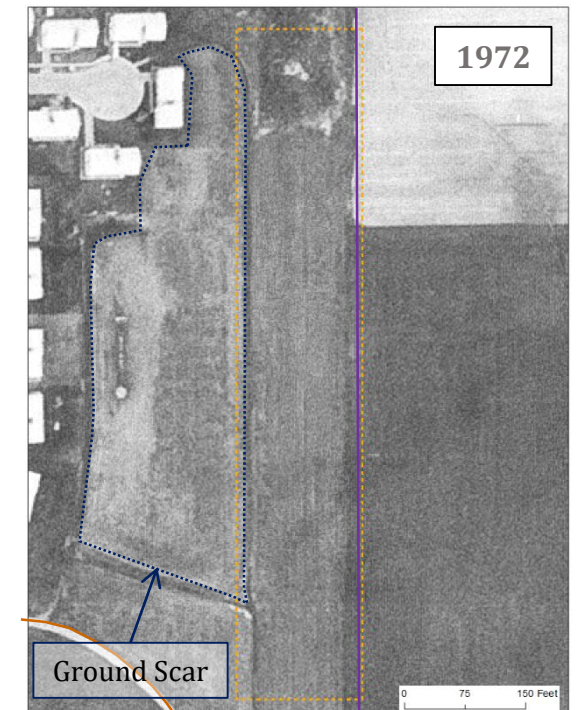
Ground Scar

The appearance of a graded area to the west of Area 3 is indicative of something possibly being buried. It could be associated with the unknown feature that is first observed in 1966.

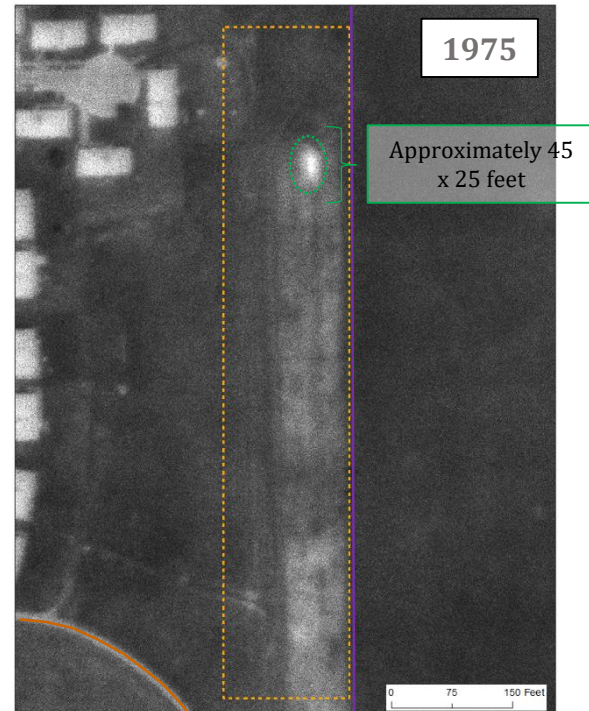
Activity appears to have occurred between the 1972 and 1975 photographs. Much of Area 3 has disturbed ground, including a small area of extreme disturbed ground measuring approximately 45 x 25 feet.
