Former Lockport Air Force Station, NY

HISTORICAL PHOTO ANALYSIS (FUDS C02NY0868)

FORMER LOCKPORT AIR FORCE STATION || MARCH 2019
Prepared for USACE – New England District

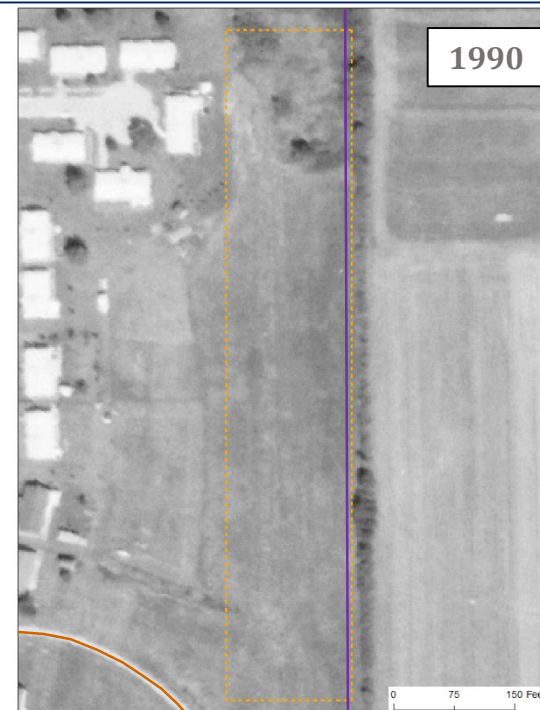
By 1990, the northern part of Area 3 has been left dormant long enough for a large amount of vegetation to grow and take over the area. No evidence of activity is present in the remainder of Area 3.

By 2005, most of Area 3 has been overgrown with vegetation. There is a ground scar (approximately 40 x 50 feet) indicating an area of possible activity since 1990.
