TAR SEEP INVESTIGATION REPORT

**North Tonawanda Botanical Gardens
1825 Sweeney Street
North Tonawanda, NY 14120
Site #932068**

November 30, 2015

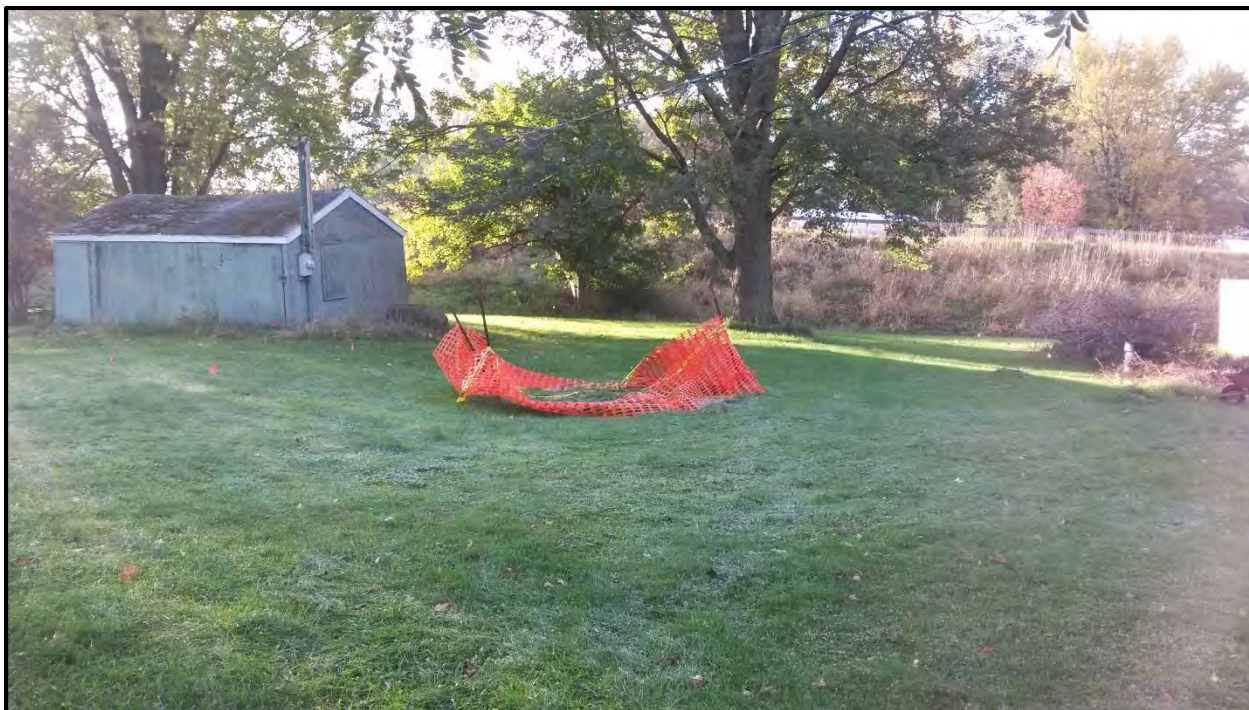
Photo 1: picture of tar seep area (surrounded by the orange construction fence) before boring work, facing south-east looking towards Robinson Street.

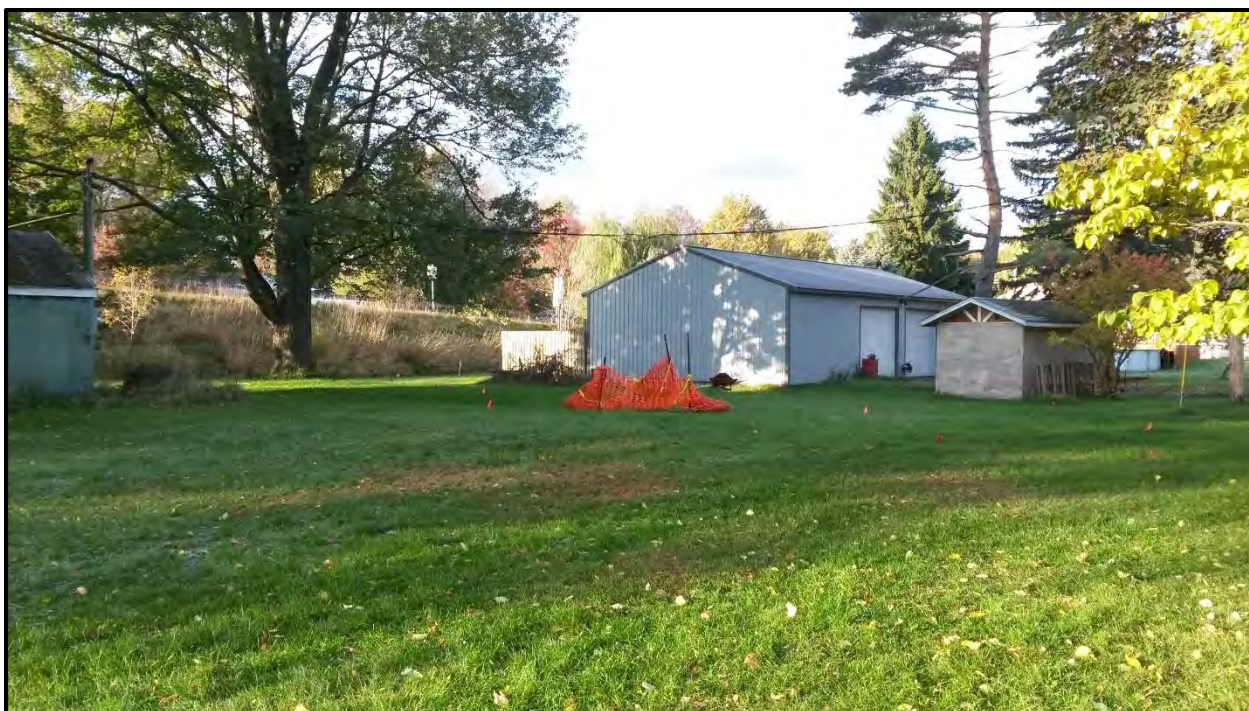
Photo 2: picture of tar seep area (surrounded by the orange construction fence) before boring work, facing south-west looking towards Robinson Street.

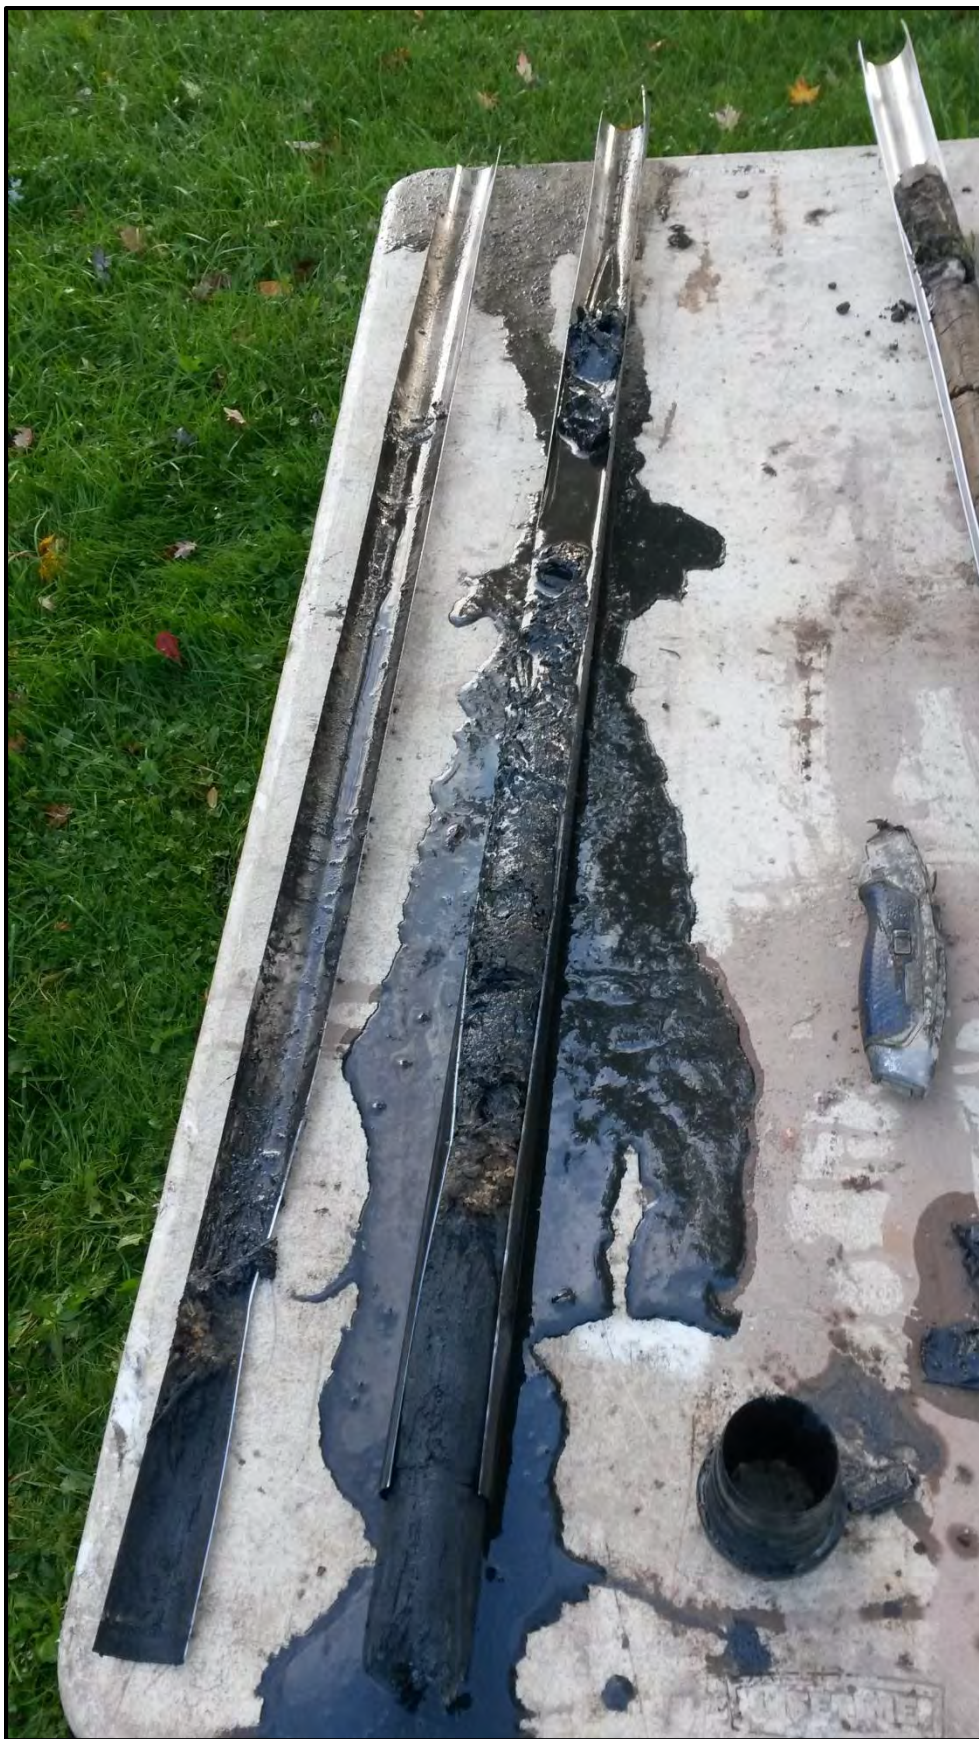
Photo 3: picture of B-2 from 4'–8' core. Note high moisture content and black material throughout. Very strong sewage smell. Refuse debris evident in the middle portion of the core.

The black refuse material was consistently encountered in borings from the low 'trough' area. The exact thickness of the material is unknown as the probe tended to compress the soft material or become plugged with debris. Based on the cores with better recoveries the refuse material is likely several feet thick. It is recommended that future analytical samples be collected if material of sufficient quality and volume is encountered. When the refuse material was exposed to the atmosphere numerous small bubbles appeared on the surface of the saturated material. It is suspected that this was due to increased aerobic microbial activity.

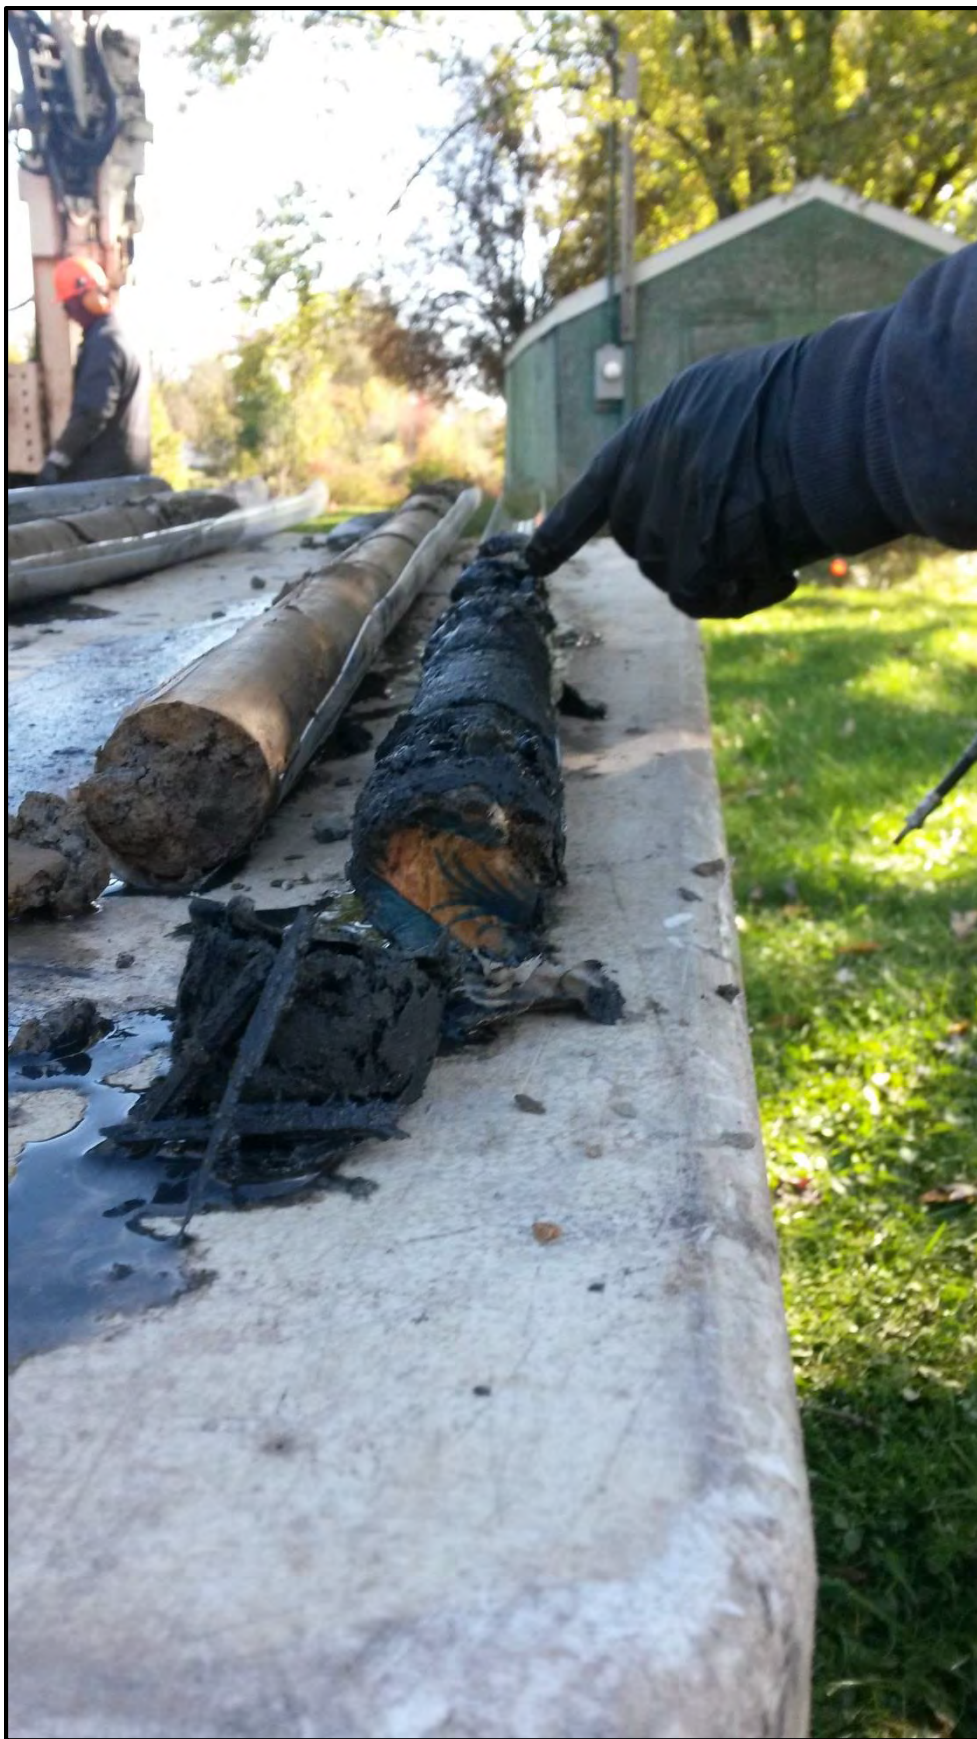
Photo 4: picture of B-4 from 4'–8' core. Note woody debris mixed with refuse material. Apparent wall paper in the end of the core. Very strong sewage smell. Black discoloration throughout.

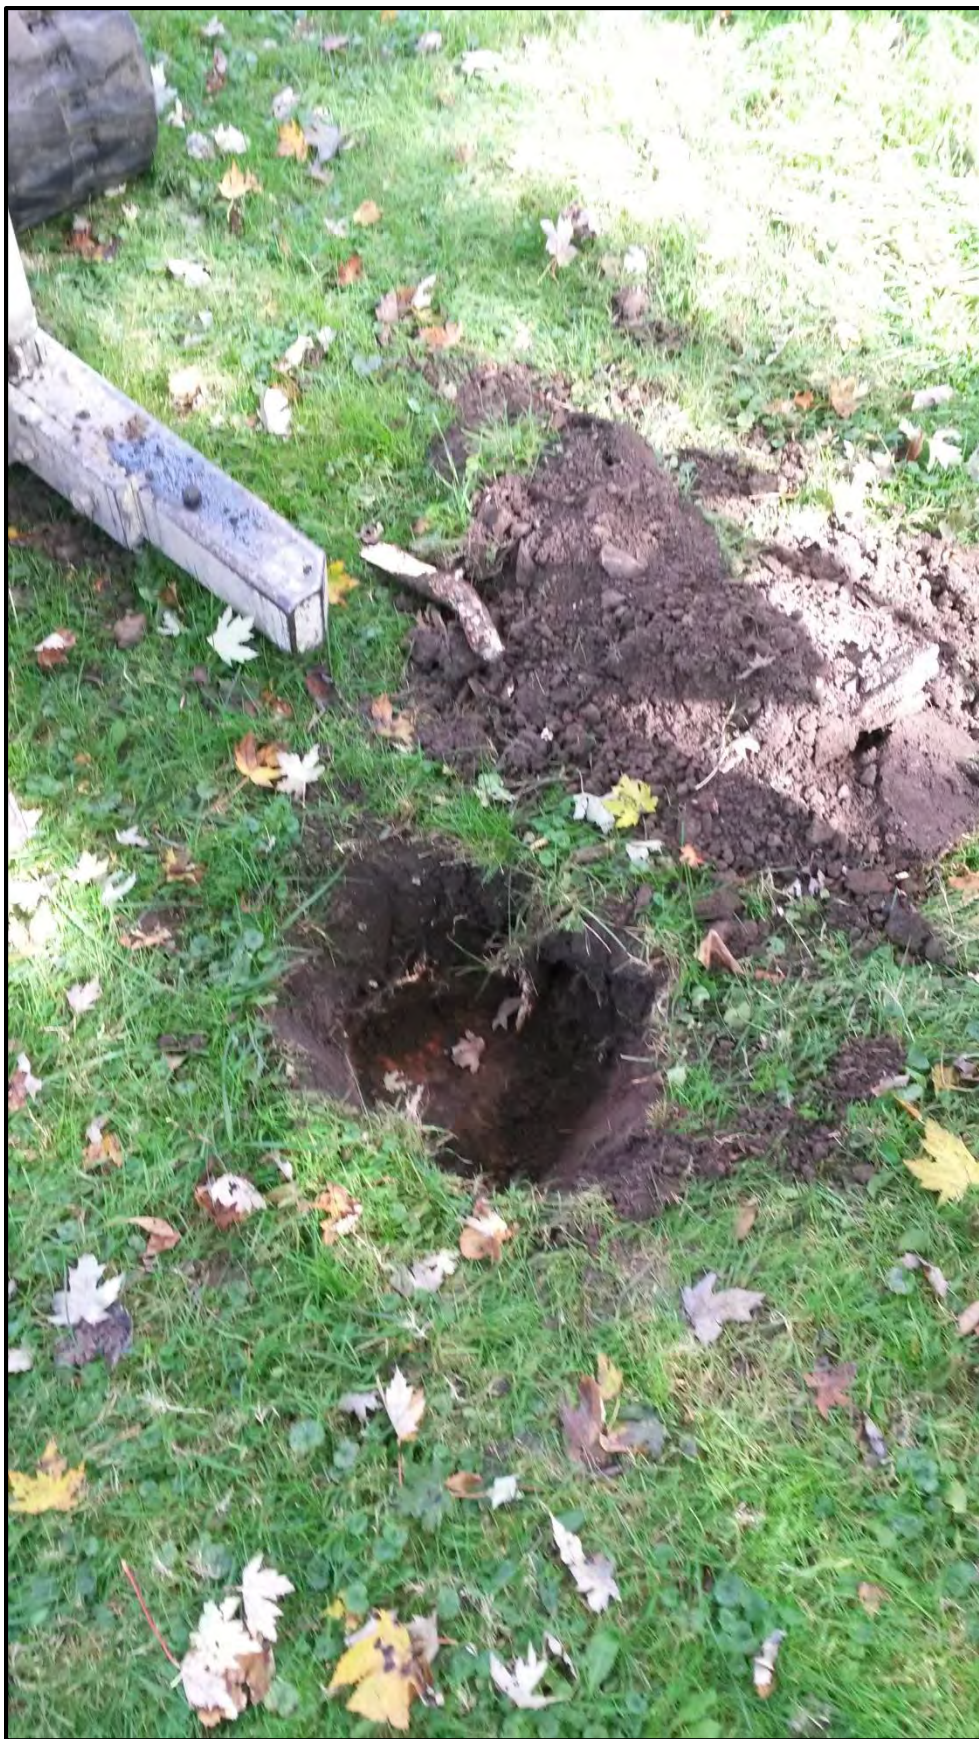
like material B-6 was advanced near the center of the anomaly. B-6 was only completed to approximately 1 foot bgs, where the probe encountered a hollow metal object. The boring was abandoned and the hole expanded using a shovel until it was approximately 1.5 feet in diameter. The metal object appeared to be a small underground storage tank (UST) of unknown size and contents. The majority of the western anomaly is attributed to this UST. B-7 was completed in the smaller north-western anomaly, but did not find any material that would cause such a response. Additional investigation surrounding B-7 was limited by the overhead power lines.

Photo 5: picture of hand dug hole surrounding B-6. Reddish-orange material in hole is the top of the discovered UST.

The UST that was discovered in front of the park shed is not a registered tank, and based on its depth not properly installed. It will have to be removed and the surrounding soil investigated to determine if there have been leaks from the tank. Prior to removing the tank the overhead power lines would have to be decommissioned and several limbs of the nearby tree would have to be removed. It should be pointed out, that due to the size of the western electromagnetic anomaly that there may be another tank/metal object near the park shed.

A previously unknown UST was discovered near the park shed. The exact size and contents of the tank are unknown at this time, but based on field observations it is likely relatively small. As this tank is not registered or properly installed it will have to be removed, and the surrounding subsurface investigated for signs leakage from the tank. Concurrent with tank removal activities it is recommended that test pits be completed to fully investigate the remainder of the western electromagnetic anomaly and the area of the tar seep. Any tar material encountered during future site work should be removed for disposal off-site at a permitted facility.

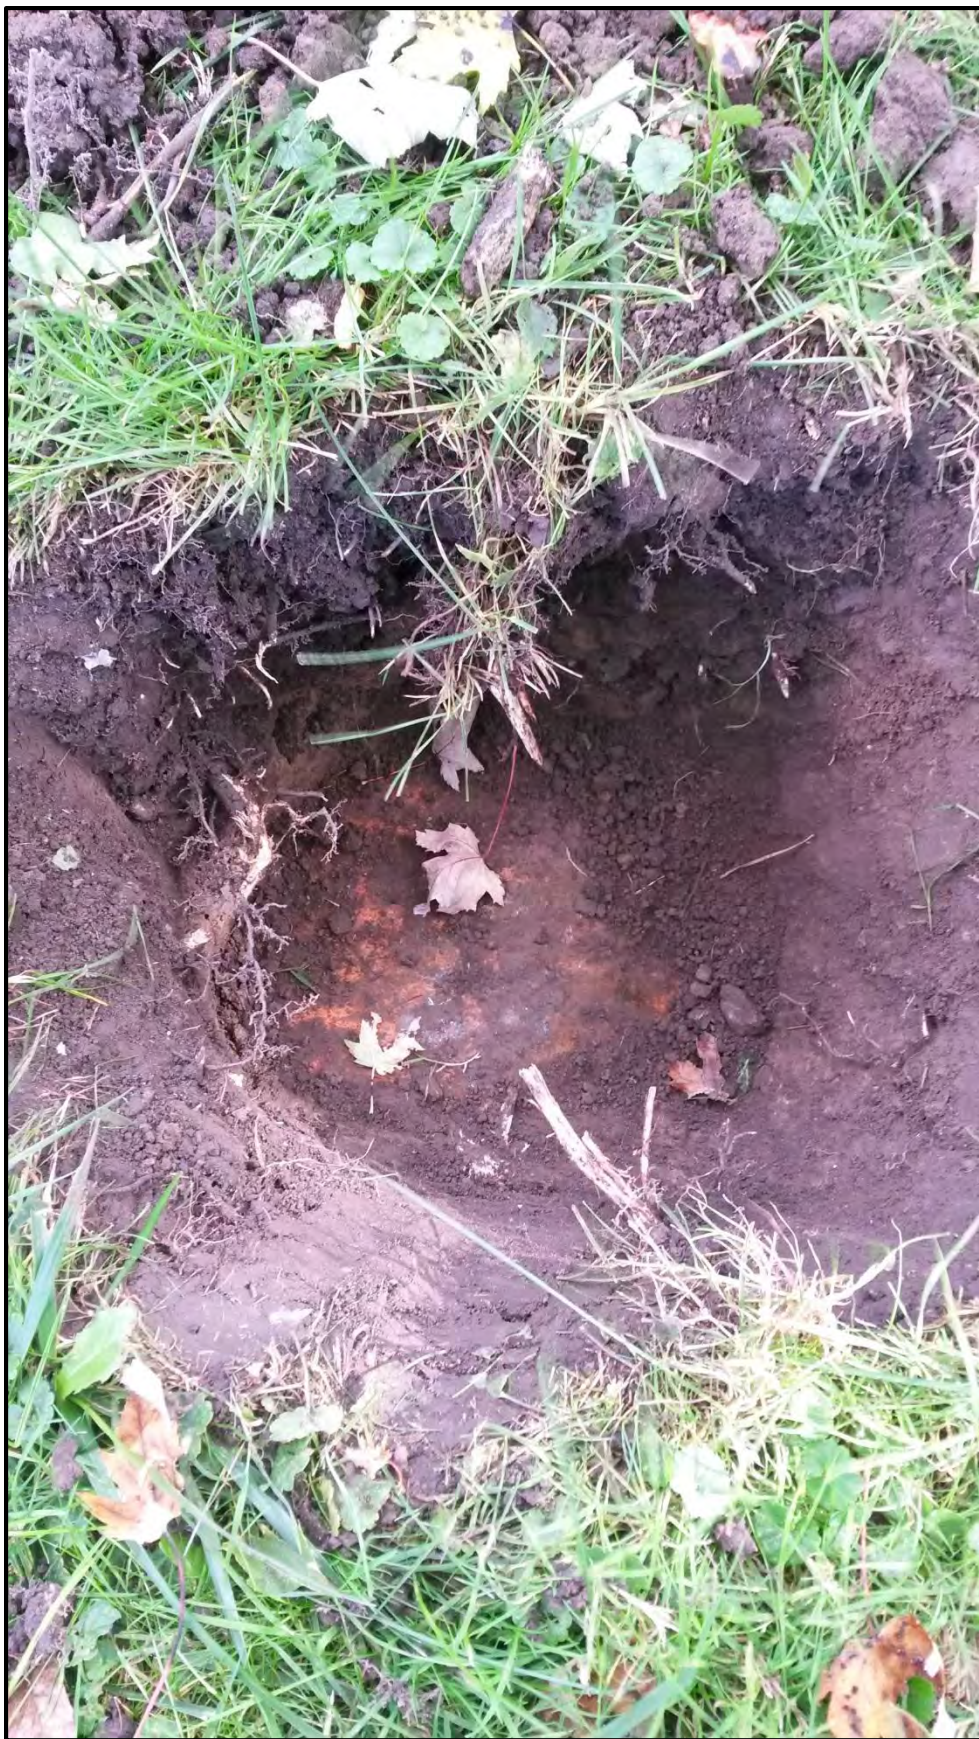
Photo 6: close-up picture of hand dug hole surrounding B-6. Reddish-orange material in hole is the top of the discovered UST.

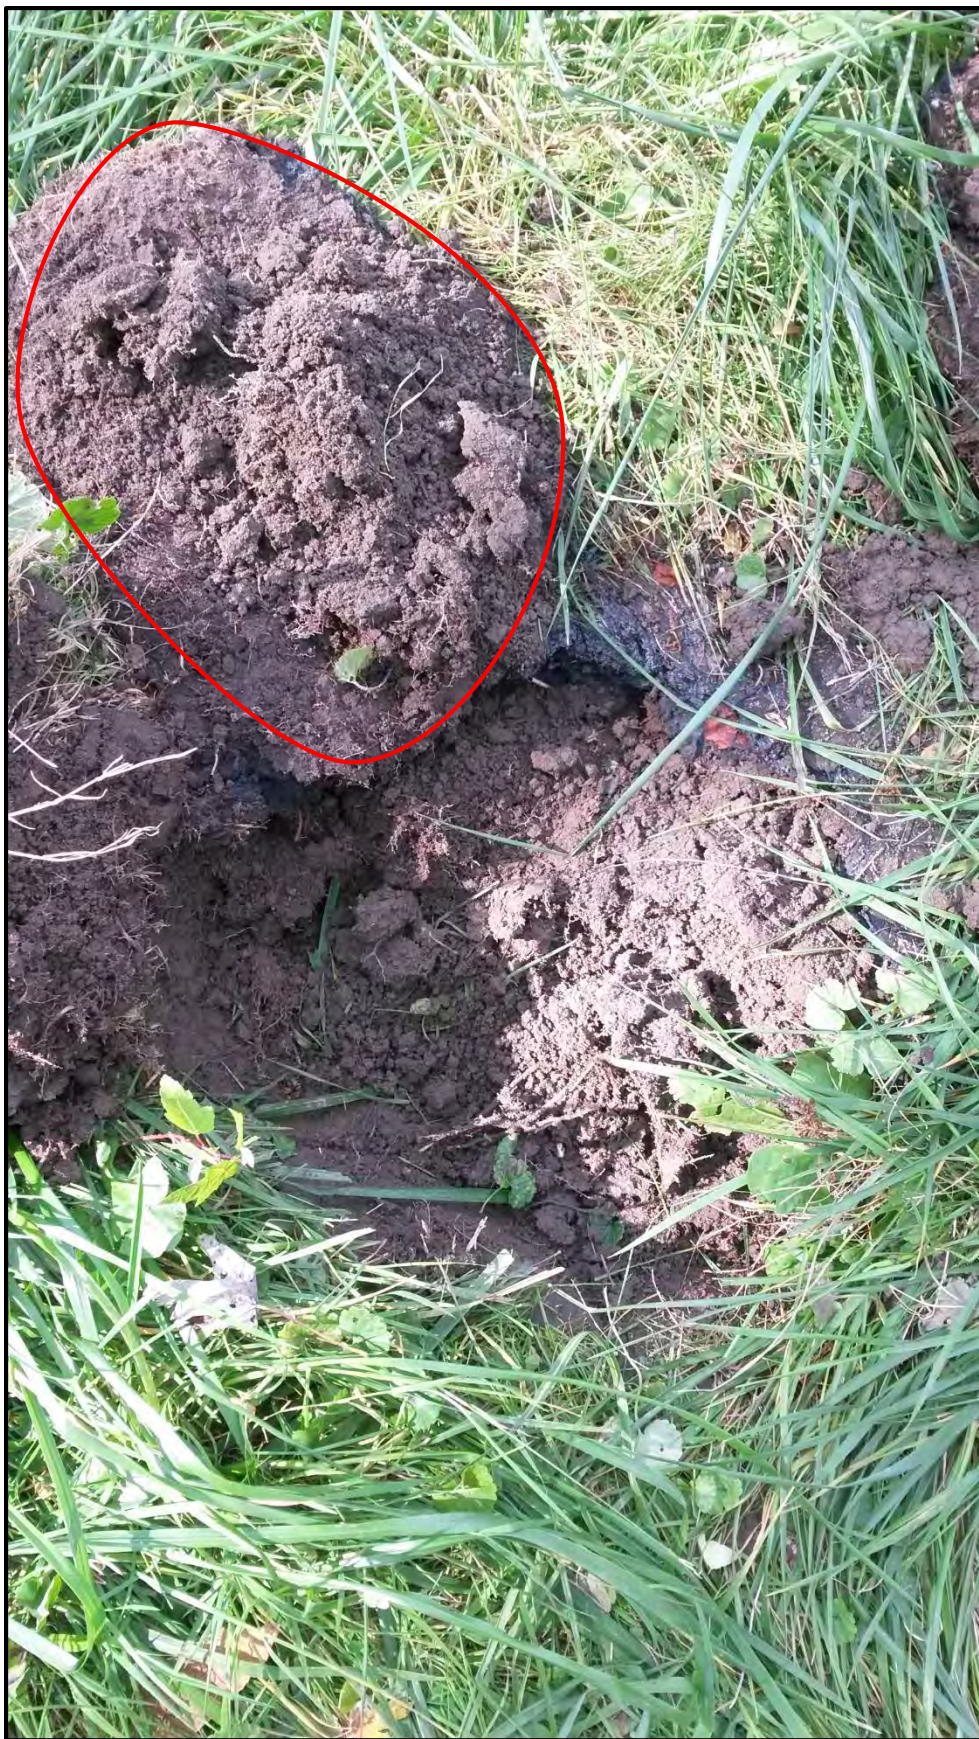
Photo 7: picture of hand dug hole surrounding the tar seep. Note that soil/root layer immediately below the seep does not appear impacted by tar (outlined in red).

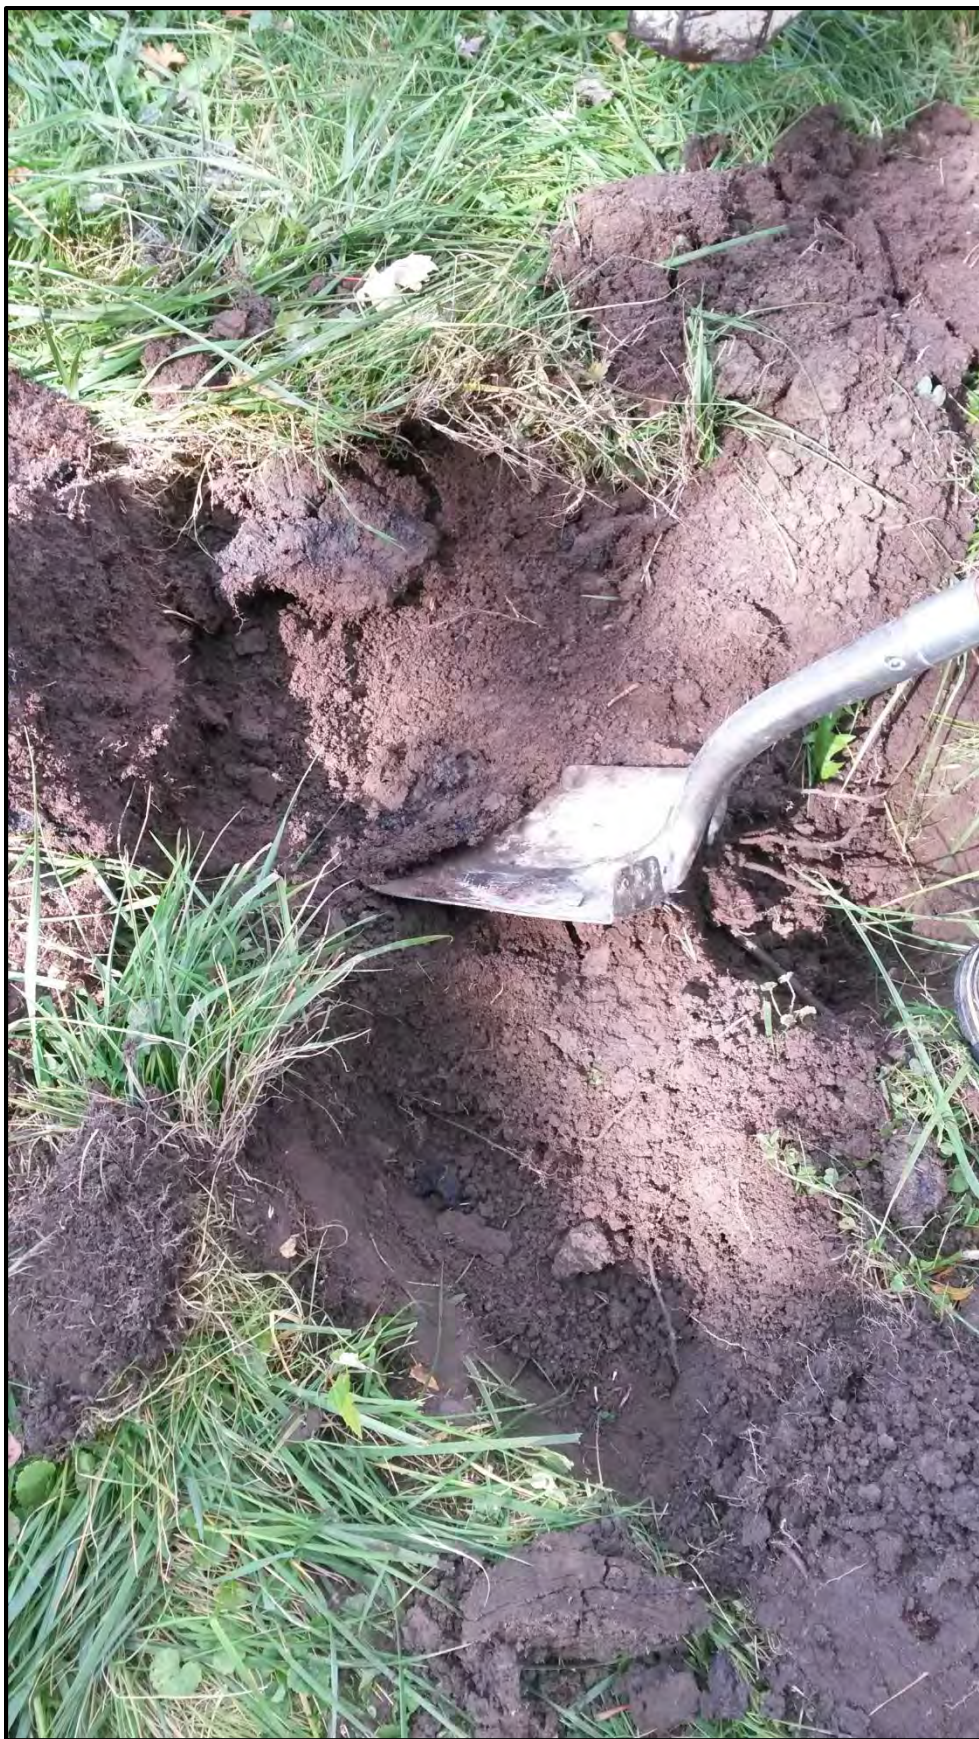
Photo 8: picture of hand dug hole surrounding the tar seep, below surface soil. Note that tar impacts are not widespread.

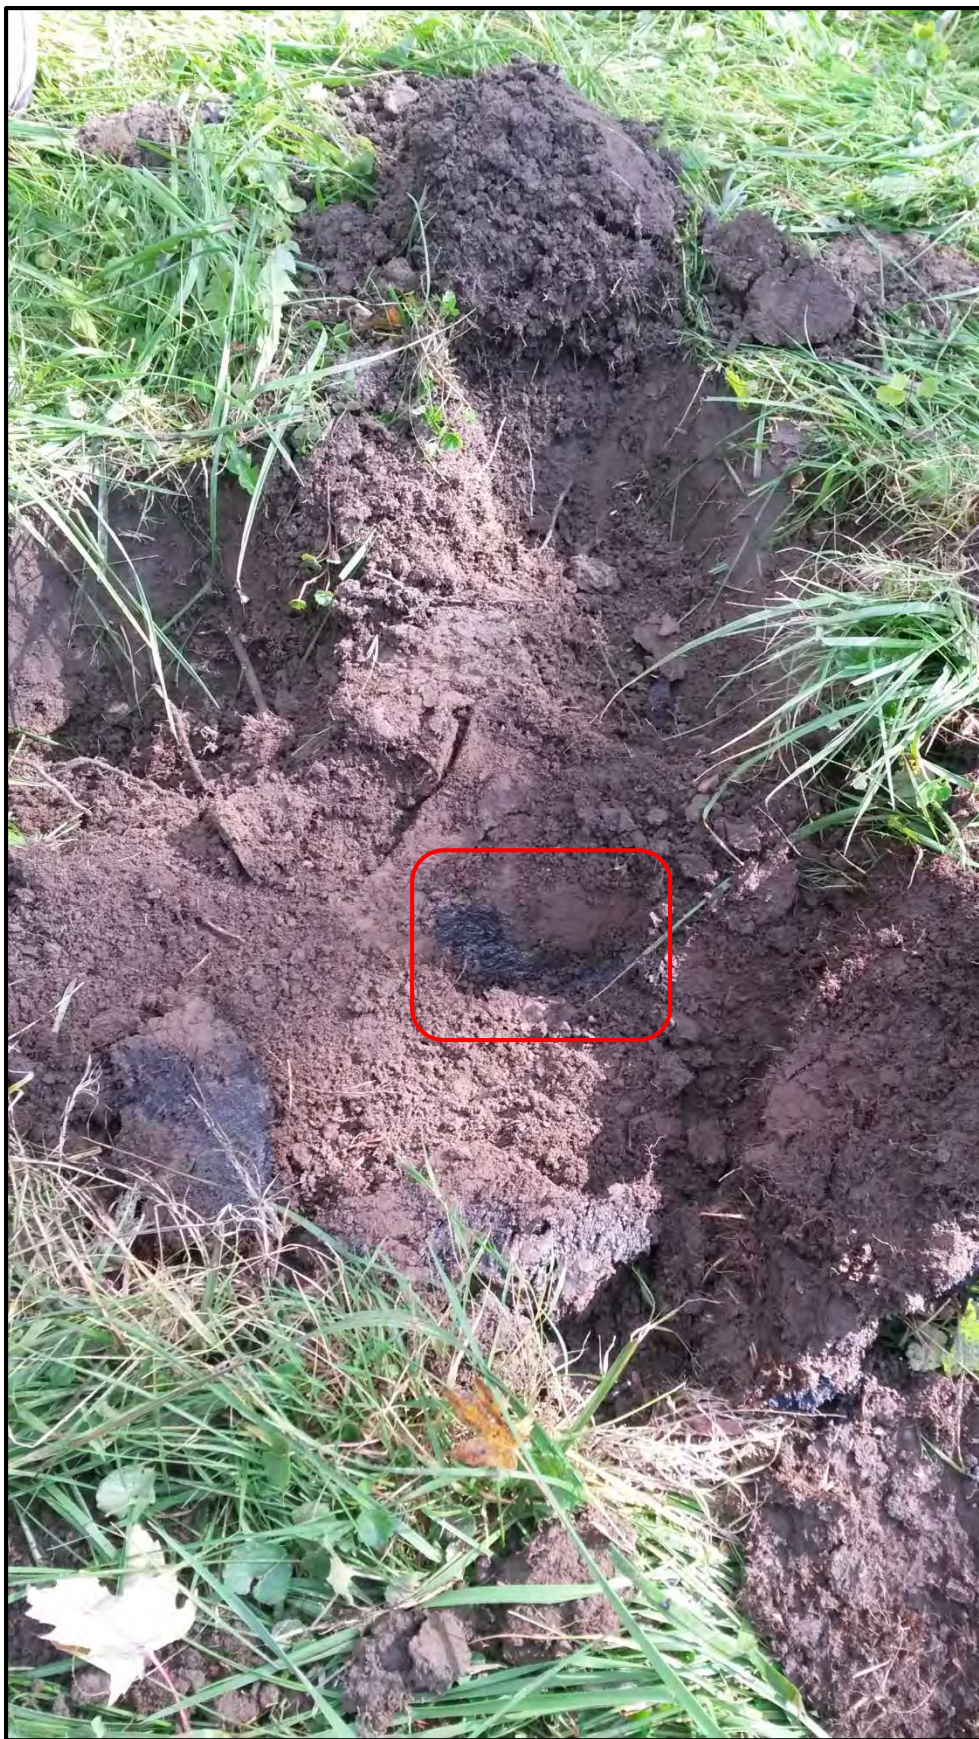
The subsurface investigation surrounding the tar seep was unable to locate the source of the tar material. The tar migrated to the ground surface through a thin vein in the soil that was too fine for the GeoProbe to consistently locate. Additional investigation using test pits or hand excavations may provide greater insight into the source of the material. Based on the observed hydrogeology surrounding the seep area it is likely that the tar had accumulated on top of the clay and till layer and was transported to the ground surface on top of rain water that had pooled on the low permeability clay. This theory is supported by precipitation data collected by the National Weather Service, included as Appendix C.

Photo 9: picture of hand dug hole surrounding the tar seep, below surface soil. Note the 'vein' of tar that appears to be the migration pathway to the surface (outlined in red).

Based on these results the NYSDEC will pursue negotiations with the City of North Tonawanda for the removal and further investigation of the UST. It is also recommended that test pits be completed to locate the source of the tar seep or determine if it was an isolated pocket of material.

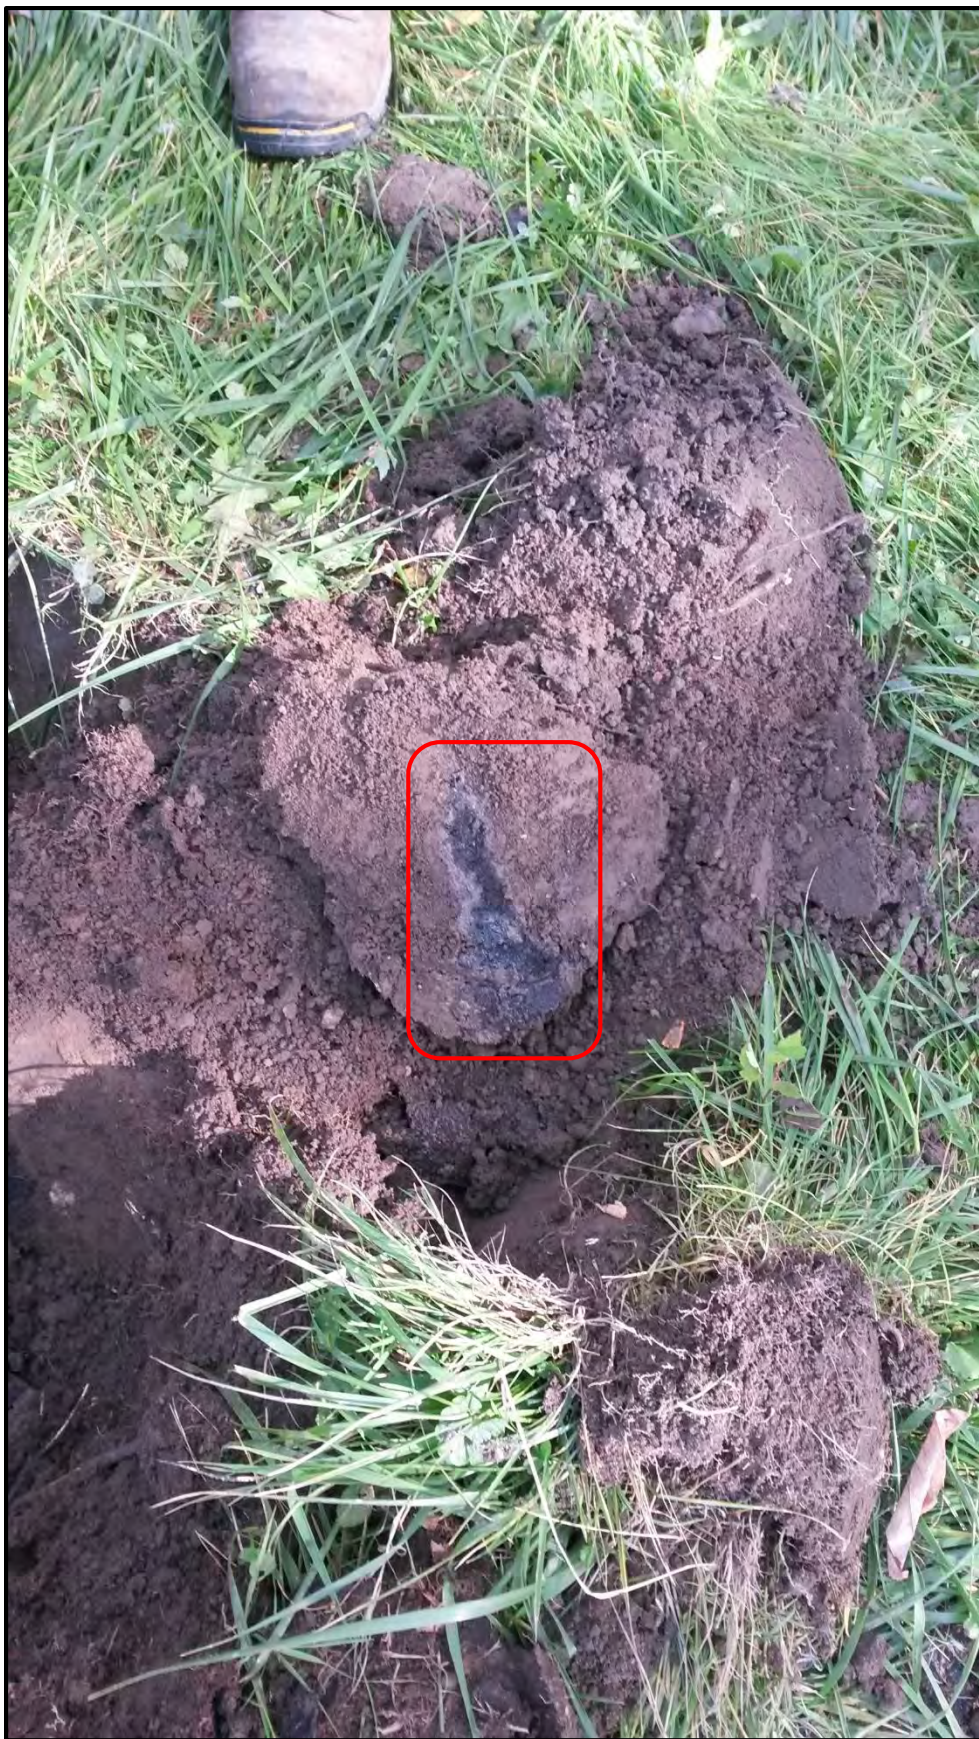
Photo 10: picture of a horizontal shovel recovery from under the tar seep. Note the 'vein' of tar that appears to be the migration pathway to the surface (outlined in red).

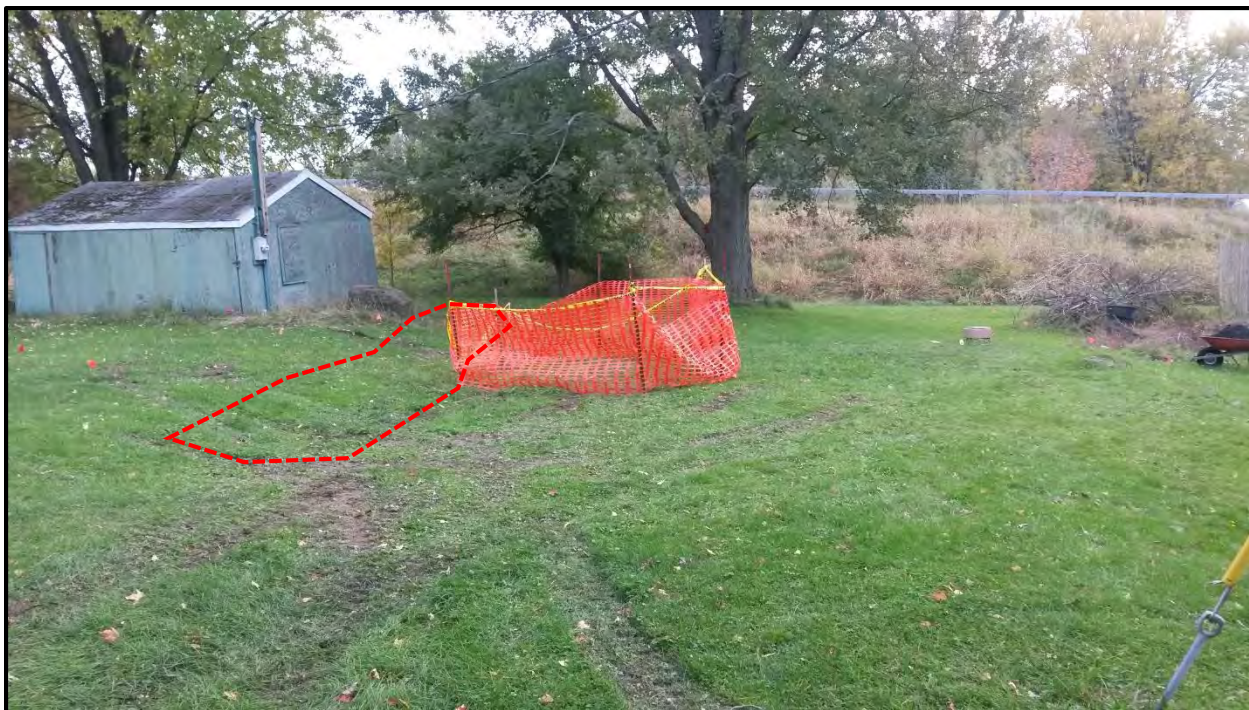
Photo 11: picture of tar seep area (surrounded by the orange construction fence) after completion of boring work, facing south-east looking towards Robinson Street. Approximate location of the low 'trough' area (outlined in red) that extends past the tar seep towards the park shed.

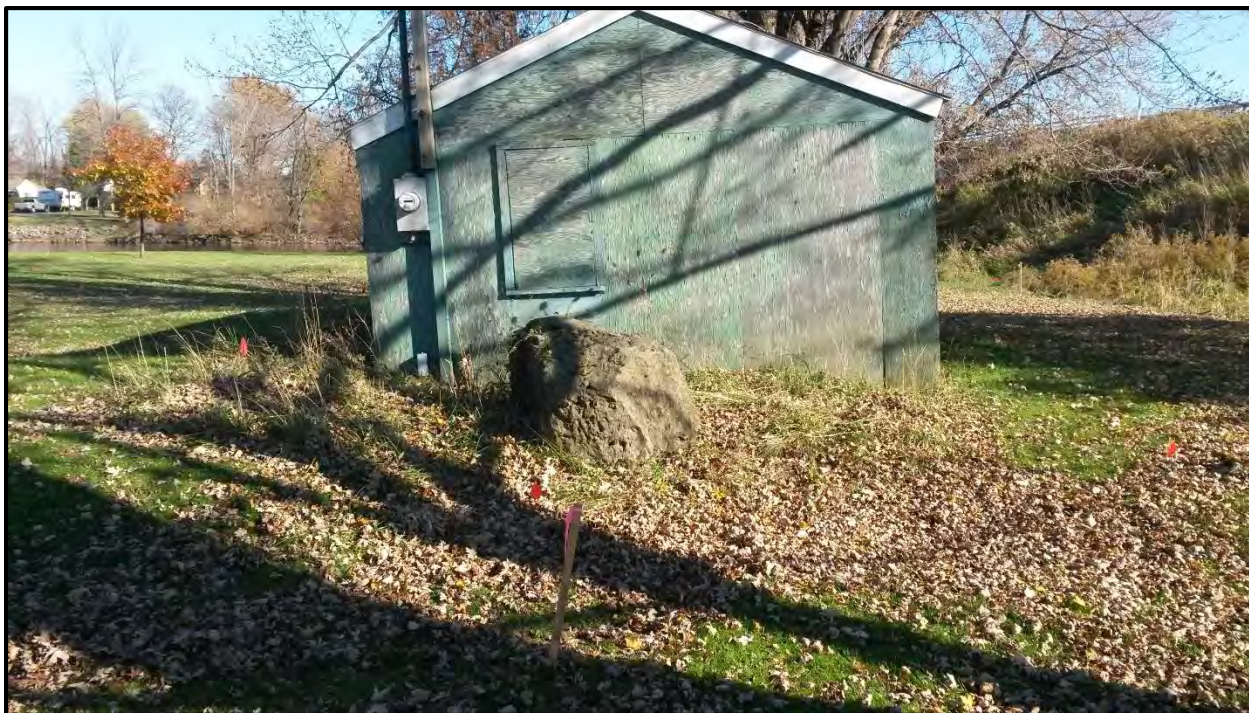
Photo 12: picture of discovered UST/B-6 location relative to the park shed (stake with pink flag), facing east.

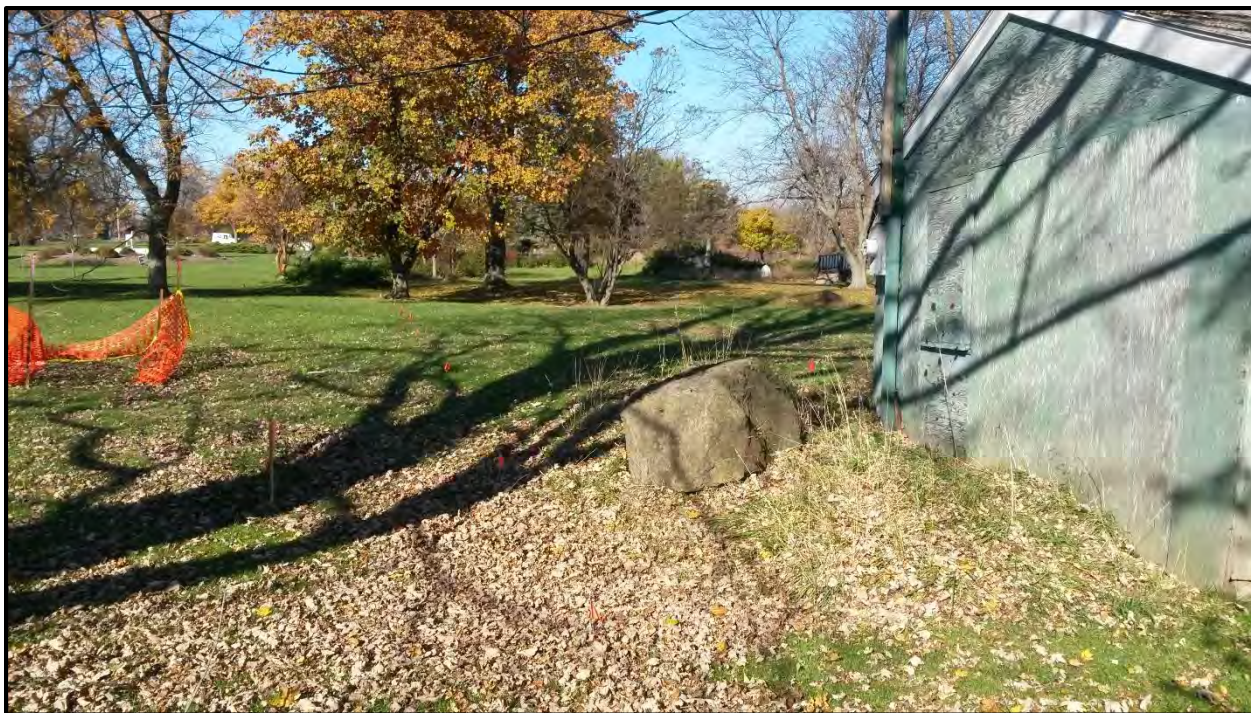
Photo 13: picture of discovered UST/B-6 location relative to the park shed (stake with pink flag), facing north.

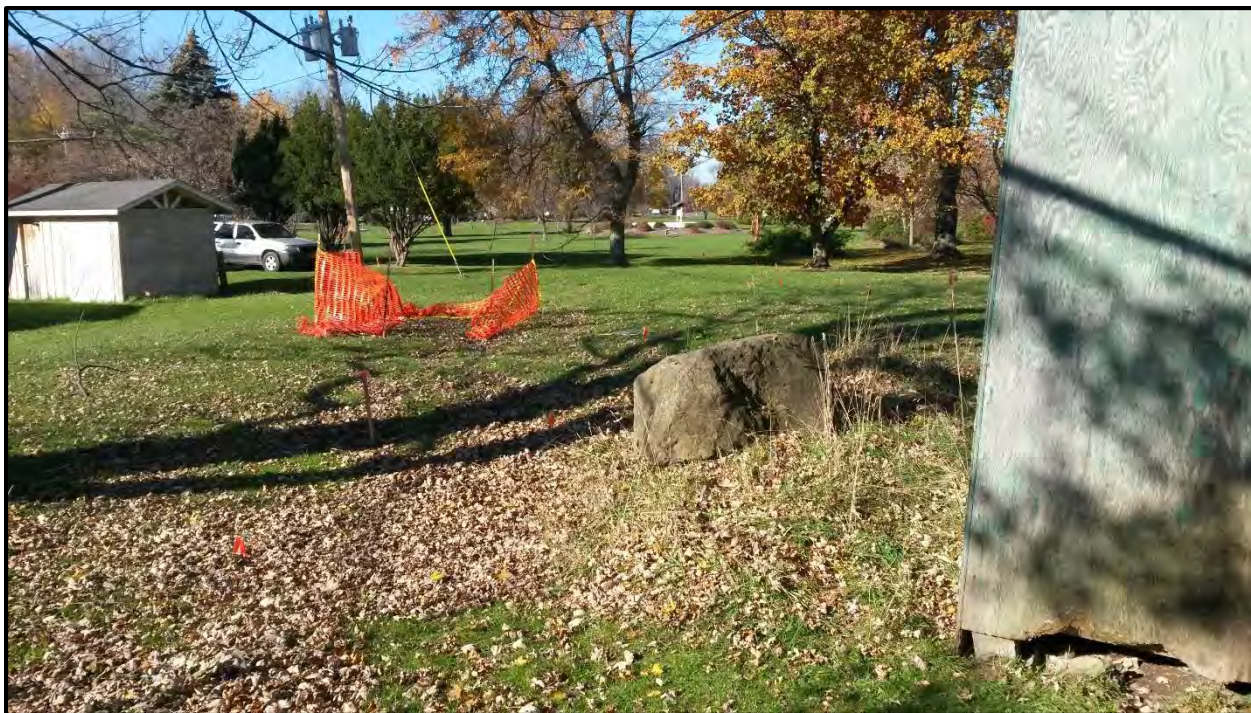
Photo 14: picture of discovered UST/B-6 location relative to the park shed (stake with pink flag), facing north-west. Private shed in background.
