# ENGINEERING INVESTIGATIONS AT INACTIVE HAZARDOUS WASTE SITES

## PHASE I INVESTIGATION

J.T. Salvage

Site No. 932074

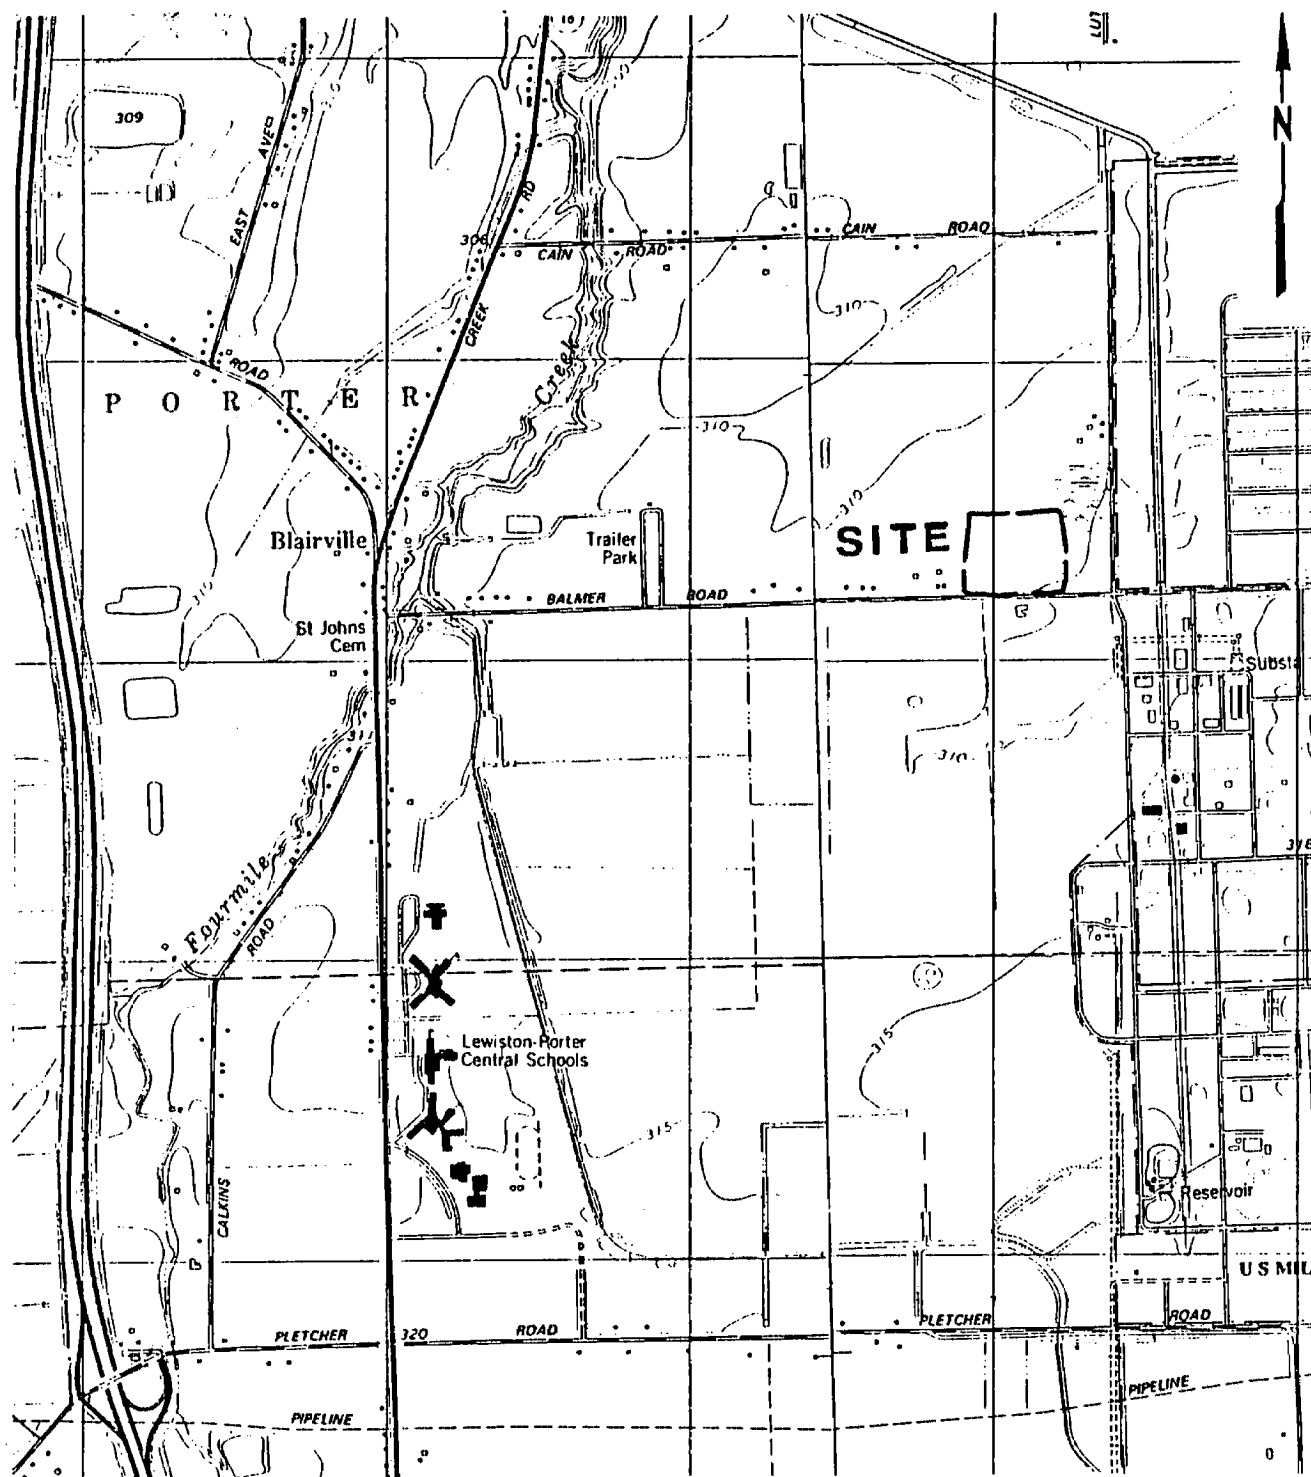
FIGURE iv-1

On March 19, 1982, the NYSDEC collected soil and water samples from a single sampling station (see Figure IV-1). The depth at which the soil sample was collected from the on-site fill is not known. Analytical results showed the presence of two heavy metals and polynuclear aromatic hydrocarbons in the soil; 0.32 mg/liter of total recoverable phenolics in the standing water sample. Two heavy metals were found to be in high concentrations including cadmium and lead. Aluminum was also found in high concentrations. Based on the known nature of fill materials used at the site, the presence of polynuclear aromatic hydrocarbons in the site soil is probably due to the presence of spilled oil.

Table IV-1 presents the results for selected parameters for the soil analyses conducted. It should be noted that this one sampling event is not sufficient to characterize the entire volume of fill disposed of on the 10-acre site. Also, the scrap yard activities may affect the results of on-site monitoring as compared to former disposal/filling operations.

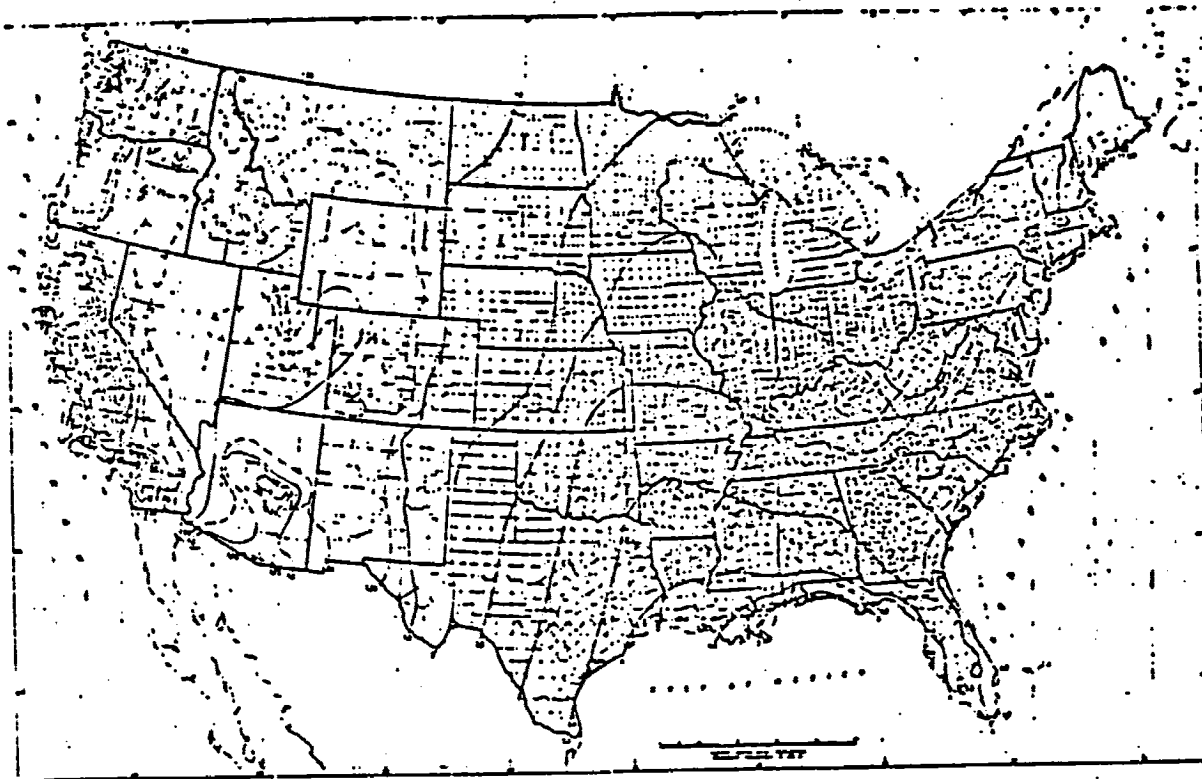
Figure 8

Source: Rainfall Frequency Atlas of the United States, Technical Paper No. 40, U.S. Department of Commerce,  
U.S. Government Printing Office, Washington, D.C., 1963.

1-Year 24-Hour Rainfall (Inches)
