# **ENGINEERING INVESTIGATIONS AT INACTIVE HAZARDOUS WASTE SITES IN THE STATE OF NEW YORK**

## **PRELIMINARY SITE ASSESSMENT TASK 1**

**J. & T. Salvage Site  
Site Number 932074  
Town of Porter, Niagara County**

**August 1992**

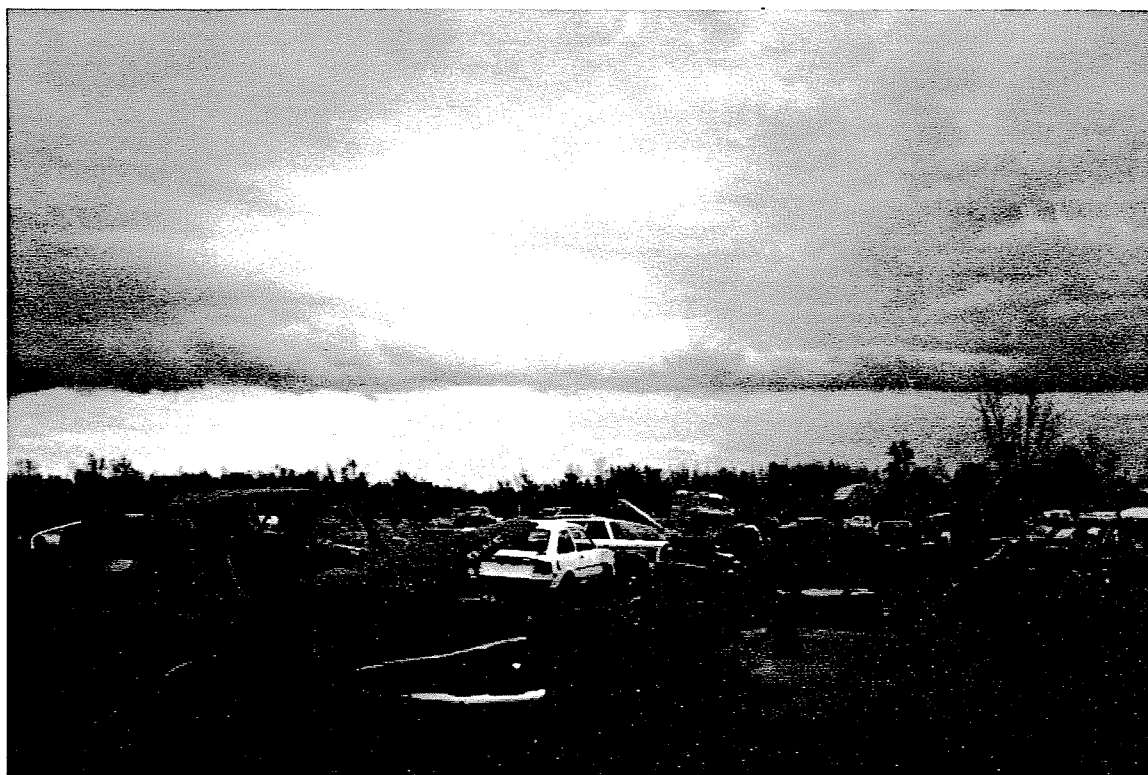
Time: 2:00 p.m. Frame No.: 7

Comments\*: Looking northeast from near  
the swampy area; fill area mounds and  
standing water with sheen encroach on  
swamp vegetation.

the standing water exhibited an oily sheen, probably resulting from the leakage of residual oil from the stored automobiles.

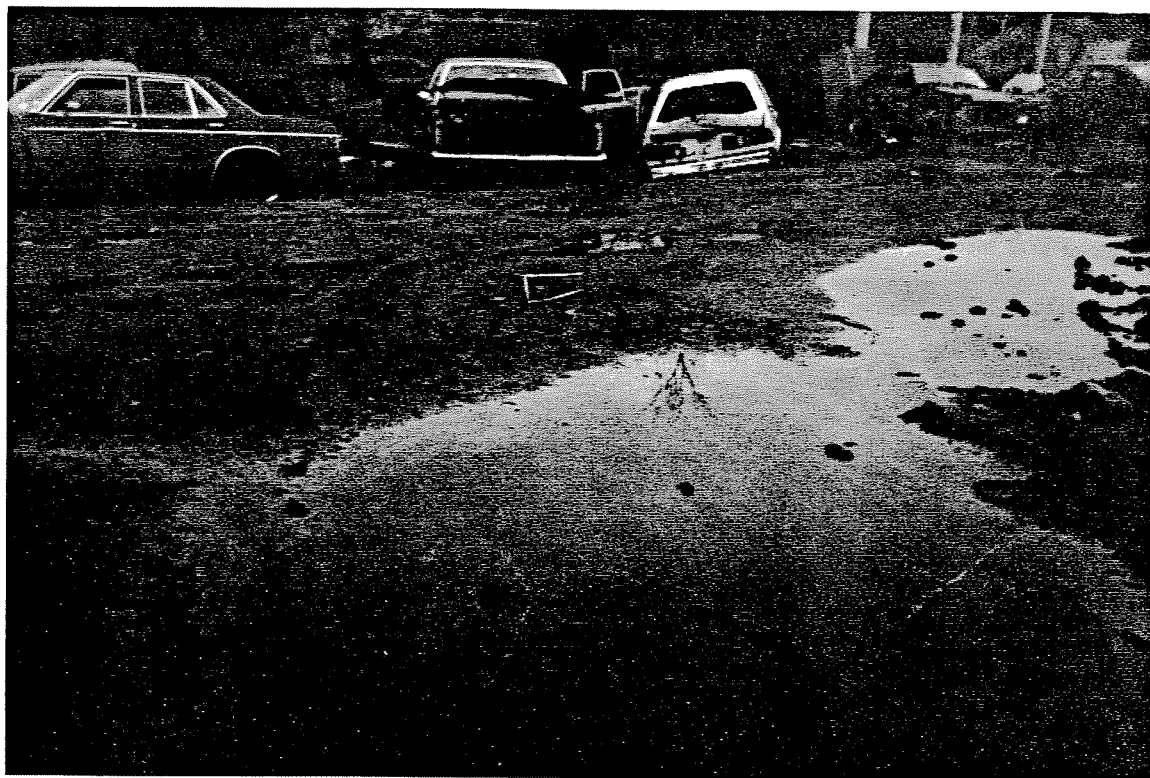
Time: 2:00 p.m. Frame No.: 8

Comments\*: Ponded water with oily sheen  
on surface atop fill area. At approximate  
location of NYSDEC 1982 sample location.
