# ENGINEERING INVESTIGATIONS AT INACTIVE HAZARDOUS WASTE SITES IN THE STATE OF NEW YORK

## PHASE II INVESTIGATIONS

**Town of Lewiston Landfill  
Site No. 932076  
Town of Lewiston, Niagara County**

**December 1990**

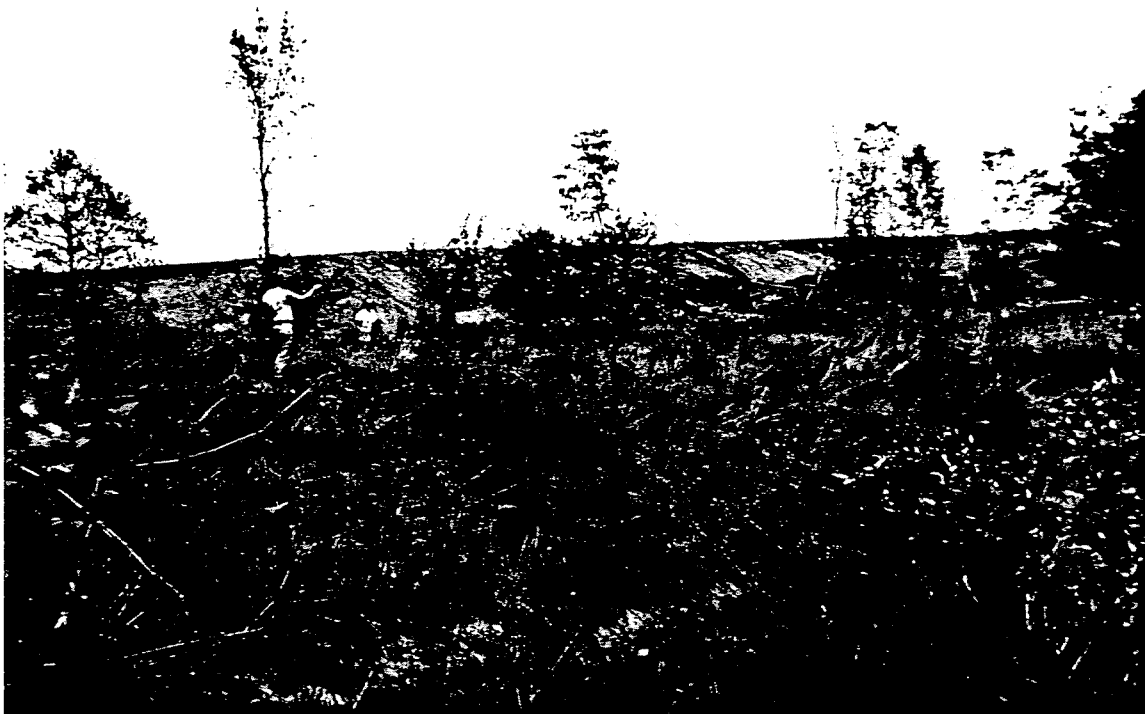
Client: NYSDEC Phase II Lewiston LandfillE & E Job No.: YQ-1030Camera: Make Kodak FlingSN: N/APhotographer: Gene Florentino, E & EDate/Time: 5/22/90Lens: Type Single ReflexSN: N/AFrame No.: 1-10Comments: View to north of GW-3A/3B grid near northeast corner of site.

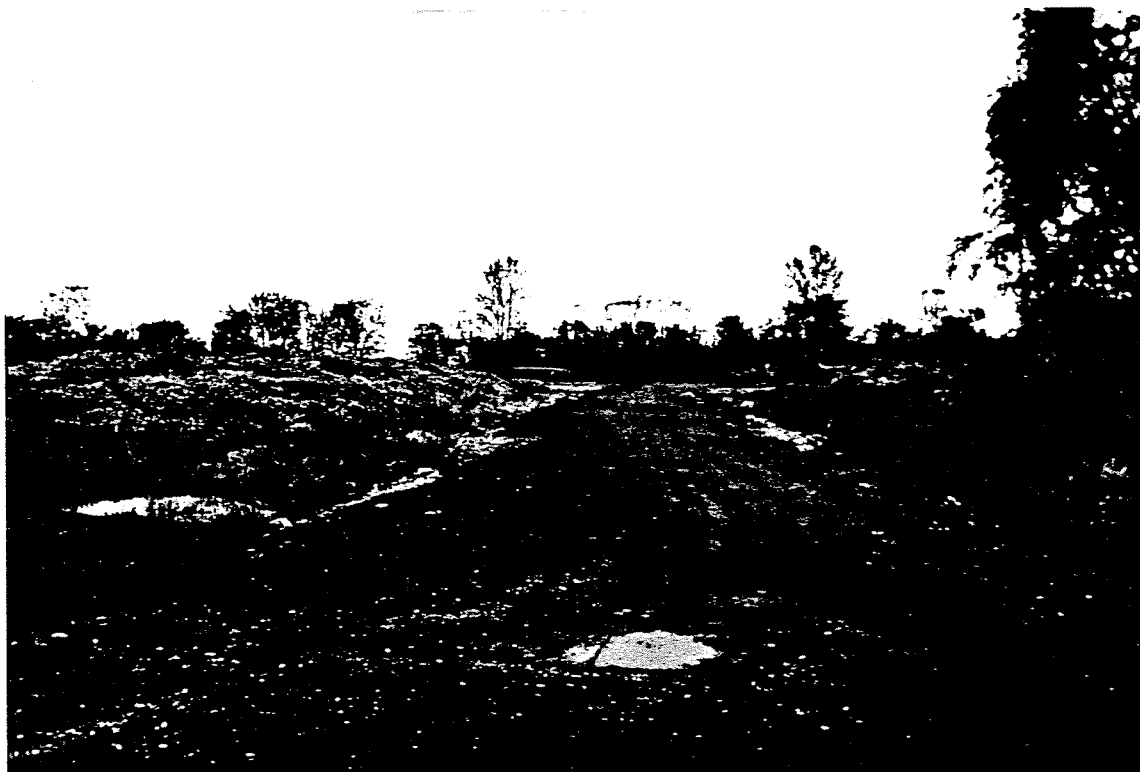
Client: NYSDEC Phase II Lewiston Landfill E & E Job No.: YQ-1030Camera: Make Kodak Fling SN: N/APhotographer: Gene Florentino, E & E Date/Time: 5/22/90Lens: Type Single Reflex SN: N/A Frame No.: 1-11Comments: View to west of mulch piles in northeast corner of site.

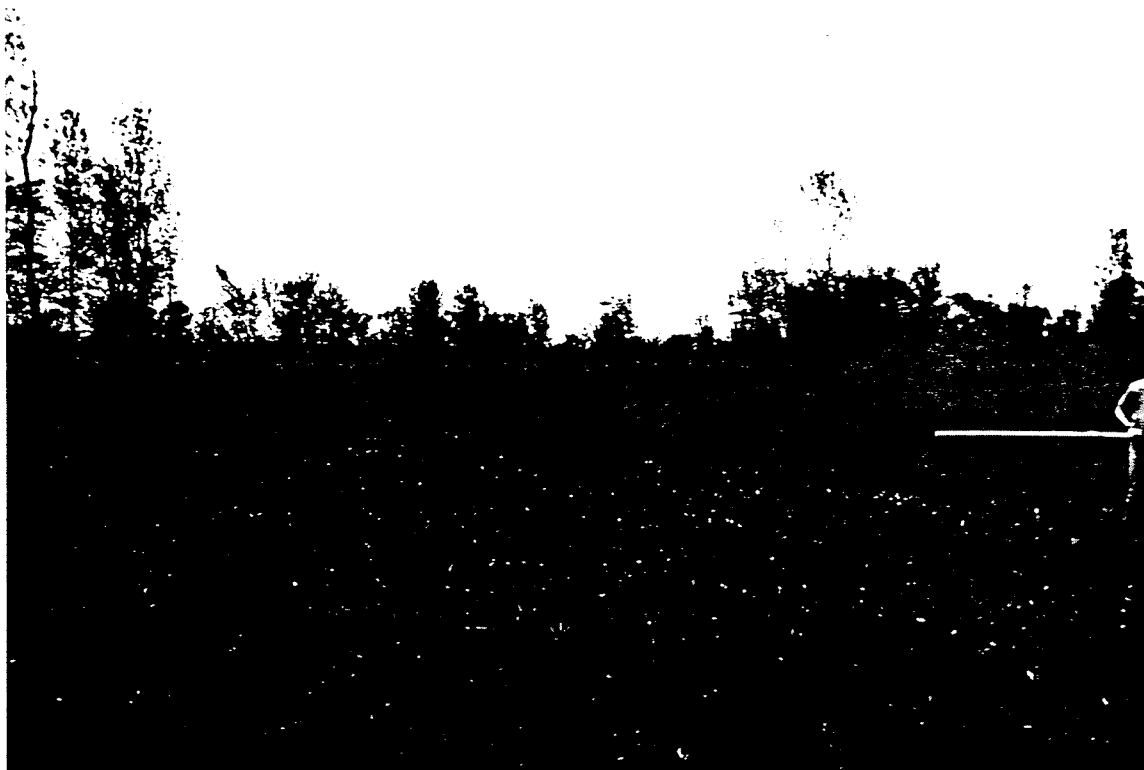
Client: NYSDEC Phase II Lewiston LandfillE & E Job No.: YQ-1030Camera: Make Kodak FlingSN: N/APhotographer: Gene Florentino, E & EDate/Time: 5/22/90Lens: Type Single ReflexSN: N/AFrame No.: 1-12Comments: View to south of GW2A/2B grid.

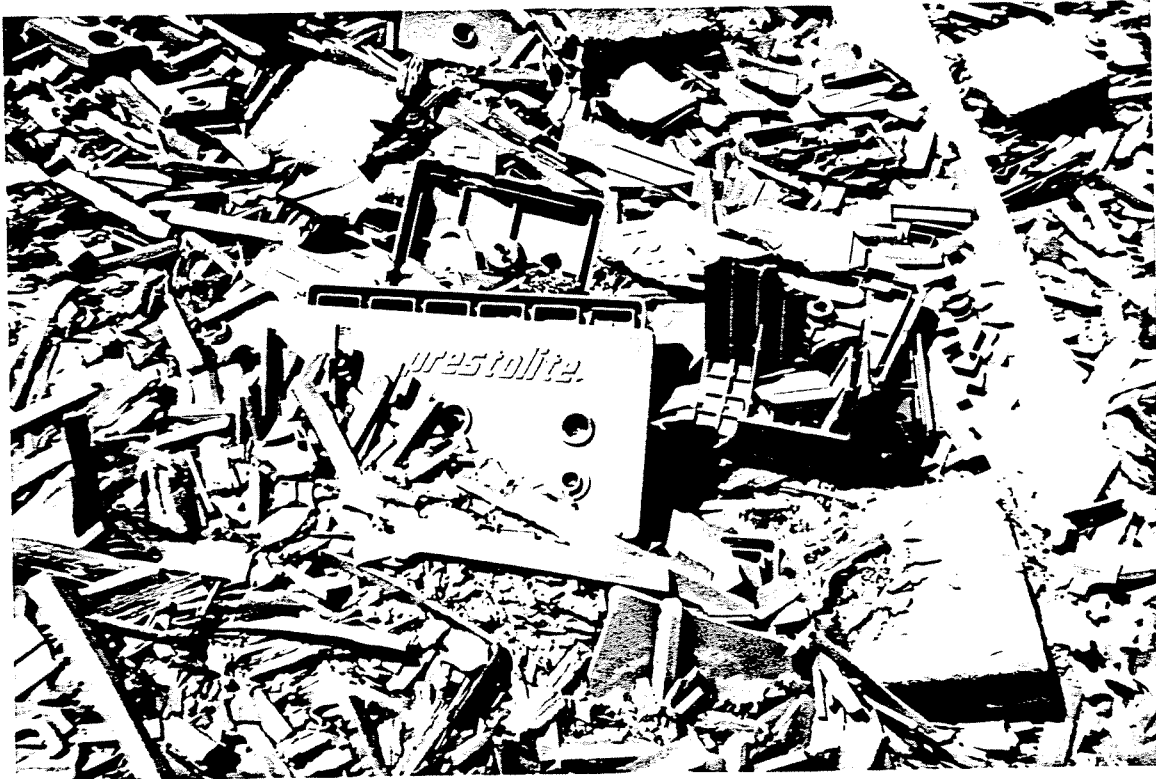
Client: NYSDEC Phase II Lewiston Landfill E & E Job No.: YQ-1030Camera: Make Kodak Fling SN: N/APhotographer: Gene Florentino, E & E Date/Time: 5/22/90Lens: Type Single Reflex SN: N/A Frame No.: 1-13Comments: View of battery casing pile.

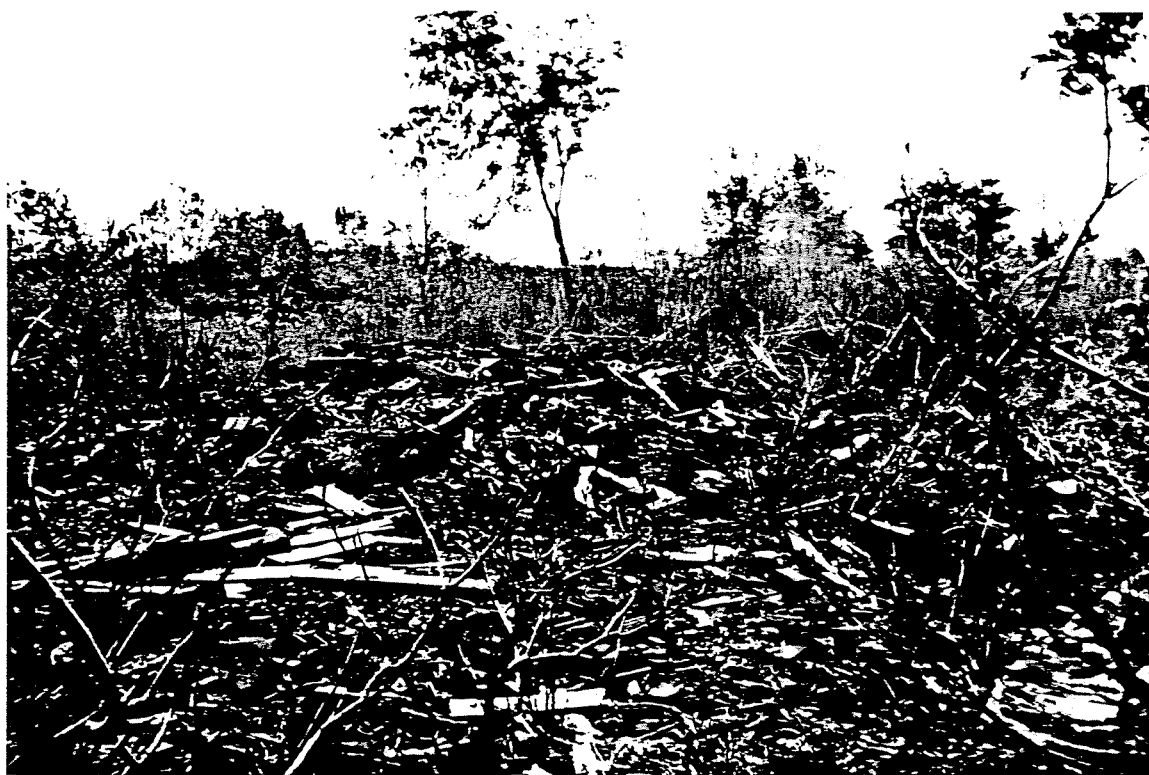
Client: NYSDEC Phase II Lewiston LandfillE & E Job No.: YQ-1030Camera: Make Kodak FlingSN: N/APhotographer: Gene Florentino, E & EDate/Time: 5/22/90Lens: Type Single ReflexSN: N/AFrame No.: 1-14Comments: View to south of battery casing pile.

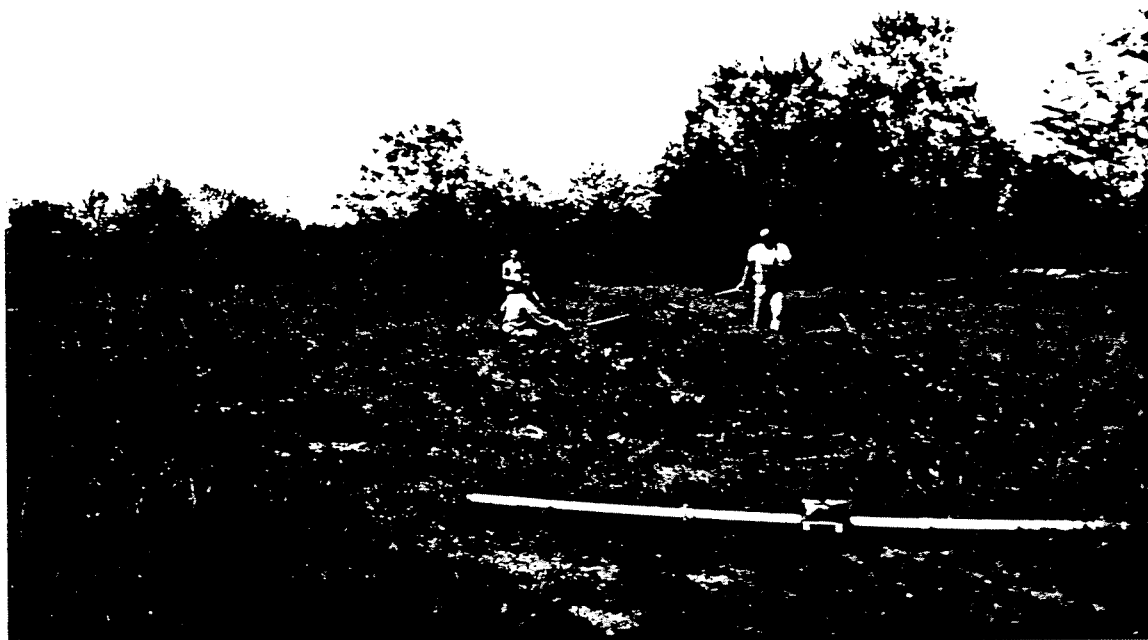
Client: NYSDEC Phase II Lewiston Landfill E & E Job No.: YQ-1030Camera: Make Kodak Fling SN: N/APhotographer: Gene Florentino, E & E Date/Time: 5/22/90Lens: Type Single Reflex SN: N/A Frame No.: 1-16Comments: View to west of GW-4A/4B grid area.

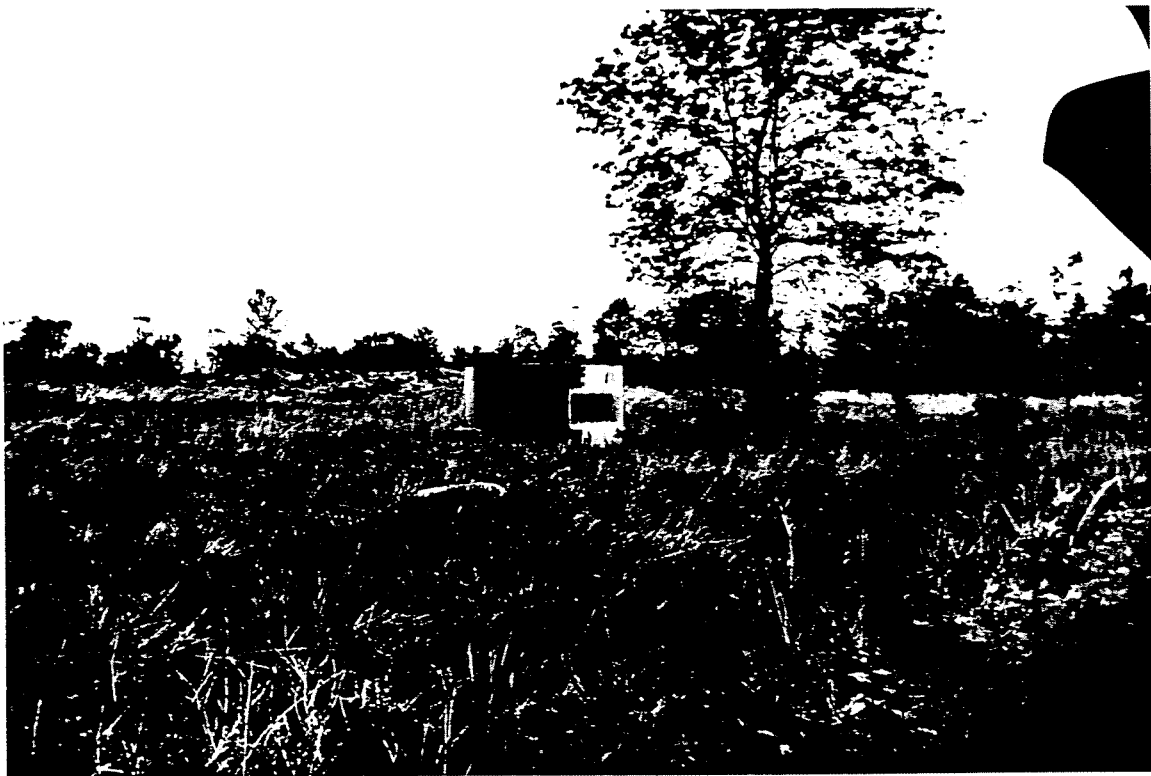
Client: NYSDEC Phase II Lewiston Landfill E & E Job No.: YQ-1030Camera: Make Kodak Fling SN: N/APhotographer: Gene Florentino, E & E Date/Time: 5/22/90Lens: Type Single Reflex SN: N/A Frame No.: 1-17Comments: View to north of mulch area.

The air monitoring survey indicated no organic vapor readings above background except near the mulch piles due to methane production from decay processes.

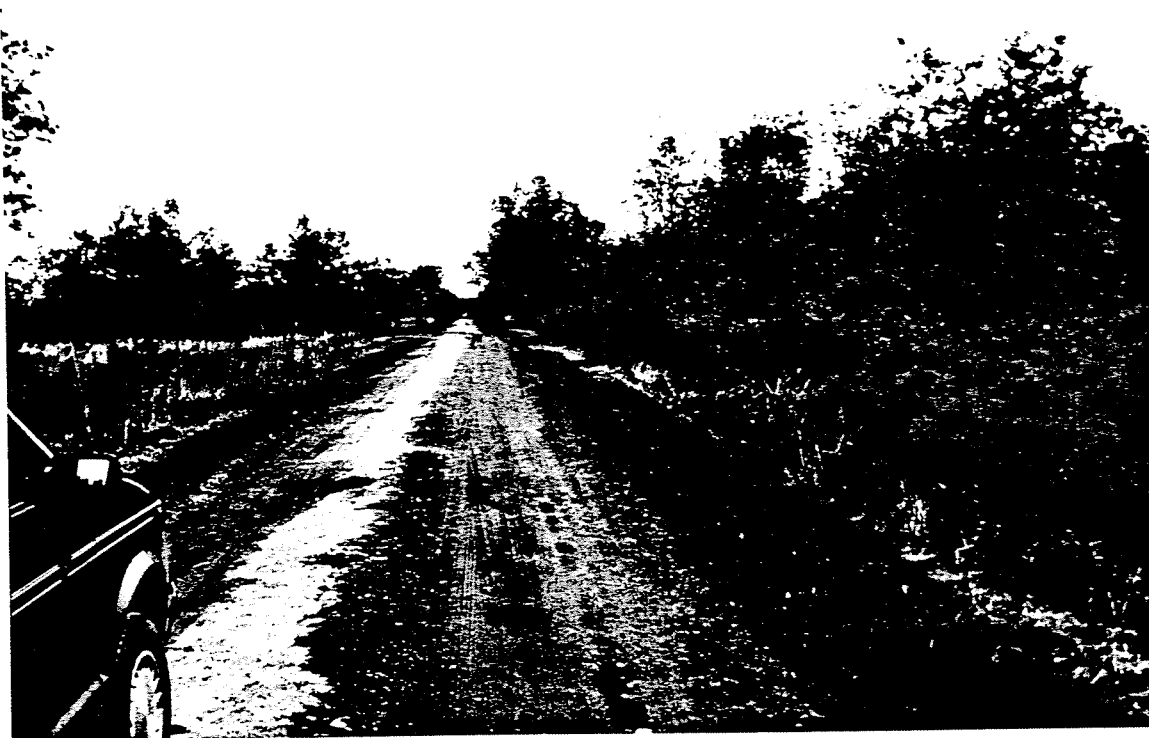
Client: NYSDEC Phase II Lewiston Landfill E & E Job No.: YQ-1030Camera: Make Kodak Fling SN: N/APhotographer: Gene Florentino, E & E Date/Time: 5/22/90Lens: Type Single Reflex SN: N/A Frame No.: 1-18Comments: View to northeast along access road.

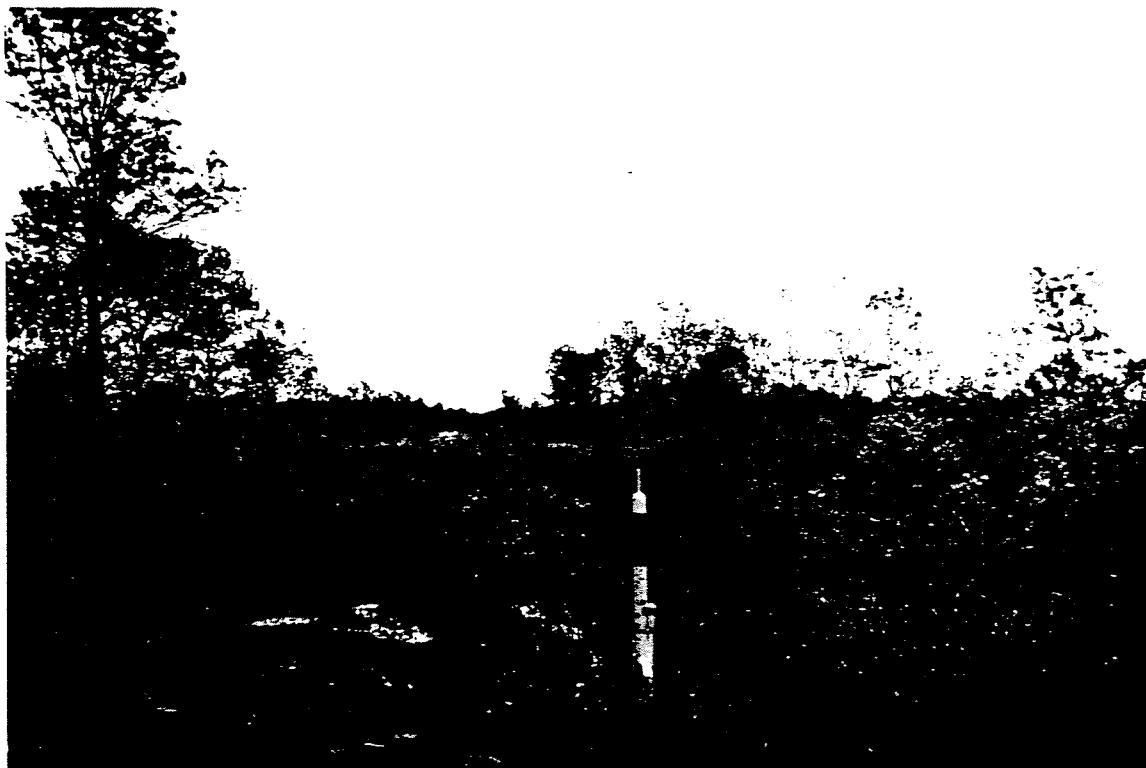
Client: NYSDEC Phase II Lewiston Landfill E & E Job No.: YQ-1030Camera: Make Kodak Fling SN: N/APhotographer: Gene Florentino, E & E Date/Time: 5/22/90Lens: Type Single Reflex SN: N/A Frame No.: 1-19Comments: View to east of gas pipeline.

The site is crossed by a natural gas pipeline owned and operated by Tennessee Gas. In May 1987, E & E analyzed soil and groundwater samples along the Tennessee Gas right-of-way to determine if contaminants were present that may be hazardous to workers performing routine maintenance along the pipeline. Low levels of toluene and levels of lead exceeding the New York State Class GA Groundwater Quality Standards were found in the groundwater tested.

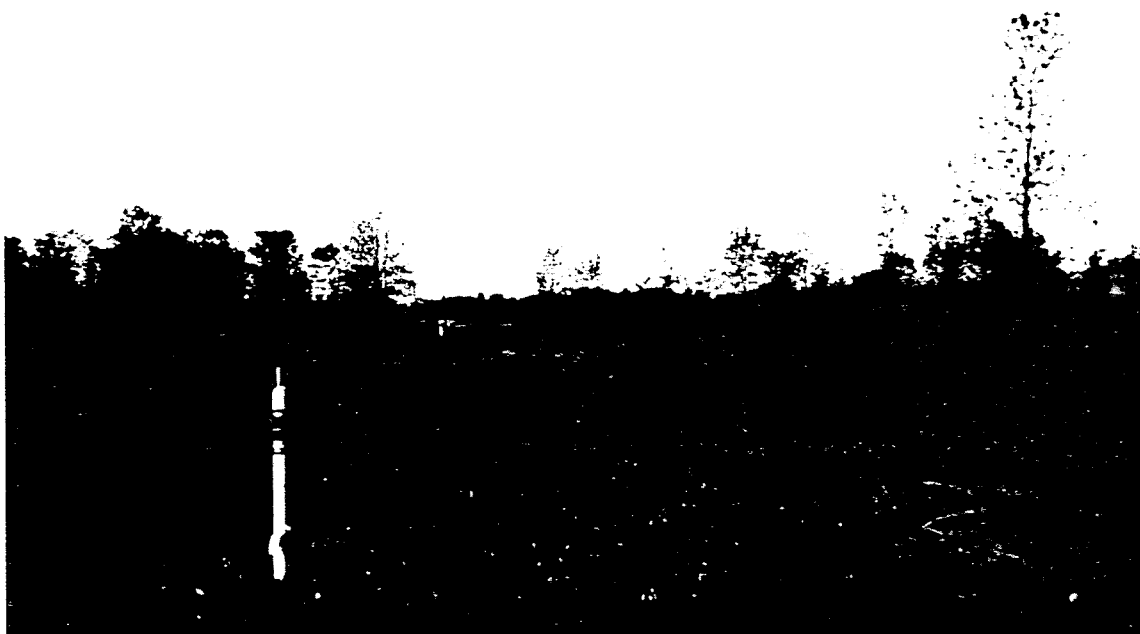
Client: NYSDEC Phase II Lewiston LandfillE & E Job No.: YQ-1030Camera: Make Kodak FlingSN: N/APhotographer: Gene Florentino, E & EDate/Time: 5/22/90Lens: Type Single ReflexSN: N/AFrame No.: 1-20Comments: View to west from ballast-covered road of gas pipeline.

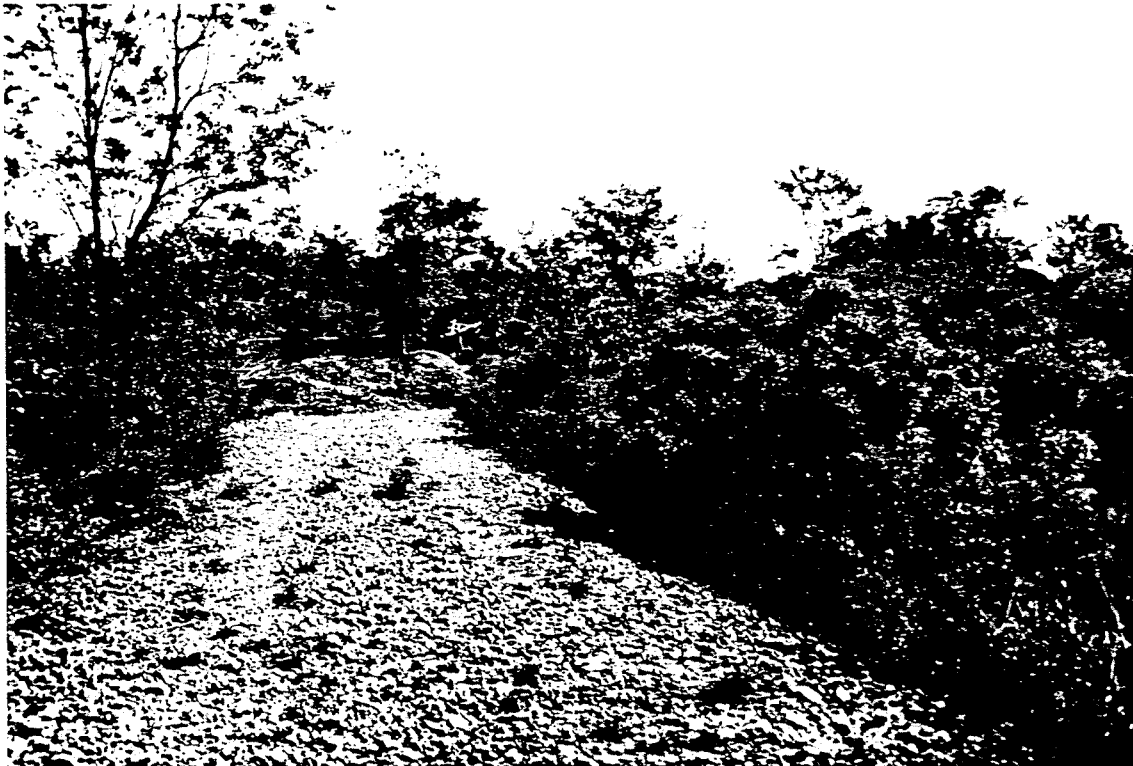
Client: NYSDEC Phase II Lewiston LandfillE & E Job No.: YQ-1030Camera: Make Kodak FlingSN: N/APhotographer: Gene Florentino, E & EDate/Time: 5/22/90Lens: Type Single ReflexSN: N/AFrame No.: 1-21Comments: View to north of slag berm in northwest corner of facility.

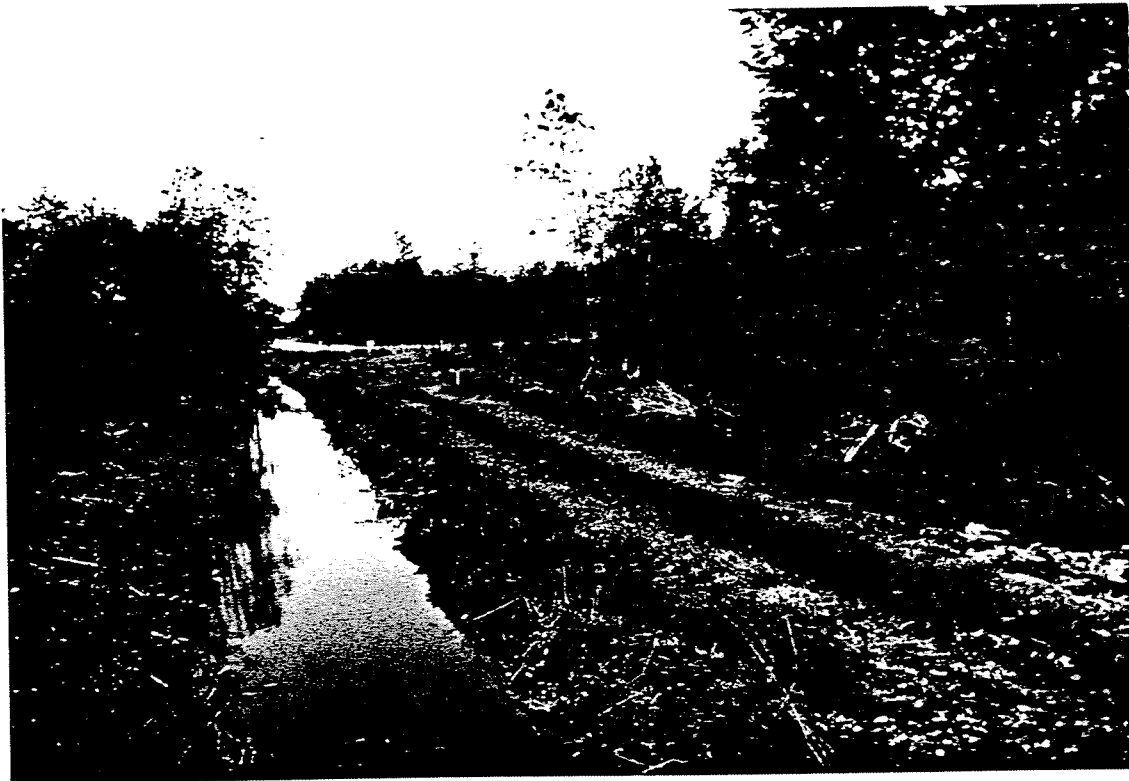
Client: NYSDEC Phase II Lewiston Landfill E & E Job No.: YQ-1030Camera: Make Kodak Fling SN: N/APhotographer: Gene Florentino, E & E Date/Time: 5/22/90Lens: Type Single Reflex SN: N/A Frame No.: 1-22Comments: View to west of northern border.

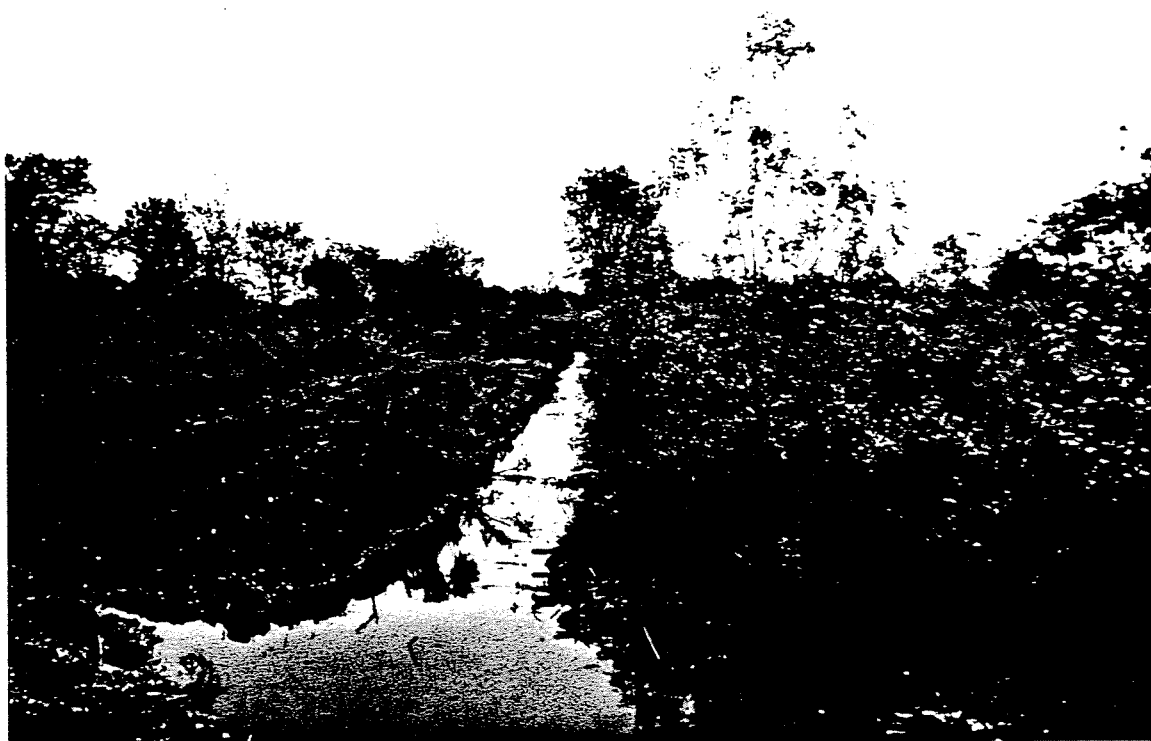
Client: NYSDEC Phase II Lewiston Landfill E & E Job No.: YQ-1030Camera: Make Kodak Fling SN: N/APhotographer: Gene Florentino, E & E Date/Time: 5/22/90Lens: Type Single Reflex SN: N/A Frame No.: 1-23Comments: View to east of northern border.

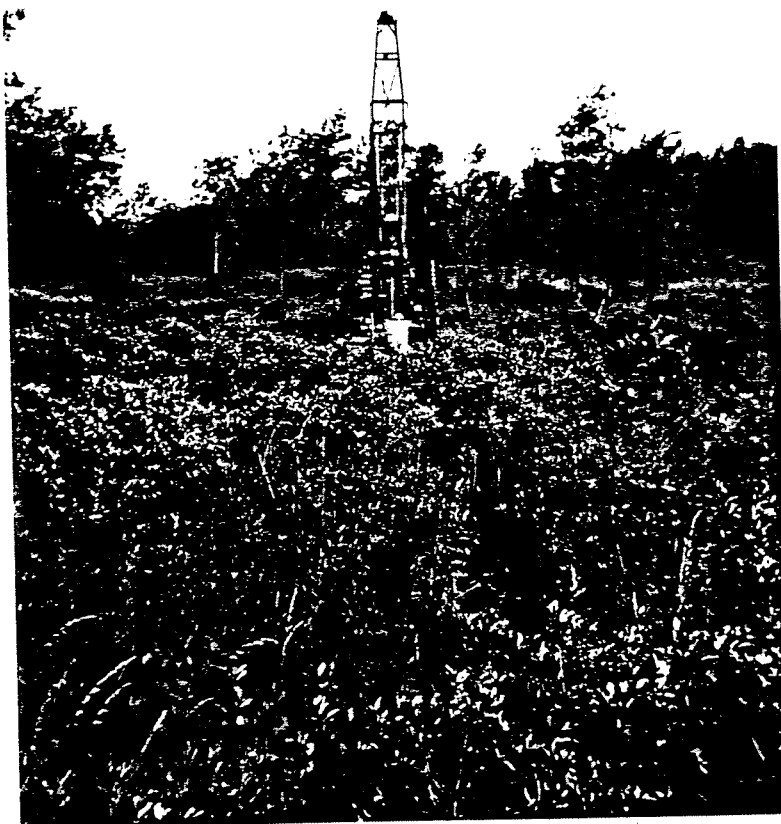
Lens: Type Single Reflex SN: \_\_\_\_\_ Frame No.: Roll 2-1

Comments: American Auger ATV drill rig on GW-1B looking northwest toward Harold Road.

The boreholes were advanced using 4.25-inch inside diameter (ID) hollow-stem augers until refusal. The shallow wells (GW-1A, GW-2A, GW-3A, GW-3C, and GW-4A) were set in the overburden, above bedrock, and the bedrock wells (GW-1B, GW-2B, GW-3B, and GW-4B) were cored using an HQ bit (3.97-inch outside diameter) and set into the uppermost fractured bedrock zone. Well screen consisting of 2-inch ID 0.010 machine-slot polyvinyl chloride (PVC) was set at the bottom of each borehole. The screen length was 5 feet for each of the nine wells. The screens were followed by threaded, flush-joint PVC riser of the same diameter as the well screen to approximately 2 feet above ground surface. The wells were completed with a sand pack varying from 0.5 to 1.78 feet above the top of the well screen, followed by 1.5 to 3.5 feet of bentonite pellets, followed by cement/bentonite grout. A locking protective steel casing was placed over the PVC and a concrete pad was constructed on the ground surface around the protective casing.

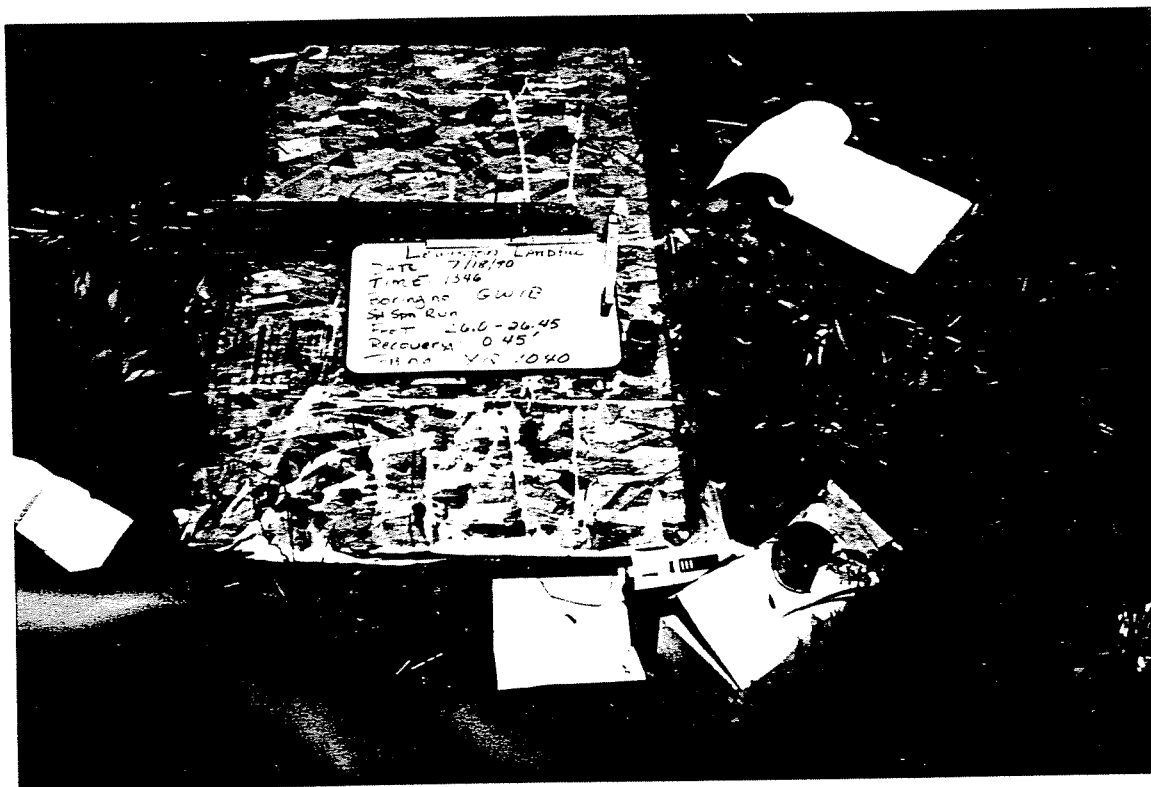
Client: NYSDEC Phase II Lewiston Landfill E & E Job No.: YQ1040Camera: Make Kodak Fling SN: \_\_\_\_\_Photographer: Carol Waddell, E & E Date/Time: 7/18/90 1346Lens: Type Single Reflex SN: \_\_\_\_\_ Frame No.: Roll 2-2Comments: Boring Number: GW-1B. Split Spoon Run 11: 26.0-28.0 0.45'/2.0 recovery. This split spoon  
penetrated bedrock (The Queenston Shale).

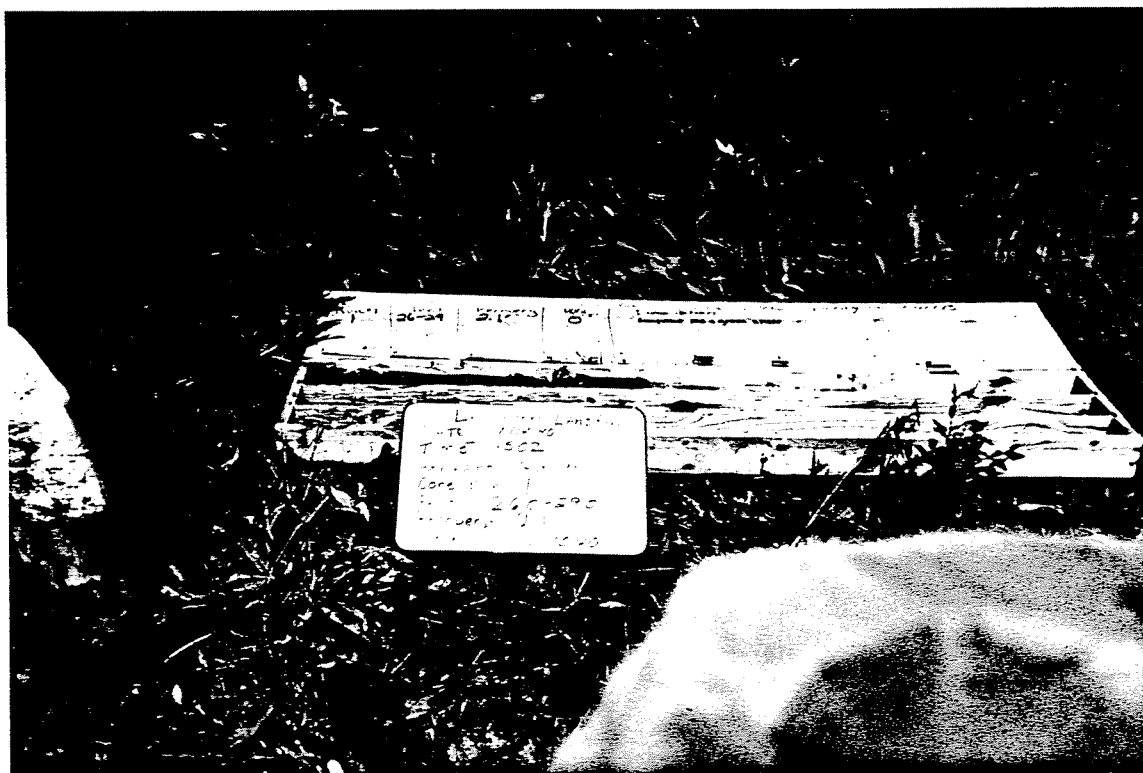
Comments: Boring Number: GW-1B. Core Run 1: 26.0-29.0 2.1'/3.0 recovery. RQD = 0. This shale  
exhibited many zones of weakness. The green section showed multiple zones of clay, which is an  
indication of the presence of groundwater.

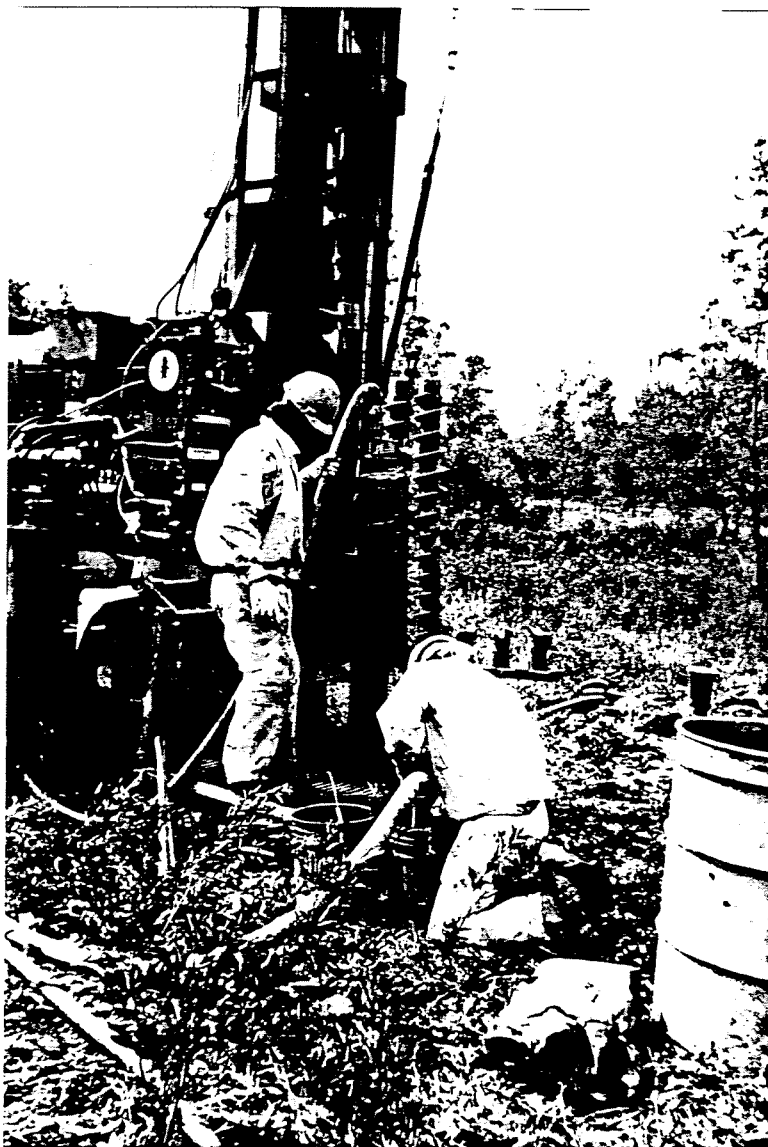
Frame No.: Roll 2-6Comments: Boring Number: GW-1A. Tremie of bentonite seal.

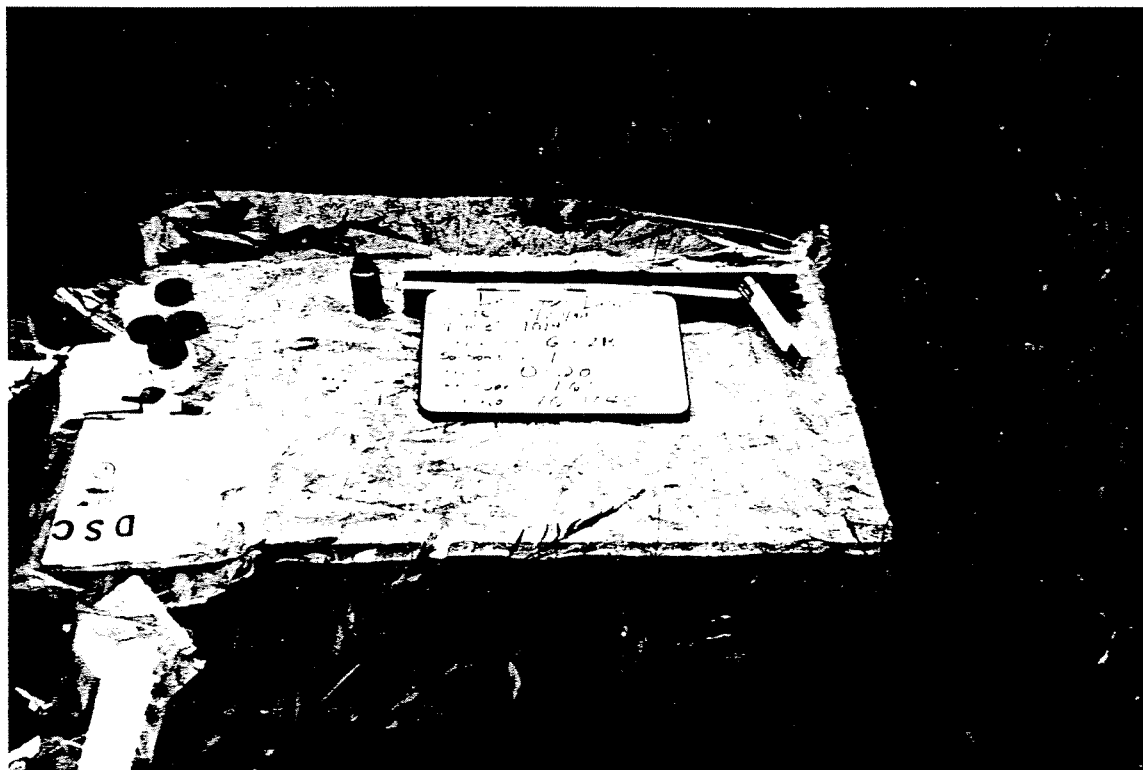
Frame No.: Roll 2-7

Comments: Boring Number: GW-2B. Split Spoon Run 1: 0.0-2.0 1.6'/2.0' recovery. NOTE: Heavy rains  
throughout the day.

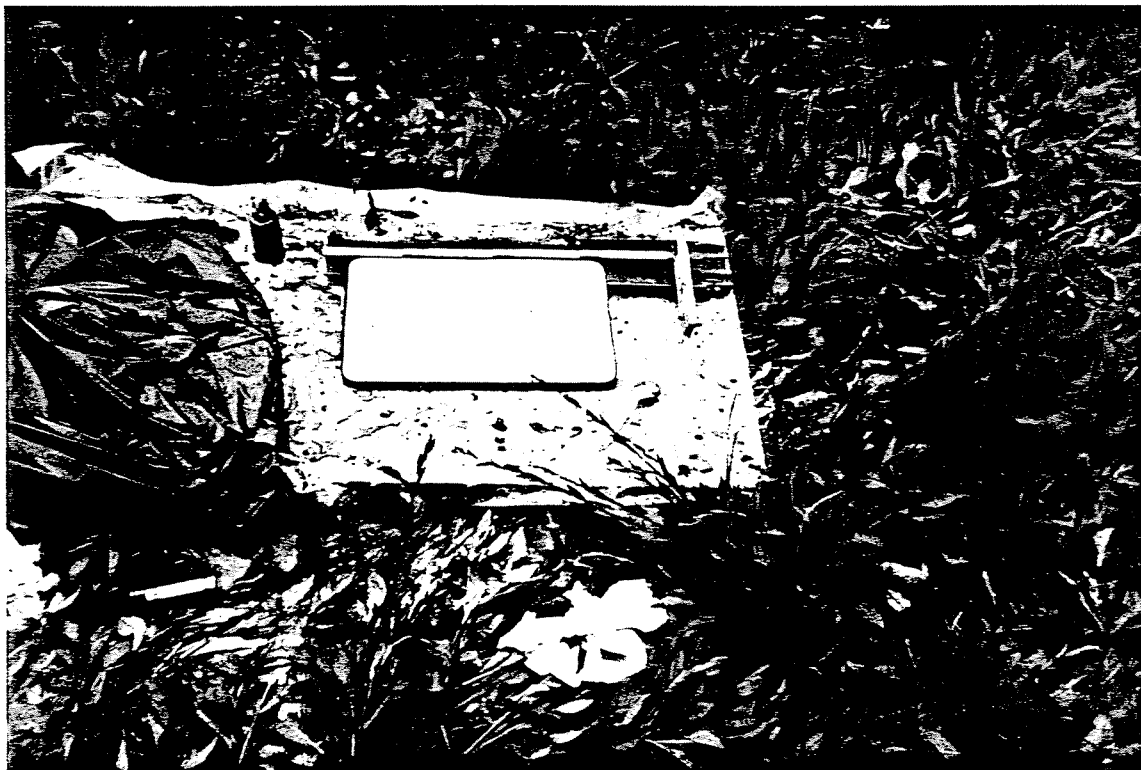
Frame No.: Roll 2-13Comments: Boring Number: GW-2B. Split Spoon Run 7: 12.0-14.0 1.9'/2.0' recovery.

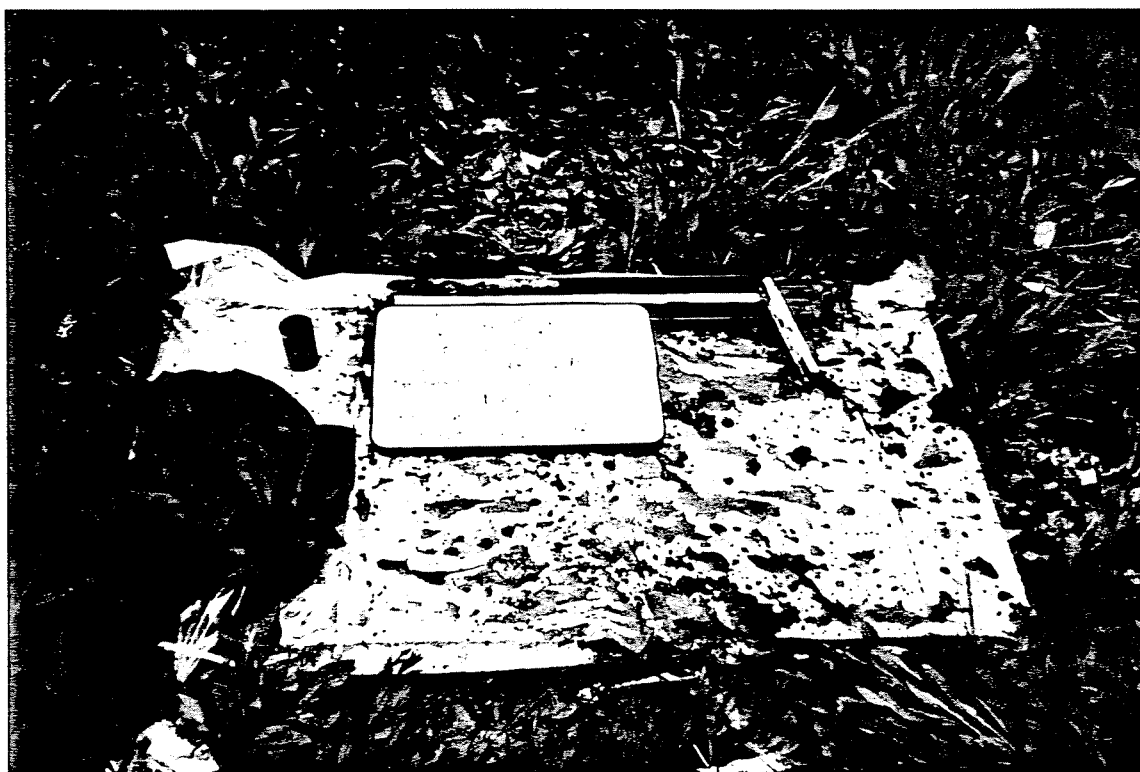
Client: NYSDEC Phase II Lewiston Landfill E & E Job No.: YQ1040Camera: Make Kodak Fling SN: \_\_\_\_\_Photographer: Carol Waddell, E & E Date/Time: 7/20/90 1202Lens: Type Single Reflex SN: \_\_\_\_\_ Frame No.: Roll 2-18Comments: Boring Number: GW-2B. Split Spoon Run 12: 22.0-24.0 0.7'/2.0' recovery.

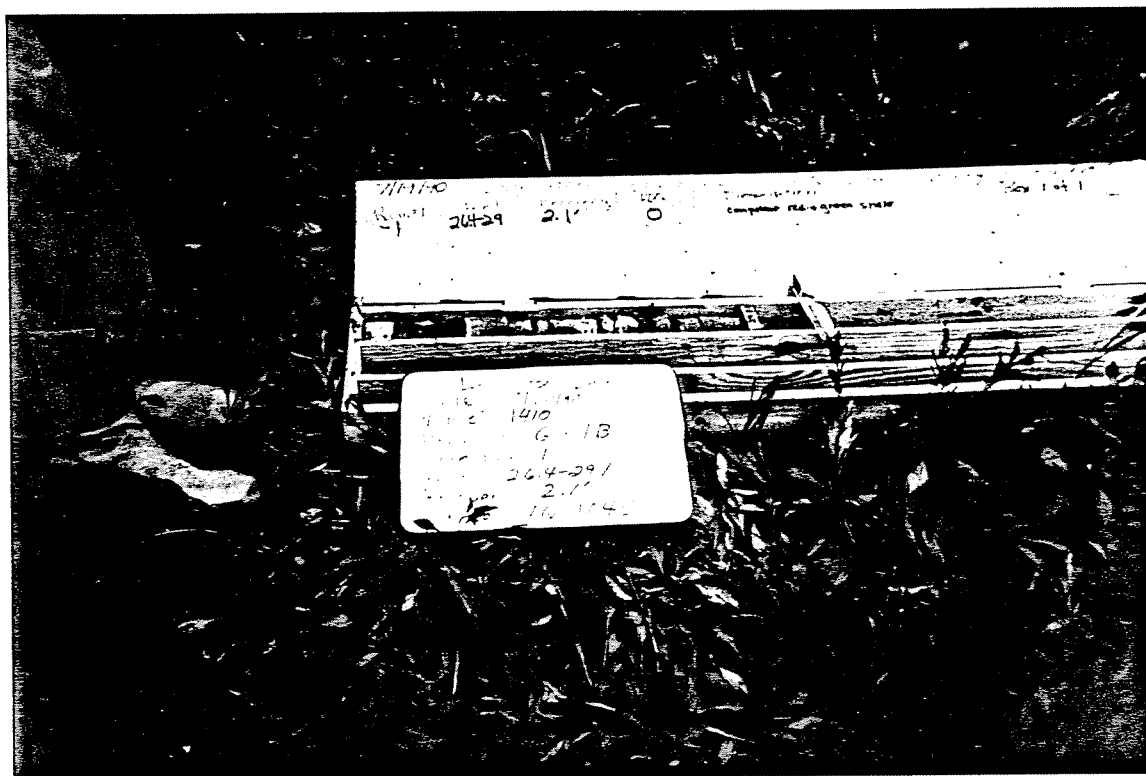
Comments: Boring Number: GW-1B. Entire core: 26.4-29.1. This shale exhibited many zones of  
weakness. The green section exhibited multiple clay zones, which indicate the presence of groundwater.
