"ENVIRONMENTAL PROPERTY ASSESSMENT"

TOPS Markets, Inc.  
60 Dingens Street  
Buffalo, NY 14206

Waste Resource Associates, Inc.  
2576 Seneca Avenue  
Niagara Falls, NY 14305

November 29, 1989

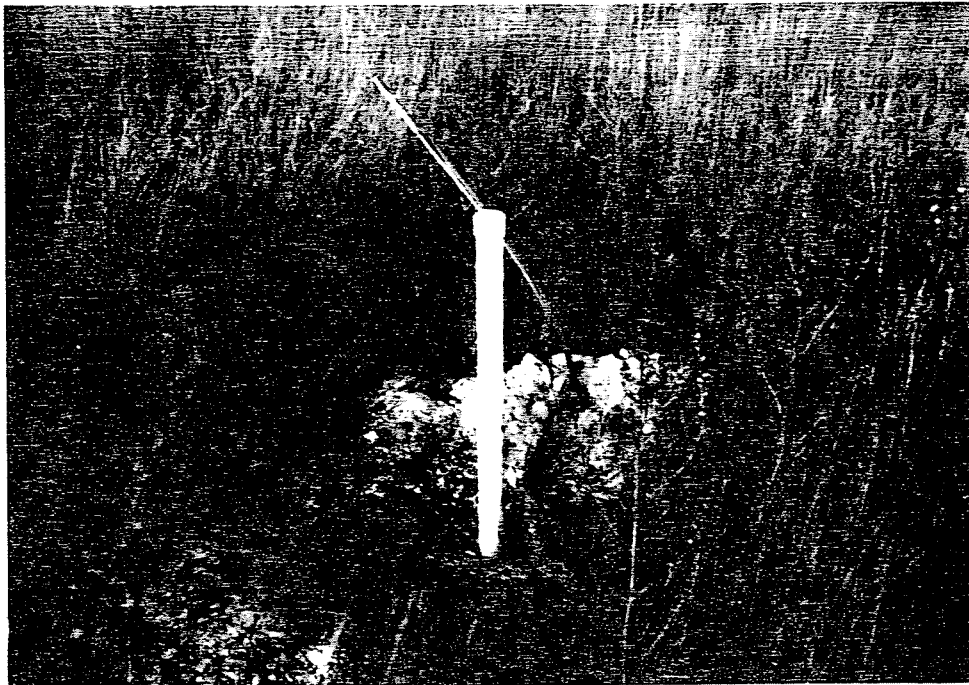
[Photo No. 9]  
Monitoring Well  
(near northwest corner of property)

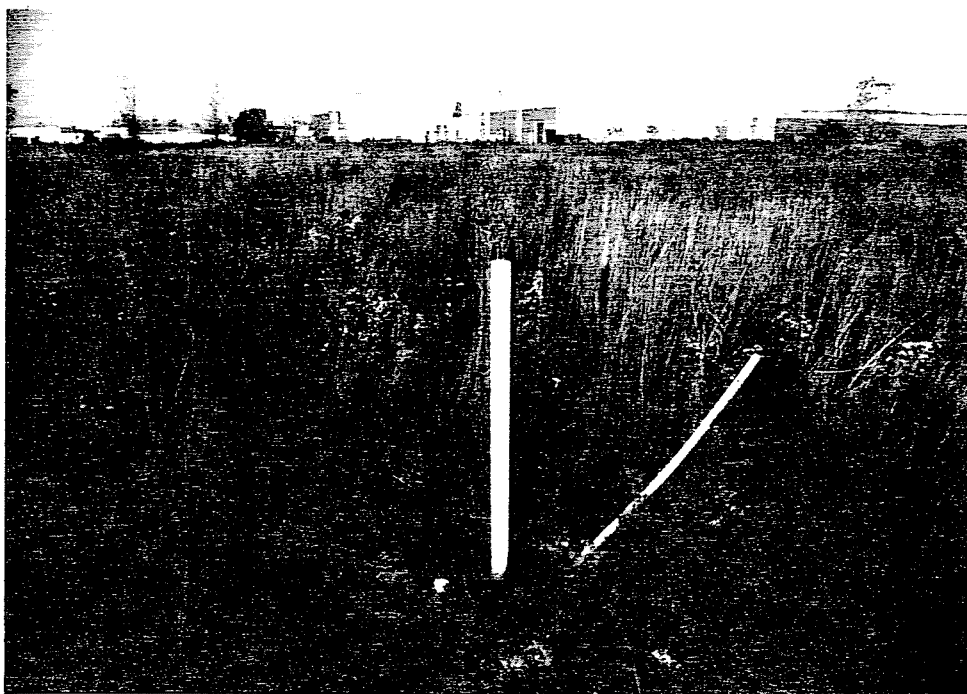
[Photo No. 10]  
Monitoring Well  
(near northeast corner of property)

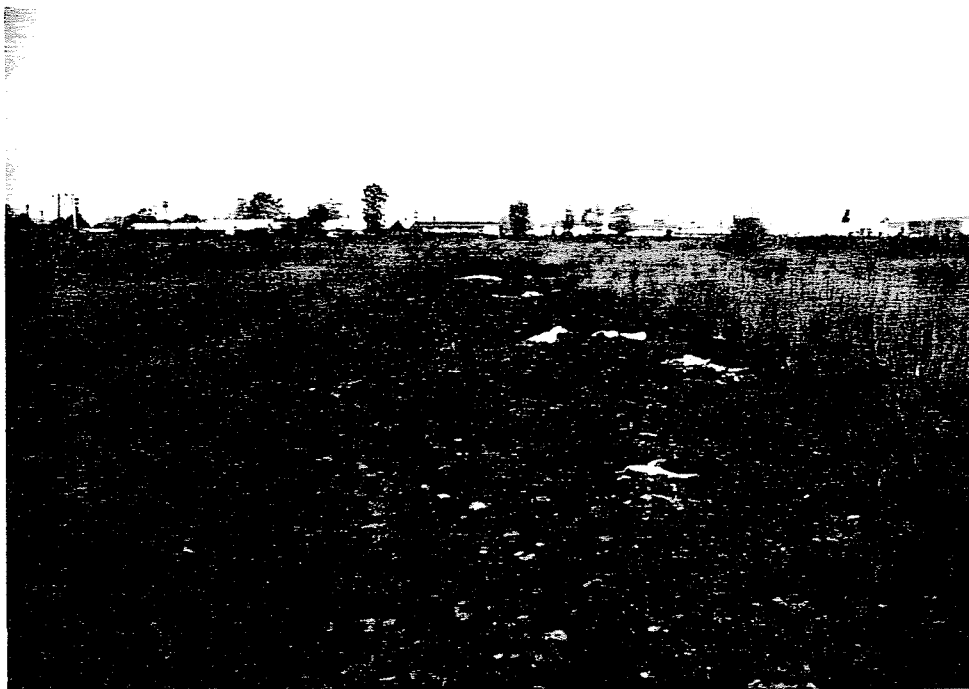
[Photo No. 16]  
Old Roofing Material Dumped to form Roadway on PJS Parcel  
(looking west)

If TOPS is intent on acquiring the P.J. Schmitt parcel and developing the properties at that location, it is imperative that further sub-surface soil sampling and analytical testing be conducted to more accurately define the extent of contamination on the property. Once the sub-surface information is developed, an assessment can be made relative to the scope and costs of whatever remedial actions may be required in order to develop the parcels.

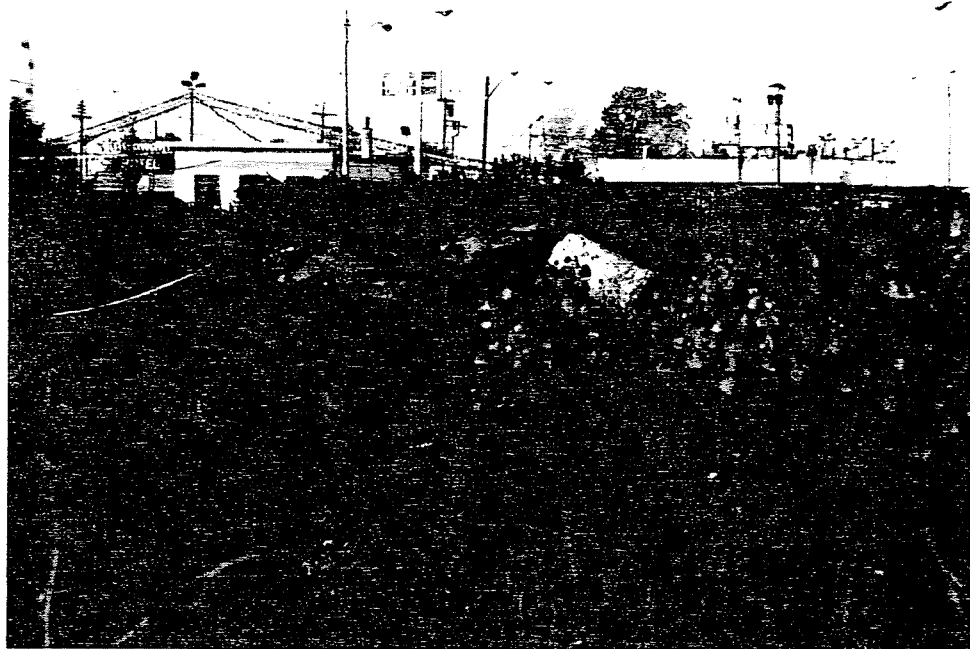
Walter S. Johnson Building Company, Inc. never developed the property in any significant manner. However, the property was previously used as a disposal site for construction and demolition debris. This fact is evidenced by the various mounds of debris present on the site and from sub-surface soil boring information developed by Empire Soils Investigations for P.J. Schmitt. Exhibit 9 illustrates the material encountered during Empire Soils Investigations sub-surface soil boring activities. Although the construction and demolition debris still remains on the property, it is not possible at this point to specifically determine the exact origin of the material. Various contractors made use of the site before any type of disposal and environmental regulations were in effect.

[Photo No. 17]  
C&D Debris on Tops Parcel  
(looking southwest)
