ENGINEERING INVESTIGATIONS AT INACTIVE HAZARDOUS WASTE SITES IN THE STATE OF NEW YORK

PHASE II INVESTIGATIONS

**97th Street Methodist Church (Site Number 932084A)
City of Niagara Falls, Niagara County**

December 1990

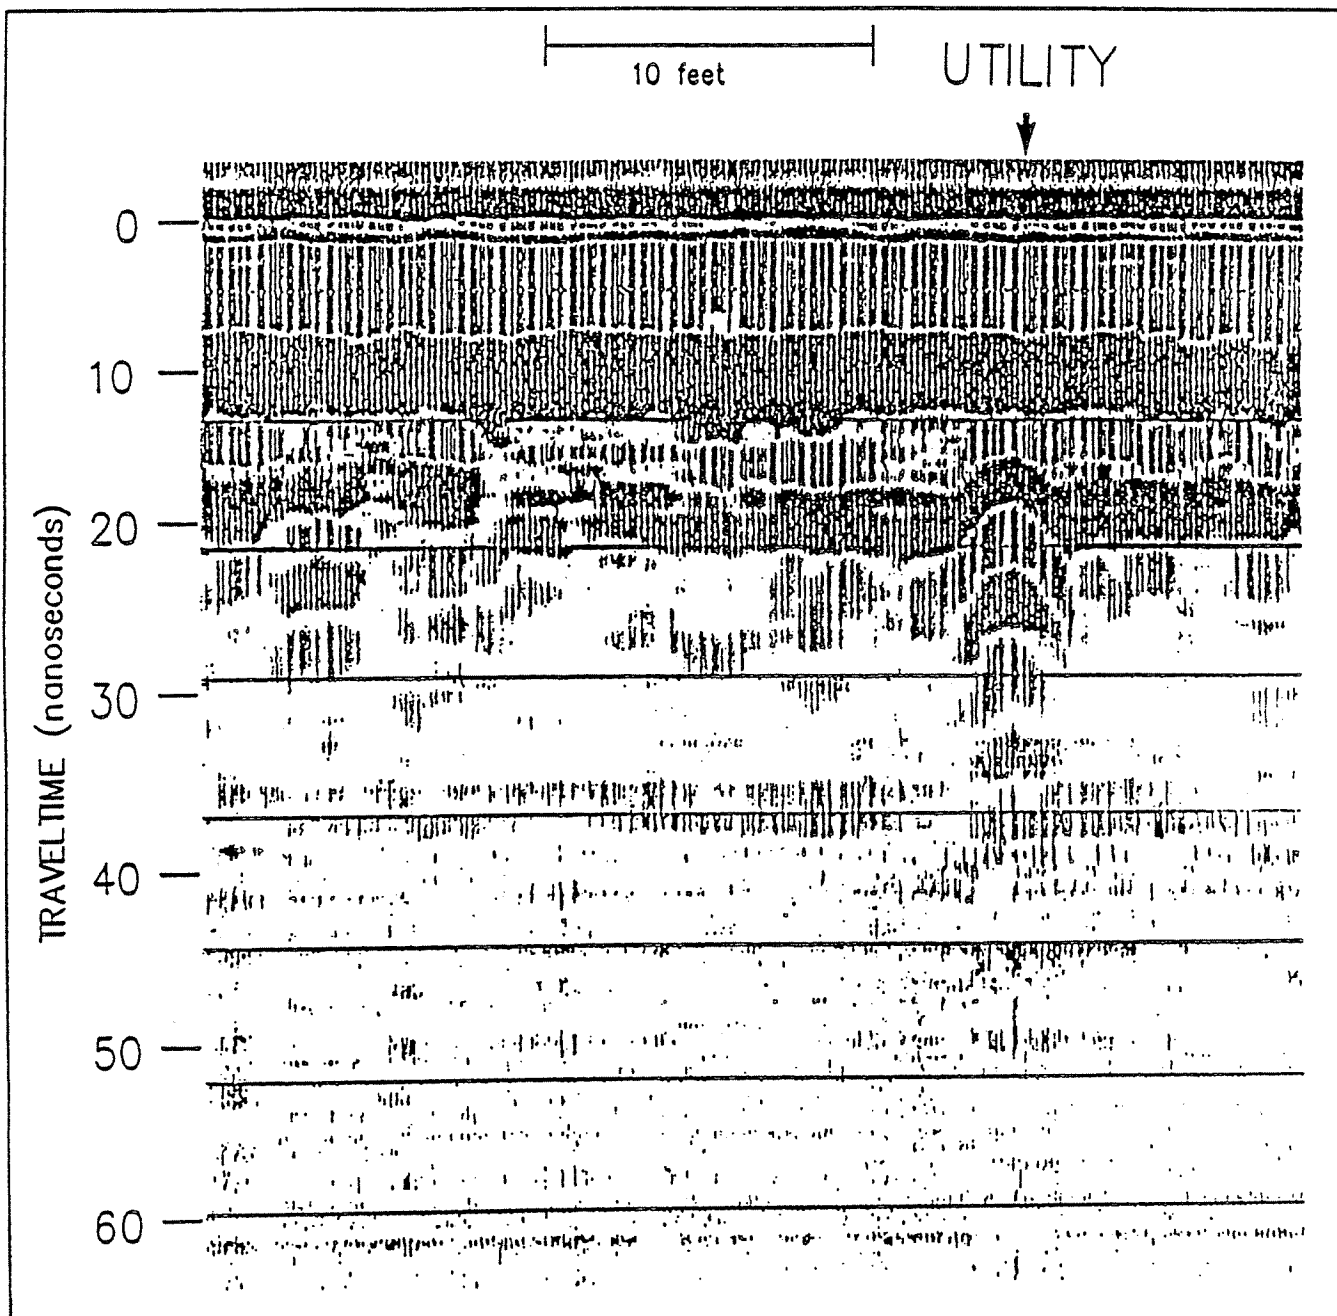
Figure C-2 GPR SIGNATURE CHARACTERISTIC OF BURIED UTILITIES. SHOWN IS LINE D 0+15 TO 0+35; 97TH STREET METHODIST CHURCH SITE, NIAGARA FALLS, NEW YORK.

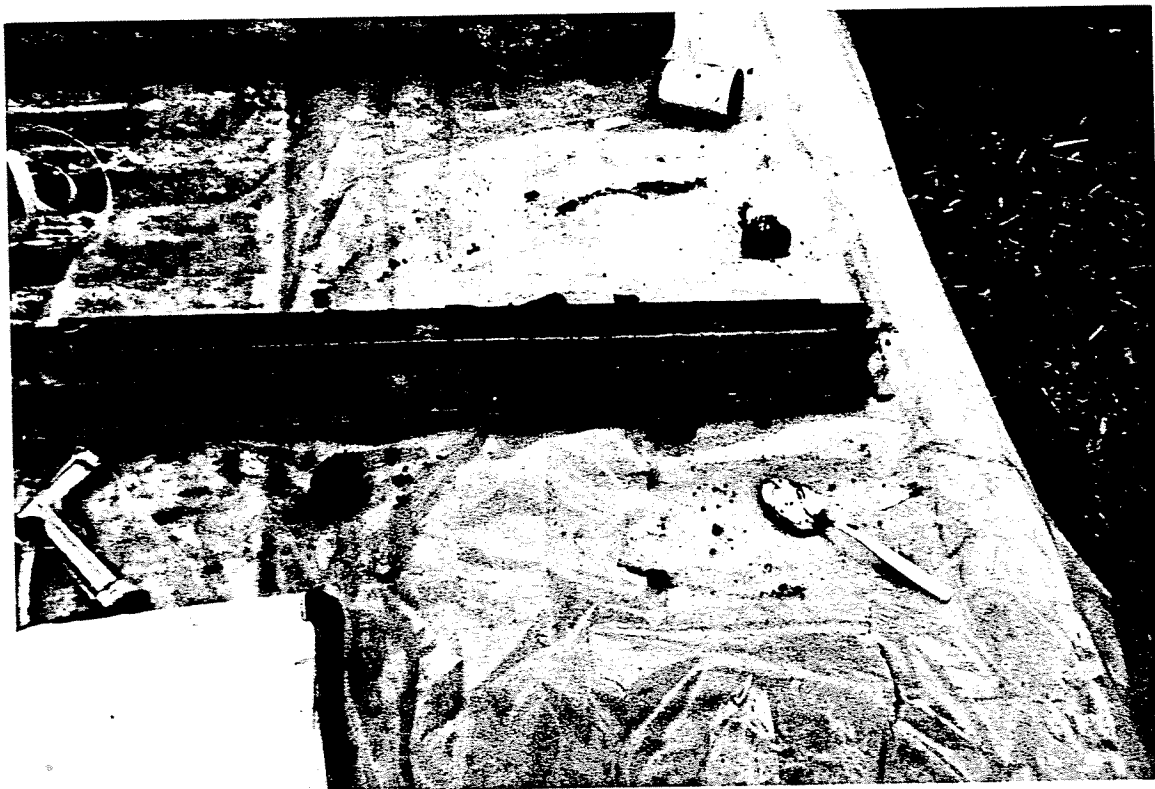
Photographer: G. Florentino Date/Time: 11/29/89 / 16:00
Lens: Type N/A SN: N/A Frame No.: 23, Roll No. 2
Comments: GW-3155 Split Spoon No.1 (0 - 2 feet).

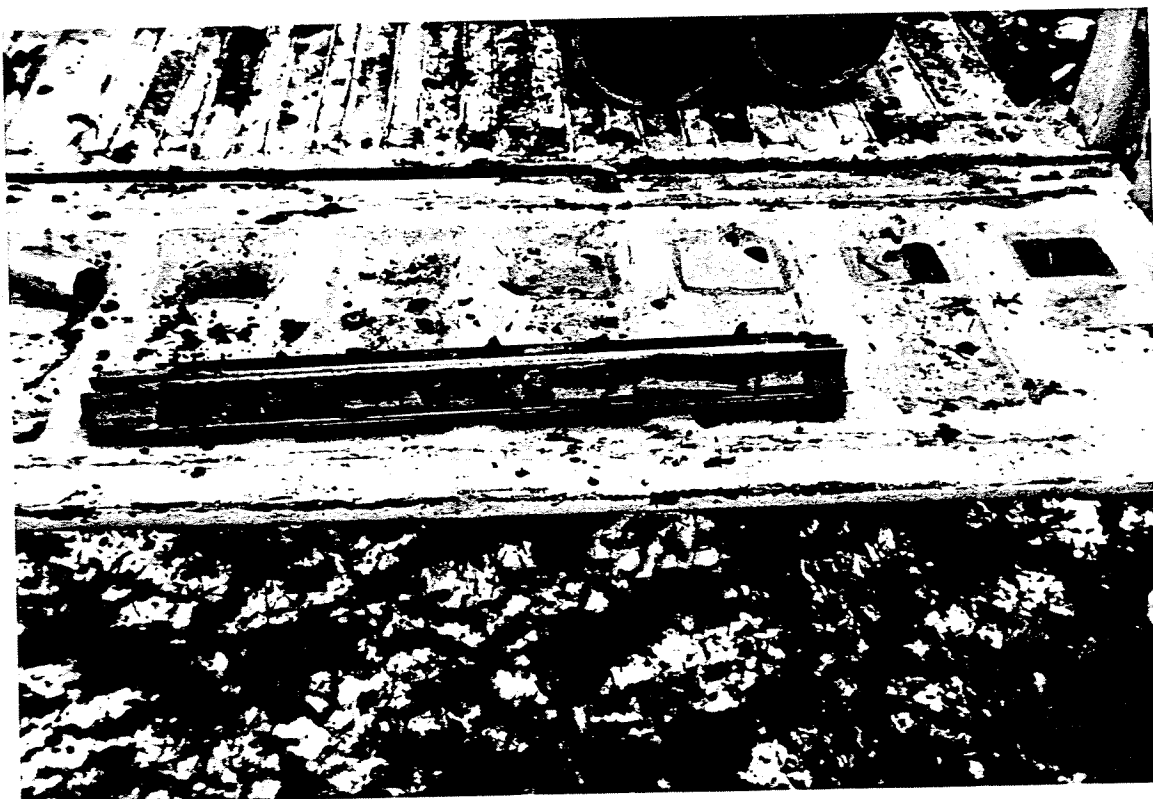
Photographer: G. Florentino Date/Time: 11/30/89 / 13:40
Lens: Type N/A SN: N/A Frame No.: 12, Roll No. 2
Comments: GW-3257 Split Spoon No. 3 (4 - 6 feet).

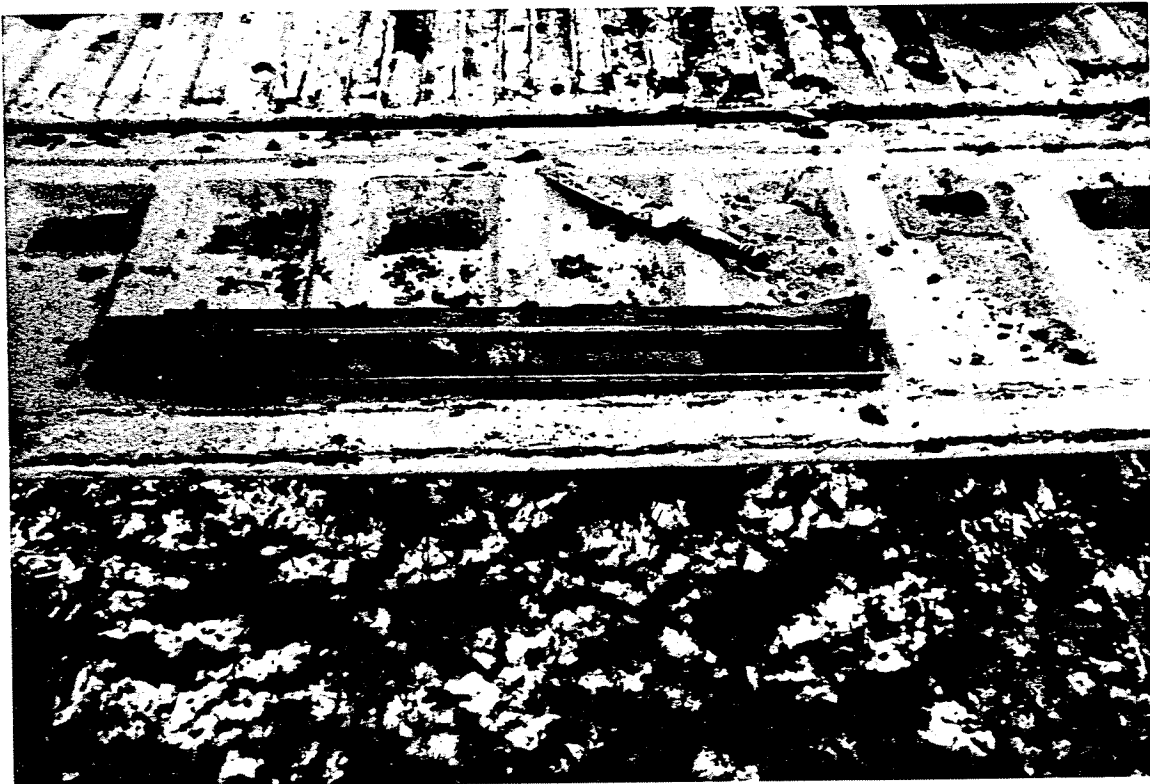
Comments: GW-3257 Split Spoon No. 5 (8 - 10 feet).

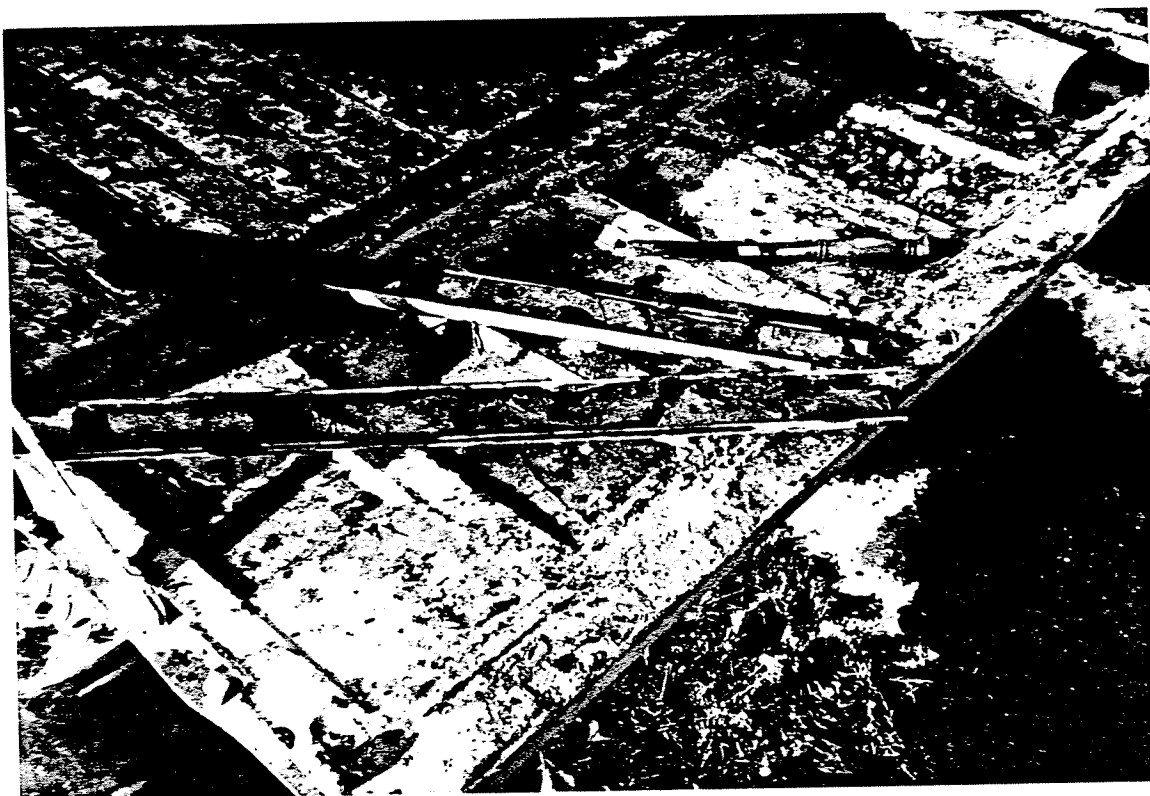
Client: NYSDEC E & E Job No.: YO-7000
Camera: Make Kodak Fling 35-mm Disposable SN: N/A
Photographer: G. Florentino Date/Time: 12/01/89 / 11:50
Lens: Type N/A SN: N/A Frame No.: 4, Roll No. 2
Comments: GW-3159 Split Spoon No. 2 (2 - 4 feet).

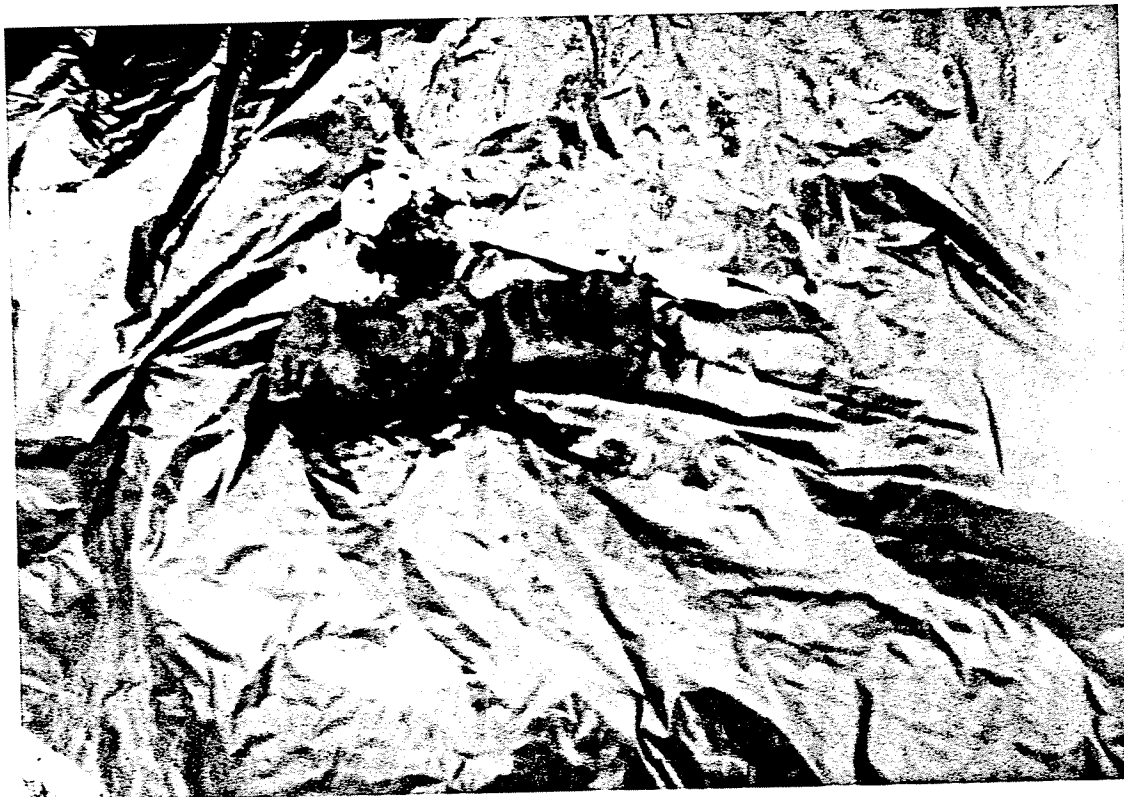
Comments: GW-3257 Split Spoon No. 7 (12 - 14 feet).

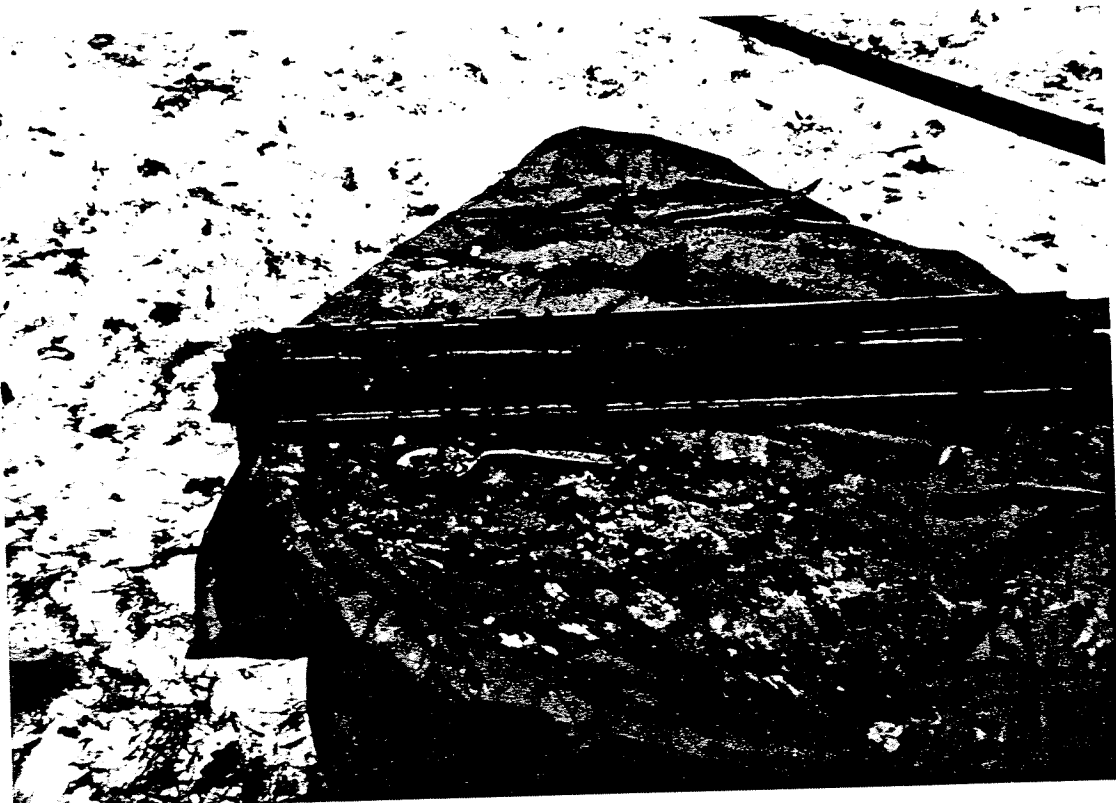
Photographer: G. Florentino Date/Time: 12/04/89 / 15:44
Lens: Type N/A SN: N/A Frame No.: 16, Roll No. 3
Comments: GW-3257 Split Spoon No. 12 (22 - 24 feet).

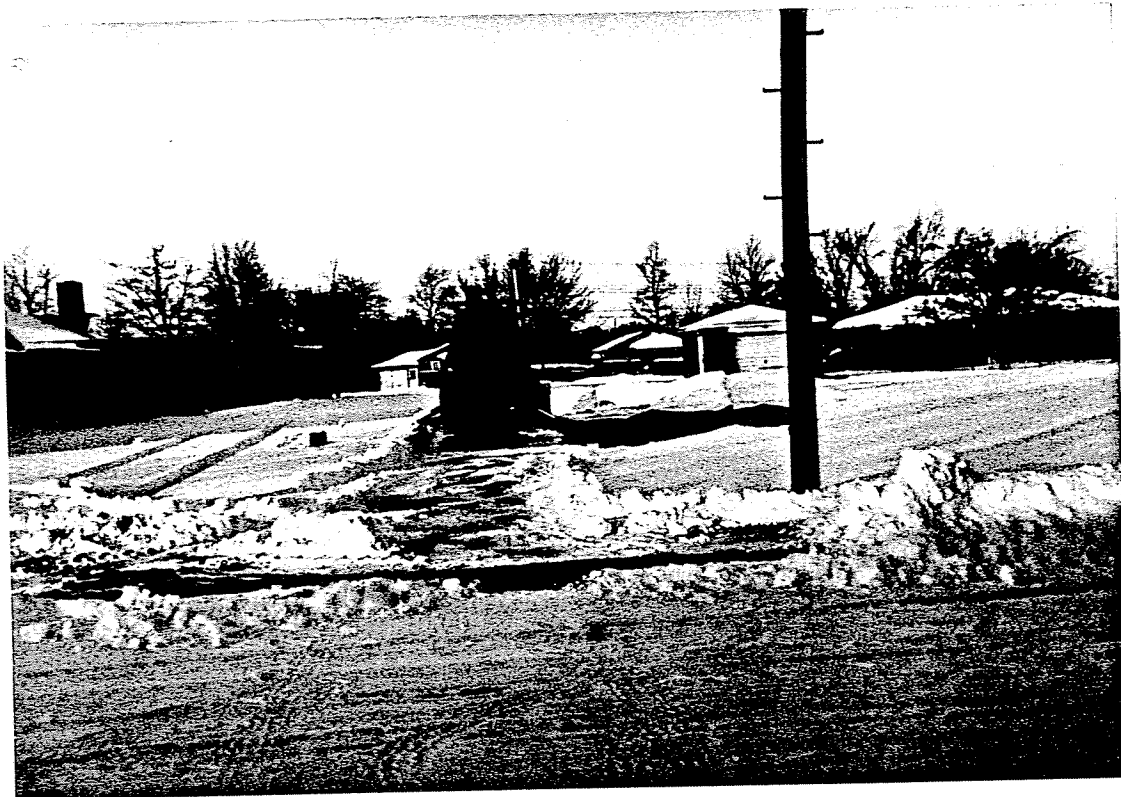
Comments: View to west of Test Pit No. 1 (blacktop area of parking lot).

A 4-inch clay pipe trending north-south was ruptured during the excavation of Test Pit No. 1, causing water to flow into the test pit. The pipe is believed to be part of the roof drainage system of the church building carrying runoff to the local storm sewer system due to the close proximity of a manhole in line with the pipe in the parking lot. Soil was backfilled over the pipe to stop the water flow. The pipe was repaired on August 1, 1990 by Green Environmental Specialists, Inc., under the supervision of E & E prior to repaving the test pits. All three test pits were repaved with blacktop cold-patch on the above mentioned date. Soil samples TP-1 and TP-2 were analyzed by E & E's ASC for TCL organics and inorganics. The concrete fragment sample TP-3 was only tested for mercury. In addition, a QA/QC sample consisting of one MS/MSD sample (TP-2MS/TP-2MSD) was analyzed for these parameters.
