# **ENGINEERING INVESTIGATIONS AT INACTIVE HAZARDOUS WASTE SITES IN THE STATE OF NEW YORK**

## **PRELIMINARY SITE ASSESSMENT**

**64th Street-North Site  
Site Number 932085A  
City of Niagara Falls, Niagara County**

**June 1991**

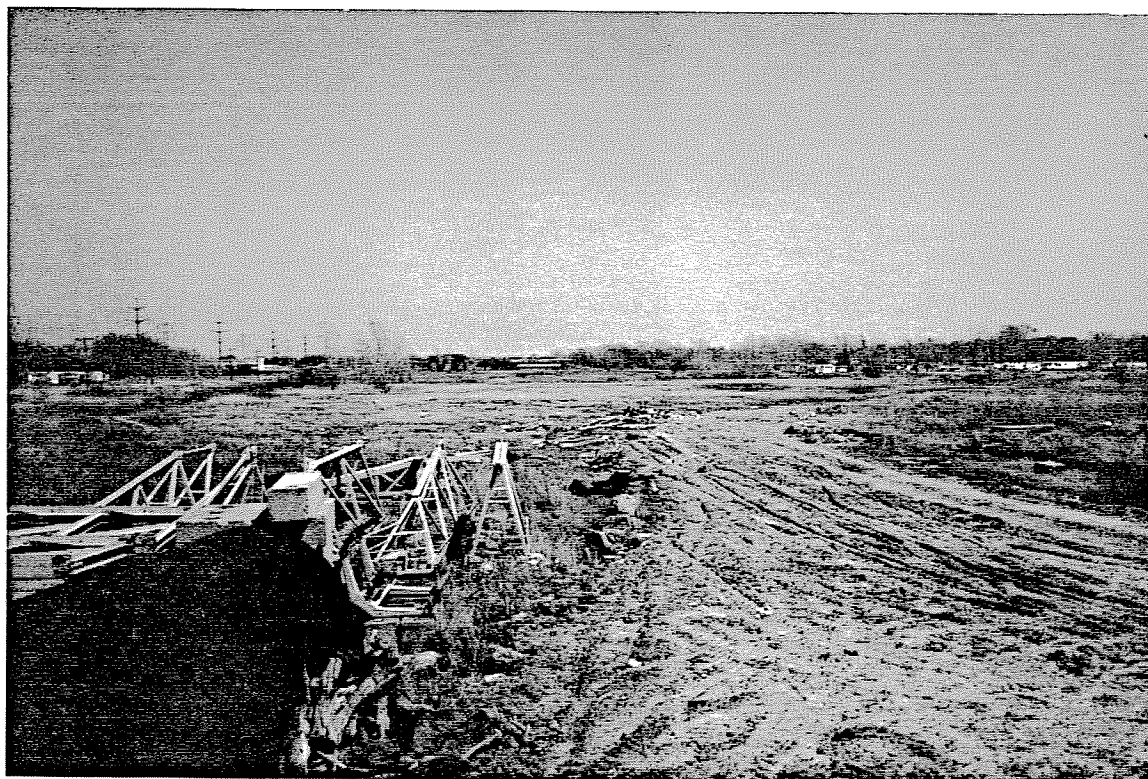
Client: NYSDEC	E & E Job No.: SB5320
Site: 64th Street-North Site	
Camera: Make Olympus Jr. (Infinity)	SN --
Lens Type --	SN --
Photographer: S. Lare Date: 4-30-91	
Time: 14:50 Frame No.: 2	
Comments*: Looking east from top of pile of earth/ gravel fill pile north of Walter S. Johnson building. Note powerline ROW, trailer homes, flat (alleged) dumping area.	
*Comments to include location.

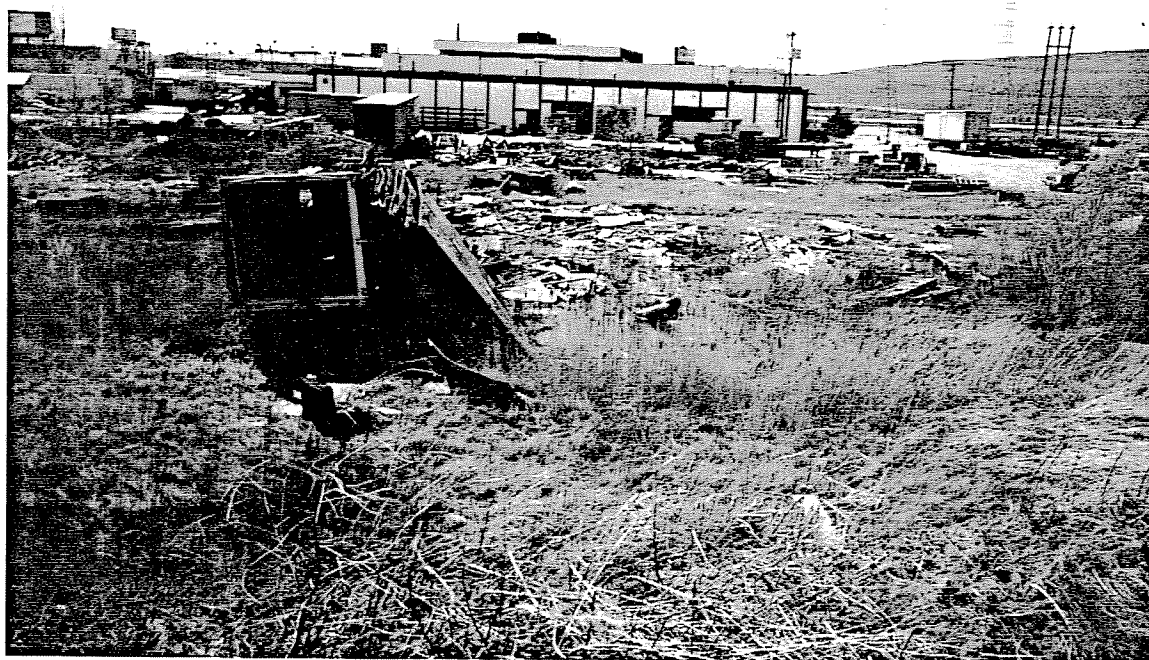
Comments\*: On Mooradian Drive looking north on east  
end of long multi-business building. This drainage swale  
runs from west to east around the back (north) of  
building, and turns south, apparently draining here to the  
sewer. Swale ends here.

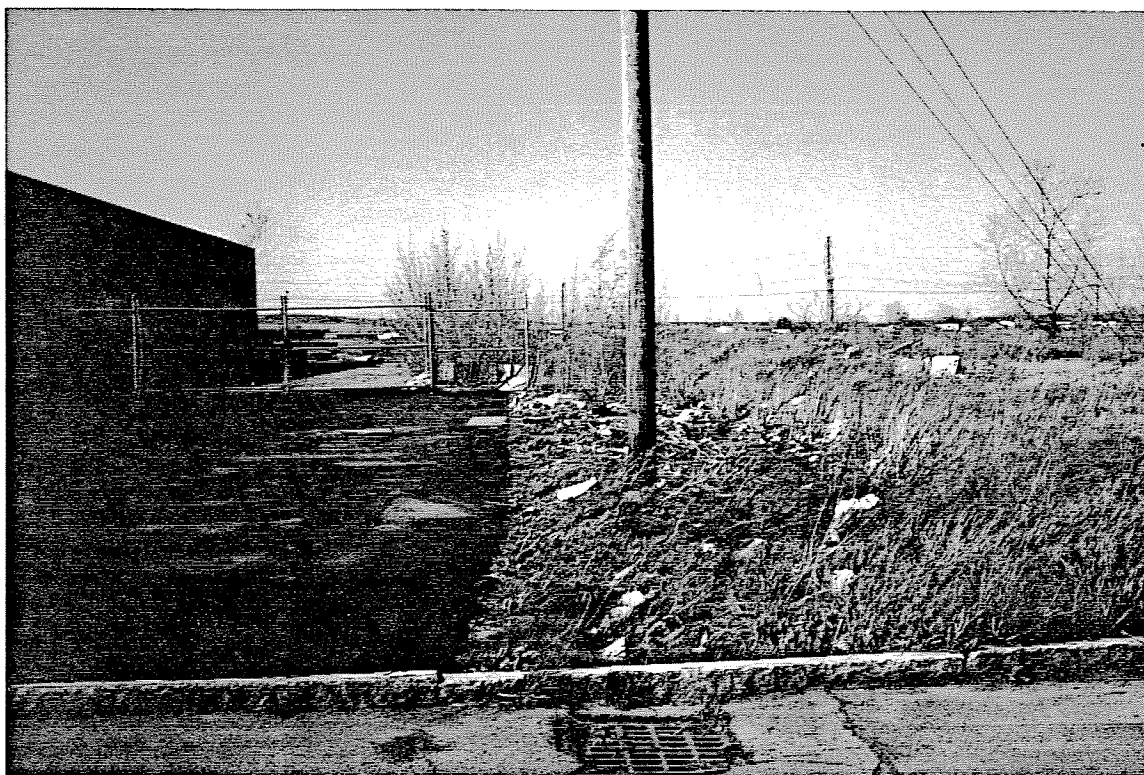
Comments\*: Standing at corner of Mooradian Drive  
and 70th Street, looking south at alleged disposal (swale-  
filled) area. No visible swale or wetlands, all grass with  
few trees.

The suspected filled-in swale area in the portion east of Interstate I-190 between Mooradian Drive and Niagara Falls Boulevard bounded by 66th and 70th streets, was observed as a grassy, lawn-like area supporting a few trees. No wetlands vegetation or any sign of a drainage swale was observed (see Figure 1-3).

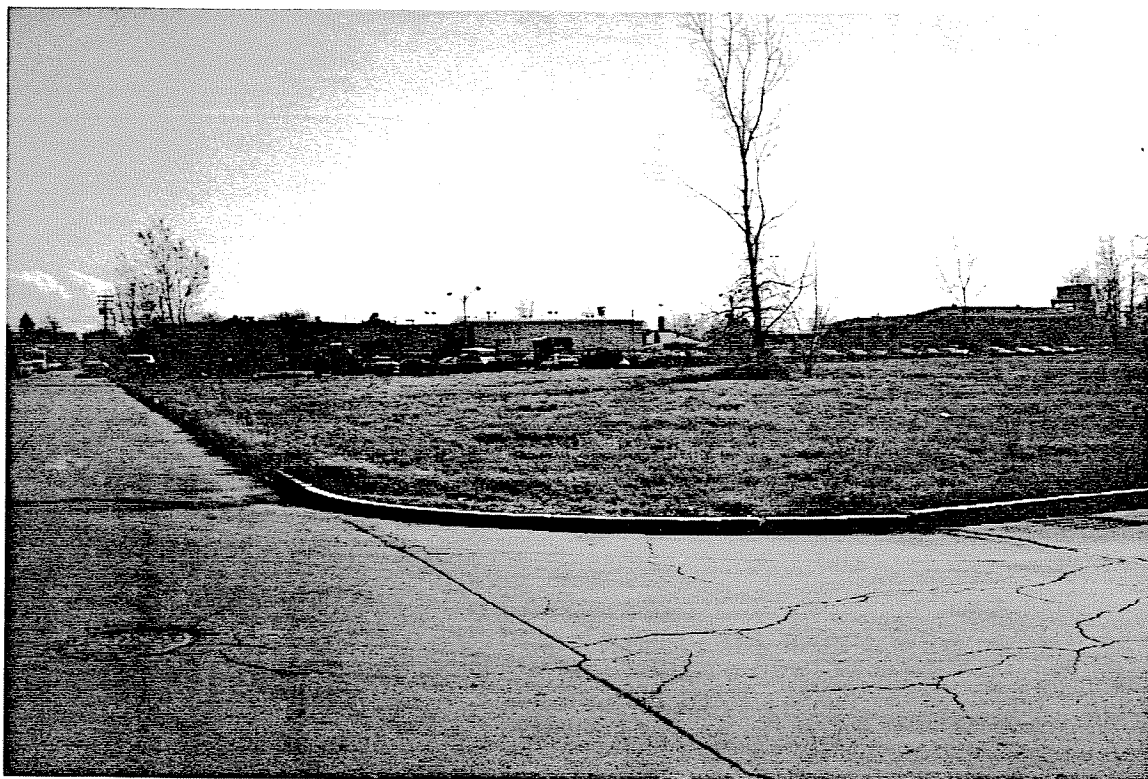
Comments\*: Standing at corner of Mooradian Drive  
and 70th Street, looking southwest at alleged disposal  
(swale-fill) area, (western portion of land from previous  
frame). No visible swale or wetlands.

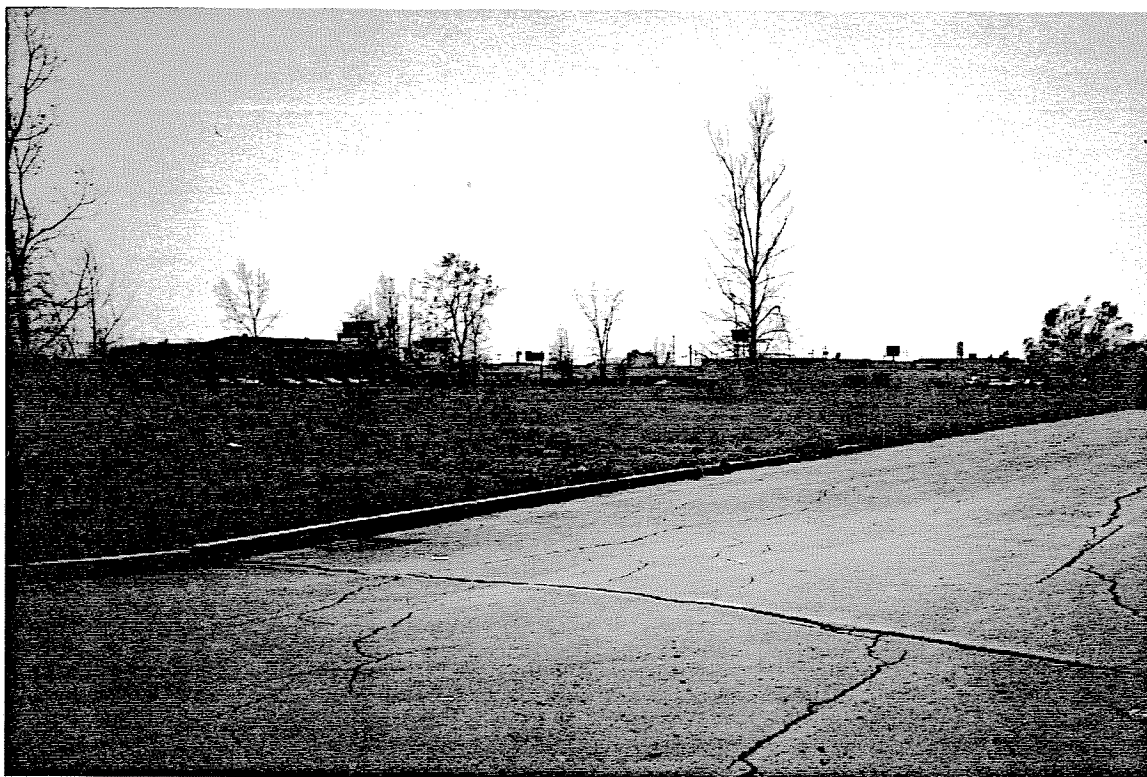
Comments\*: Standing on 70th Street (near corner of  
Mooradian Drive and 70th Street) looking southeast at  
wetlands area and monitoring well. This is a section of  
the land on which Tops Markets wants to build.

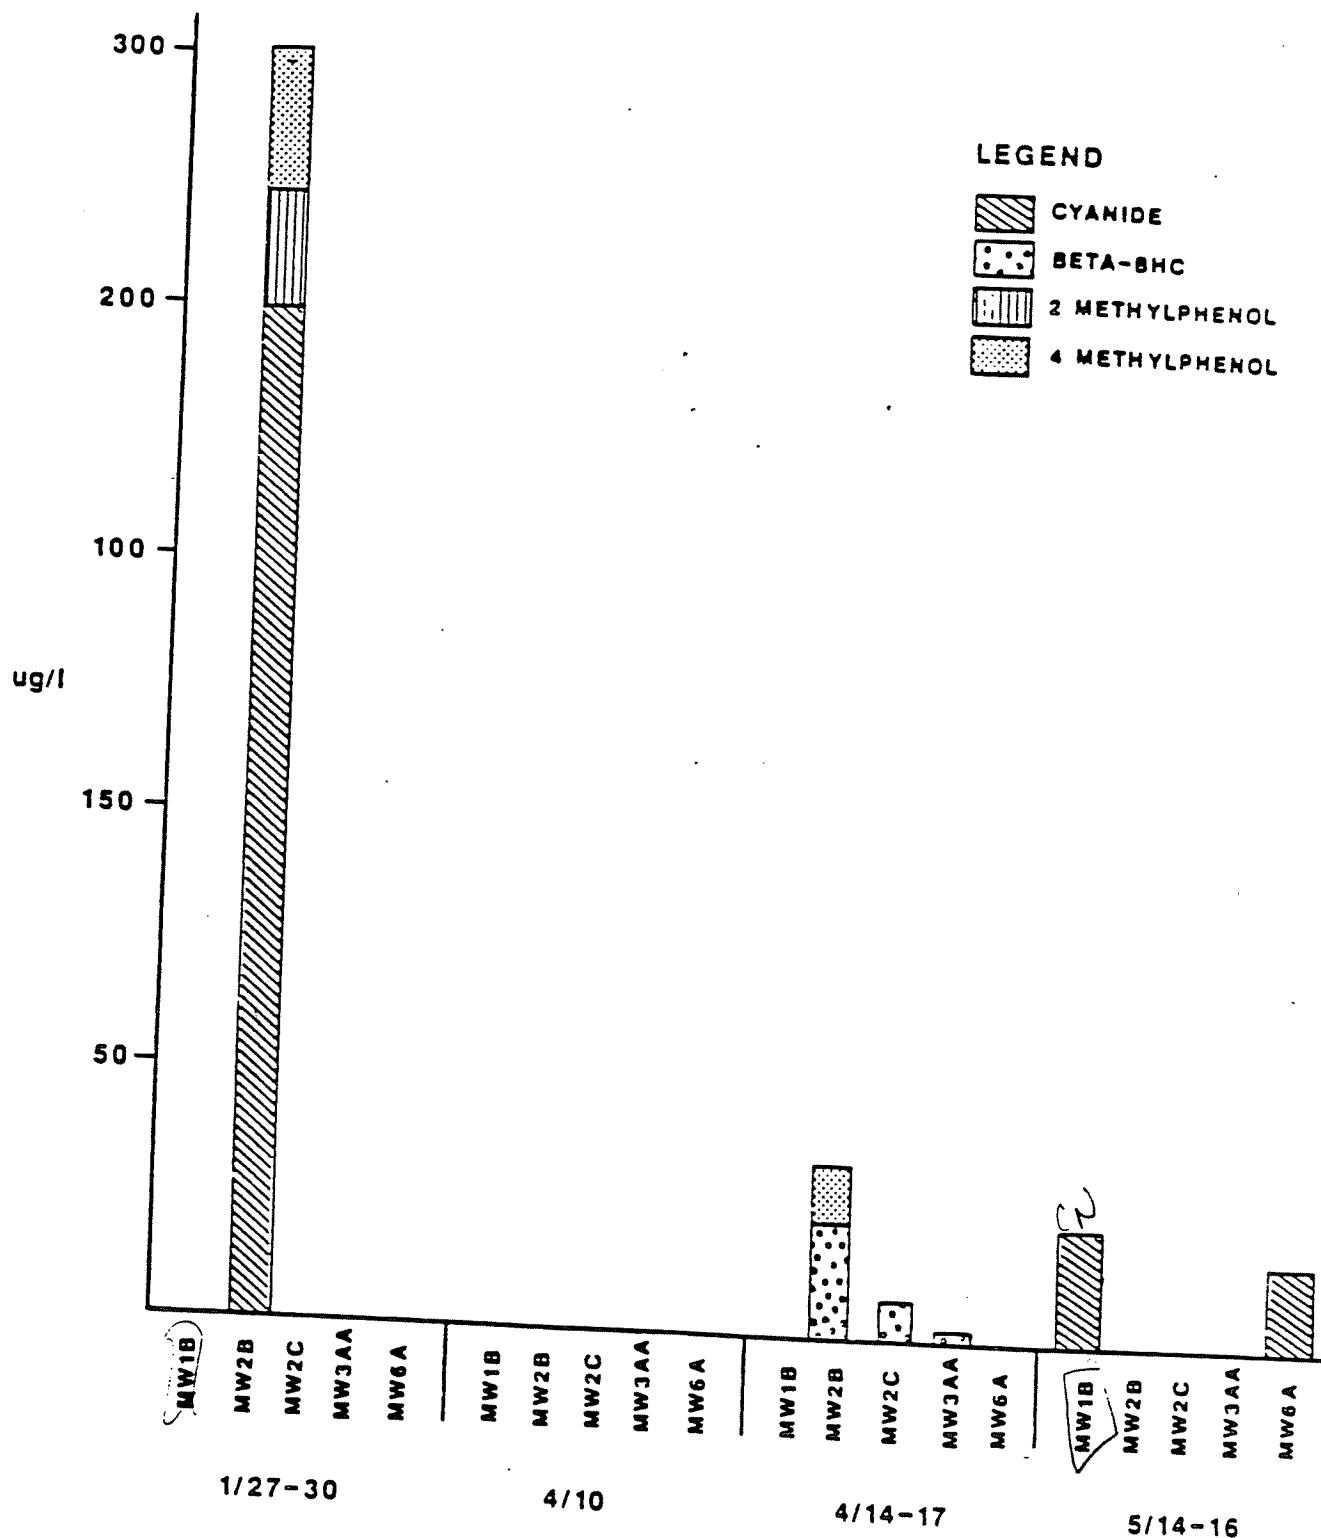
FIGURE 1-5

**VARIATIONS OF SEMI-VOLATILES, PESTICIDES  
AND CYANIDE PER SAMPLING EVENT**  
LaSALLE AREA GROUNDWATER MONITORING PROGRAM  
NIAGARA FALLS, N.Y.

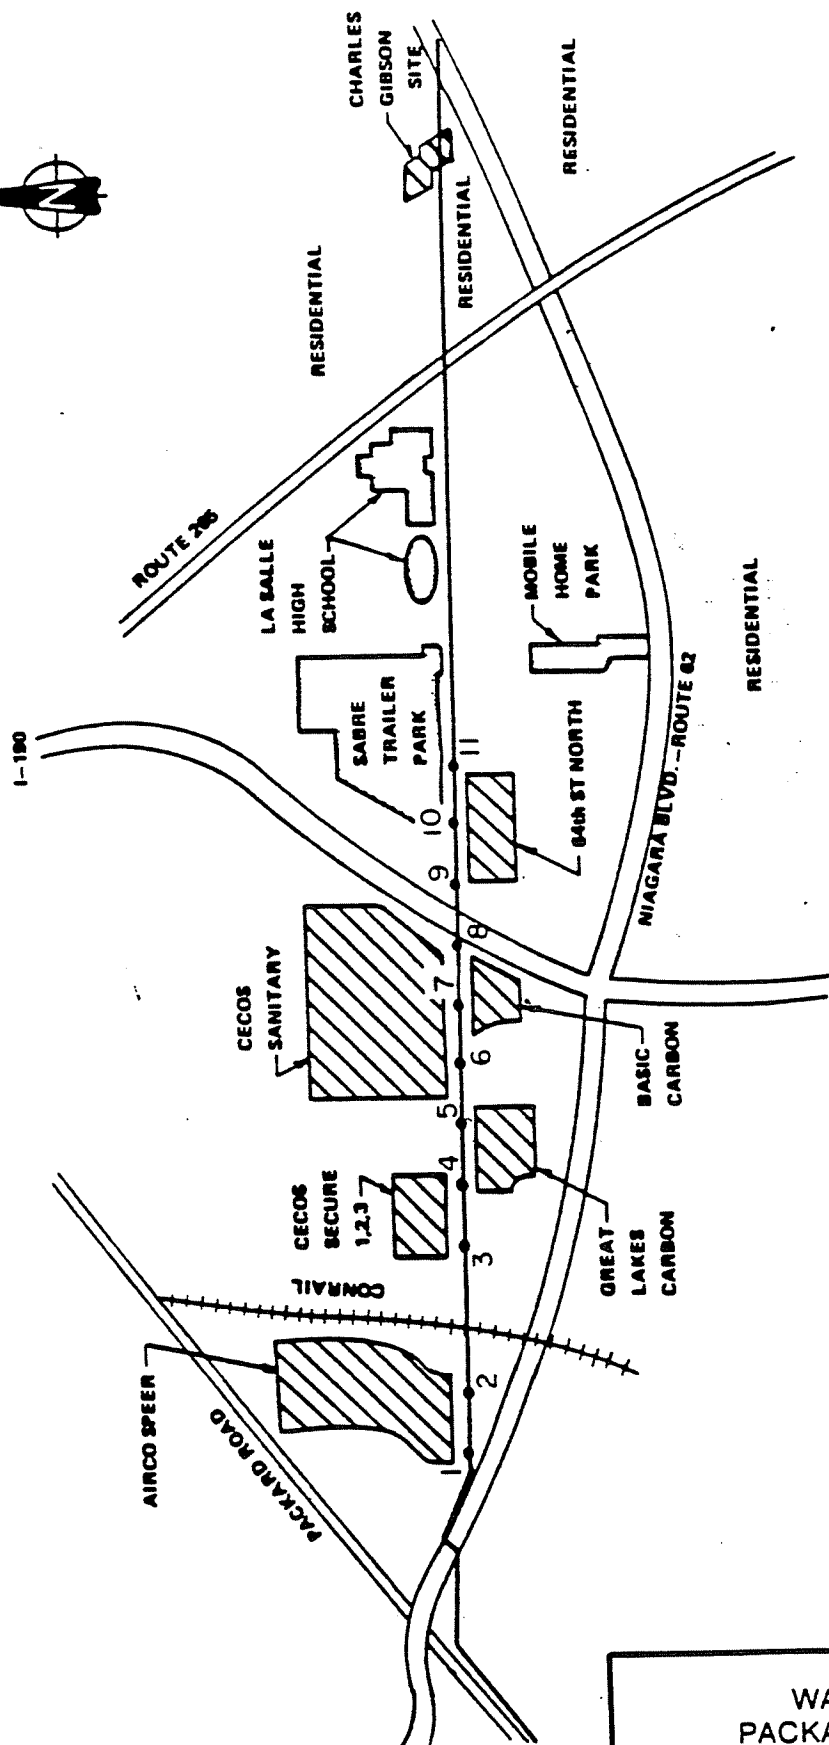
WASTE DISPOSAL SITES  
PACKARD ROAD TO ROUTE 265  
NIACHLOR BRINE PIPELINE ROUTE  
SOIL SAMPLING PROGRAM
