ENGINEERING INVESTIGATIONS AT INACTIVE HAZARDOUS WASTE SITES IN THE STATE OF NEW YORK

PRELIMINARY SITE ASSESSMENT TASK 1

**64th Street-North Site
Site Number 932085A
City of Niagara Falls, Niagara County**

February 1992

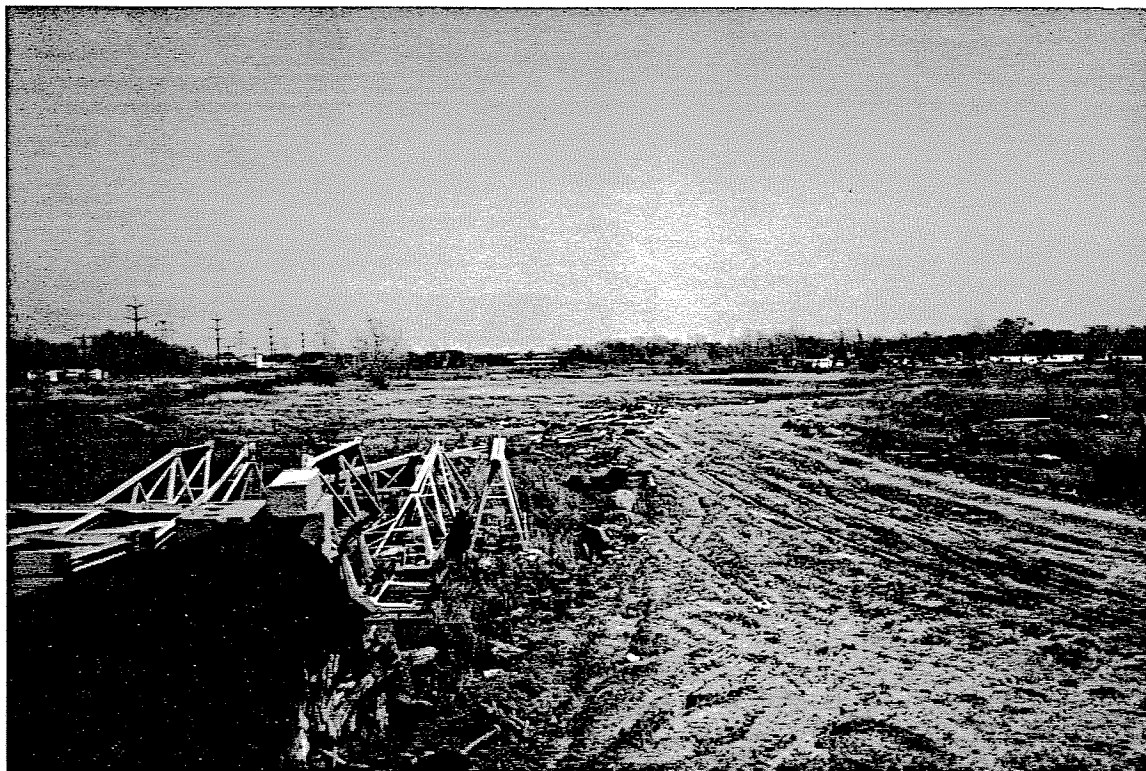
Comments*: Looking west from top of earth/fill pile
behind Walter S. Johnson building. Equipment, scrap
wood, metal, etc. in standing water assumed to belong to
Johnson Construction. CECOS Landfill is visible at the
right.

The area north of Mooradian Drive, the Walter S. Johnson Construction Company property, was observed to be a storage area for numerous materials associated with construction operations. A rocky, crushed brick and stone fill was present on the driveway. The driveway leads through areas of heavy construction equipment; outside storage of ladders, pipes, and wooden platforms; large and small brick, stone, asphalt, and dirt fill piles; scattered old liquid storage tanks; empty oil drums; a flammable liquid and paint storage area; a small area of ponded water containing scrap wood, metal and other debris; and gasoline pumps (see Figure 1-3).

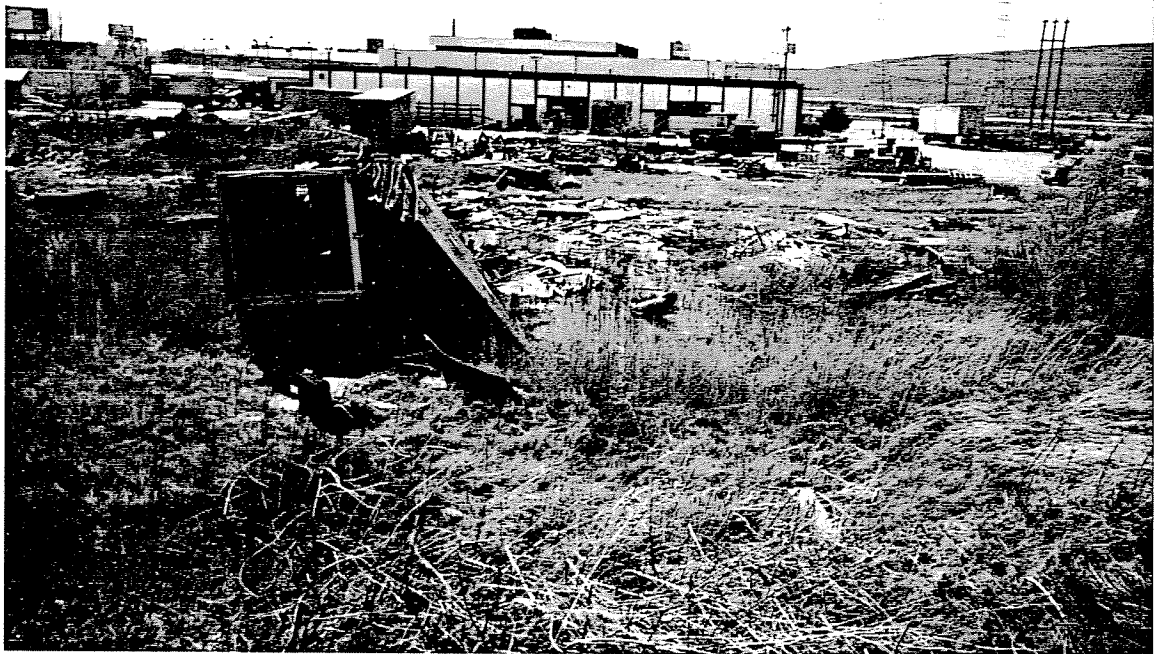
| ecology and environment engineering, p.c. PHOTOGRAPHIC RECORD | |
|--|--|
| | sewer. Swale ends here. |

A depressed drainageway with stone-fill banks runs parallel and adjacent to the Walter S. Johnson Construction building, leading from the north side of the building around the east side, apparently terminating at the Mooradian Drive sewer line. Manholes noted

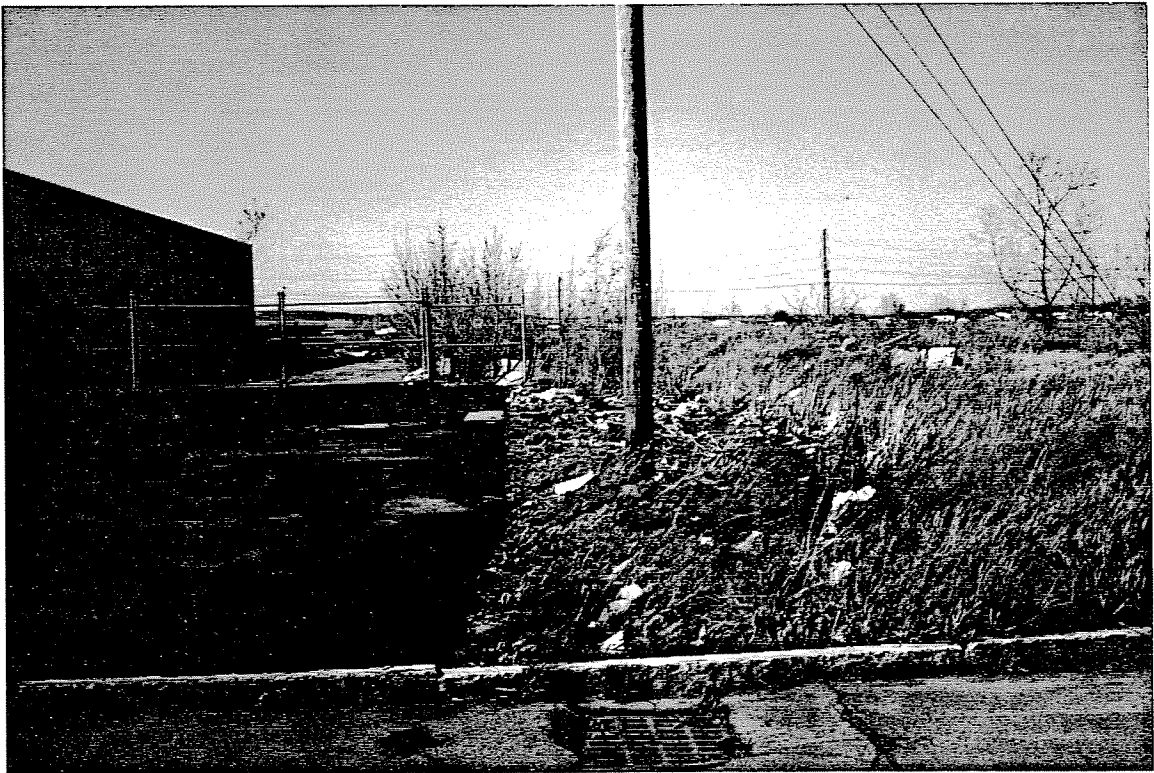
| ecology and environment engineering, p.c. PHOTOGRAPHIC RECORD | |
|--|--|
| | few trees. |

The suspected filled-in swale area in the portion east of Interstate I-190 between Mooradian Drive and Niagara Falls Boulevard bounded by 66th and 70th streets, was observed as a grassy, lawn-like area supporting a few trees. No wetlands vegetation or any sign of a drainage swale was observed (see Figure 1-3).

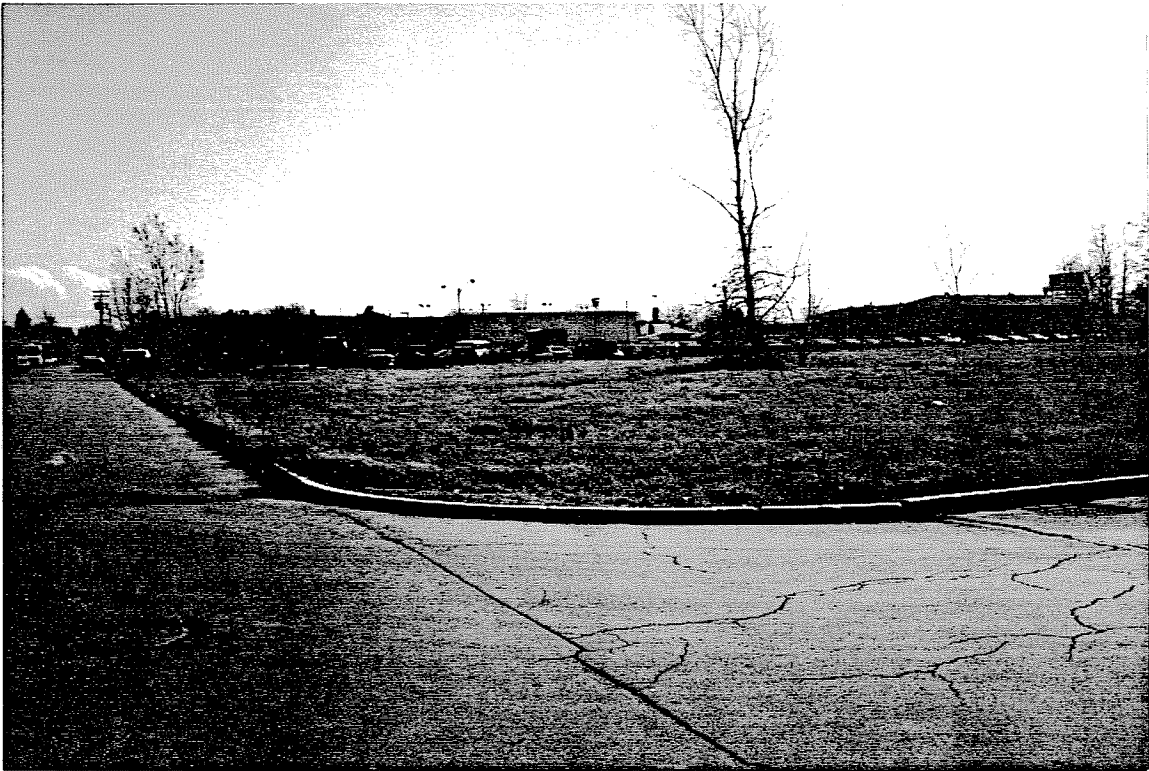
Comments*: Standing at corner of Mooradian Drive
and 70th Street, looking southwest at alleged disposal
(swale-fill) area, (western portion of land from previous
frame). No visible swale or wetlands.

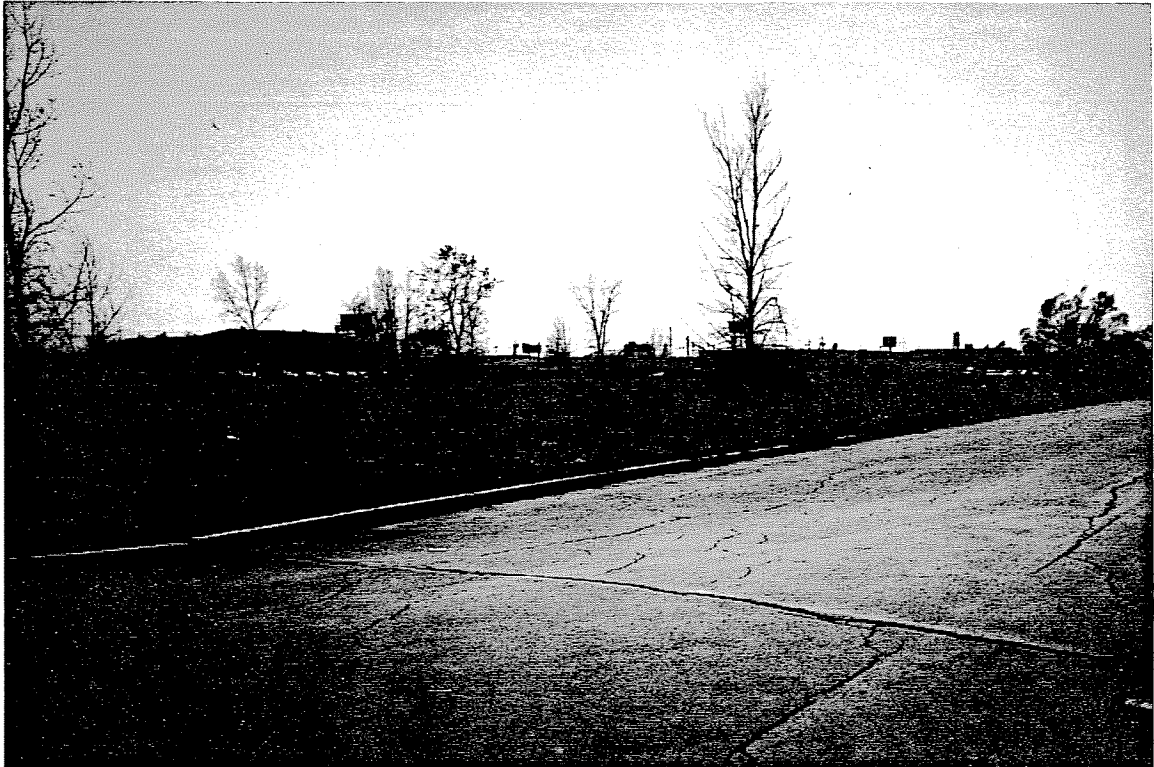
Comments*: Standing on 70th Street (near corner of Mooradian Drive and 70th Street) looking southeast at wetlands area and monitoring well. This is a section of the land on which Tops Markets wants to build.

New York State-registered wetland TW-1 (a Class II wetlands) exists on site and extends eastward as observed during the April 30, 1991 E & E site inspection. Wetlands grasses, reeds, rushes, cattails, and ducks were observed. Various windblown refuse and illegal dumping were also observed in and around the wetlands area. New York State-registered wetland TW-3 (a Class II wetlands) was also identified approximately 1 mile to
