ENGINEERING INVESTIGATIONS AT INACTIVE HAZARDOUS WASTE SITES IN THE STATE OF NEW YORK

PRELIMINARY SITE ASSESSMENT TASK1

**Niagara Frontier Transportation Authority Site
Site Number 932090
Town of Wheatfield, Niagara County**

September 1991

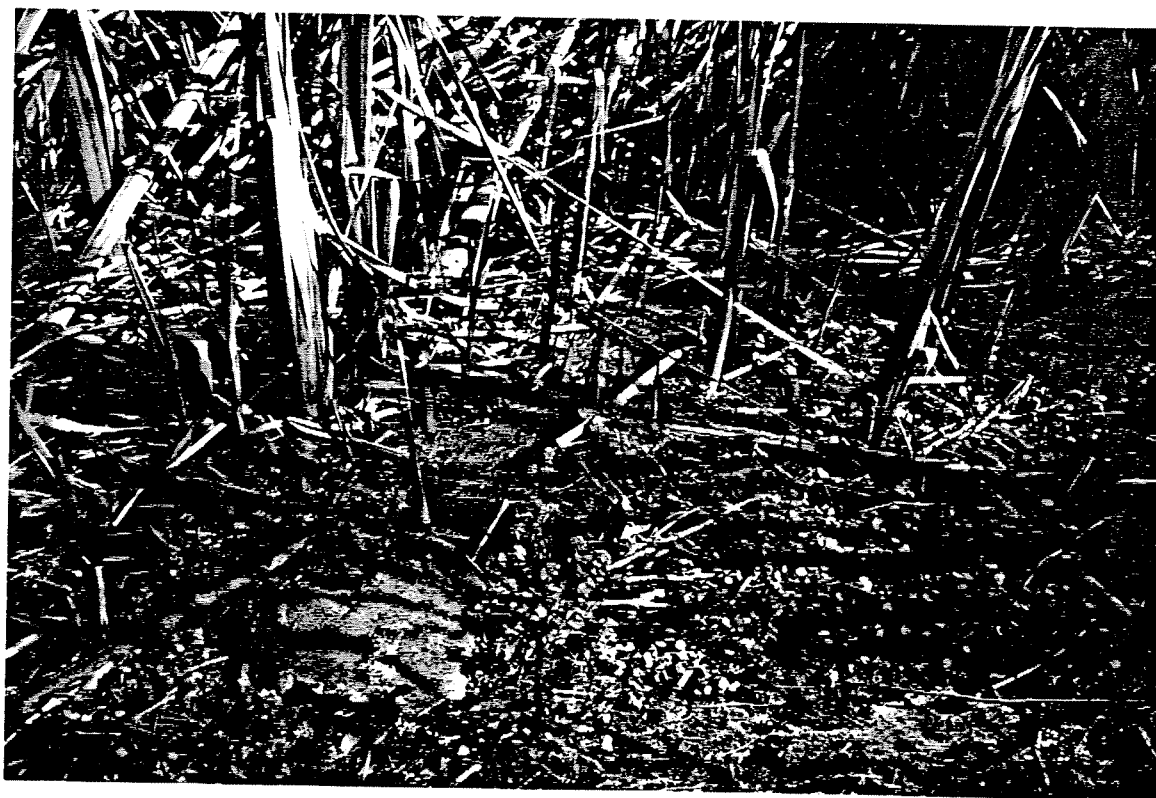
ecology and environment engineering, p.c.
PHOTOGRAPHIC RECORD

Client: NYSDEC	E & E Job No.: SB5340
Site: NFTA	
Camera: Make Olympus Infinity Jr.	SN
Lens Type	SN
	Photographer: S. Lare Date: 5-1-91
	Time: 9:30 Frame No.: 9
	Comments*: Standing on south side of pond,
	looking north, at third discharge pipe east
	(counting from west side of pond). Rusty liquid
	leading to the pond, but no visible trickle or
	flow. No HNu readings above background levels. This
	pipe is blocked off and non-flowing, according to
	G. McGee, Carborundum plant engineer.
*Comments to include location.

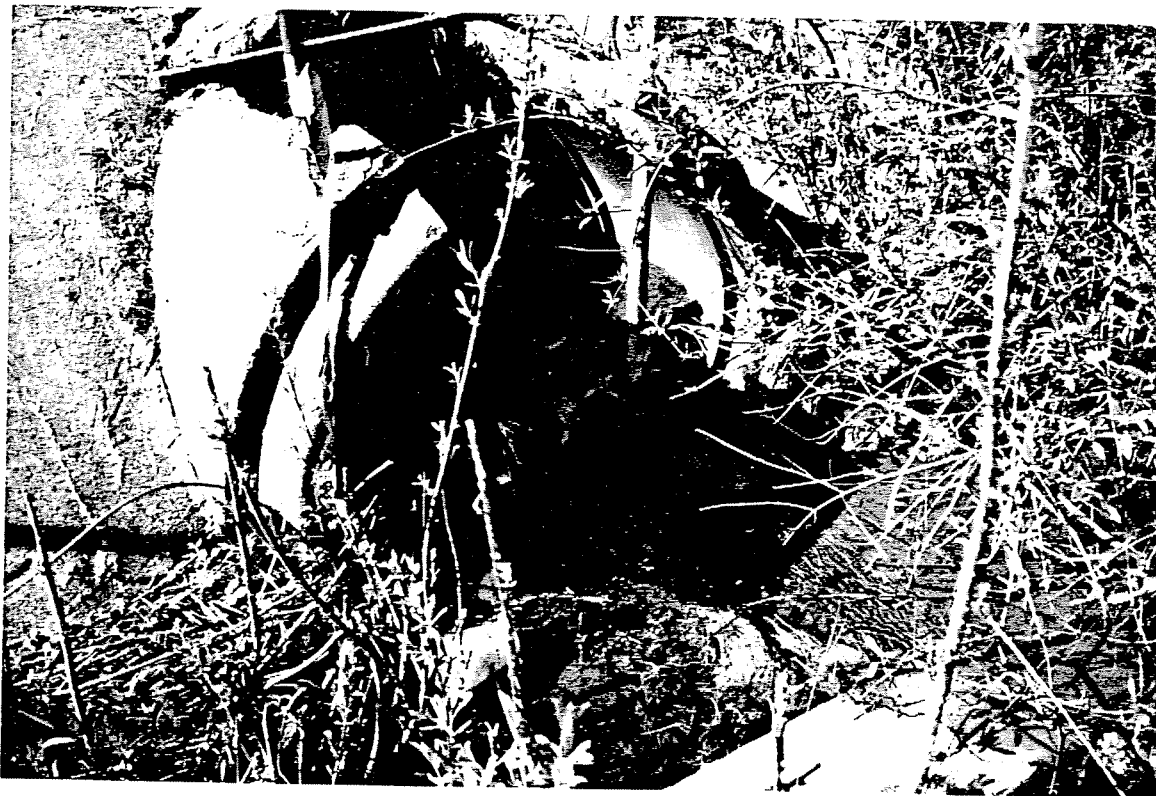
Comments*: Infall C, pipe approximately 3 feet
in diameter. Strong flow of warm water with a
strong chlorine smell. Warm air was emanating from
this discharge pipe. HNu read 4,000-5,000 ppm above
background level. Note bleached vegetation/grass
under discharge.

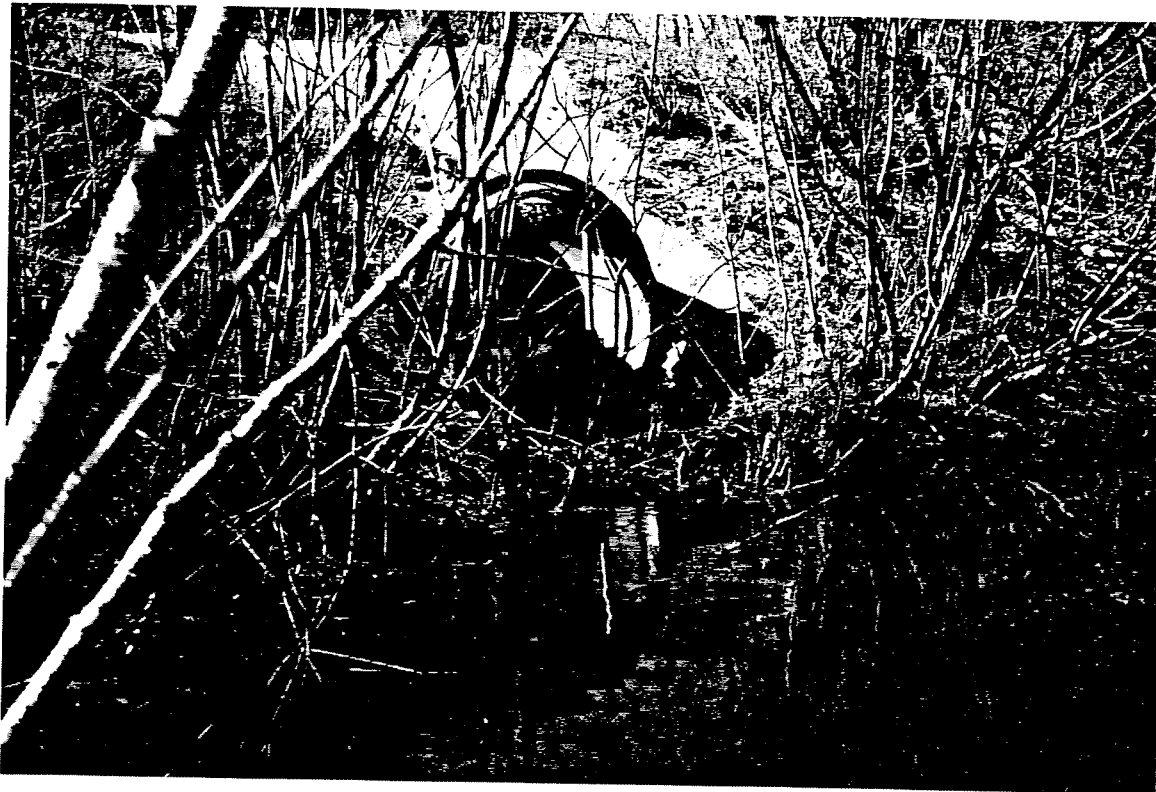
flow through v-notch weir.

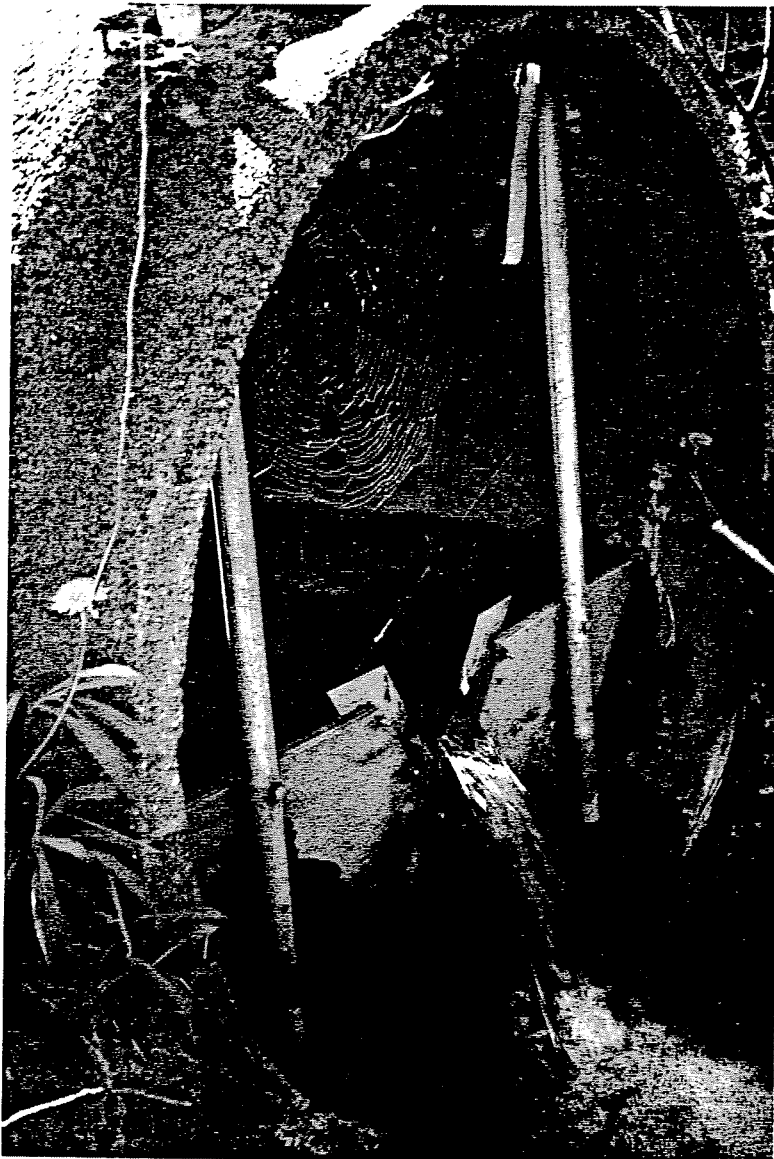
Comments*: Infall/discharge pipe E, at south-
east "corner" of pond. Strong flow through
v-notch weir. No HNu reading above background level.

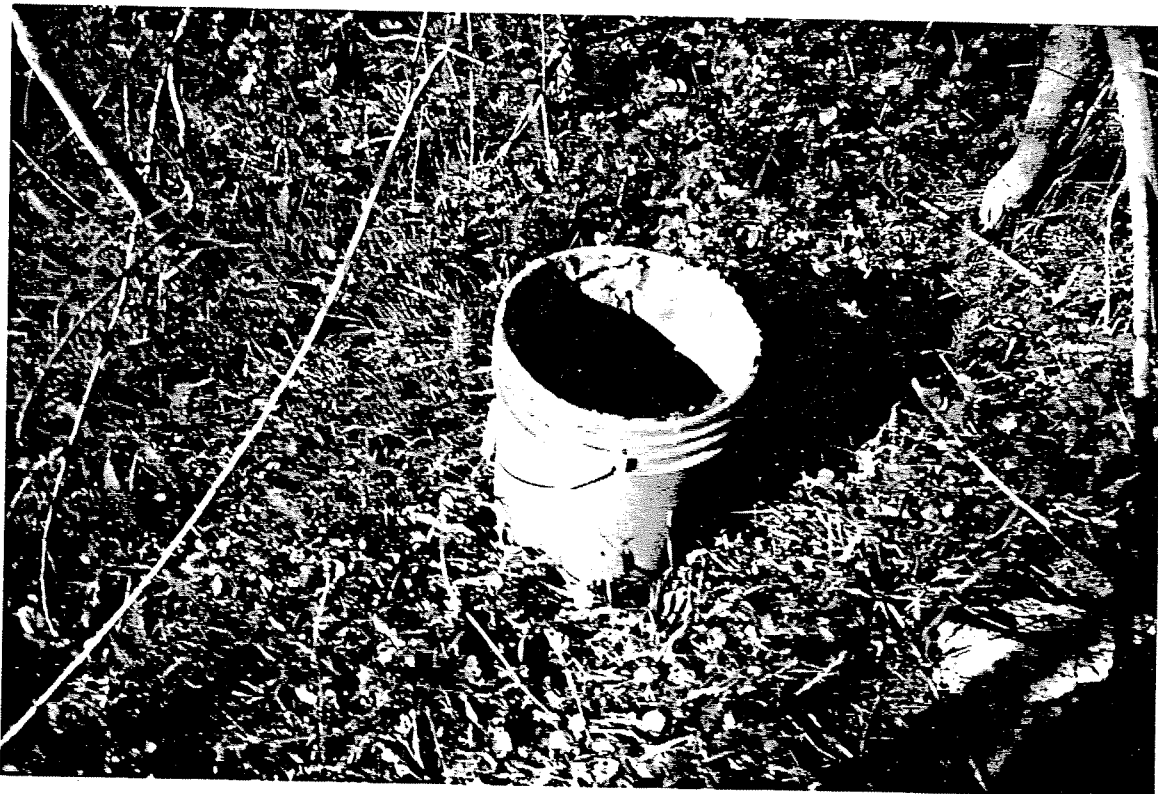
Comments*: Bucket found near east bank of
pond, behind (west of) shed. Inside: brown,
hardened resin-type material with little chunks
in it.

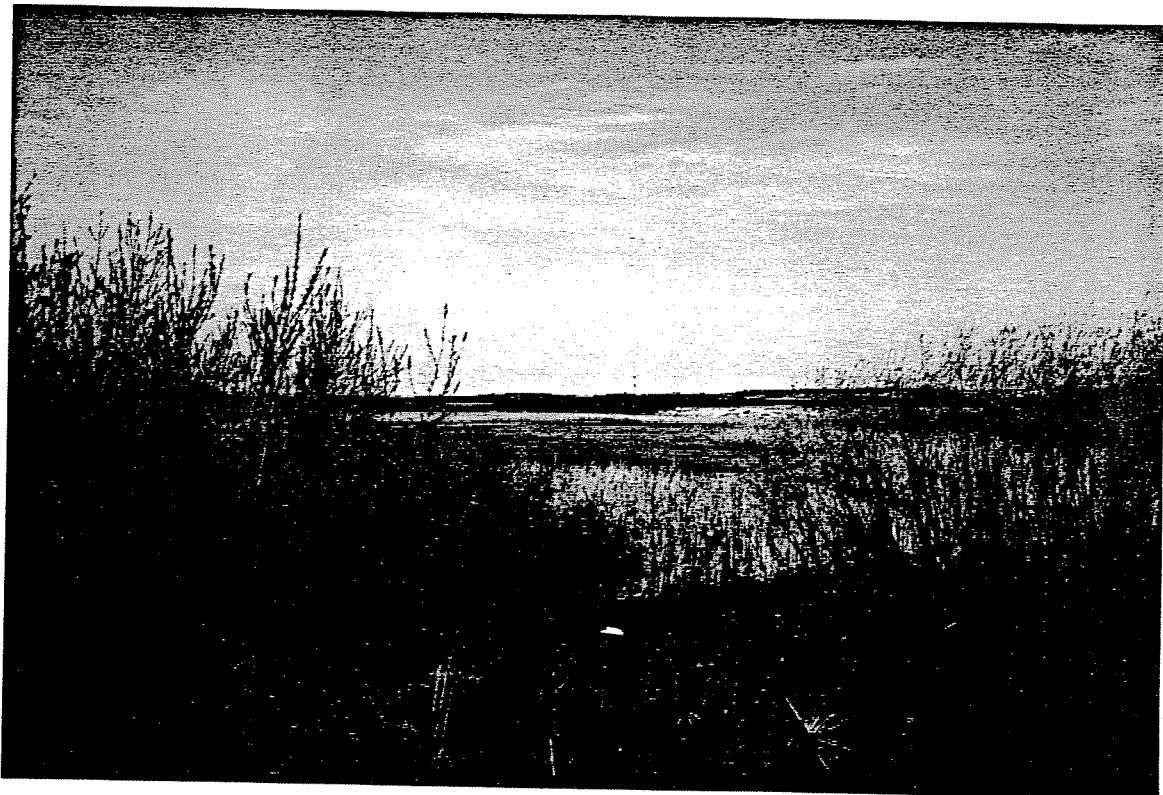
Comments*: Standing on east side of pond,
looking west. Shows pond, and concrete slab-
filled area (right of center) on north side of
pond.

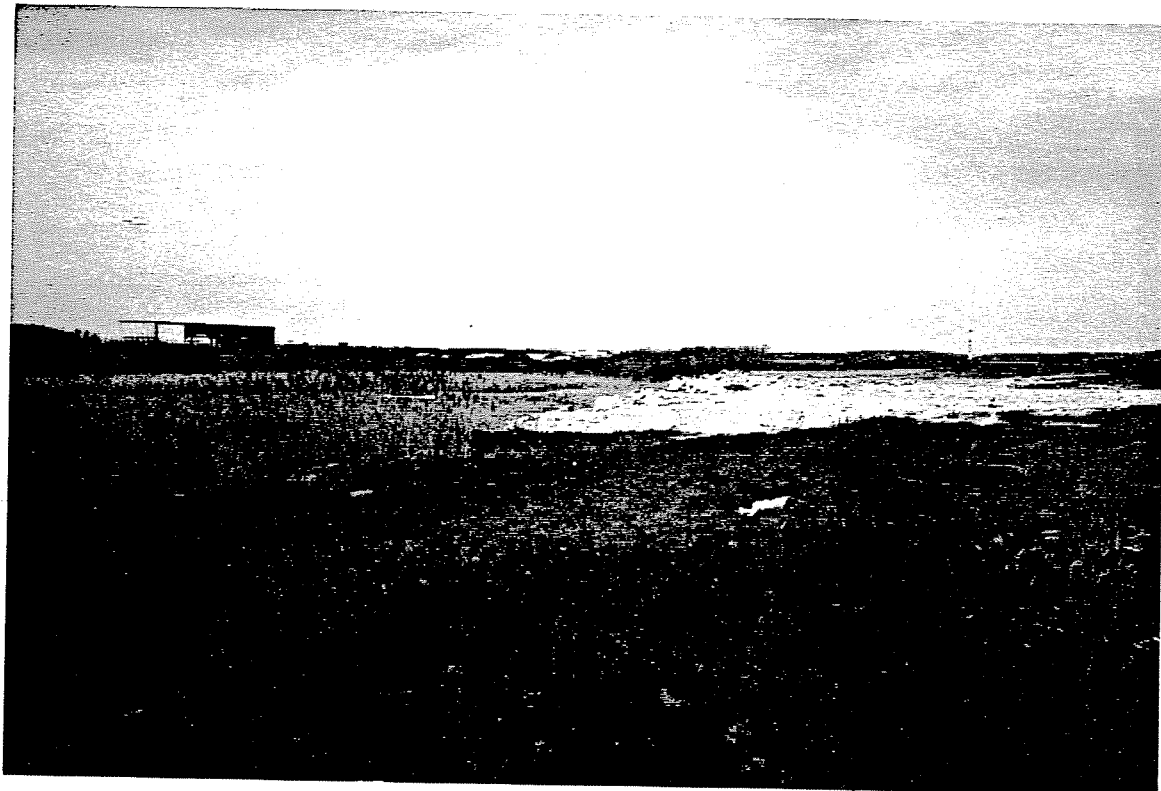
Comments*: Standing at northeast "corner" of
pond, looking west, at north bank of pond (filled
with concrete slabs and gravel).
