PERIODIC REVIEW REPORT 2018

SOLVENT CHEMICAL SITE NIAGARA FALLS, NEW YORK SITE # 9-32-096

TRC Environmental Corporation
Wannalancit Mills
650 Suffolk Street
Lowell, Massachusetts

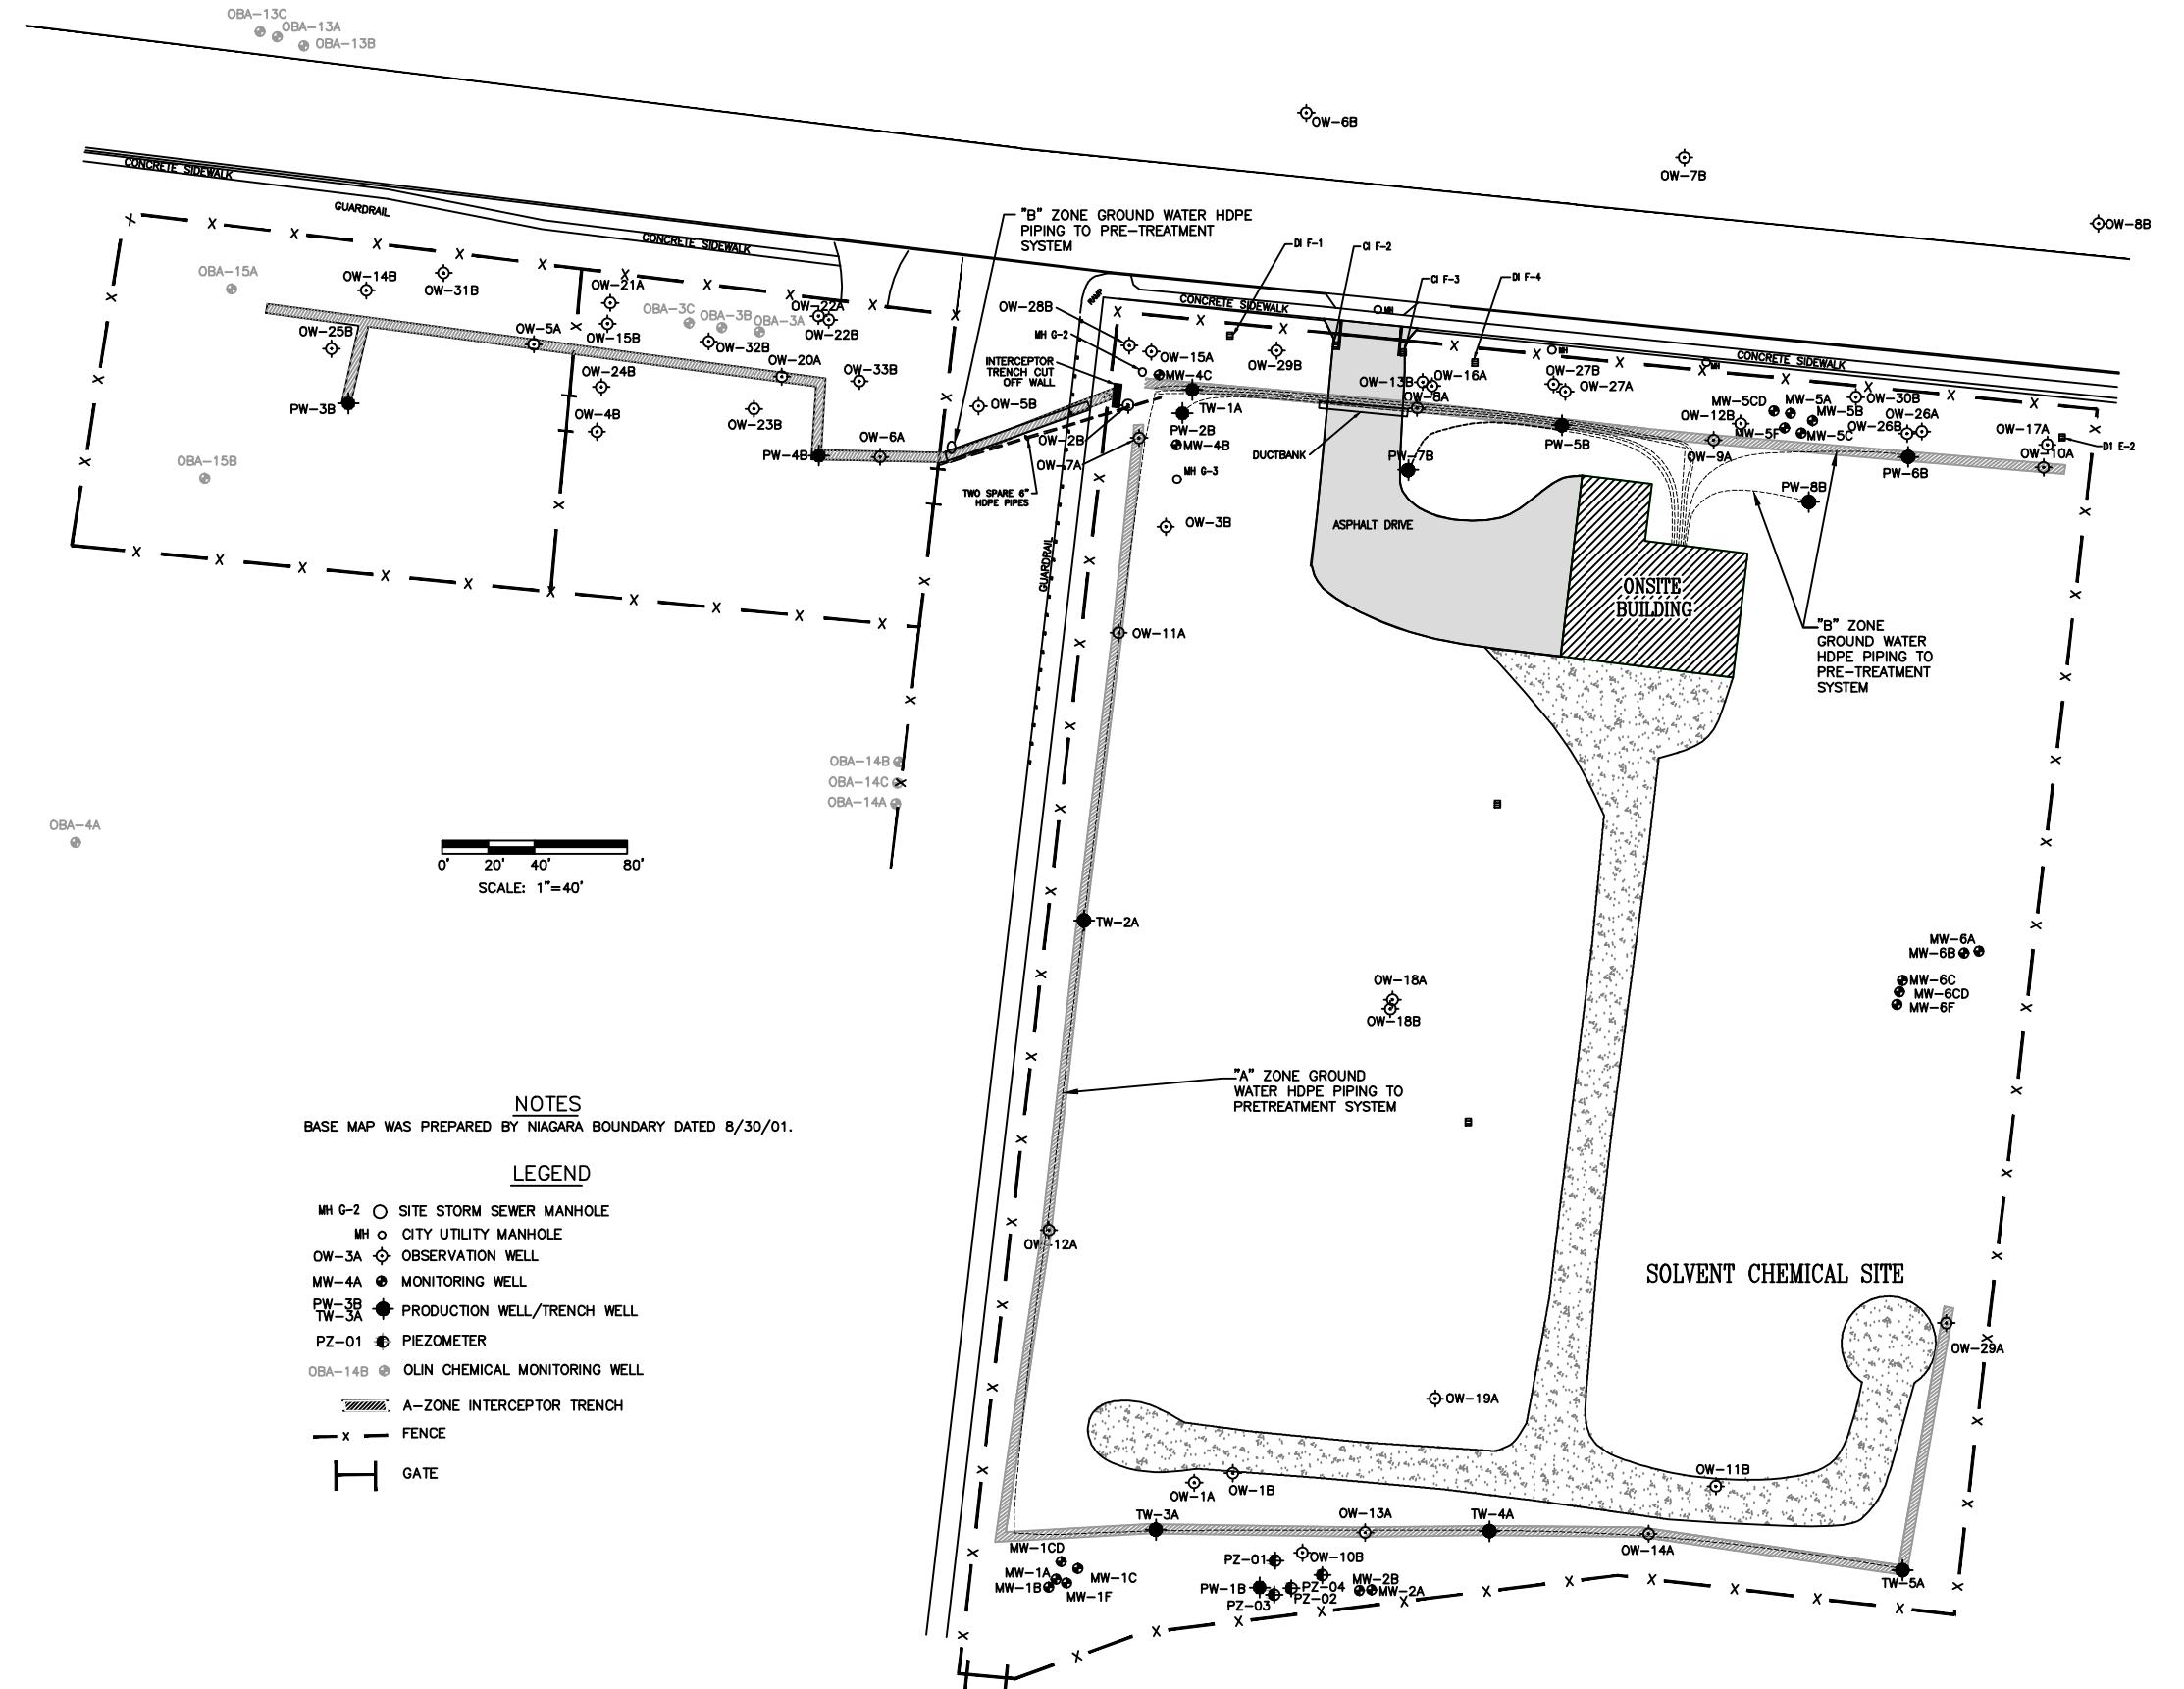
FIGURE 2

Ground water is extracted from five overburden (A-zone) and seven shallow bedrock (B-zone) recovery wells. A site plan identifying well locations is provided as Figure 2. All recovery wells are located on the Solvent Chemical Property except for two wells (PW-3B and PW-4B), which extract groundwater from both the A-zone and B-zone and are located on the "Olin Hot Spot" portion of the Site. Ground water extracted from the recovery wells is pumped to an on-site building for pre-treatment. Pre-treatment operations include oil/water separation (PW-5B through PW-8B) and air stripping. Prior to October 2005, water from the A-zone wells was also routed through the oil/water separator. This was discontinued upon approval from NYSDEC in a letter dated October 18, 2005. Pre-treated effluent is discharged to the Niagara Falls municipal sewer system. Solvent laden air from the air stripper is treated by carbon adsorption. Once treated by adsorption, the air is recycled to the air stripper in a closed loop. Consequently, there is no atmospheric discharge. Carbon beds are regenerated by steam at selected time intervals (currently twice per week). During the steam regeneration process, steam combined with vapor phase solvent is purged from the carbon beds, condensed into liquid and separated into water and waste solvent. Waste solvent accumulates in a tank on-site and is periodically removed for disposal as a hazardous waste. The water is recirculated back to the air stripper.

PROJECT:	SOLVENT CHEMICAL NIAGRA FALLS, NEW YORK	
TITLE:	GROUND WATER EXTRACTION SYSTEM LAYOUT	
DRAWN BY:	MAN/JL	PROJ. NO.: 105146
CHECKED BY:	SB	
APPROVED BY:	MP	
DATE:	MARCH 2019

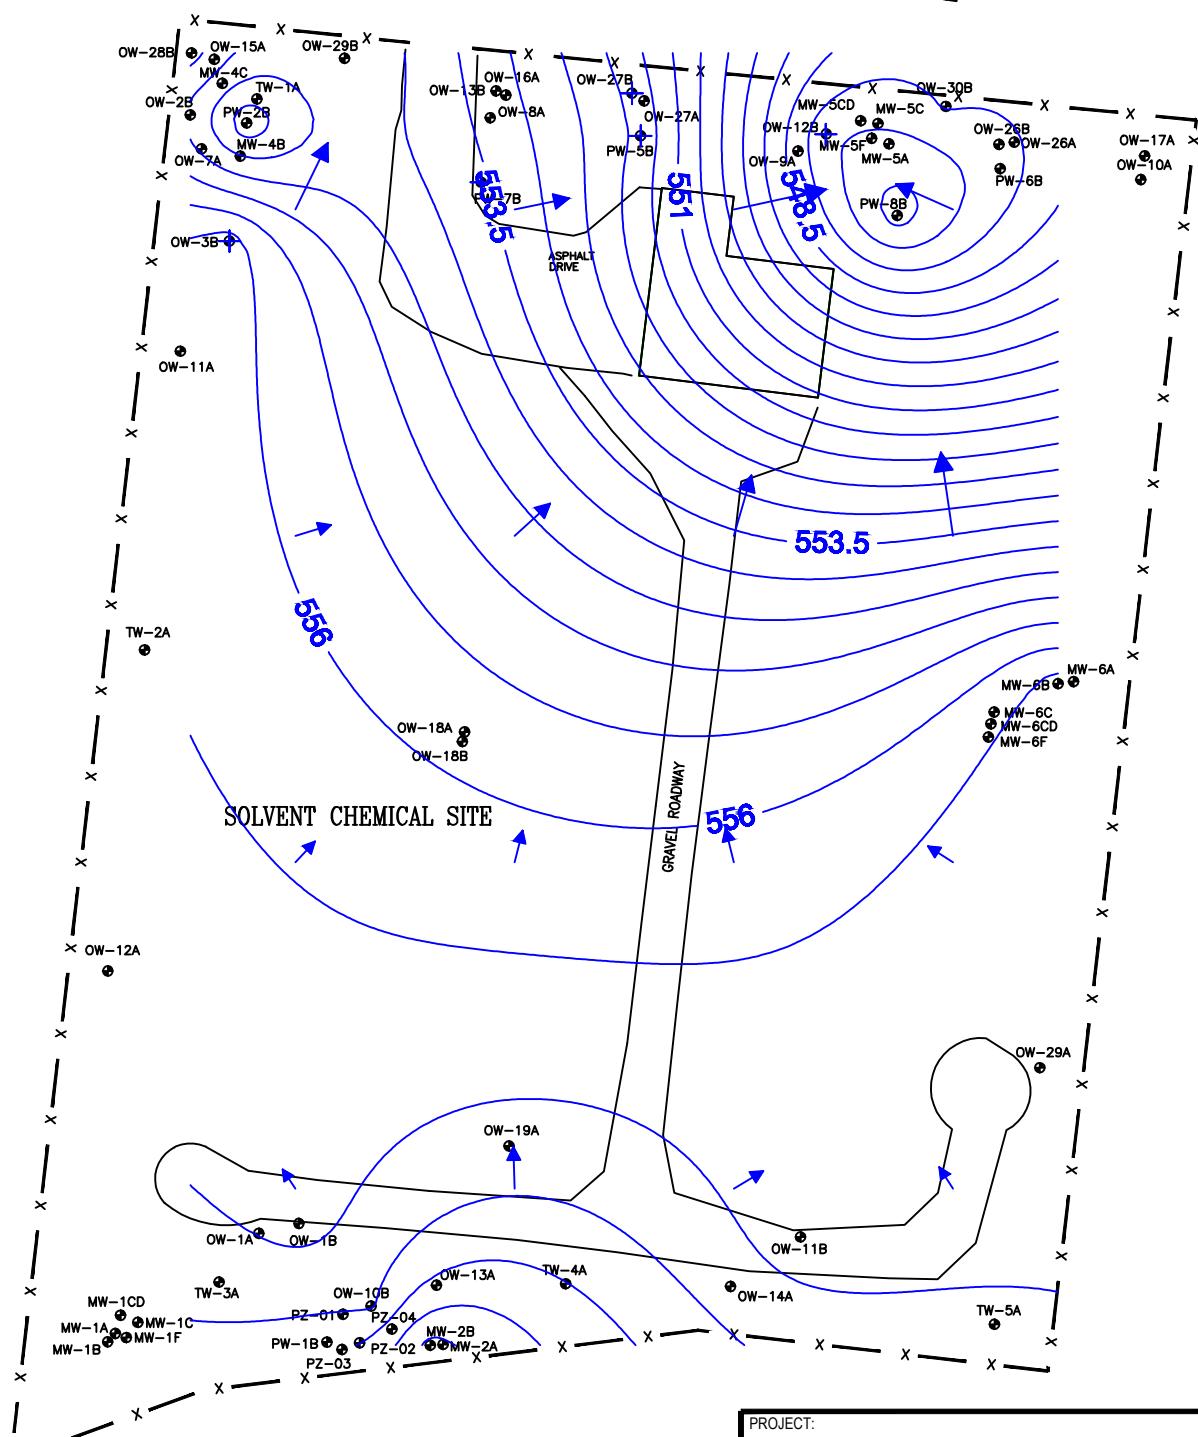
TITLE: **MARCH GROUNDWATER CONTOURS
SOLVENT SITE
MARCH 6, 2018**

Figures 3 and 4 present overburden water levels for the Solvent Chemical Property and document that the piezometric elevations of all the observation wells in the central portions of the Site are higher than the piezometric elevations encountered in the trench observation wells, indicating an overburden flow path towards the ground water extraction trench. Figures 5 through 8 present ground water contours for B-zone wells on the Solvent Chemical Site and Olin Hot Spot properties. The contours show that ground water extraction system pumping rates are achieving hydraulic capture. Figures 9 through 12 present graphical depictions of CoC concentrations versus time for the wells currently sampled. Additional discussions regarding these figures, where appropriate, are provided in the applicable sections of this report.

Water level measurements were collected both within and outside of the ground water extraction trench. Figures 3 and 4 provide ground water piezometric surface elevations for the overburden observation wells on the Solvent site. As shown on these figures, the piezometric elevations of all the observation wells in the central portions of the Site are higher than the piezometric elevations encountered in the trench observation wells indicating an overburden flow path towards the ground water extraction trench.

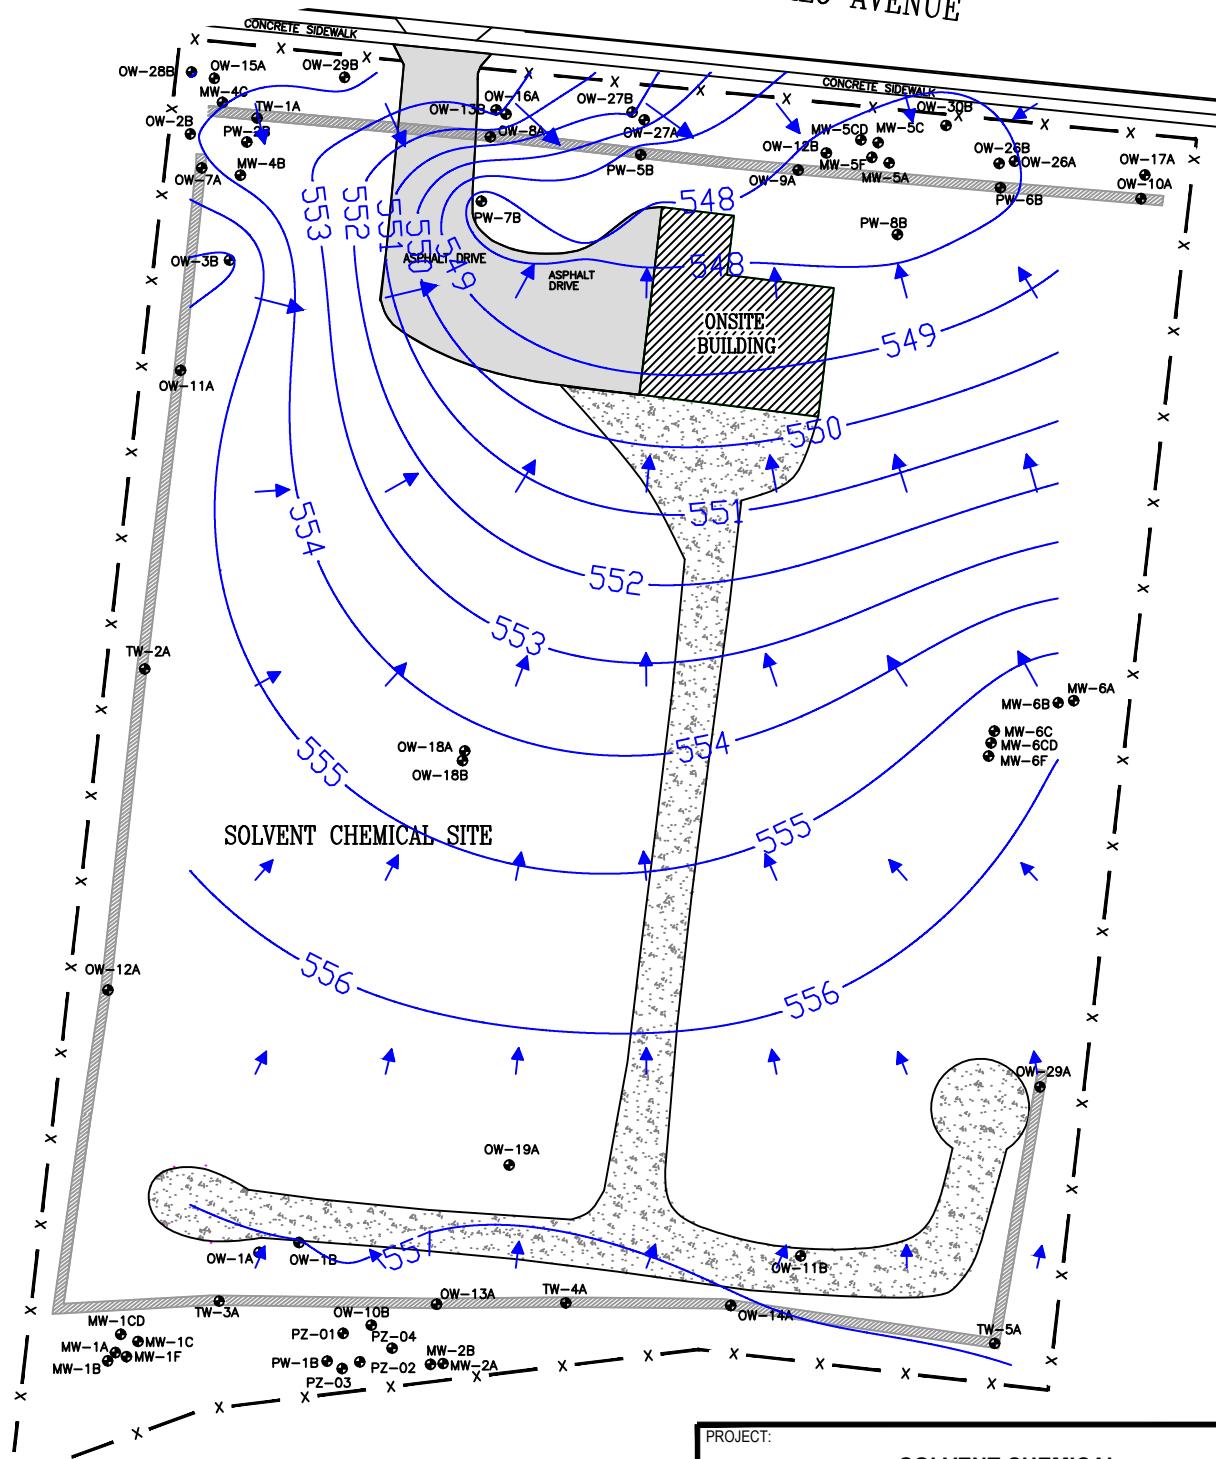
FIGURE 6

Figures 5 through 8 present quarterly water level contours for both the Solvent Site and Hotspot for 2017. The figures indicate that the B-zone pumping wells are achieving capture consistent with the baseline hydraulic conditions approved by NYSDEC, included as Appendix A of the PMP, with the exception of the occasions listed in Section 6.2 below.

PROJECT: SOLVENT CHEMICAL NIAGARA FALLS, NEW YORK		
TITLE: SEPTEMBER GROUNDWATER CONTOURS SOLVENT SITE SEPTEMBER 11, 2018		
DRAWN BY:	MAN	PROJ NO.: 105146
CHECKED BY:	SB	
APPROVED BY:	MP	
DATE:	MARCH 2019
