# **ENGINEERING INVESTIGATIONS AT INACTIVE HAZARDOUS WASTE SITES**

## **PHASE I INVESTIGATION**

**WALMORE ROAD - JOHNSON PROPERTY,  
SITE NUMBER 932101  
TOWN OF WHEATFIELD, NIAGARA COUNTY**

**June 1989**

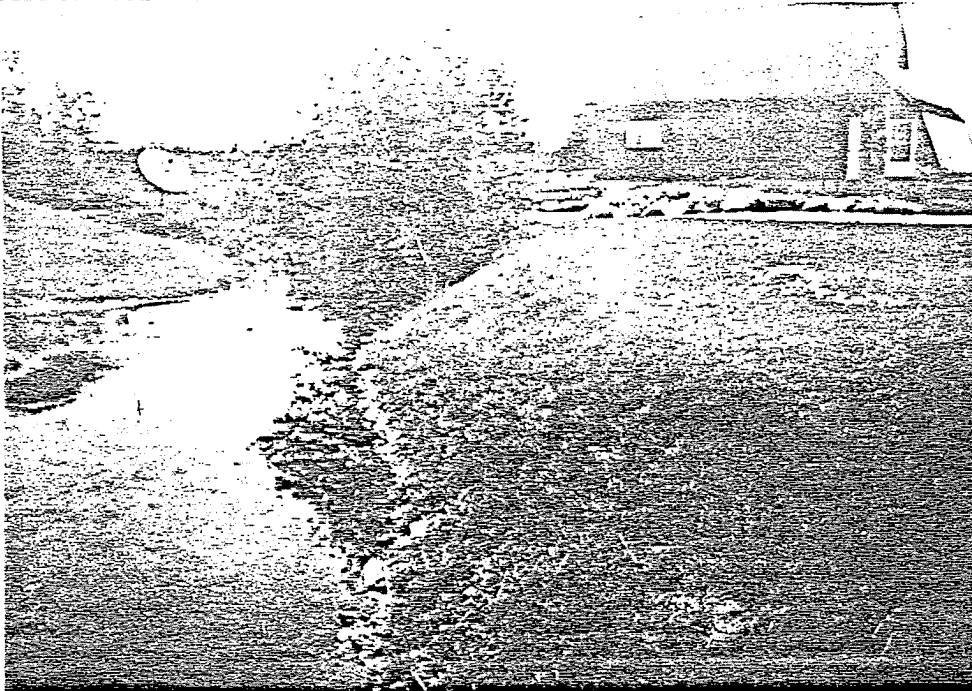
Comments\*: View east from  
Walmore Road; Cayuga Creek on  
left. Filled area on right.  
6373 Walmore Road residence  
in background.

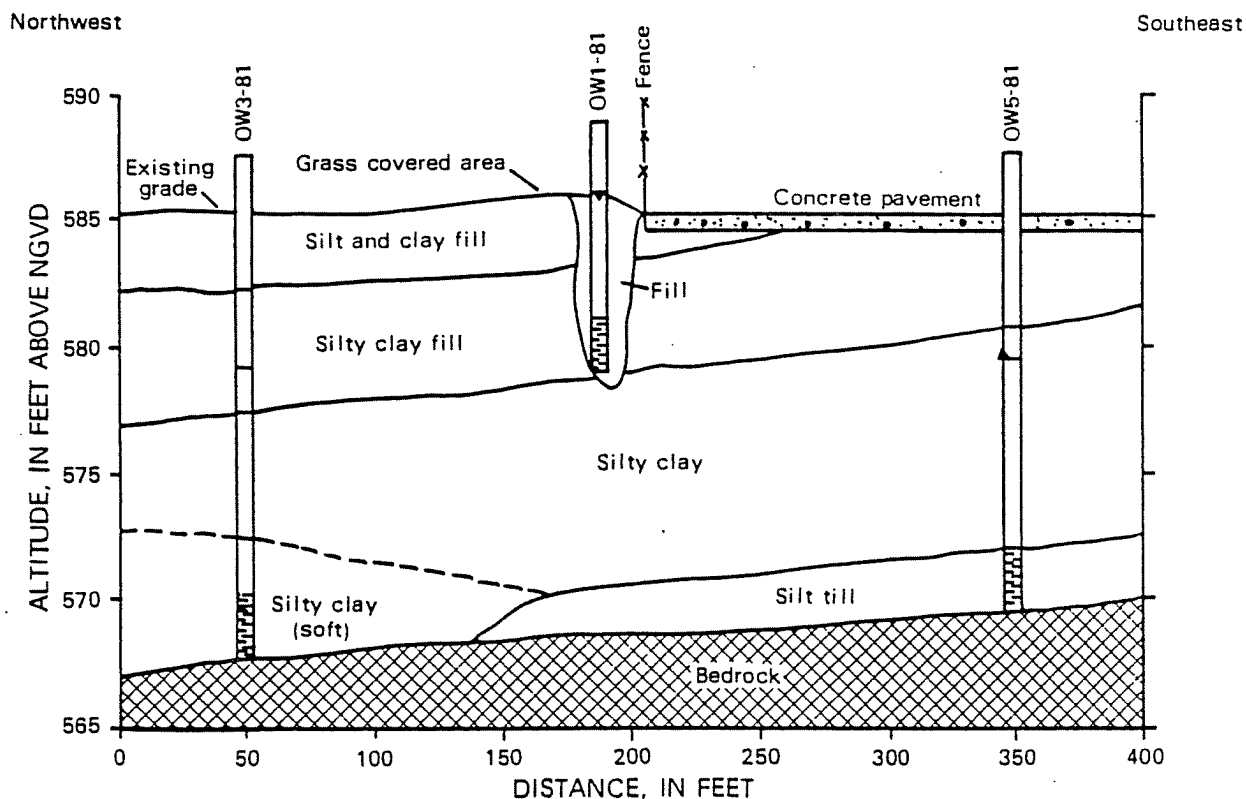
Figure C-4. Geologic cross section of formations underlying Carborundum-Abrasive Division, site 9, Wheatfield.  
(Modified from Conestoga-Rovers and Assoc., 1981.)

Geologic information.--The site consists of clay and silty fill underlain by a silty lacustrine clay, which is in turn underlain by a discontinuous layer of till. These units overlie bedrock of Lockport Dolomite. A geologic cross section is shown in figure C-4.
