ENGINEERING INVESTIGATIONS AT INACTIVE HAZARDOUS WASTE SITES IN THE STATE OF NEW YORK

PRELIMINARY SITE ASSESSMENT TASK 1

**Walmore Road - Johnson Property Site
Site Number 932101
Town of Wheatfield, Niagara County**

October 1991

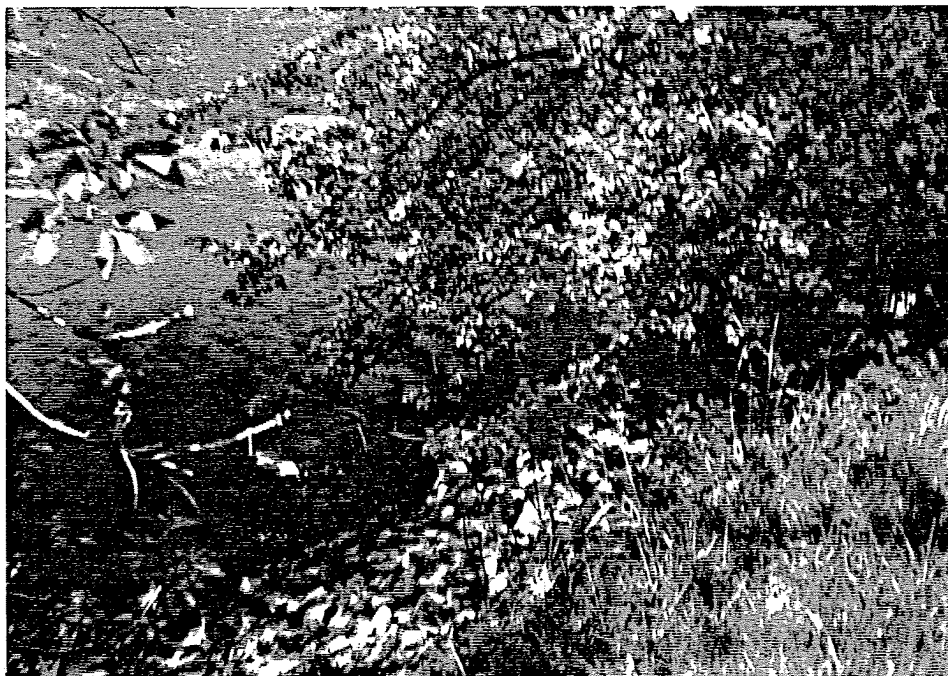
Comments*: Eastern bank of Cayuga Creek shows
 exposed debris.

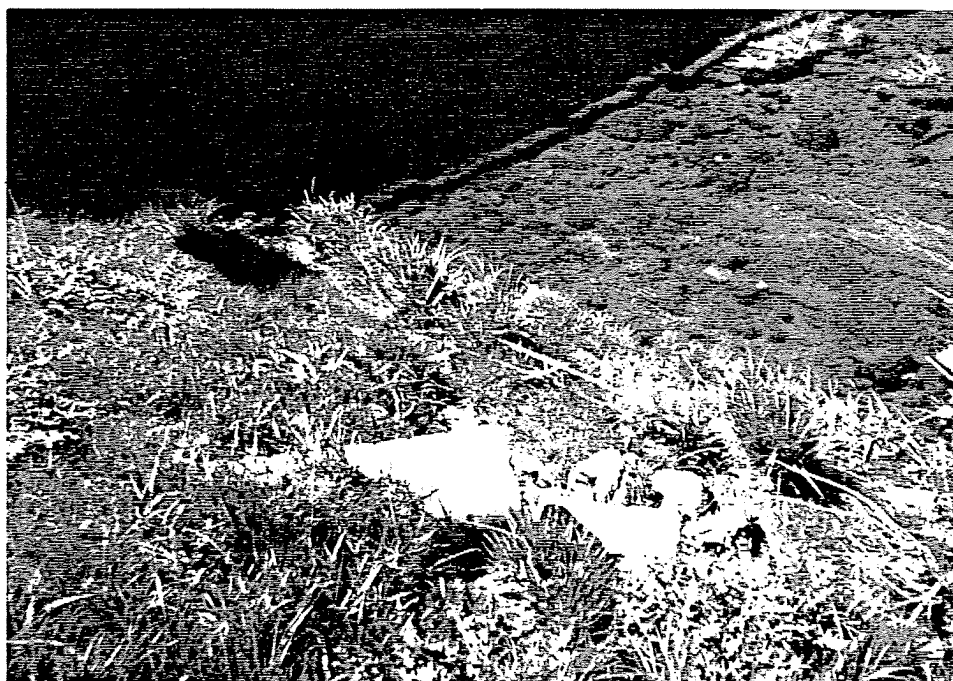
Comments*: Walmore Road drainage pipe emptying
into Cayuga Creek. Pipe runs partially through fill area.
No discharge, distressed vegetation noted in pipe area.

There were no visible signs of stained ground or stressed vegetation around a pipe for drainage off Walmore Road into Cayuga Creek. The fill area was level and covered with a layer of topsoil and healthy grass. Vegetation in the creek bed was lush and unstressed.

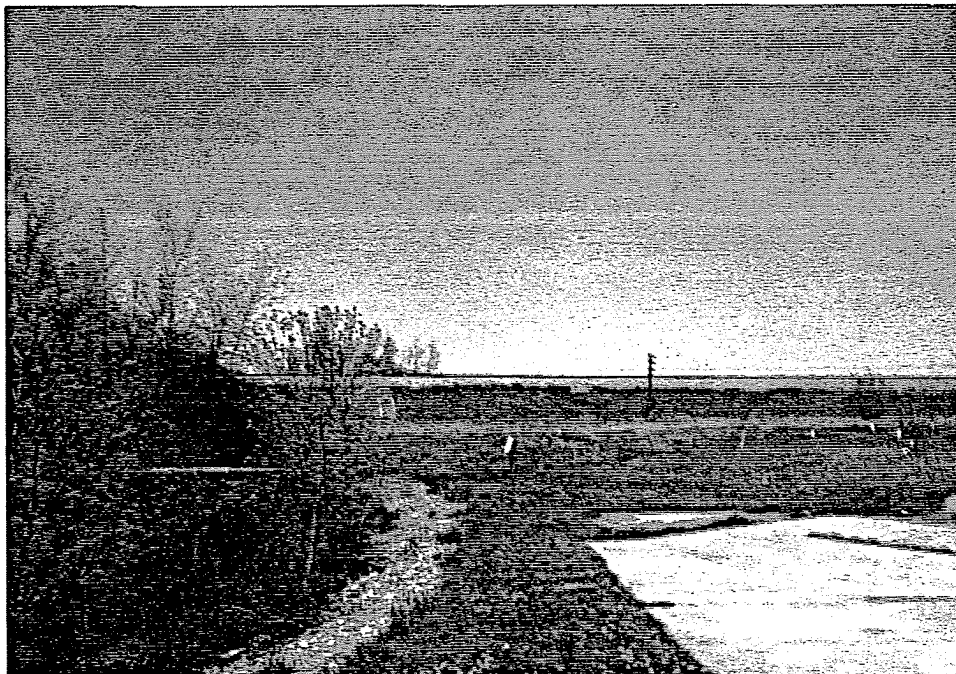
Comments*: Chicken-wired rock drainage area along
eastern creek bank, irrigation well sampled in 1984, and
orchard.

Approaching the site from the north, gabions (rock and stones retained by wire) were observed on the south bank of Cayuga Creek, approximately 30 yards from the road. No signs of stressed vegetation or discolored, milky, or sheened water was observed along or in the creek for the length of the property.
