## PROFILE REPORT

# SOUTH NIAGARA STREET QUARRY SITE

## BY NIAGARA COUNTY HEALTH DEPARTMENT JUNE, 1993

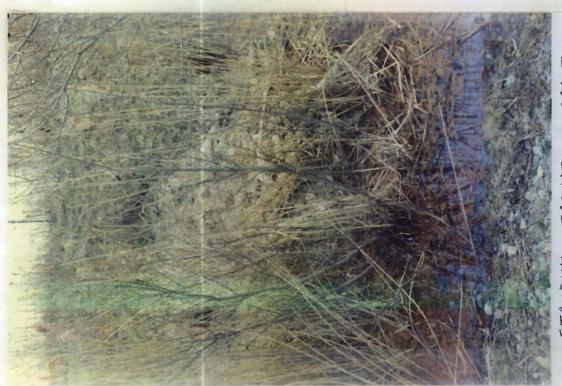
DITCH - EXPOSED WASTE VISIBLE DUE TO ANIMAL BURROWING

As a minimum, the site is in need of a proper 360 closure to prevent offsite migration of leachate.

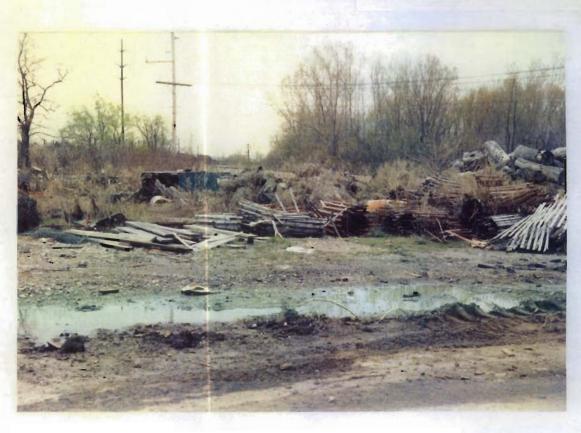
TOP OF LANDFILL USED BY CITY OF LOCKPORT FOR STORAGE
