Site Investigation Report

**South Niagara Street Quarry Site,
City of Lockport,
Niagara County, New York**

January 2008

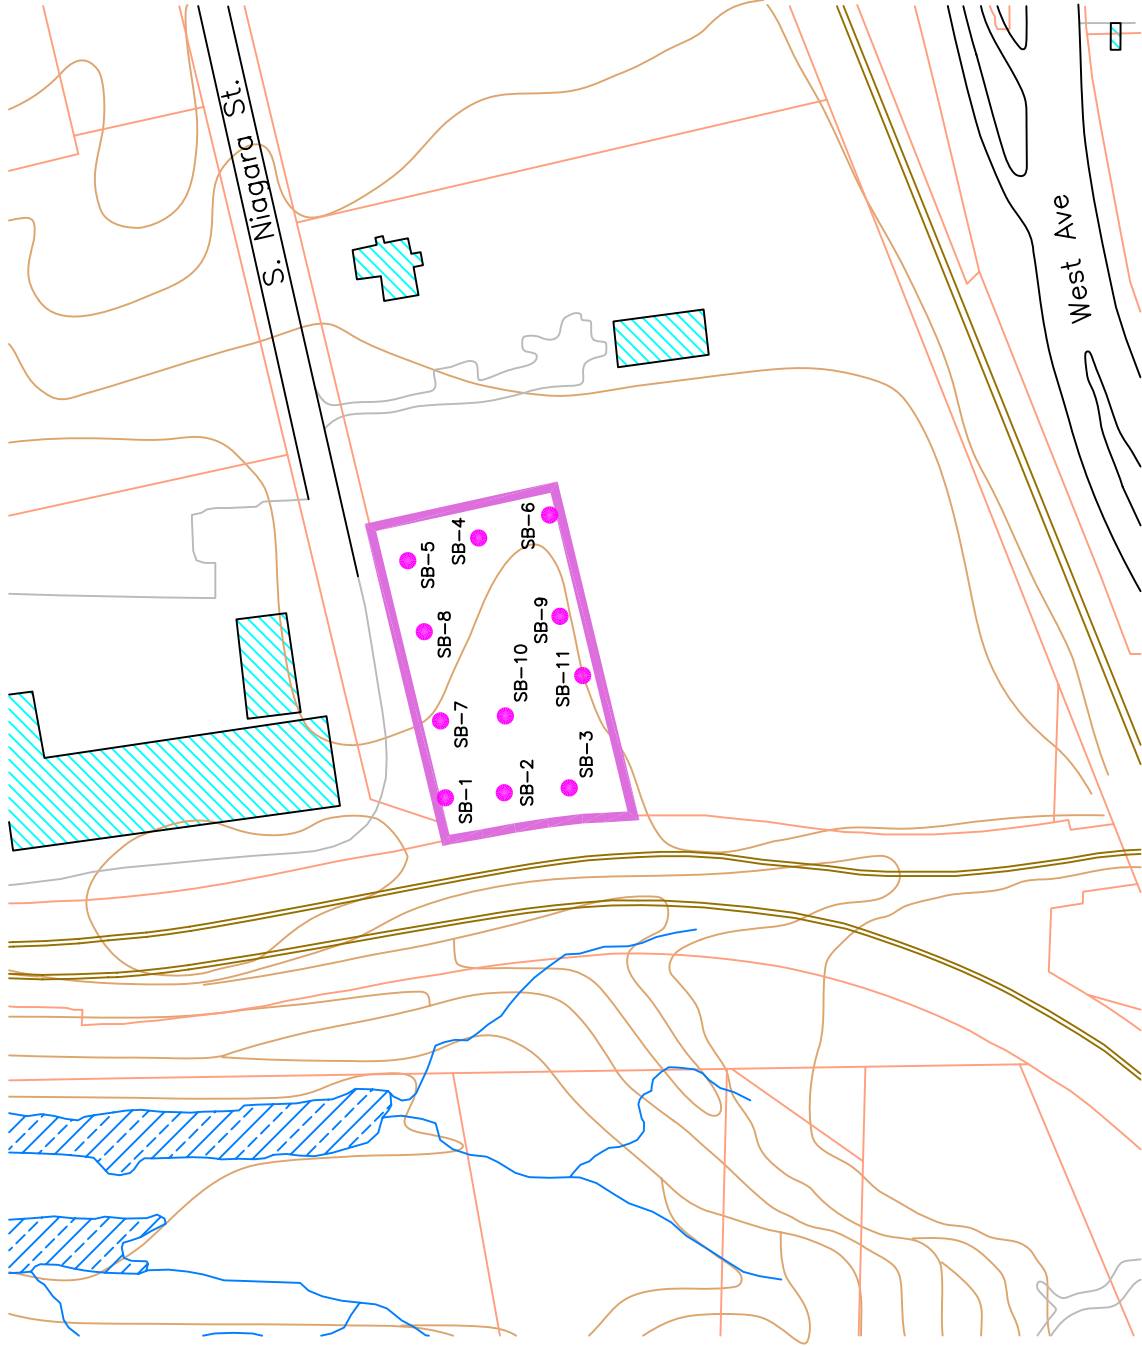
FIGURE 4-1

● SOIL BORING

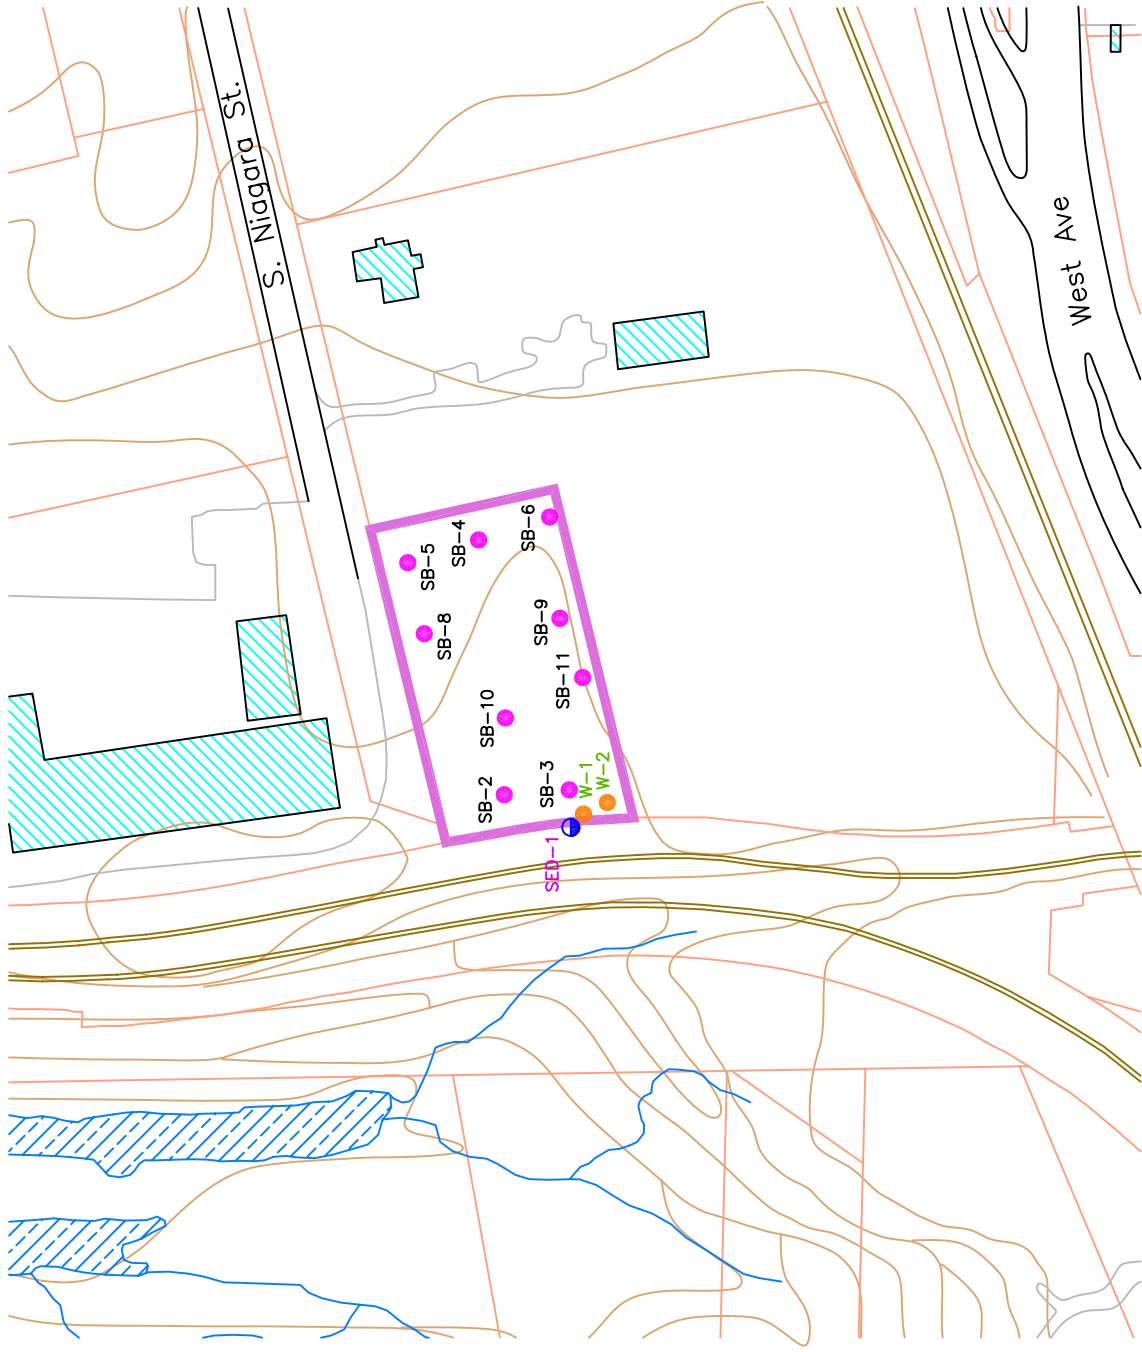
- WASTE SAMPLE FROM EMBANKMENT
- WASTE SAMPLE FROM SOIL BORING
- SEDIMENT SAMPLE

SAMPLE LOCATION MAP	
		DIVISION OF ENVIRONMENTAL REMEDIATION DATE: 04/03/07 DRAWING: S Niagara St Quarry.dwg	
		PRODUCT: SOUTH NIAGARA ST. QUARRY

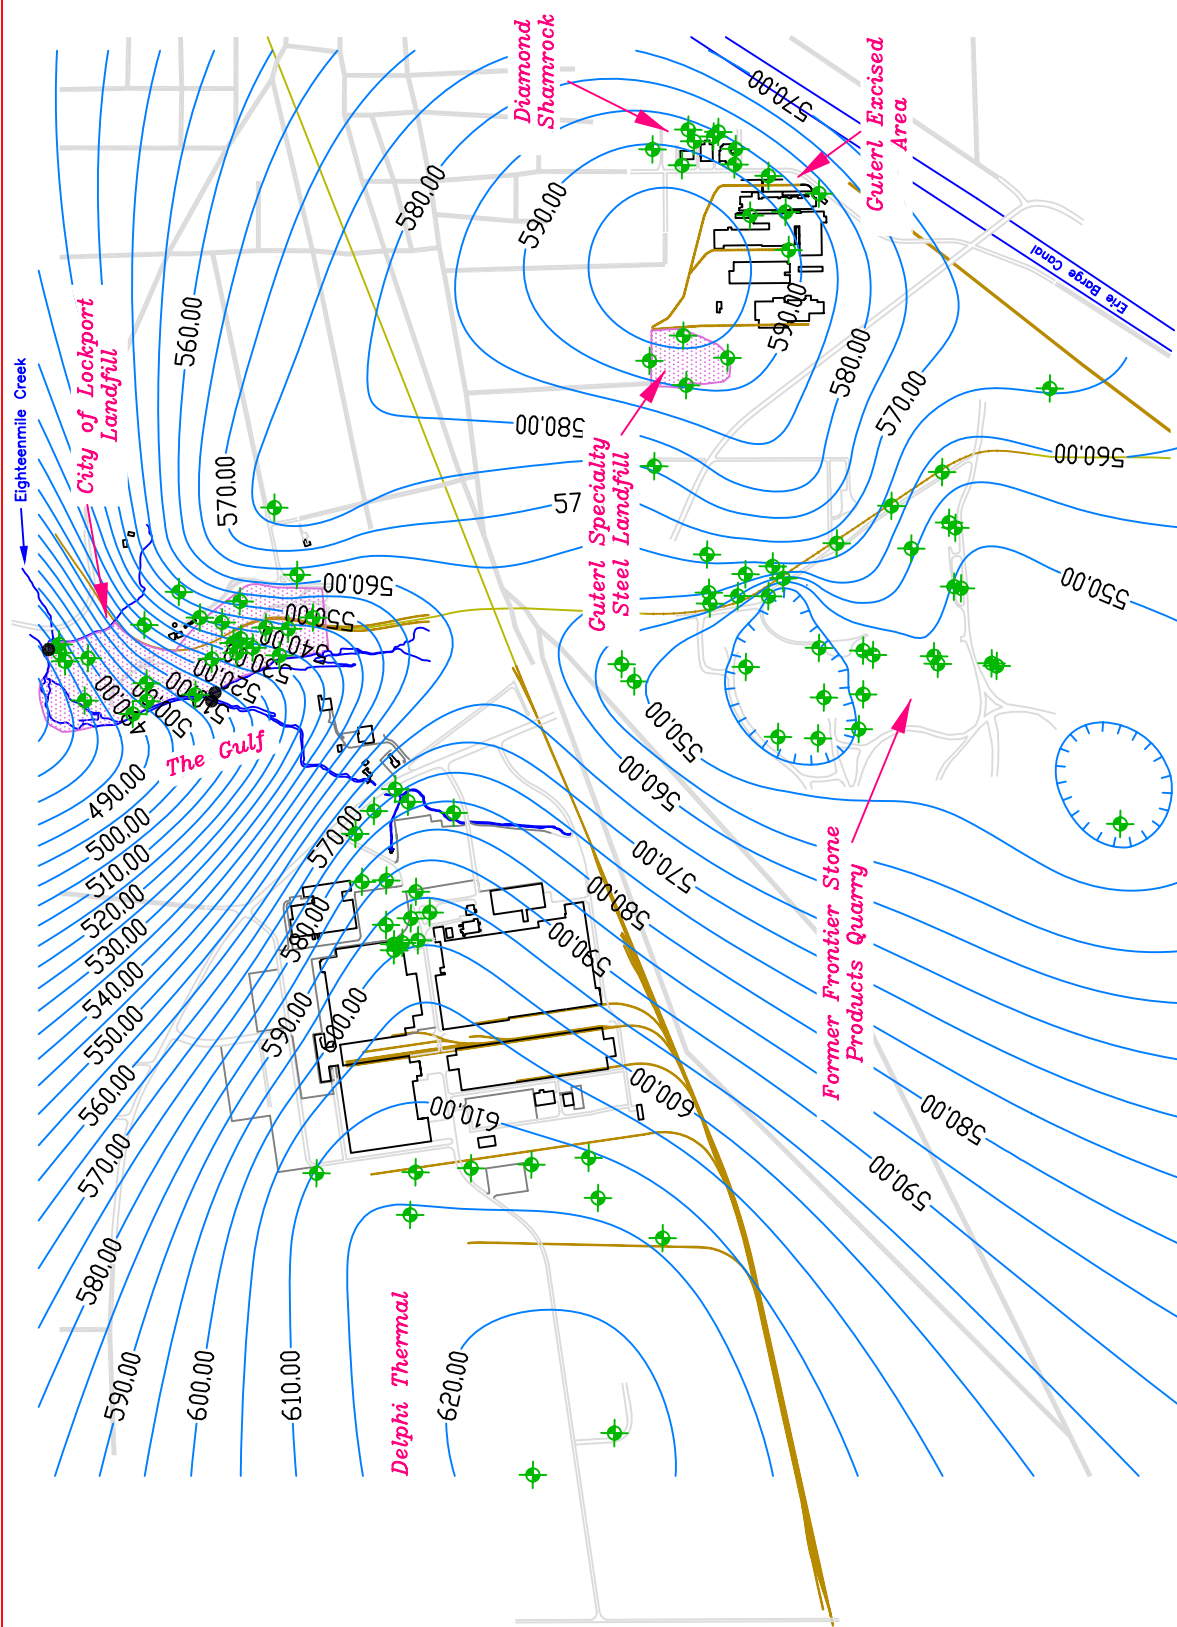
DIVISION OF ENVIRONMENTAL REMEDIATION
DATE: 10/15/07 DRAWING: GW Flow Map.dwg

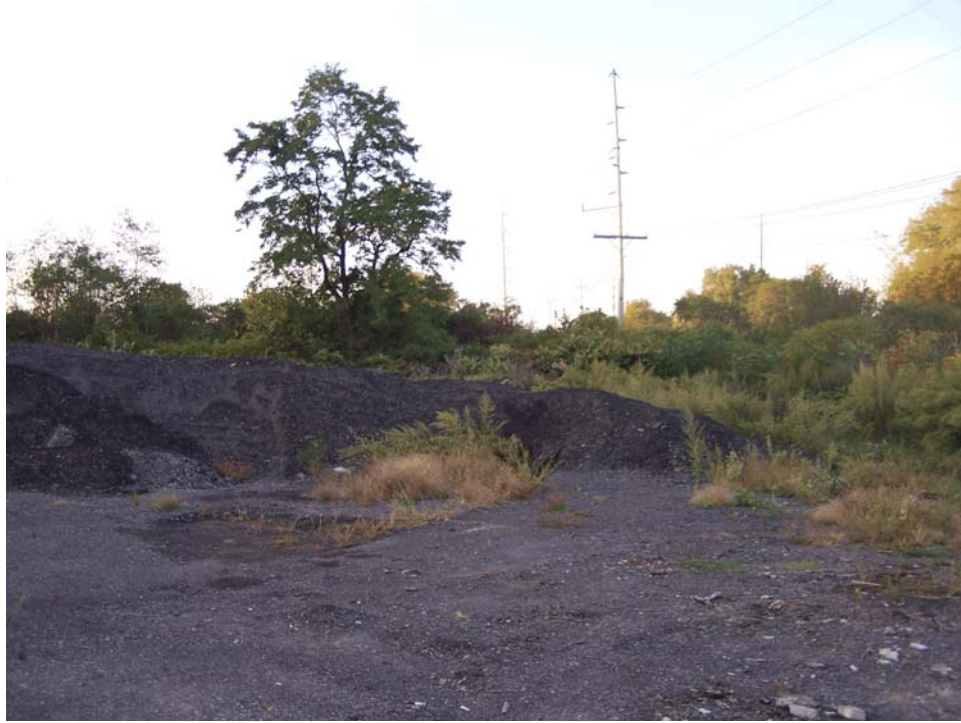
Figure 6-1. Photograph of the asphalt millings across the western portion of the South Niagara Street Quarry Site. View looking southwest. Photograph taken by Glenn May on October 1, 2007.

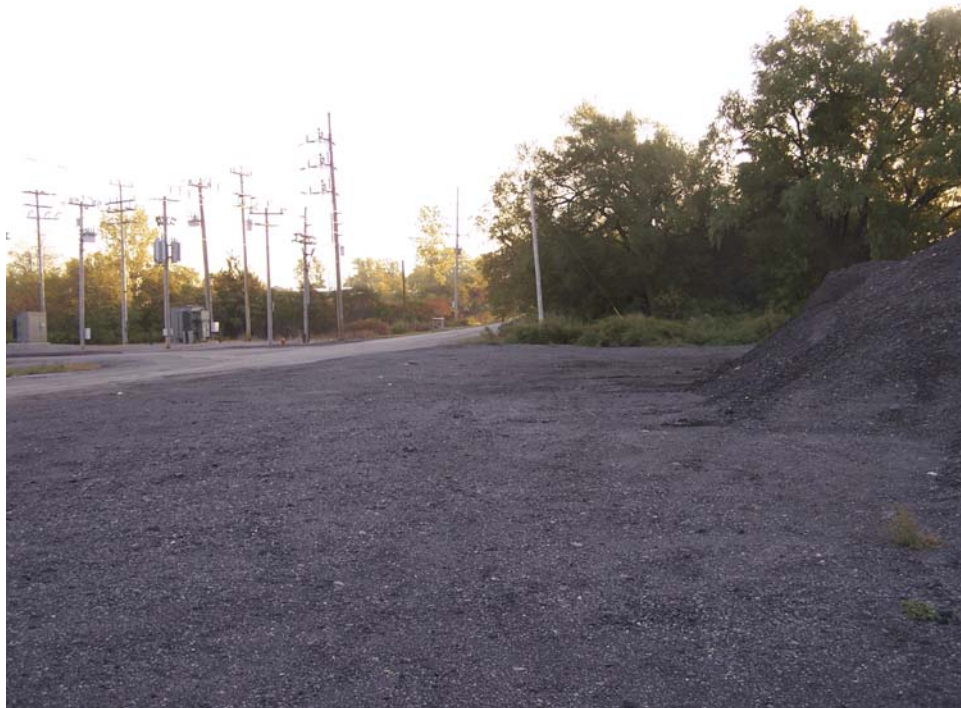
Figure 6-2. Photograph of the asphalt millings across the northern portion of the South Niagara Street Quarry Site. View looking east. Photograph taken by Glenn May on October 1, 2007.

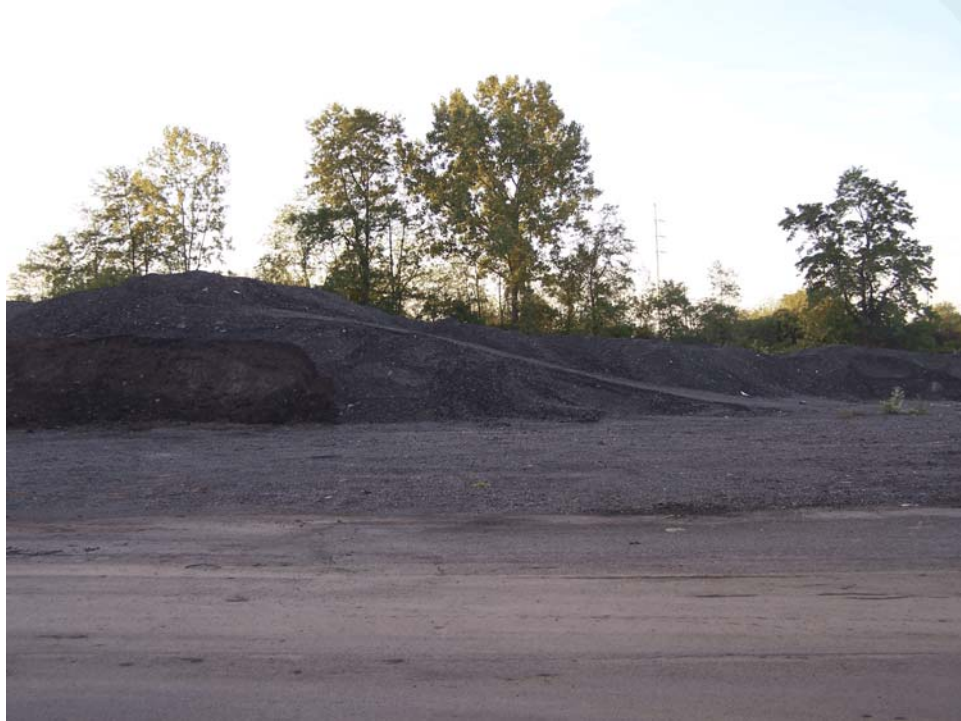
Figure 6-3. Photograph of the asphalt millings pile across the central portion of the South Niagara Street Quarry Site. View looking south. Photograph taken by Glenn May on October 1, 2007.

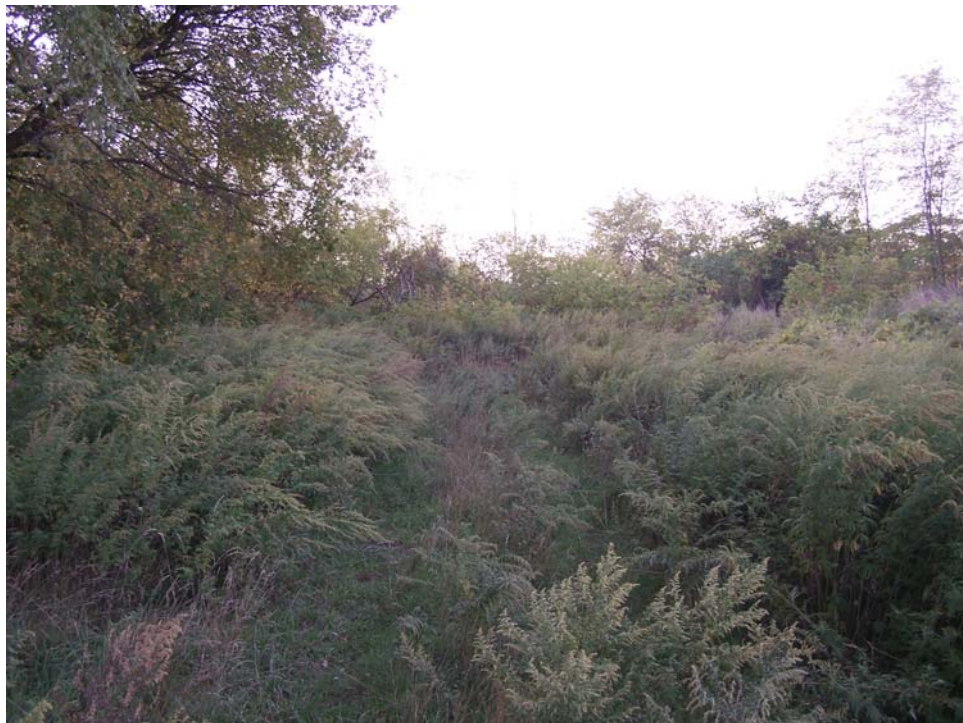
The southern and eastern portions of the site, along with the embankment to the west, are heavily vegetated with weeds and small brush (Figures 6-4 and 6-5). No buildings were observed on site, although the City of Lockport Highway garage is located to the north.

Figure 6-4. Photograph of the vegetation across the eastern portion of the South Niagara Street Quarry Site. View looking south. Photograph taken by Glenn May on October 1, 2007.

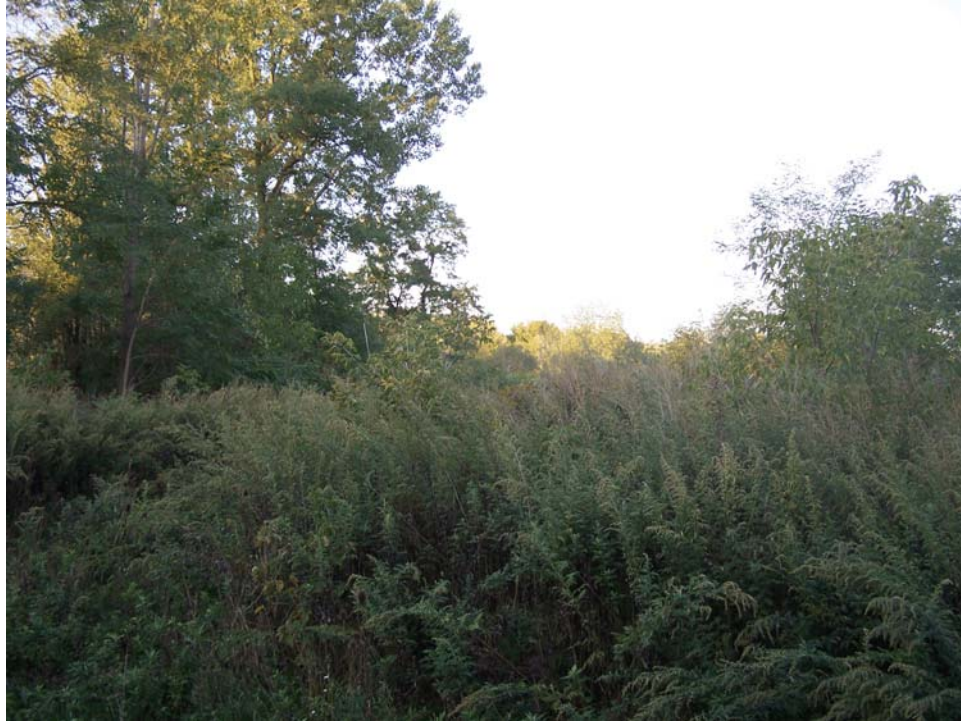
Figure 6-5. Photograph of the vegetation across the southern portion of the South Niagara Street Quarry Site. View looking west. Photograph taken by Glenn May on October 1, 2007.
