OLD UPPER MOUNTAIN ROAD SITE

NIAGARA COUNTY HEALTH DEPARTMENT  
PROFILE REPORT  
MAY 1993

### Old Upper Mountain Road Site

By Niagara County Health Department  
MAY 1993

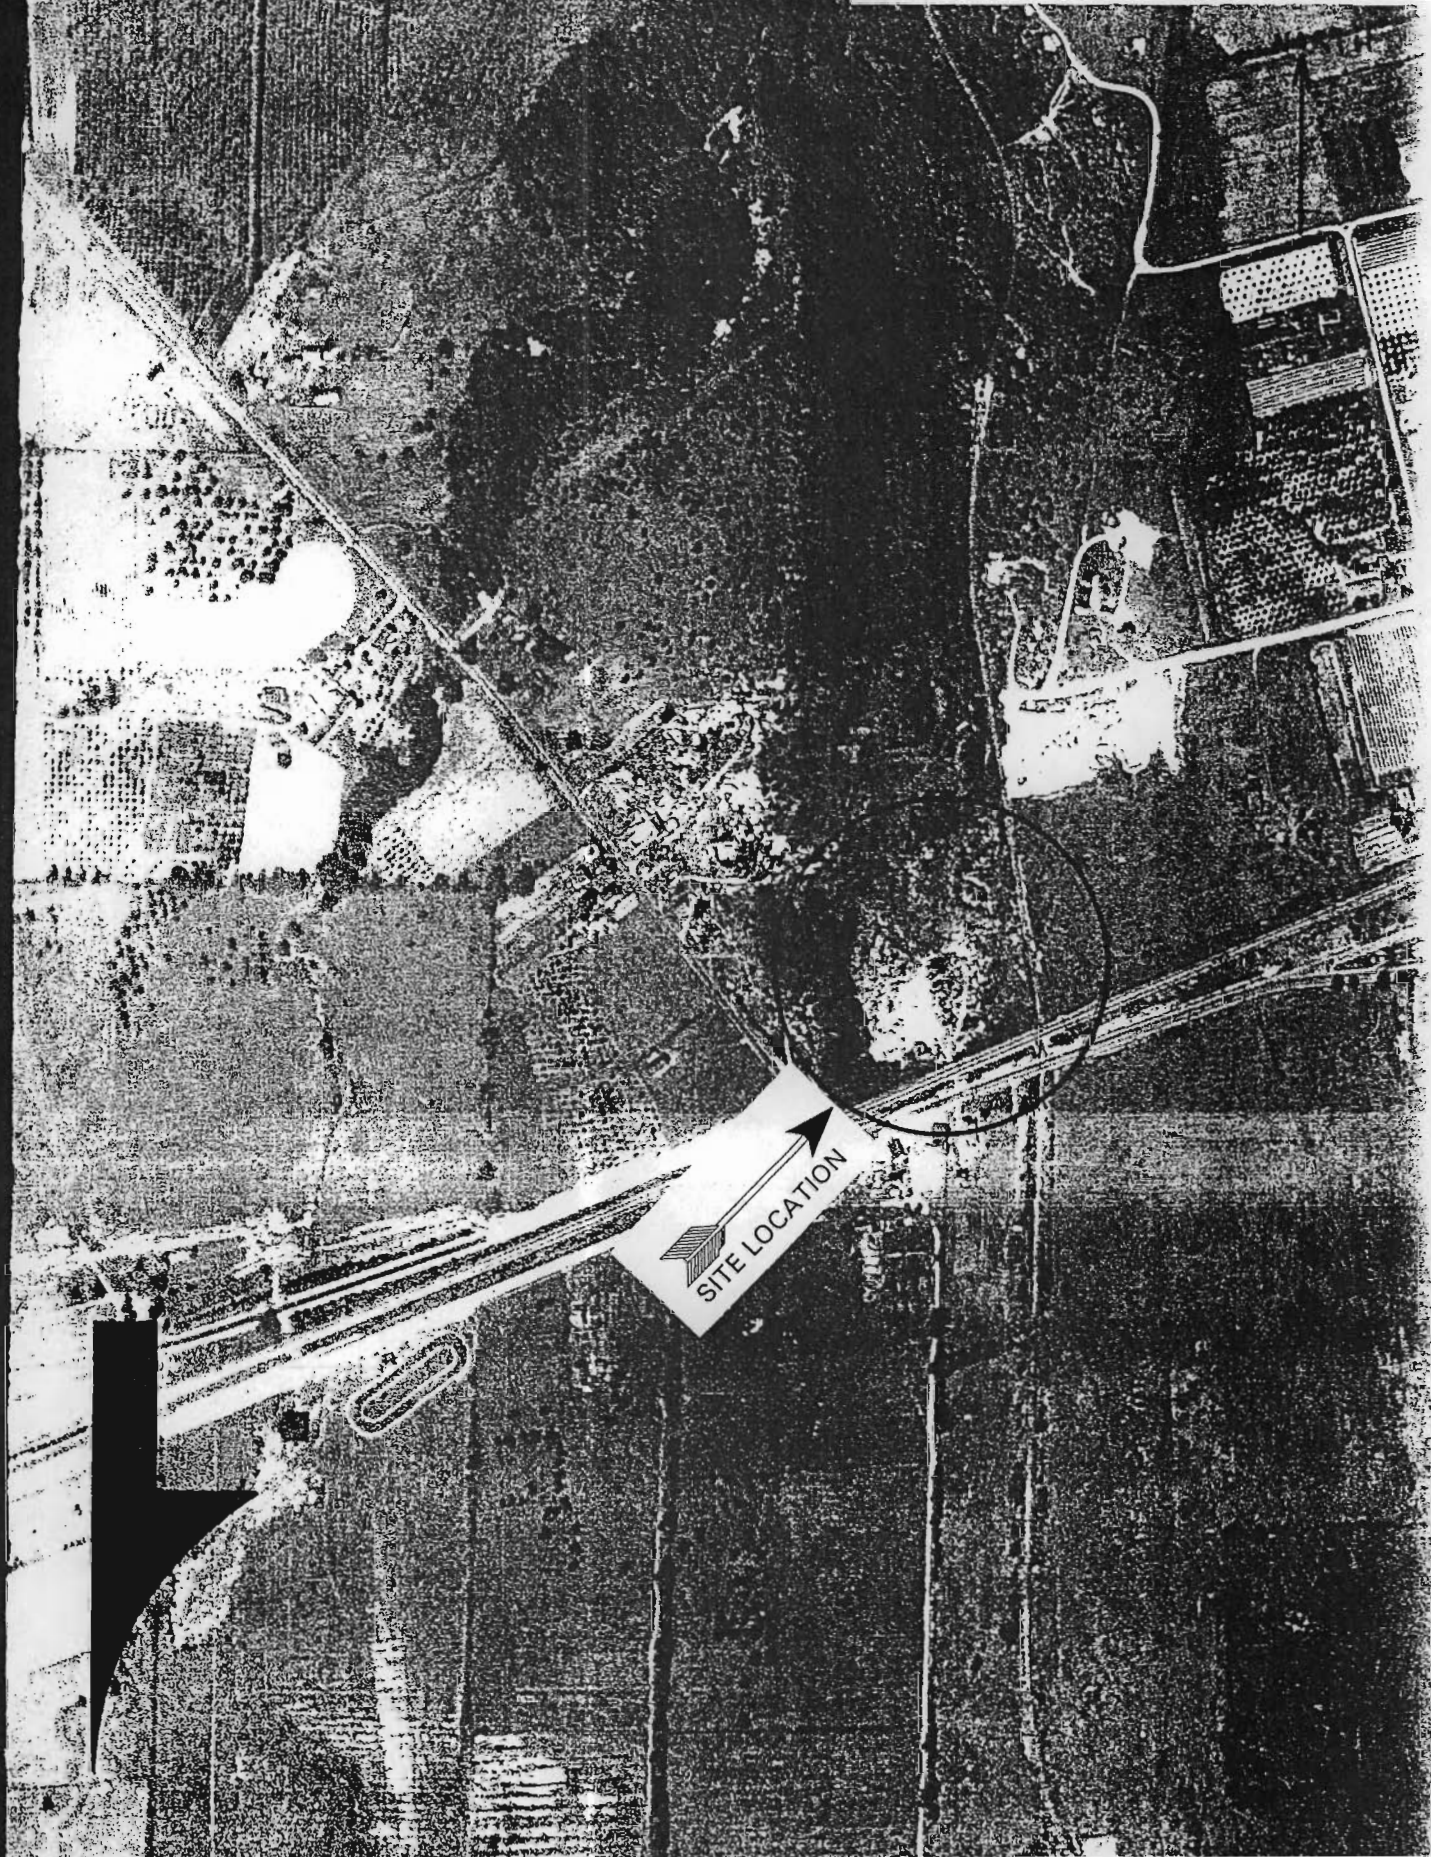
PAGE A-5

The dump was reportedly operated between the year 1921 until the 1950's. Access to the landfill at that time was from the east under a railroad viaduct just north of Old Upper Mountain Road viaduct (just south of the railroad viaduct). The 1958 aerial photograph clearly shows the access. In later years of operation, a gate was placed at the viaduct to control unauthorized dumpers because they reportedly dumped anywhere they felt rather than at the dump face in the back. It was, however, left unlocked and anyone could push it open. The method of operation seemed to be based on "filling the Gulf". The City of Lockport moved its dumping area in the 1950's to the area known today as the Lockport City Landfill, on property which it reportedly repossessed on taxes. Again, the method of operation seemed only as away to "fill in the Gulf".

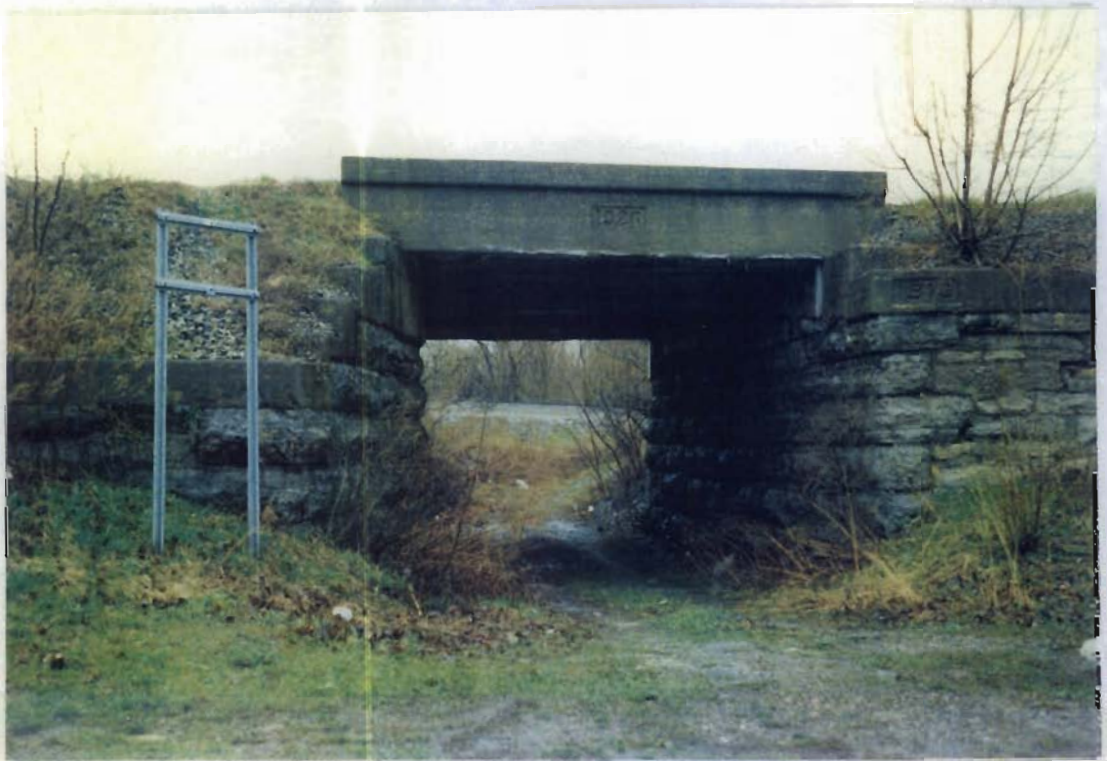
#3	Looking south from Somerset Railroad (again the old entrance).
#4	Looking northeast from Somerset Railroad - view of top of dump.
#5, #6	Both photos show evidence of animal burrowing in an area south of Somerset Railroad. These photos demonstrate that Somerset Railroad either sits atop or at least bisects the site.

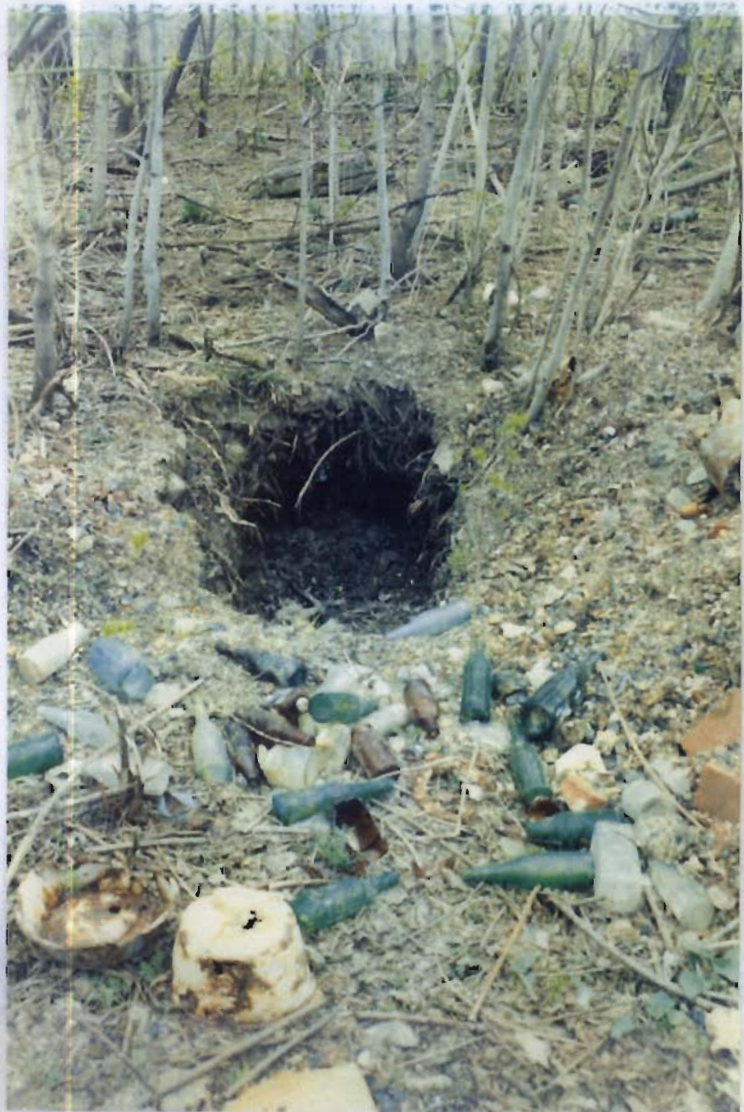
#7

#7, 8, 9, 10	Photos show evidence of animal burrowing. Wastes extend in all holes to at least the bottom (probably deeper). Visible wastes seem to be mainly incinerator residues, ash, glass, metal, as well as many tires.

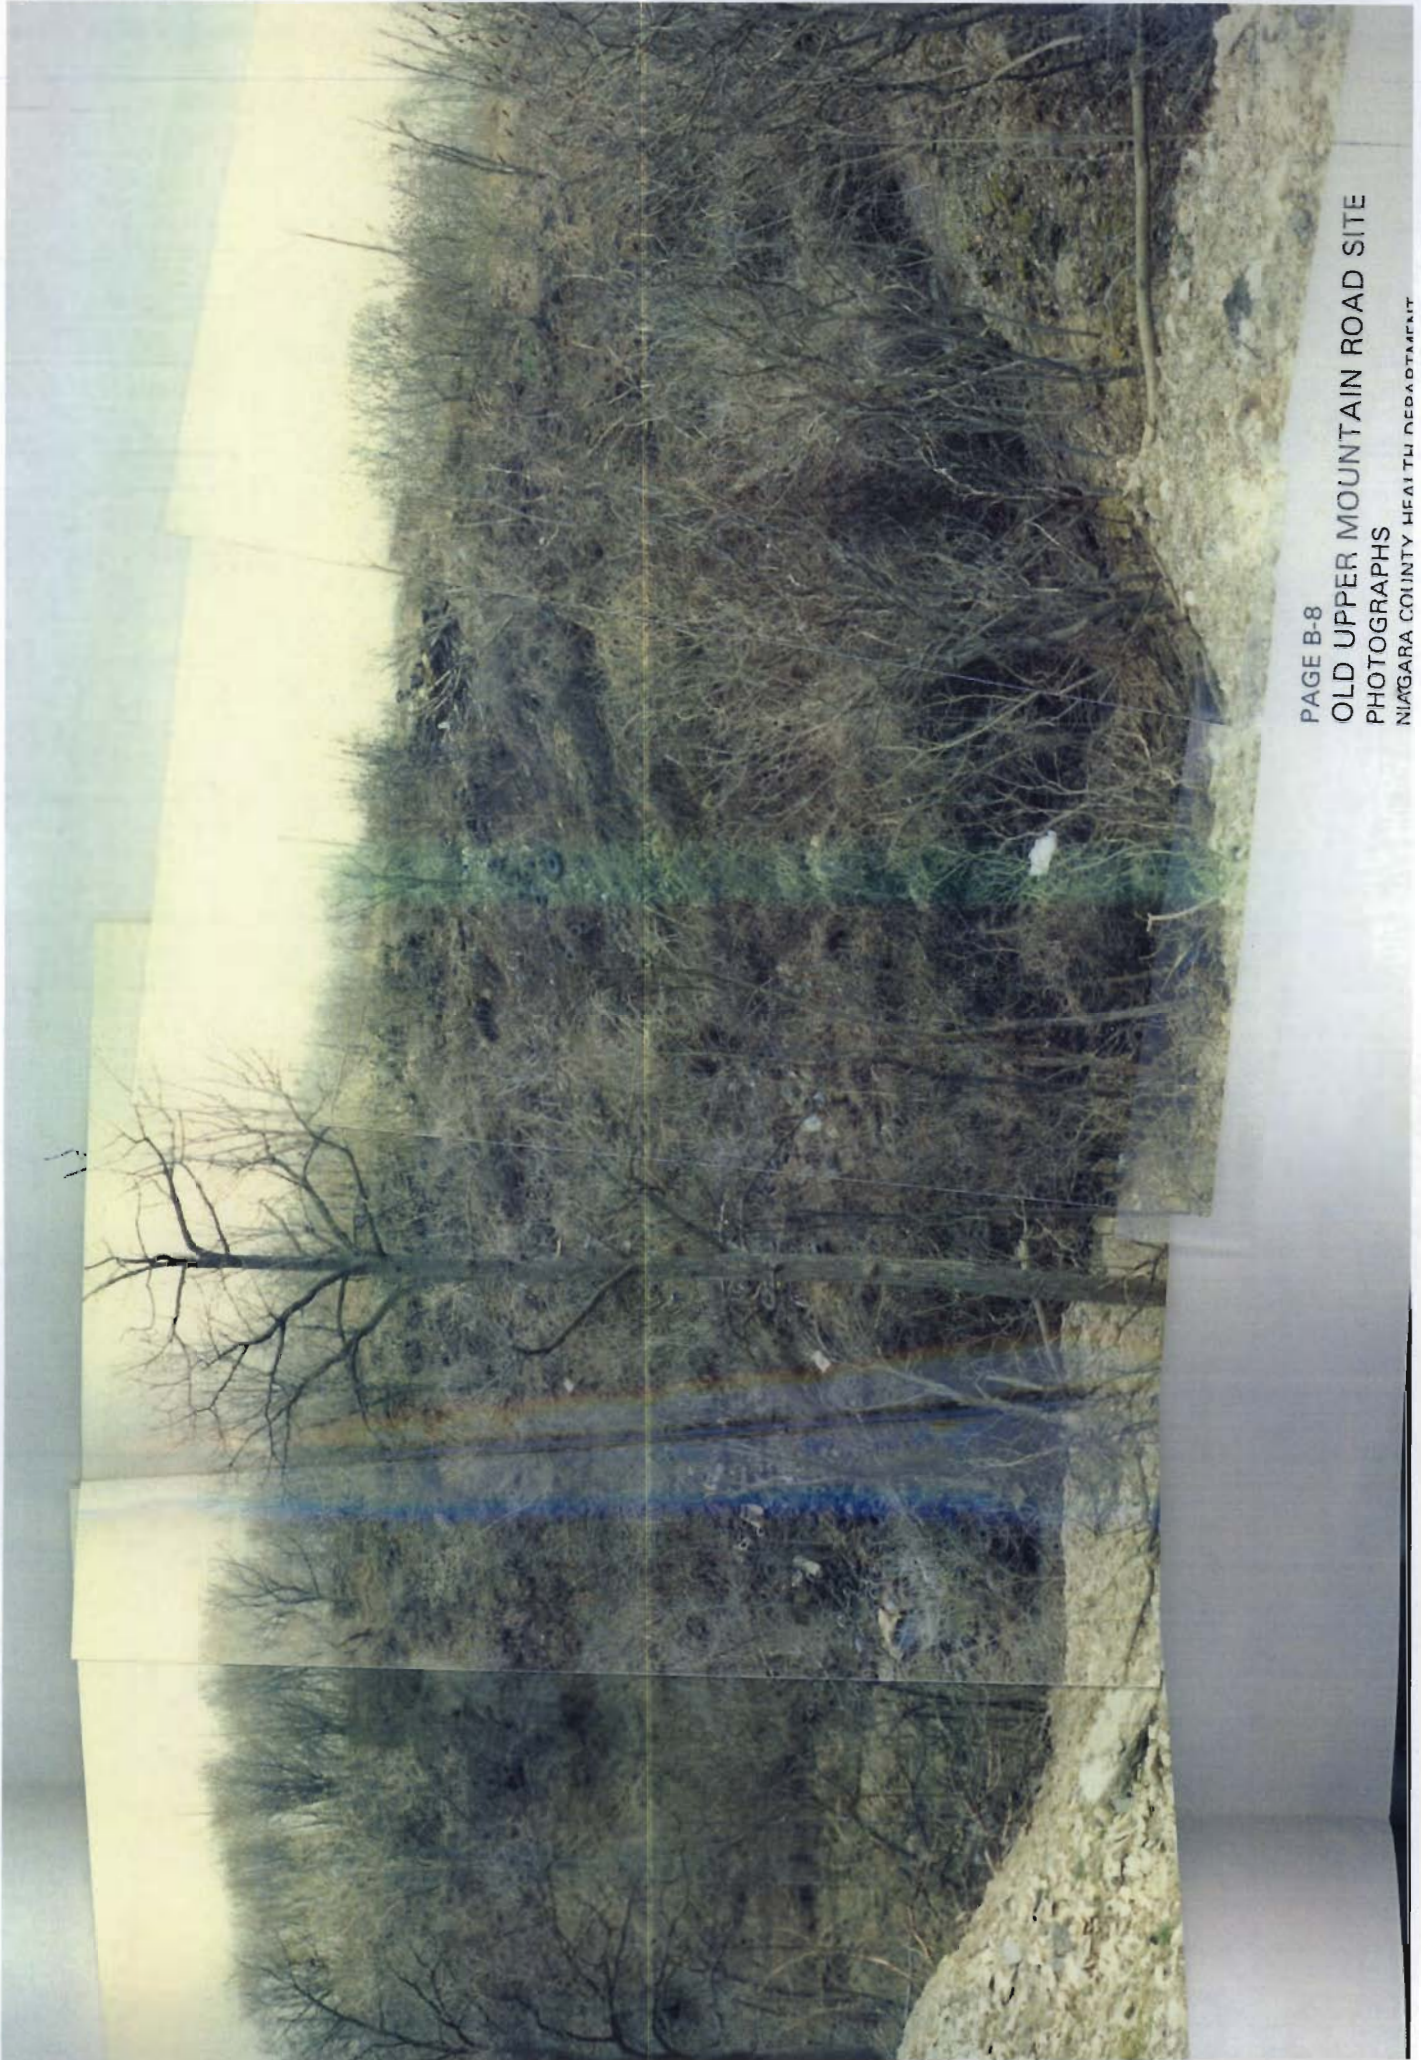
#11 SERIES

#11	Series (four photos to form panorama) looking south to southeast - shows the exposed wastes on the dump face extending vertically from the top of the escarpment to the bottom (at Gulf Creek).
