**PHASE IA LITERATURE REVIEW AND ARCHEOLOGICAL
SENSITIVITY ASSESSMENT**

**Eighteen Mile Creek Superfund Site Remedial Investigation/Feasibility Study
Operable Unit 1 (OU1)**

Water Street
City of Lockport
Niagara County, NY

HAA # 4815-11
OPRHP No. 15PR00095

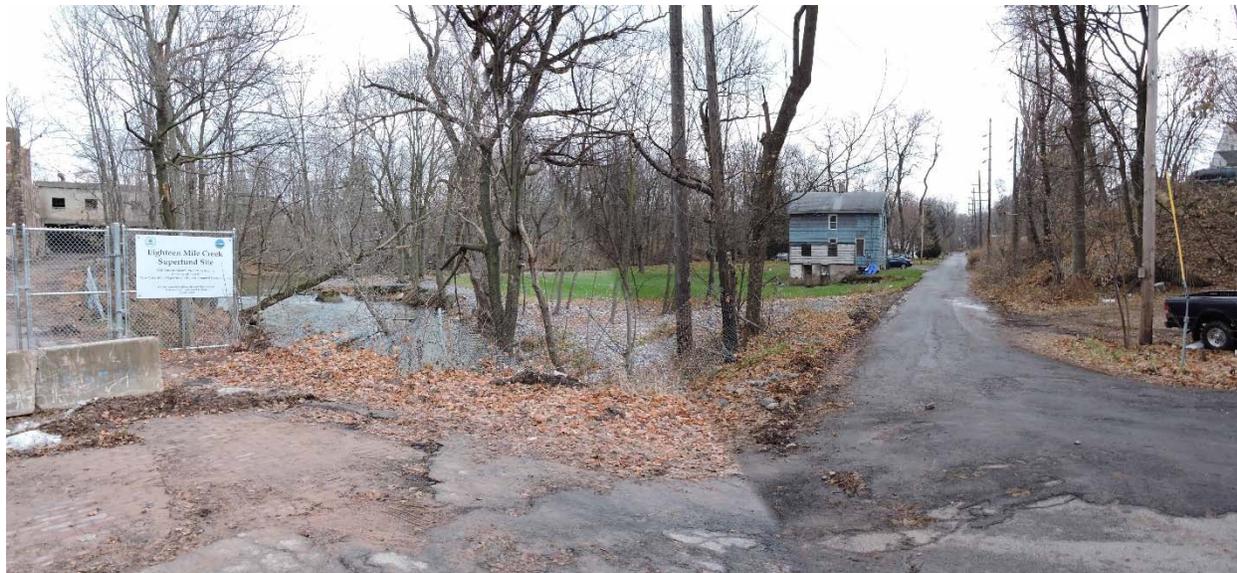
Photo 1. View facing southeast of the OU1 APE from the corner of William Street and Water Street. The blue house to the right is Structure 7, 143 Water Street. Eighteen Mile Creek flows beneath the road through a double culvert (corrugated steel arches set into concrete forms).

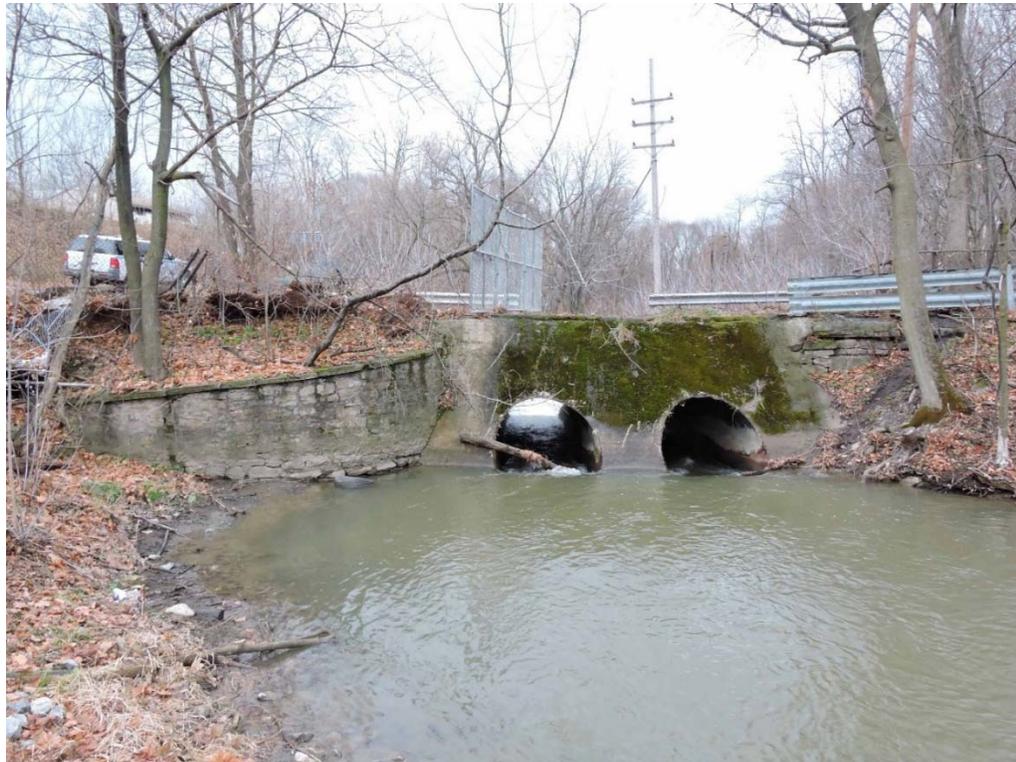
Photo 2. View facing northwest of the double culvert and associated wingwalls beneath William Street at the north end of the OU1 APE. The eastern wingwall composed of dry-laid stone is likely a remnant of an earlier bridge/dam. The double culvert is just outside of the OU1 APE to the north.

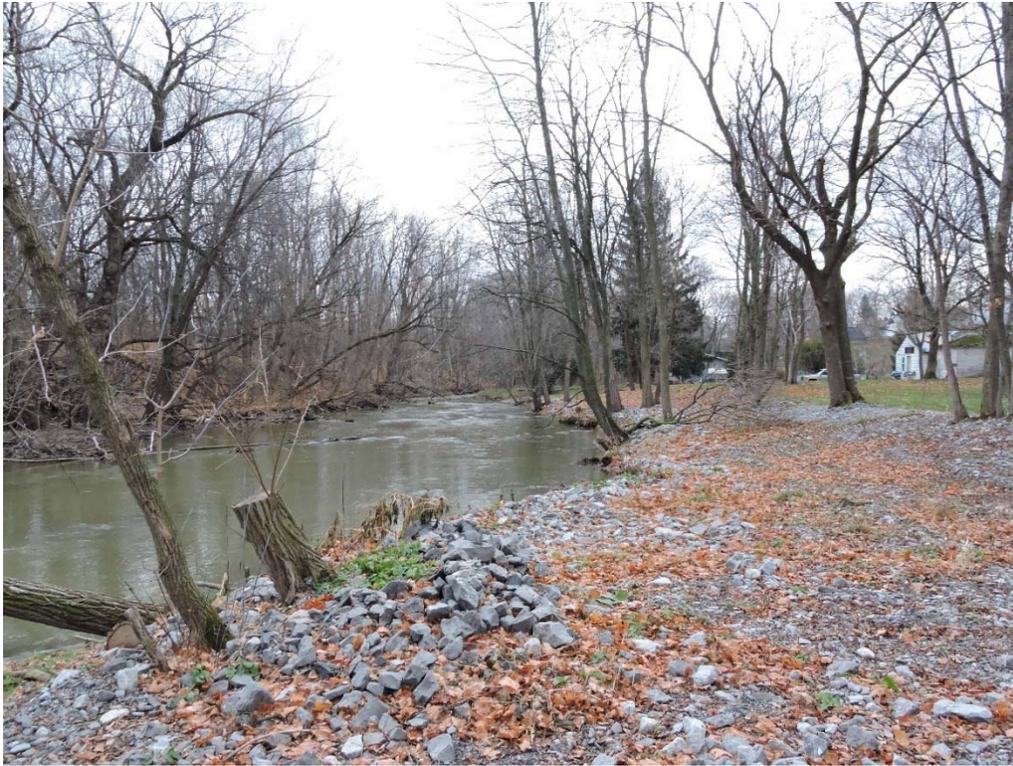
Photo 3. View facing south of Eighteen Mile Creek and the backyards of houses along Water Street. The crushed stone along the creek bank appears to be recent riprap placed to help prevent erosion of sediments. This portion of the APE was once part of a large mill pond.

The east side of the APE was once part of the former mill pond. Today it is exposed and recently covered with stone riprap.

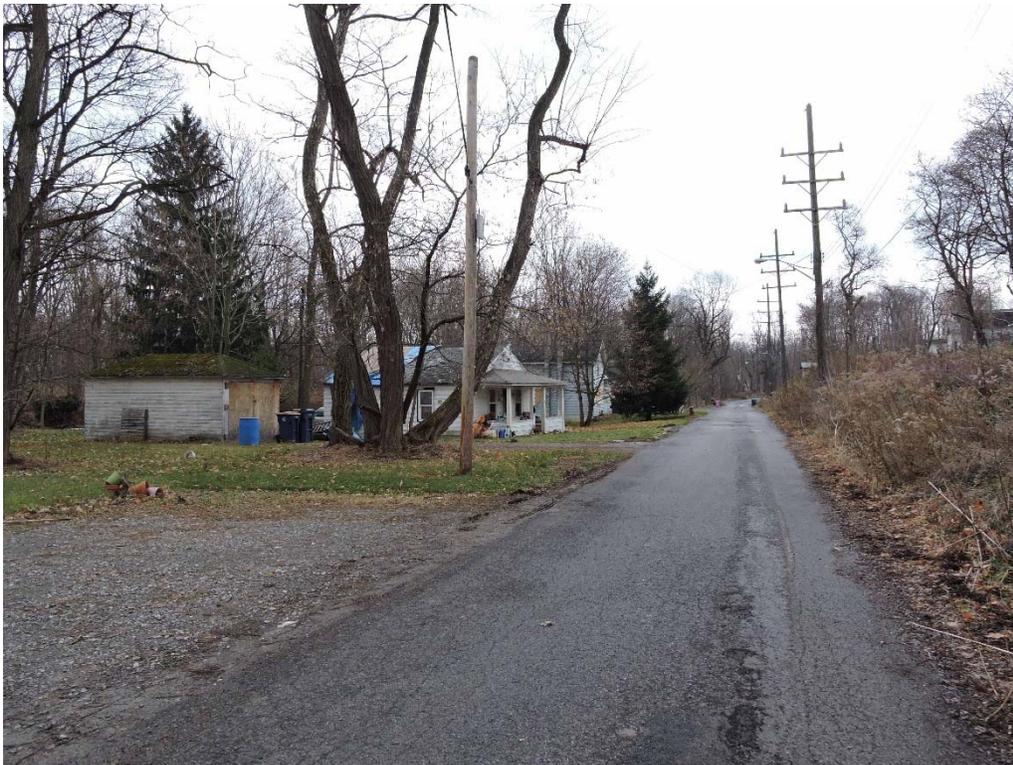
Photo 4. View facing south down Water Street in the OU1 APE. Visible buildings from left to right are 131 Water Street (Structure 9a, garage), 127 Water Street (Structure 11), and 117 Water Street (Structure 5).

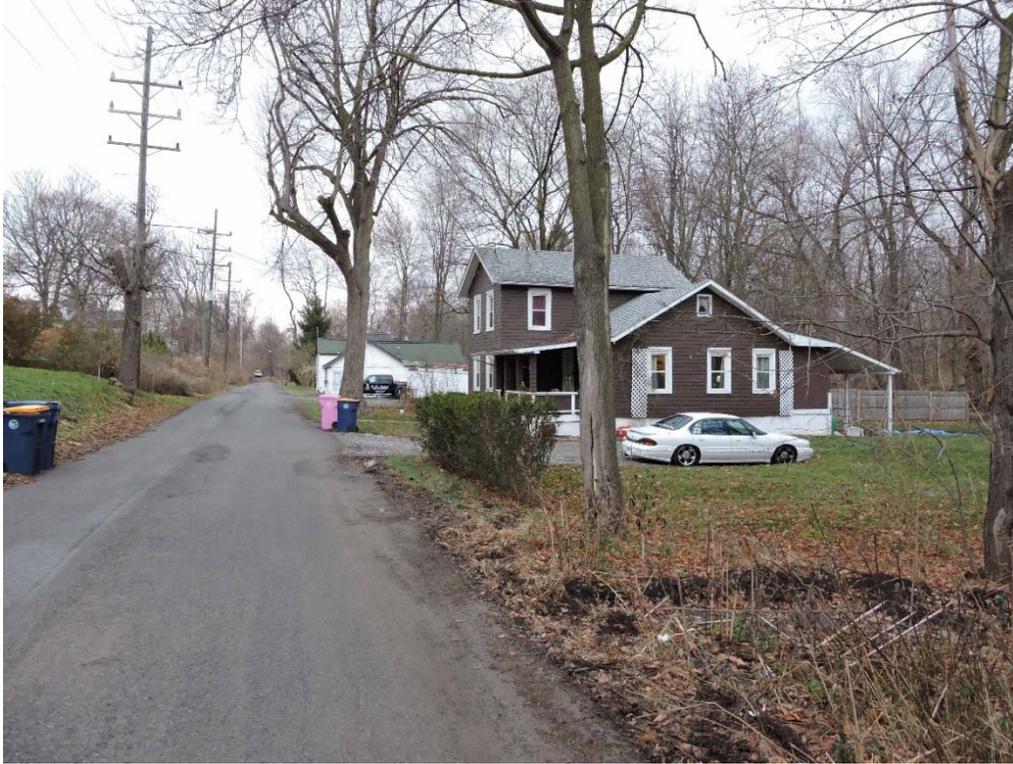
Photo 5. View facing north of the south end of the OU1 APE from the corner of Olcott Street and Water Street. Visible structures are 99 Water Street (Structure 2, foreground) and 113 Water Street (Structure 4, background).

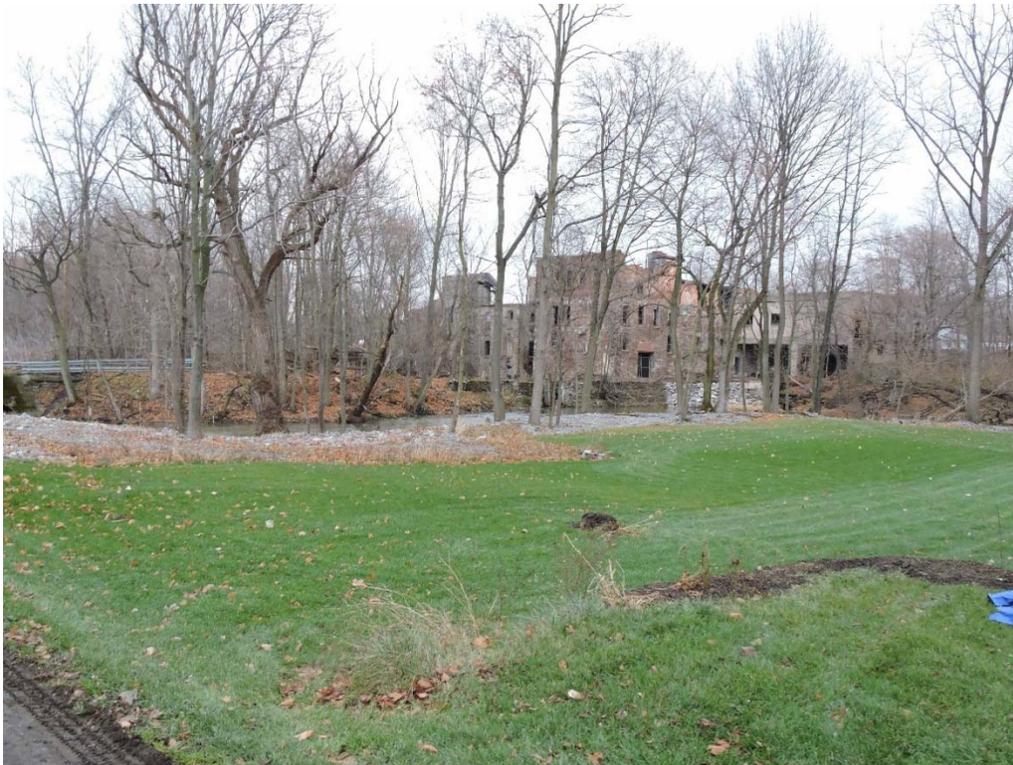
Photo 6. View facing northeast across the northern end of the OU1 APE towards the former Flintkote mill complex on the east bank of the creek. Structure 8 (MDS) formerly stood in this location until the mid-20th century.

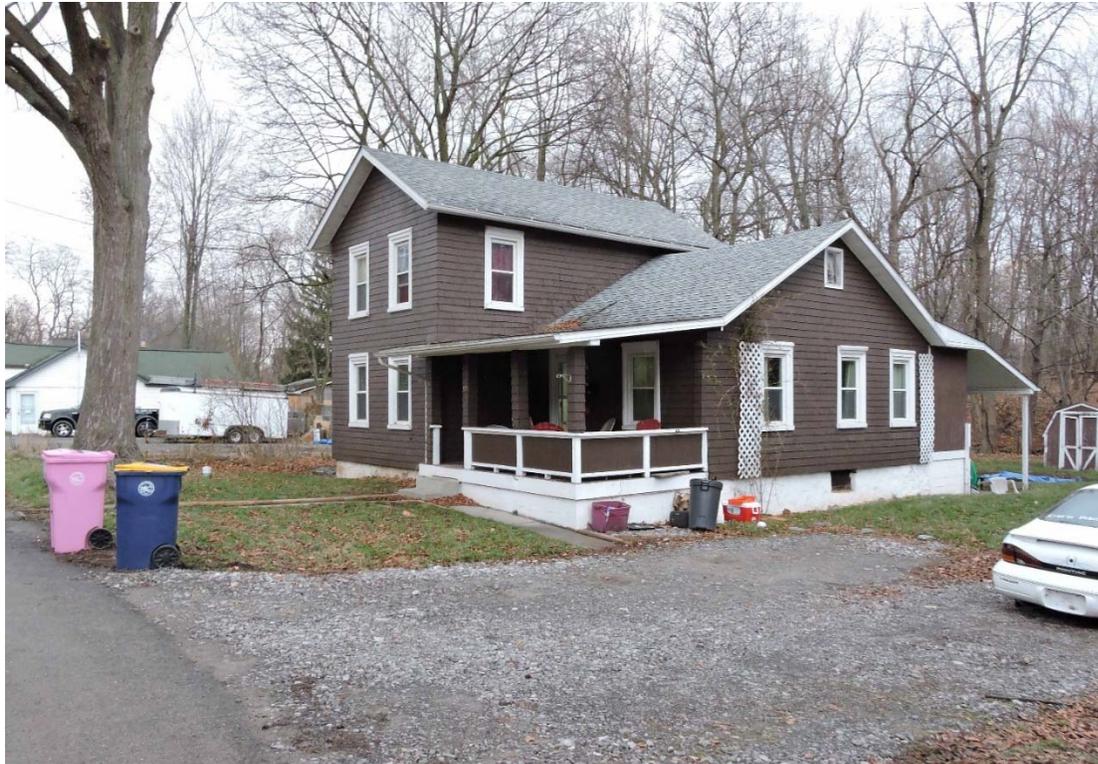
Photo 7. Structure 2, 99 Water Street, looking north. The upright section of this vernacular upright-and-wing house was constructed in 1886 (Sanborn 1886).

Structures within the project APE include five dwellings (Structures 2, 4, 5, 7, and 11; Photos 7–11). All are wood-framed, and were constructed between c.1850 and 1948. Each is a modest single-family vernacular dwelling. The majority are of upright-and-wing form. One example, dating from the second quarter of the 20th century, is a bungalow style dwelling.

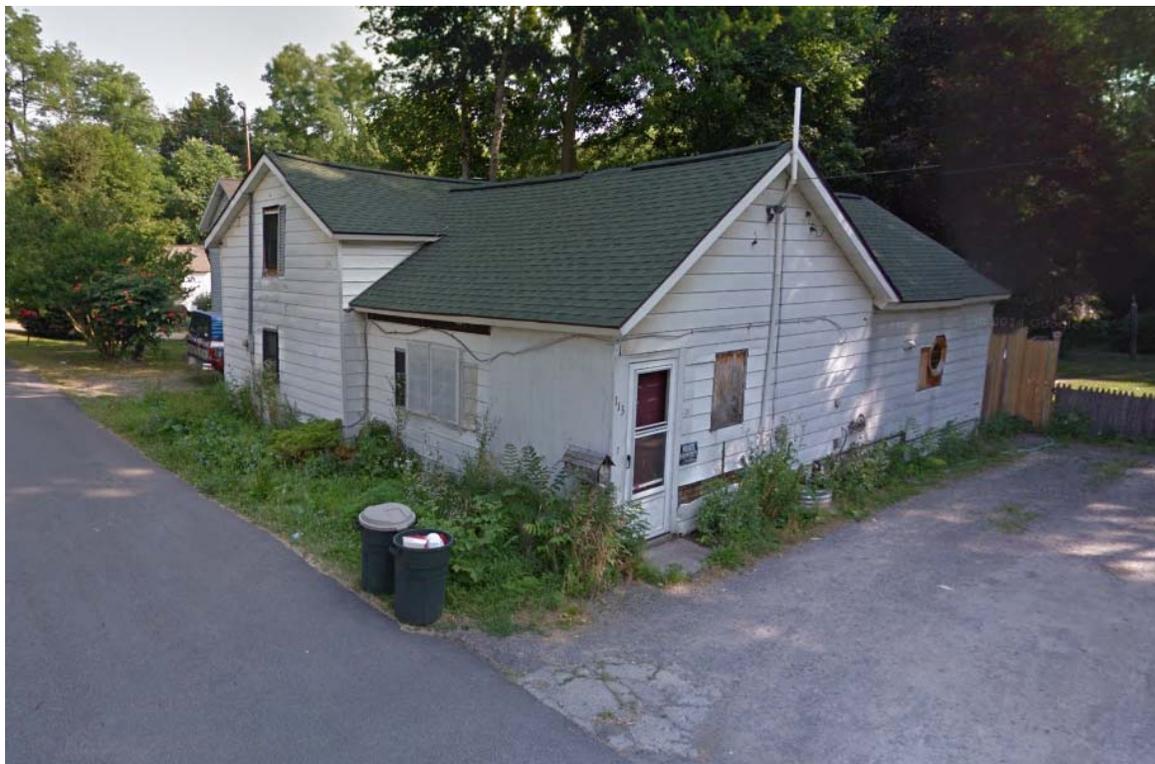
Photo 8. Structure 4, 113 Water Street, looking north. This vernacular dwelling was constructed between 1860 and 1886.

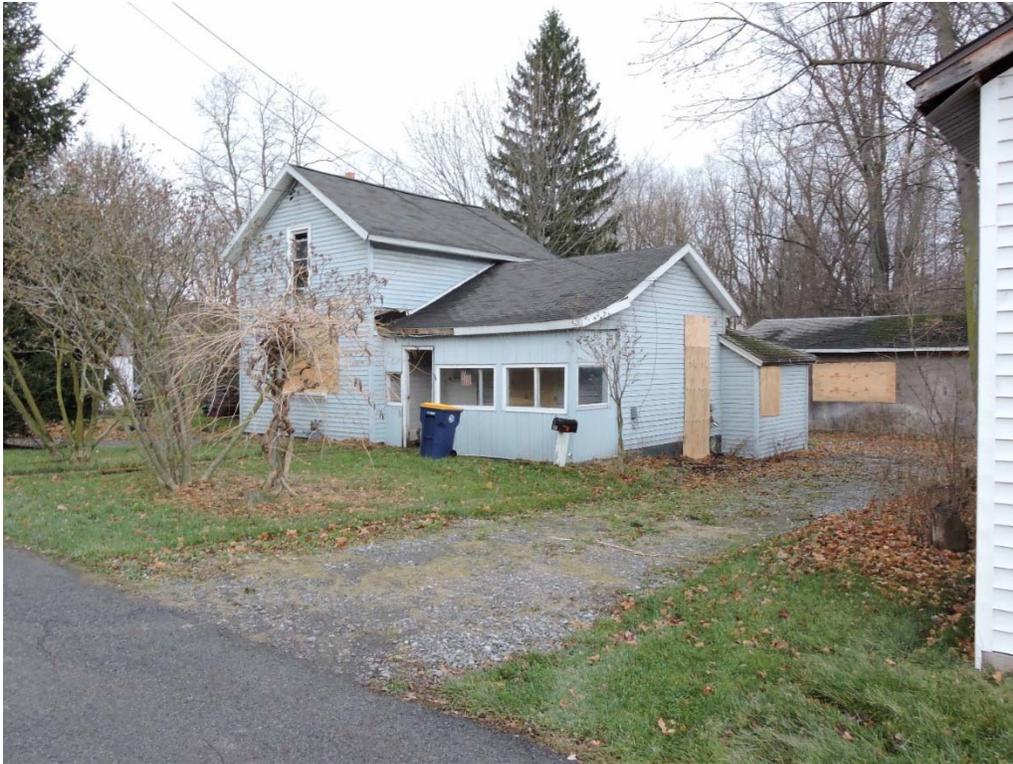
Photo 9. Structure 5, 117 Water Street, looking north. This upright-and-wing vernacular wood frame house was built by 1860, possibly as early as c.1850.

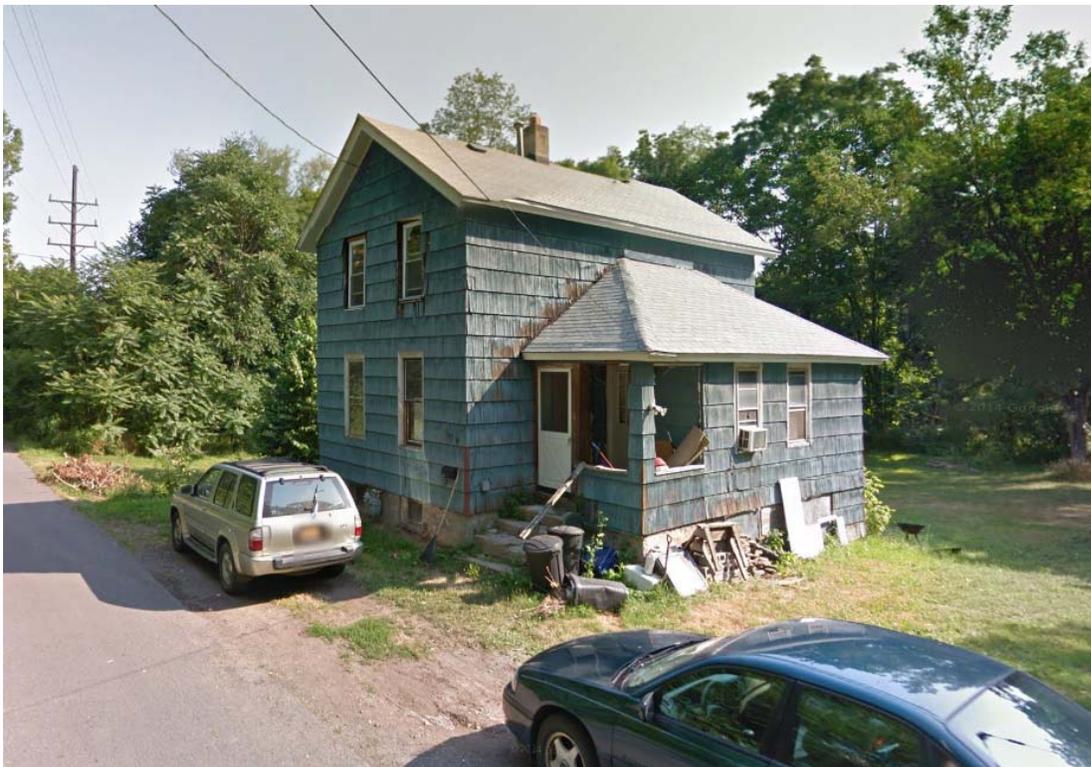
Photo 10. Structure 7, 143 Water Street, looking north. This two-story vernacular house was built before 1860, and has late-19th century additions.

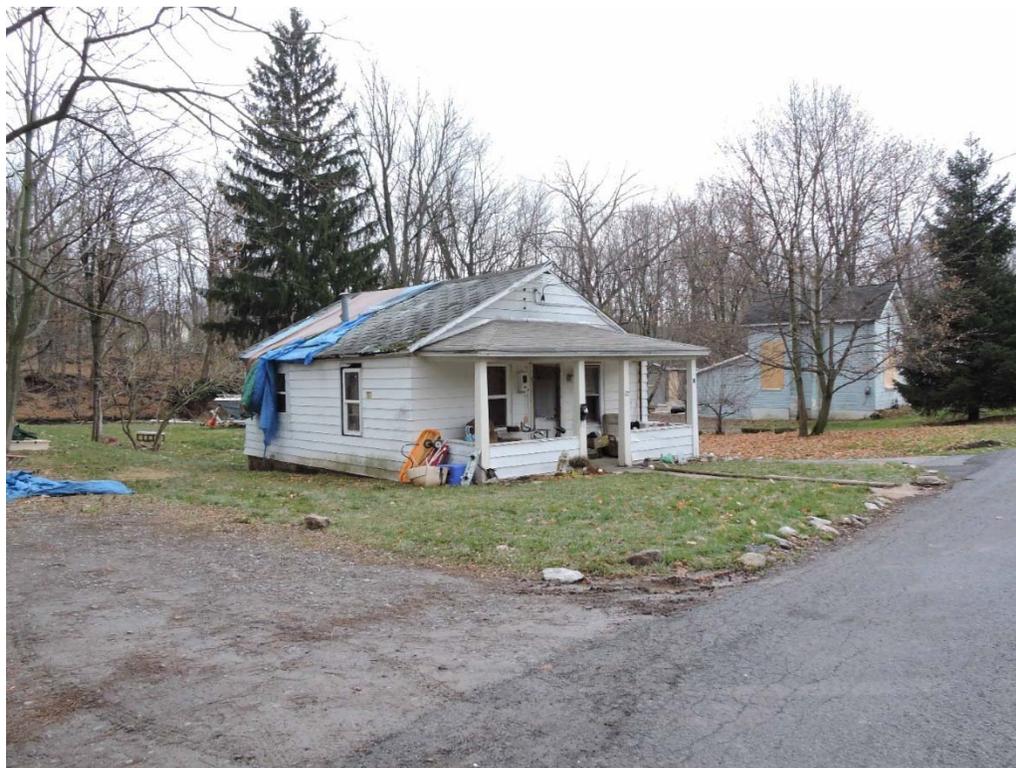
Photo 11. Structure 11, 127 Water Street, looking east. This bungalow style home was constructed between 1928 and 1948.
