RE: Isochem Inc. Lockport Site Voluntary Site Assessment.

Re: ISOCHEM Inc. – Lockport Facility
DNAPL Assessment Report

ATTACHMENT 1 – PHOTO LOG

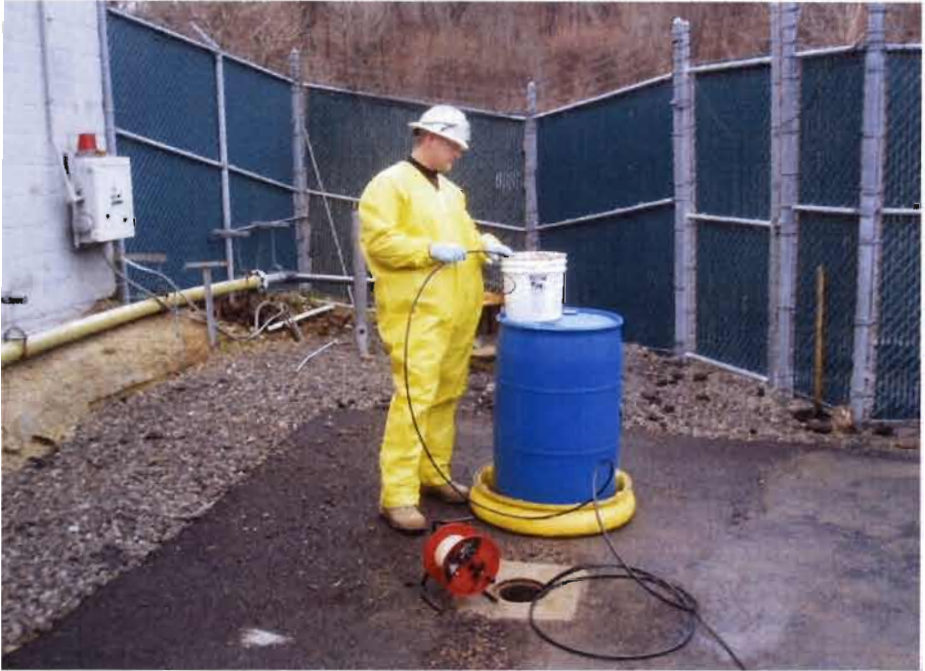
Client Name: Isochem, Inc.		Site Location: Monitoring well MW-2D	Project No.: 0049-007-100
Photo No. 1	Date 01/05/07

Direction Photo Taken: Looking south toward south limit of Site			
Description: Typical surface setup of DNAPL recovery system. Two black tubes are shown; one air line and the other product recovery. Recovered product was stored in the blue drum.

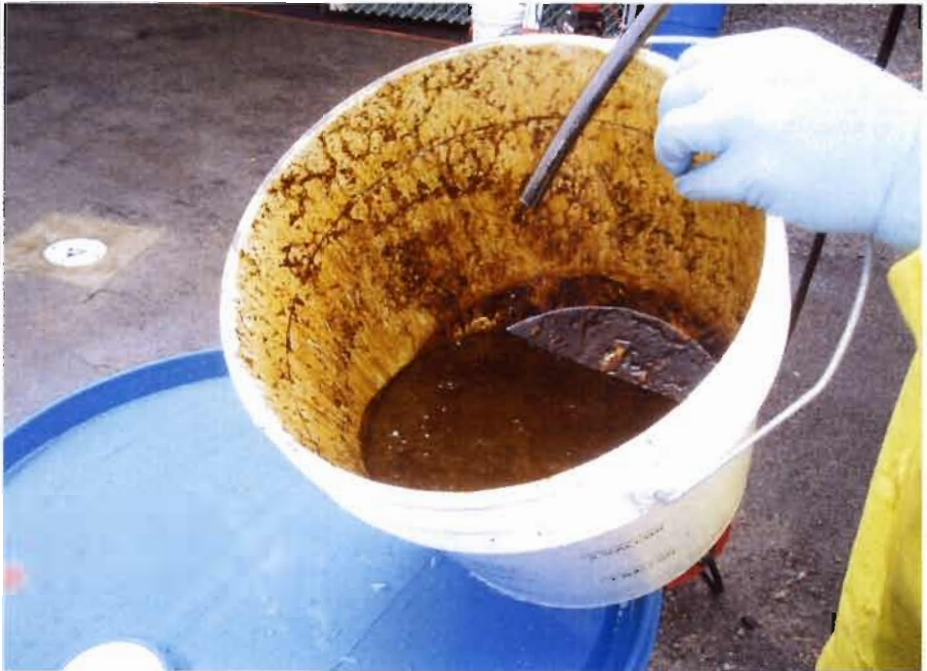
Client Name: Isochem, Inc.		Site Location: Monitoring well MW-2D	Project No.: 0049-007-100
Photo No. 3	Date 01/04/07

Direction Photo Taken: NA			
Description: Typical early discharge of product recovery system.

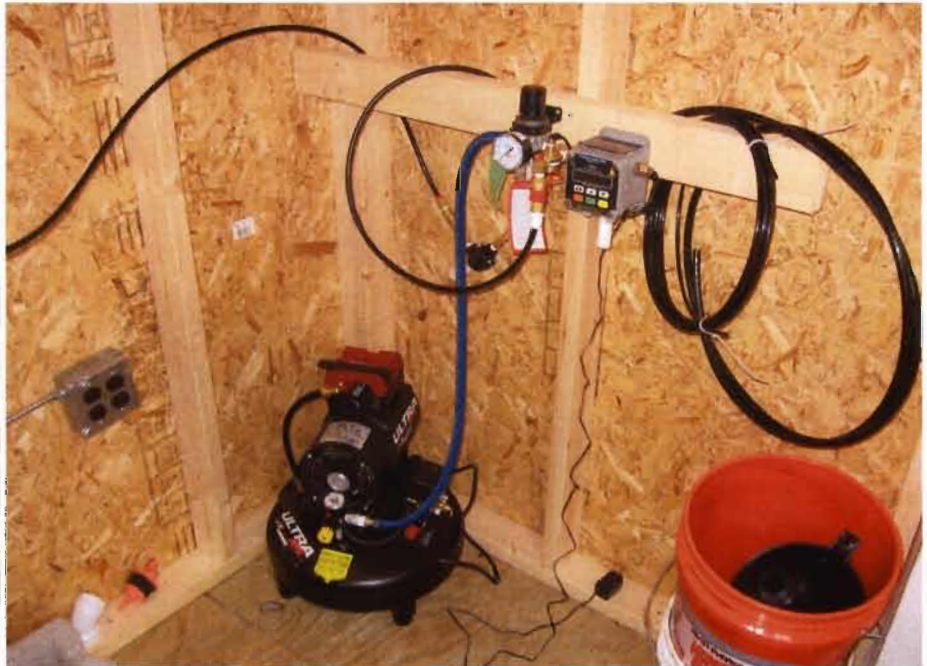
Photo No. 4	Date 03/14/07

Direction Photo Taken: NA		
Description: Inside of product recovery shed showing general layout of controls and air compressor.
