REPORT

FOCUSED CORRECTIVE MEASURES STUDY

VANDEMARK CHEMICAL LOCKPORT, NEW YORK

April 2010

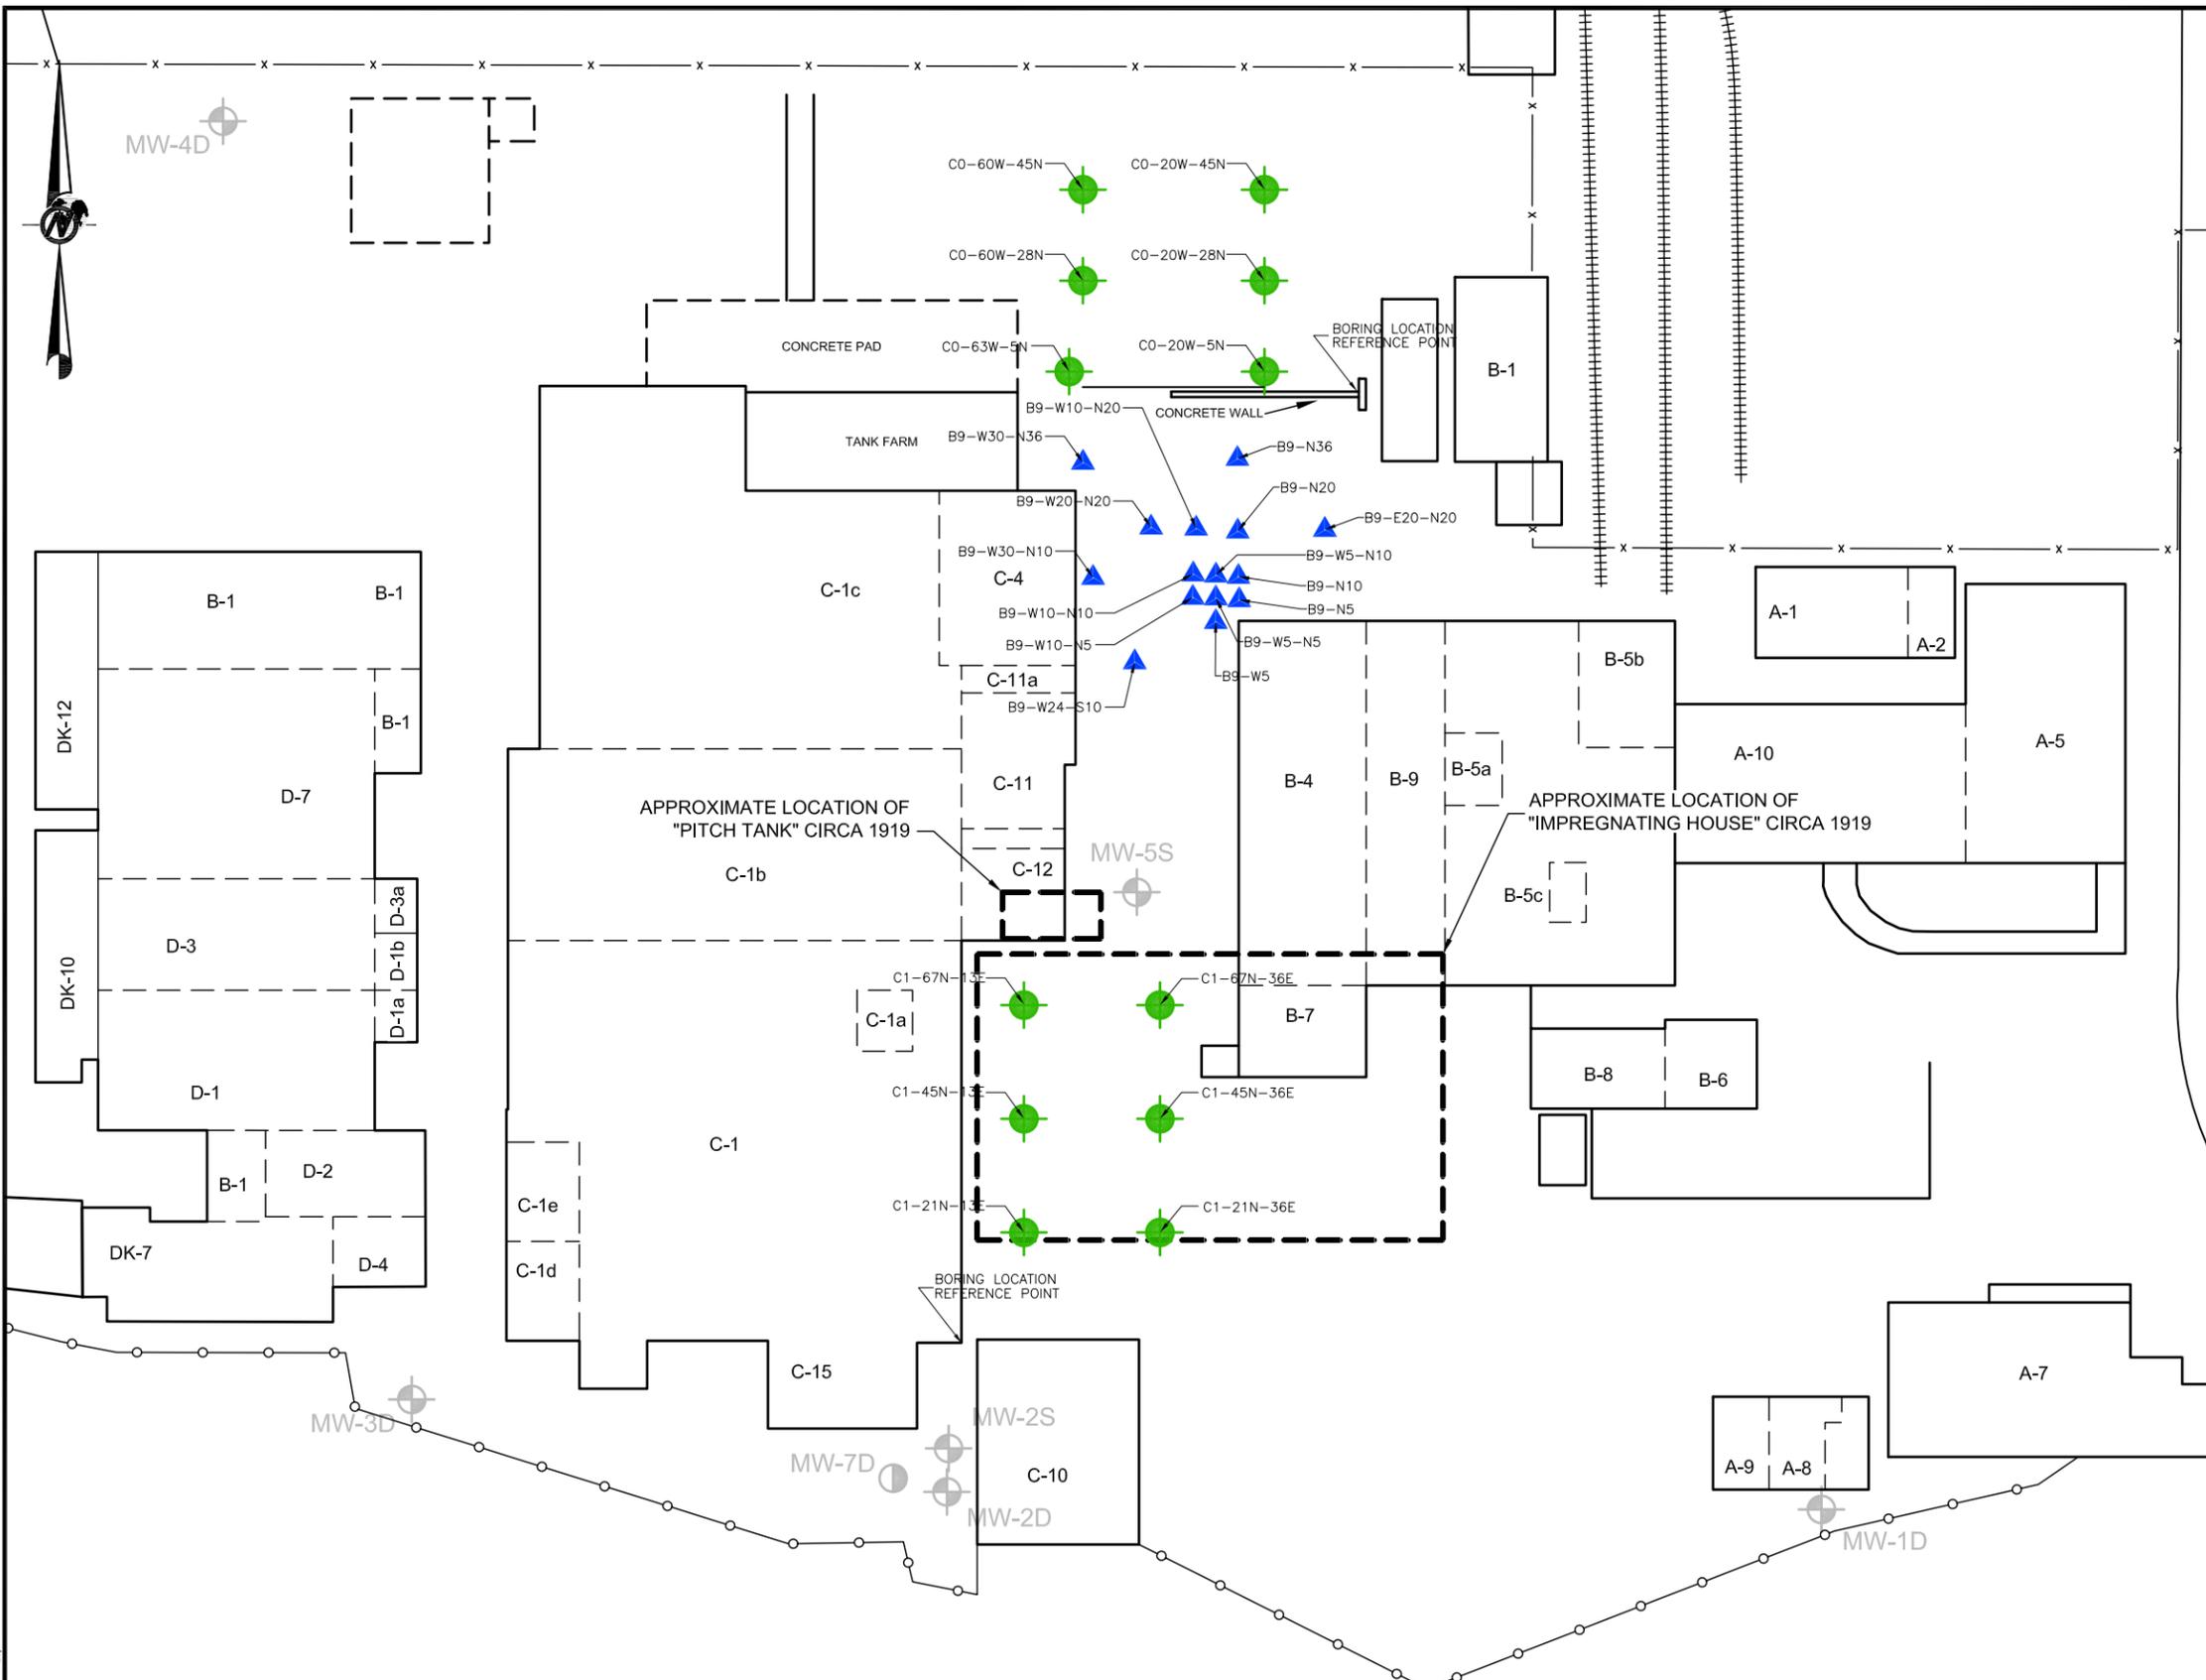
FIGURE 1-2

Figure 1-1	Site Location Map
Figure 1-2	In-Plant Borehole Location Map
Figure 1-3	Creek Bank Test Pit Location Map

All fifteen (15) borings were advanced until refusal, which was assumed to be at bedrock. The investigation determined that the average depth of the bedrock was approximately 5 feet, but varied between 4.5 to 8 feet below ground surface (bgs). The majority of the overburden was non-native fill materials which included crushed brick, concrete, wood, and foundry-like sands.

After the borings were advanced, the cores were examined by Golder and the NYSDEC and then logged. Samples were collected from 4 borings (B9-W5, B9-N10, B9-W5-N10, and B9-W10-N5). Due to the consistency of the coal tar found in each subsequent boring, Golder and the NYSDEC agreed that it was not necessary to collect any more samples for laboratory analysis. The first 9 borings were screened for VOCs by Golder using a PID. No VOCs were detected by the PID. Olfactory observations were also made for all the borings. All borings exhibited coal tar odor except borings B9-W5, B9-W30-N10, B9-E20-N20, and B9-W24-S10, however, samples B9-W30-N10 and B9-W24-S10 did have a petroleum-like odor.

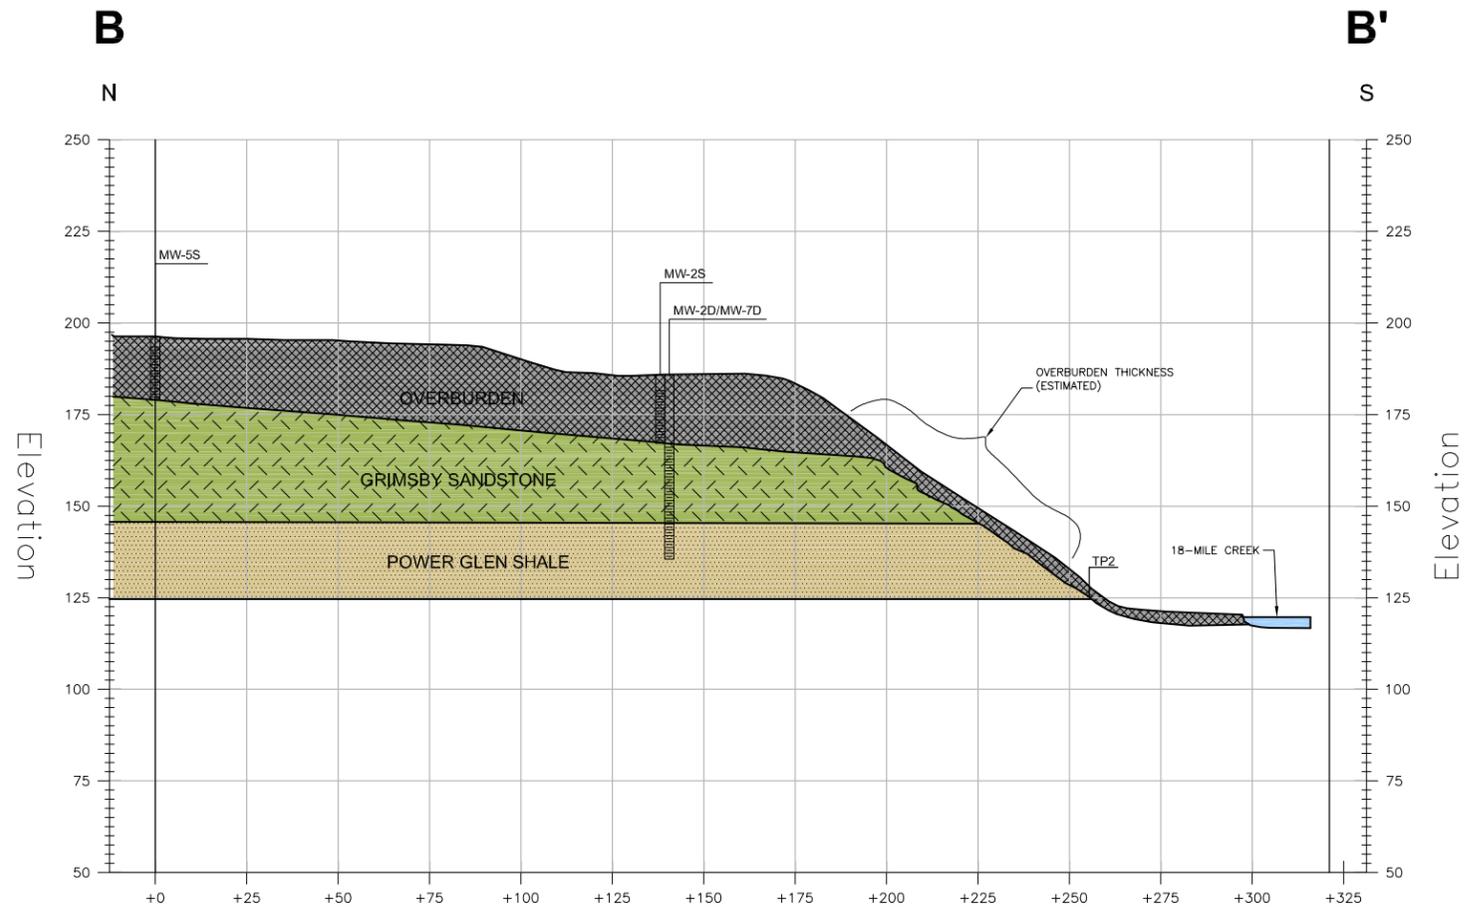
Figure 1-4 Slope Cross Section (B-B')
Figure 1-5 Test Pit Cross Section
Figure 5-1 Alternative No.2 Overburden & Bedrock Containment Curtain Layout

The unit underlying the Grimsby Sandstone is the Power Glen Shale, described in MW-7D as a dark gray with light to medium gray banded, horizontally bedded, very hard, shale. Also noted were clay filled horizontal fractures. These units are both part of the Lower Silurian age Medina Group. Both units are shown in cross sections of the site, shown in Figure 1-4.

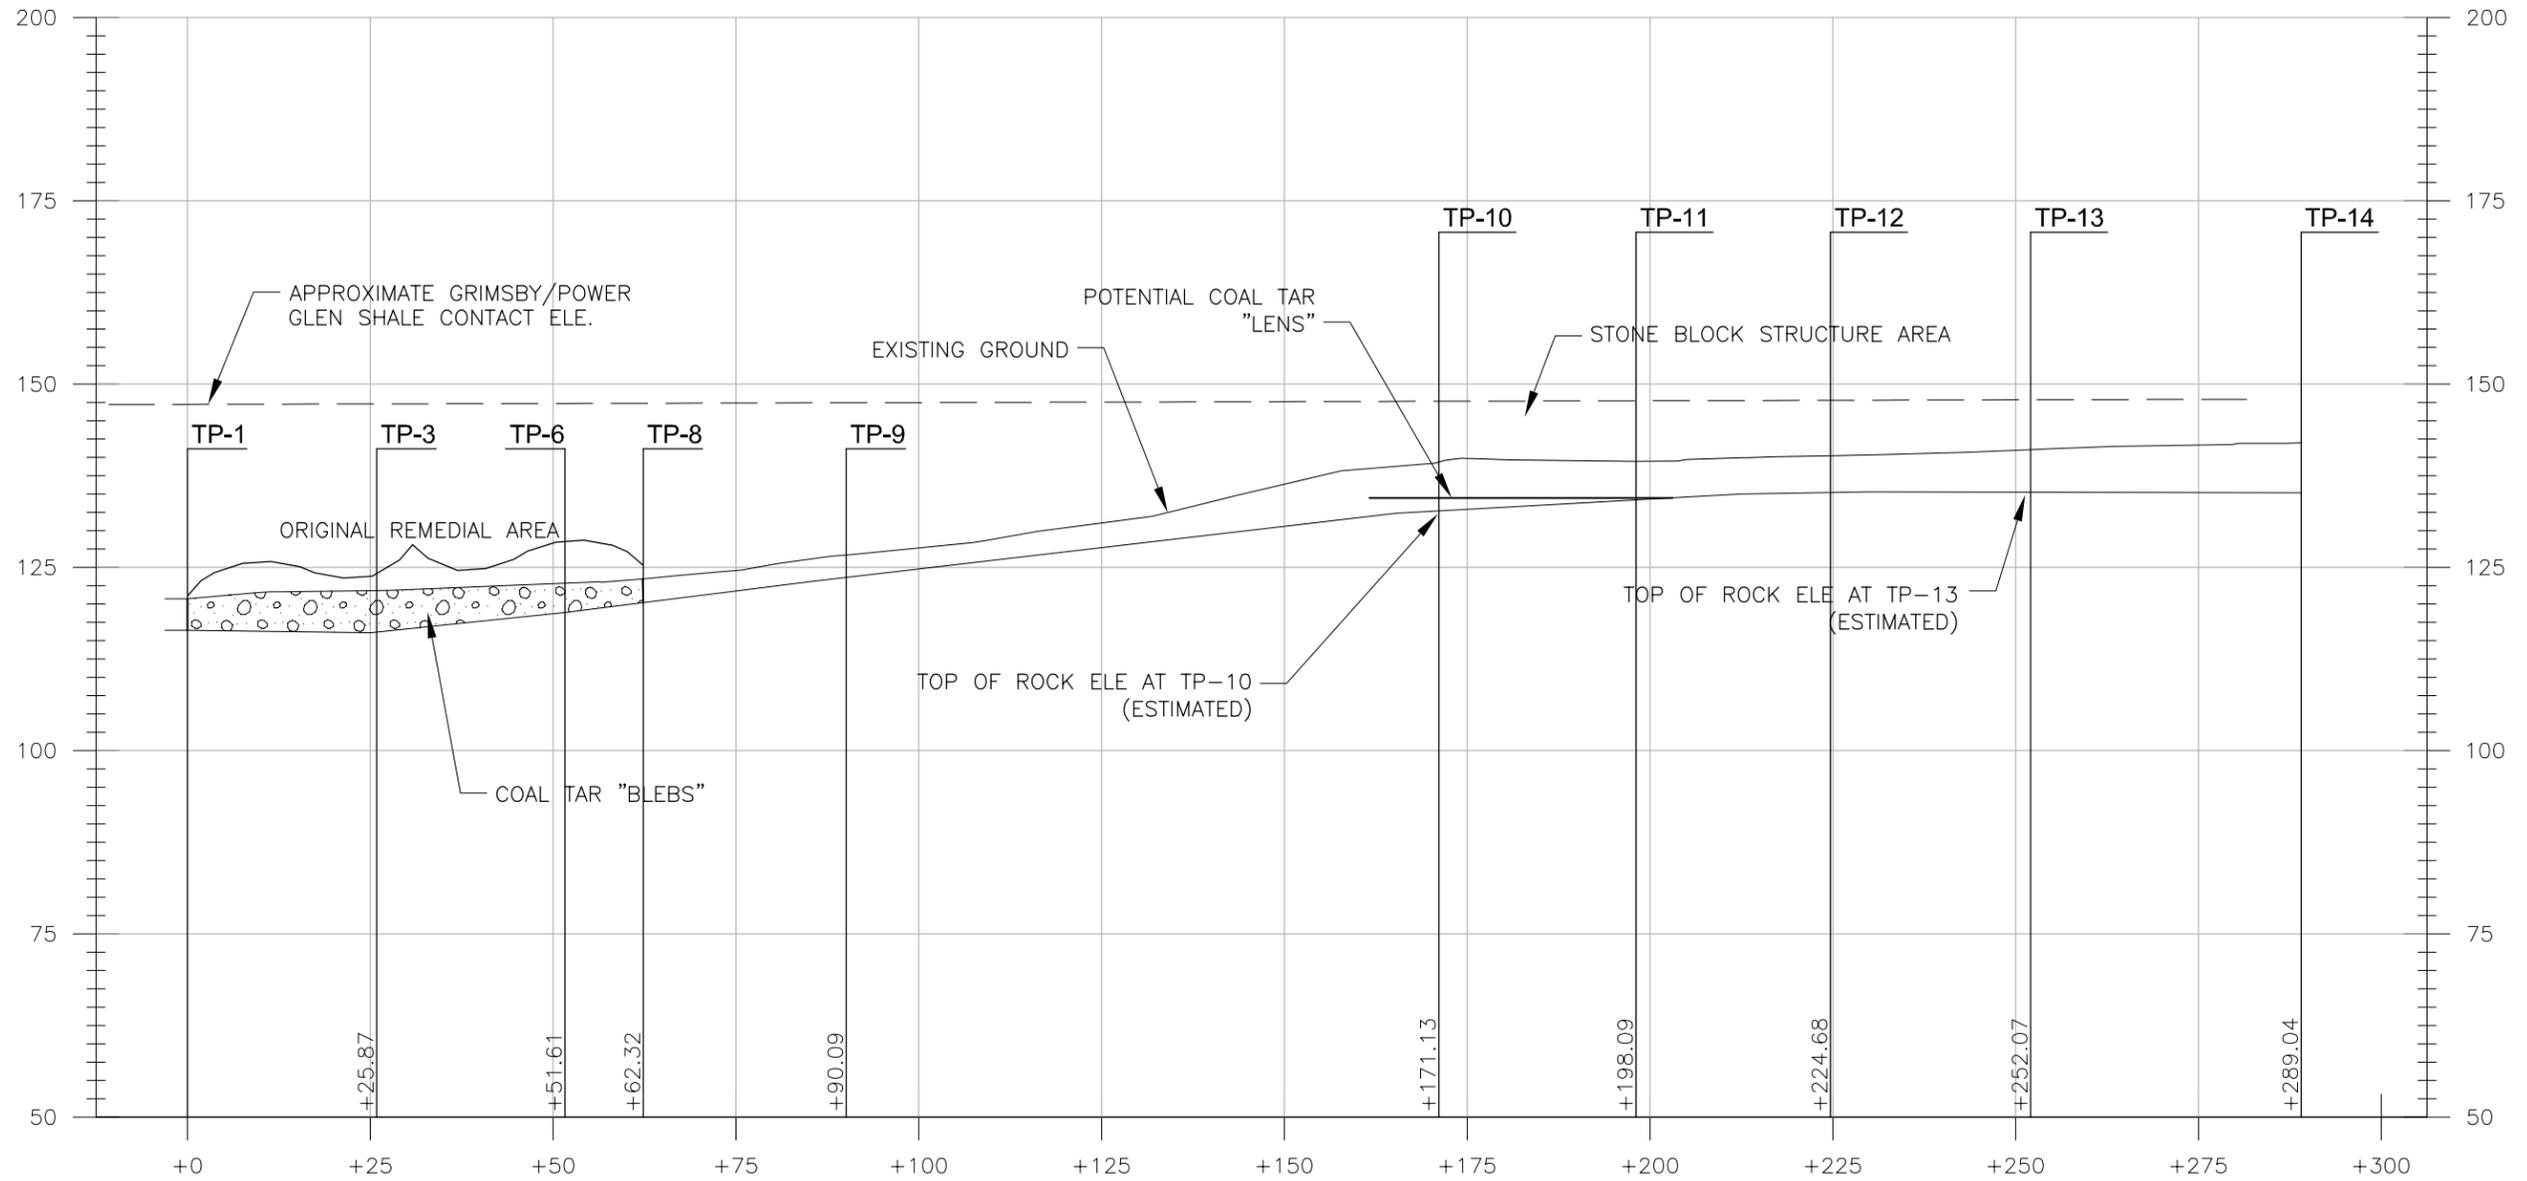
FIGURE 1-5

REV	DATE	DES	REVISION DESCRIPTION	CADD	CHK	RW
PROJECT: SNPE - VANDEMARK FOCUSED CORRECTIVE MEASURES STUDY LOCKPORT, NEW YORK						
TITLE: TEST PIT CROSS SECTION						
PROJECT No. 093-89168		FILE No. 09389168A015				
DESIGN	AL	07/29/10	SCALE AS SHOWN	REV. 0		
CADD	AML	04/12/11				
CHECK						
REVIEW

The discovery of coal tar residuals in test pits TP10 through TP13 to the east of the previously remediated area is consistent with the understanding of the bedrock geology of the formation. The vertical fracture planes that would act as a conduit for DNAPL/coal tar residuals to be conveyed from the top of bedrock deeper into the formation are expected to be oriented in both a southwest and southeast directions. This would be consistent with the discovery of the two primary deposition areas along the toe of the slope separated by an area that appears to have little or no coal tar residuals (i.e., between TP9 and TP-10).

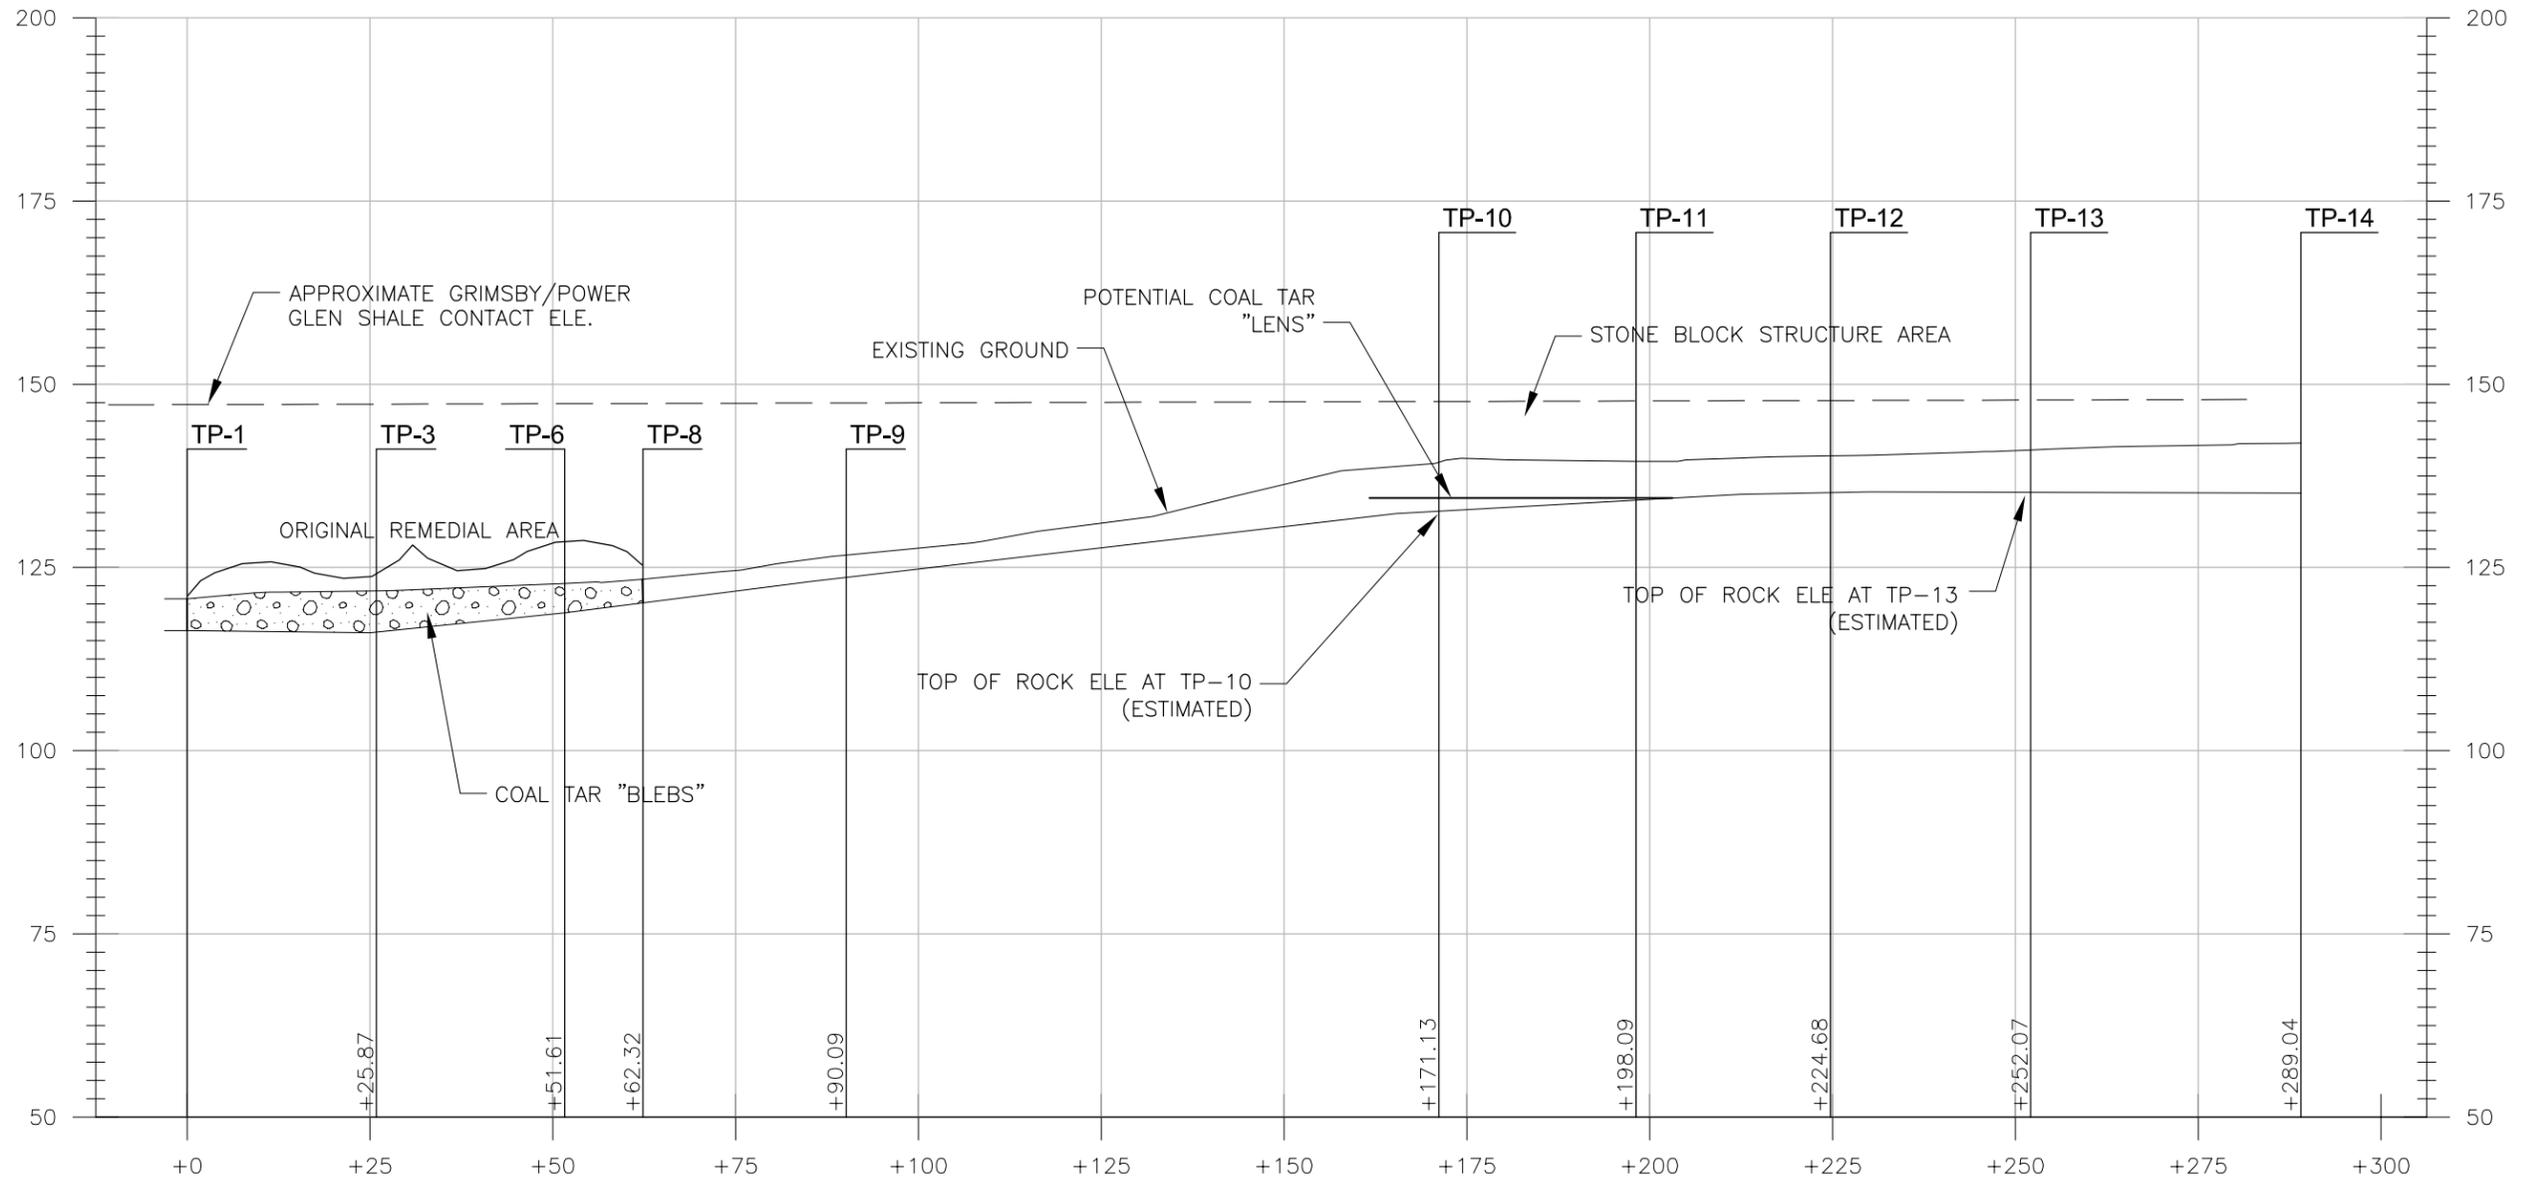
FIGURE 4

REV	DATE	DES	REVISION DESCRIPTION	CADD	CHK	RW
PROJECT						
SNPE - VANDEMARK 2010 SUPPLEMENTAL DNAPL INVESTIGATION SUMMARY LOCKPORT, NEW YORK						
TITLE						
TEST PIT CROSS SECTION						
<small>NJ Authorization #240A28029100</small>						
PROJECT No.		093-89168		FILE No.		09389168A006
DESIGN	AL	07/29/10	SCALE	AS SHOWN	REV.	0
CADD	GLS	08/09/10				
CHECK						
REVIEW
