2014 ANNUAL MONITORING / INSPECTION REPORT

SNPE- VDM Creek Bank Corrective Actions

VanDeMark Chemical Inc. – Lockport, New York

Project No. 093-89168

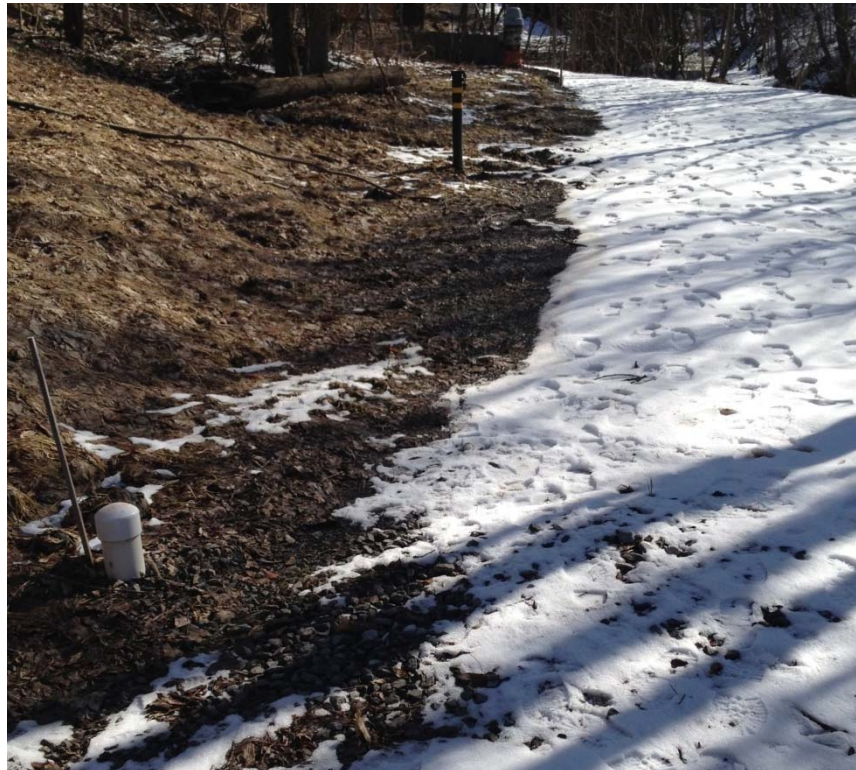
**2014 Annual Report: VanDeMark Chemical Creek Bank Operations & Monitoring Plan****PHOTO 1**

Condition of access road observed at upper creek area during March 2014 inspection event, with piezometer and observation sump, looking east.

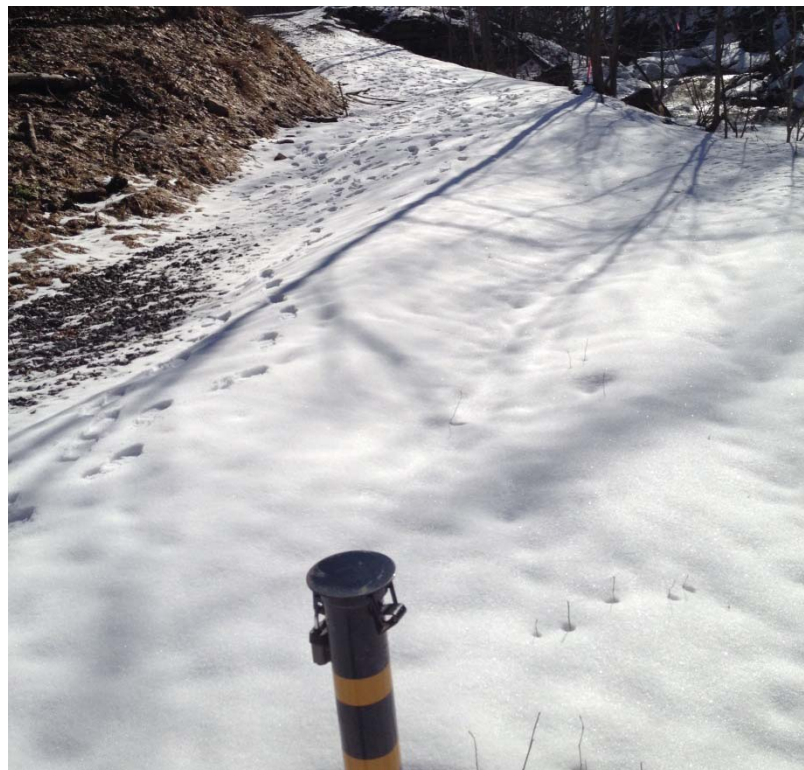
**PHOTO 2**

Condition of access road at lower creek area during March 2014 inspection event, with piezometer and north slope toe, looking east.

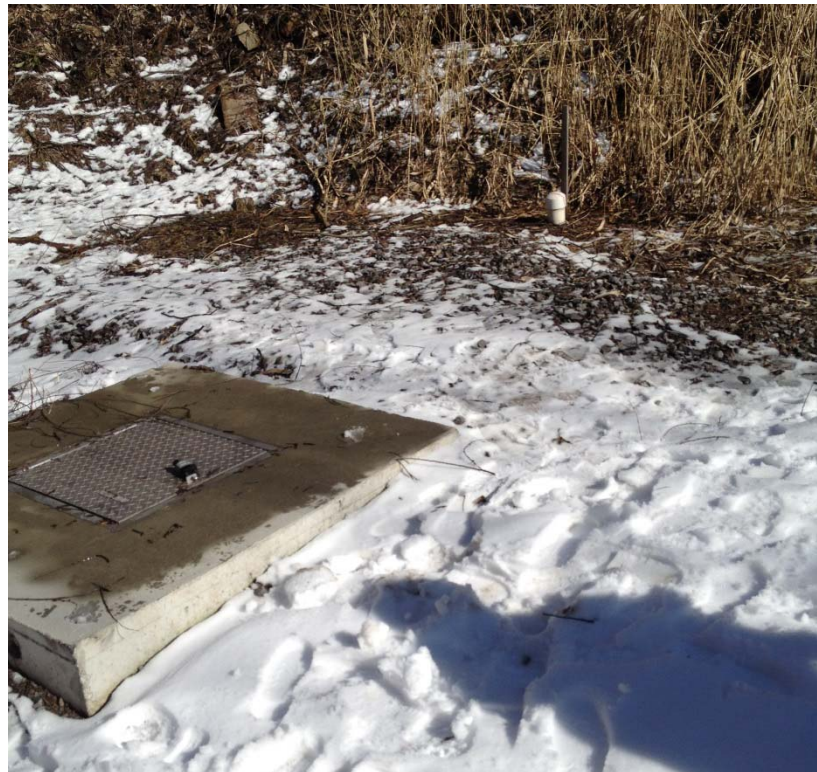
**PHOTO 3**

Collection trench filter sump hatch during March 2014 inspection event.

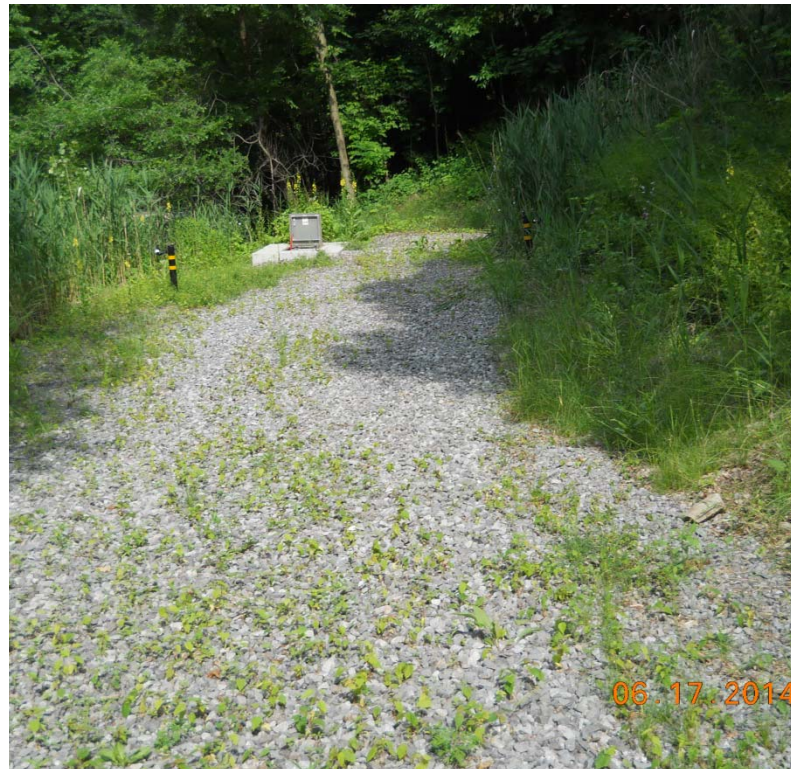
**PHOTO 4**

Condition of access road observed at lower creek area during June 2014 inspection event, with piezometers and filter sump at west end of collection trench alignment, looking west.

Some clearing of storm debris from downed trees was performed by VDM along the access road down to the bottom of the Creek Bank Area to maintain good access to the piezometers and effluent vault.

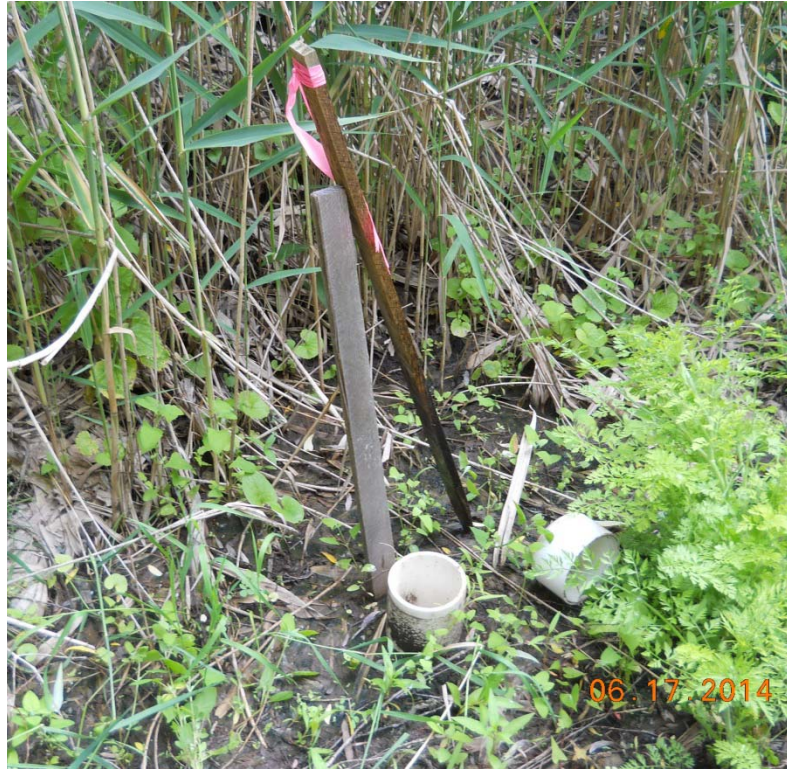
**PHOTO 5**

Observation sump at west end of collection trench, looking northeast.

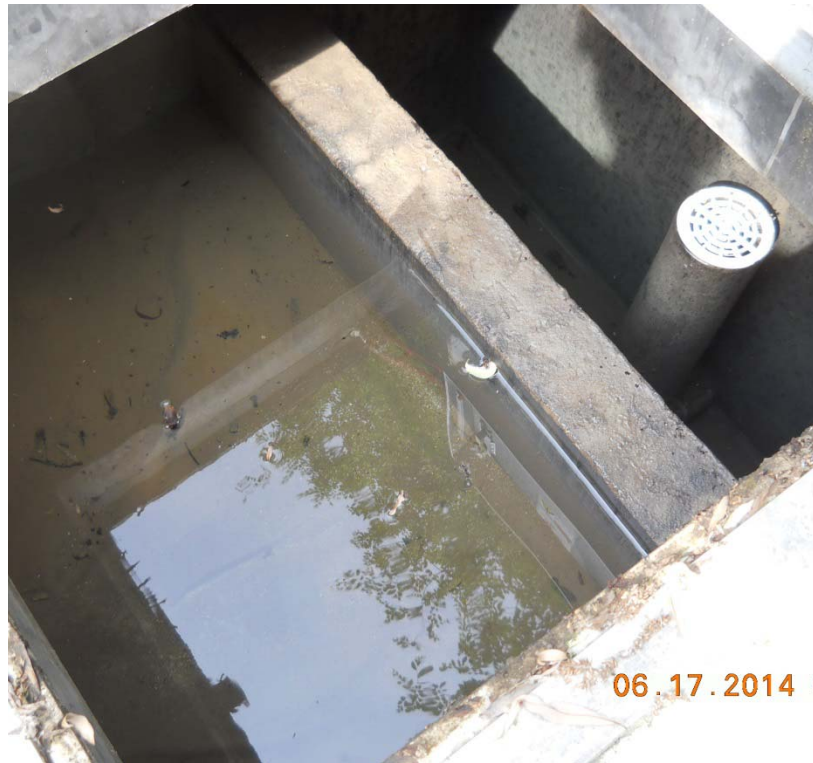
**PHOTO 6**

Filter bed material on floor of filter sump in excellent condition during June 2014 event. No observed DNAPL on filter surface and negligible sediment was present.

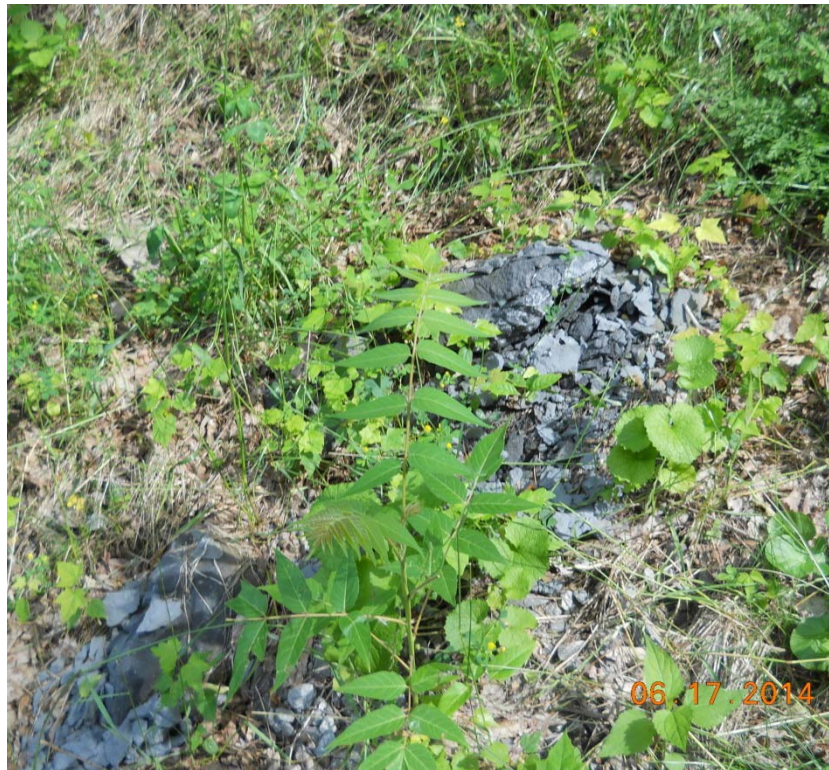
**PHOTO 7**

Observed existing coal tar (heavily weathered) outbreak along embankment on north side of collection trench during June 2014 inspection event.

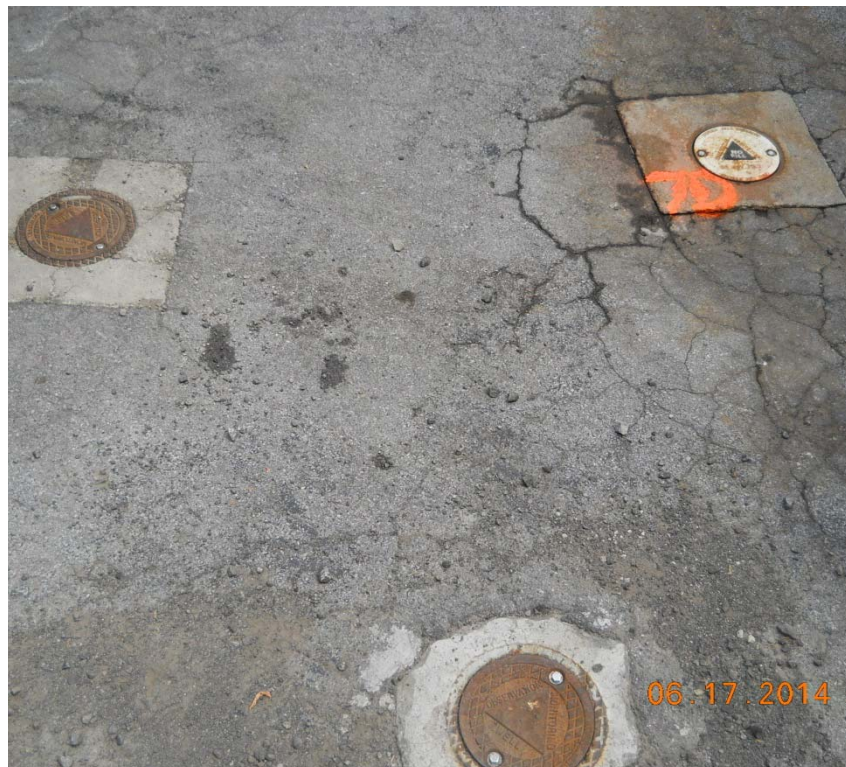
**PHOTO 8**

Monitoring wells, within facility fence line, north of slope. 7D labeled during June 2014 sample event, looking north.
