December 21, 2009 093-89168

RE: SNPE - VANDEMARK CHEMICAL DNAPL ASSESSMENT & SUPPLEMENTAL WORK PLAN VANDEMARK CHEMICAL FACILITY, LOCKPORT, NY

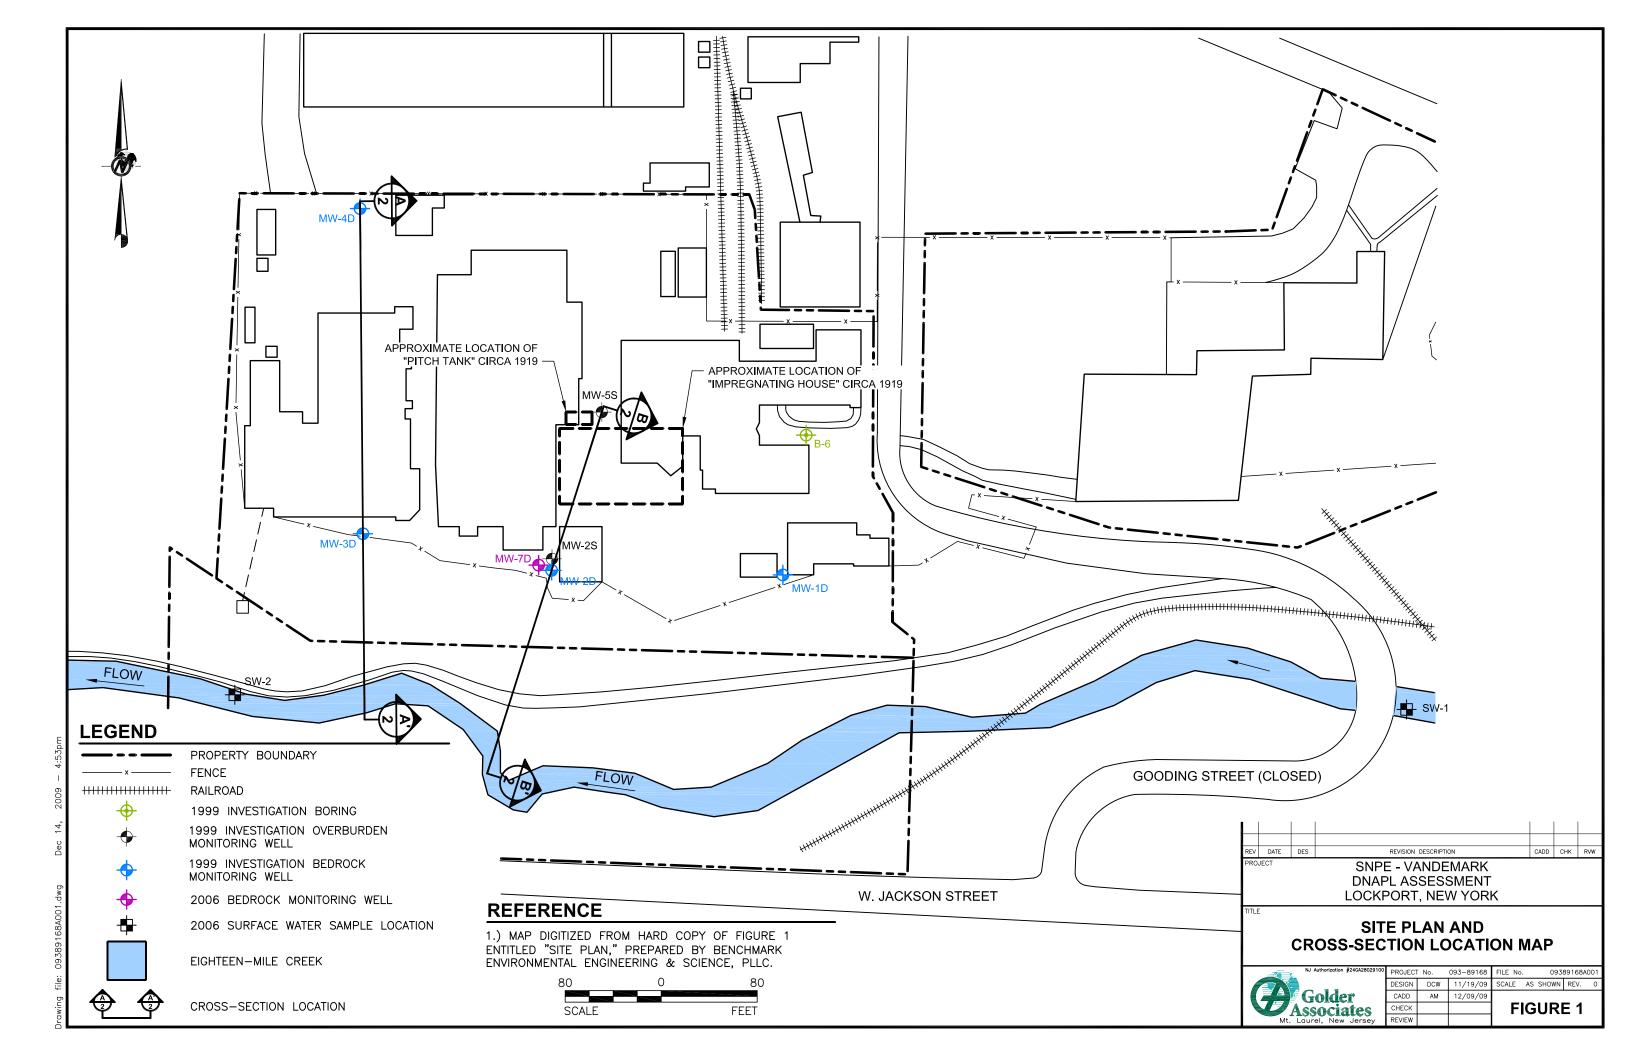
In October 2006, SNPE, as site Owner at that time, conducted sampling of the on-site groundwater monitoring wells network as part of due diligence efforts associated with the pending sale of the facility. The sampling effort identified the presence of a significant amount of dense non-aqueous phase liquid (DNAPL) in the deeper bedrock monitoring well (MW 2D) located approximately 25 feet north of the top of the creek bank in a paved area just west of the training and men's locker room building (Figure 1).

Though the exact mechanism for how the DNAPL was transported from the pitch impregnation process line to the upper bedrock is unknown, the approximate location of the pitch impregnation structures (Figure 1) directly north (upgradient) from MW-2D (the only location where DNAPL is currently present in a well) suggests the tar either leaked directly from the process equipment into the site soils, or it was possibly disposed of in an unlined pit very near the process buildings (a common practice of that era).

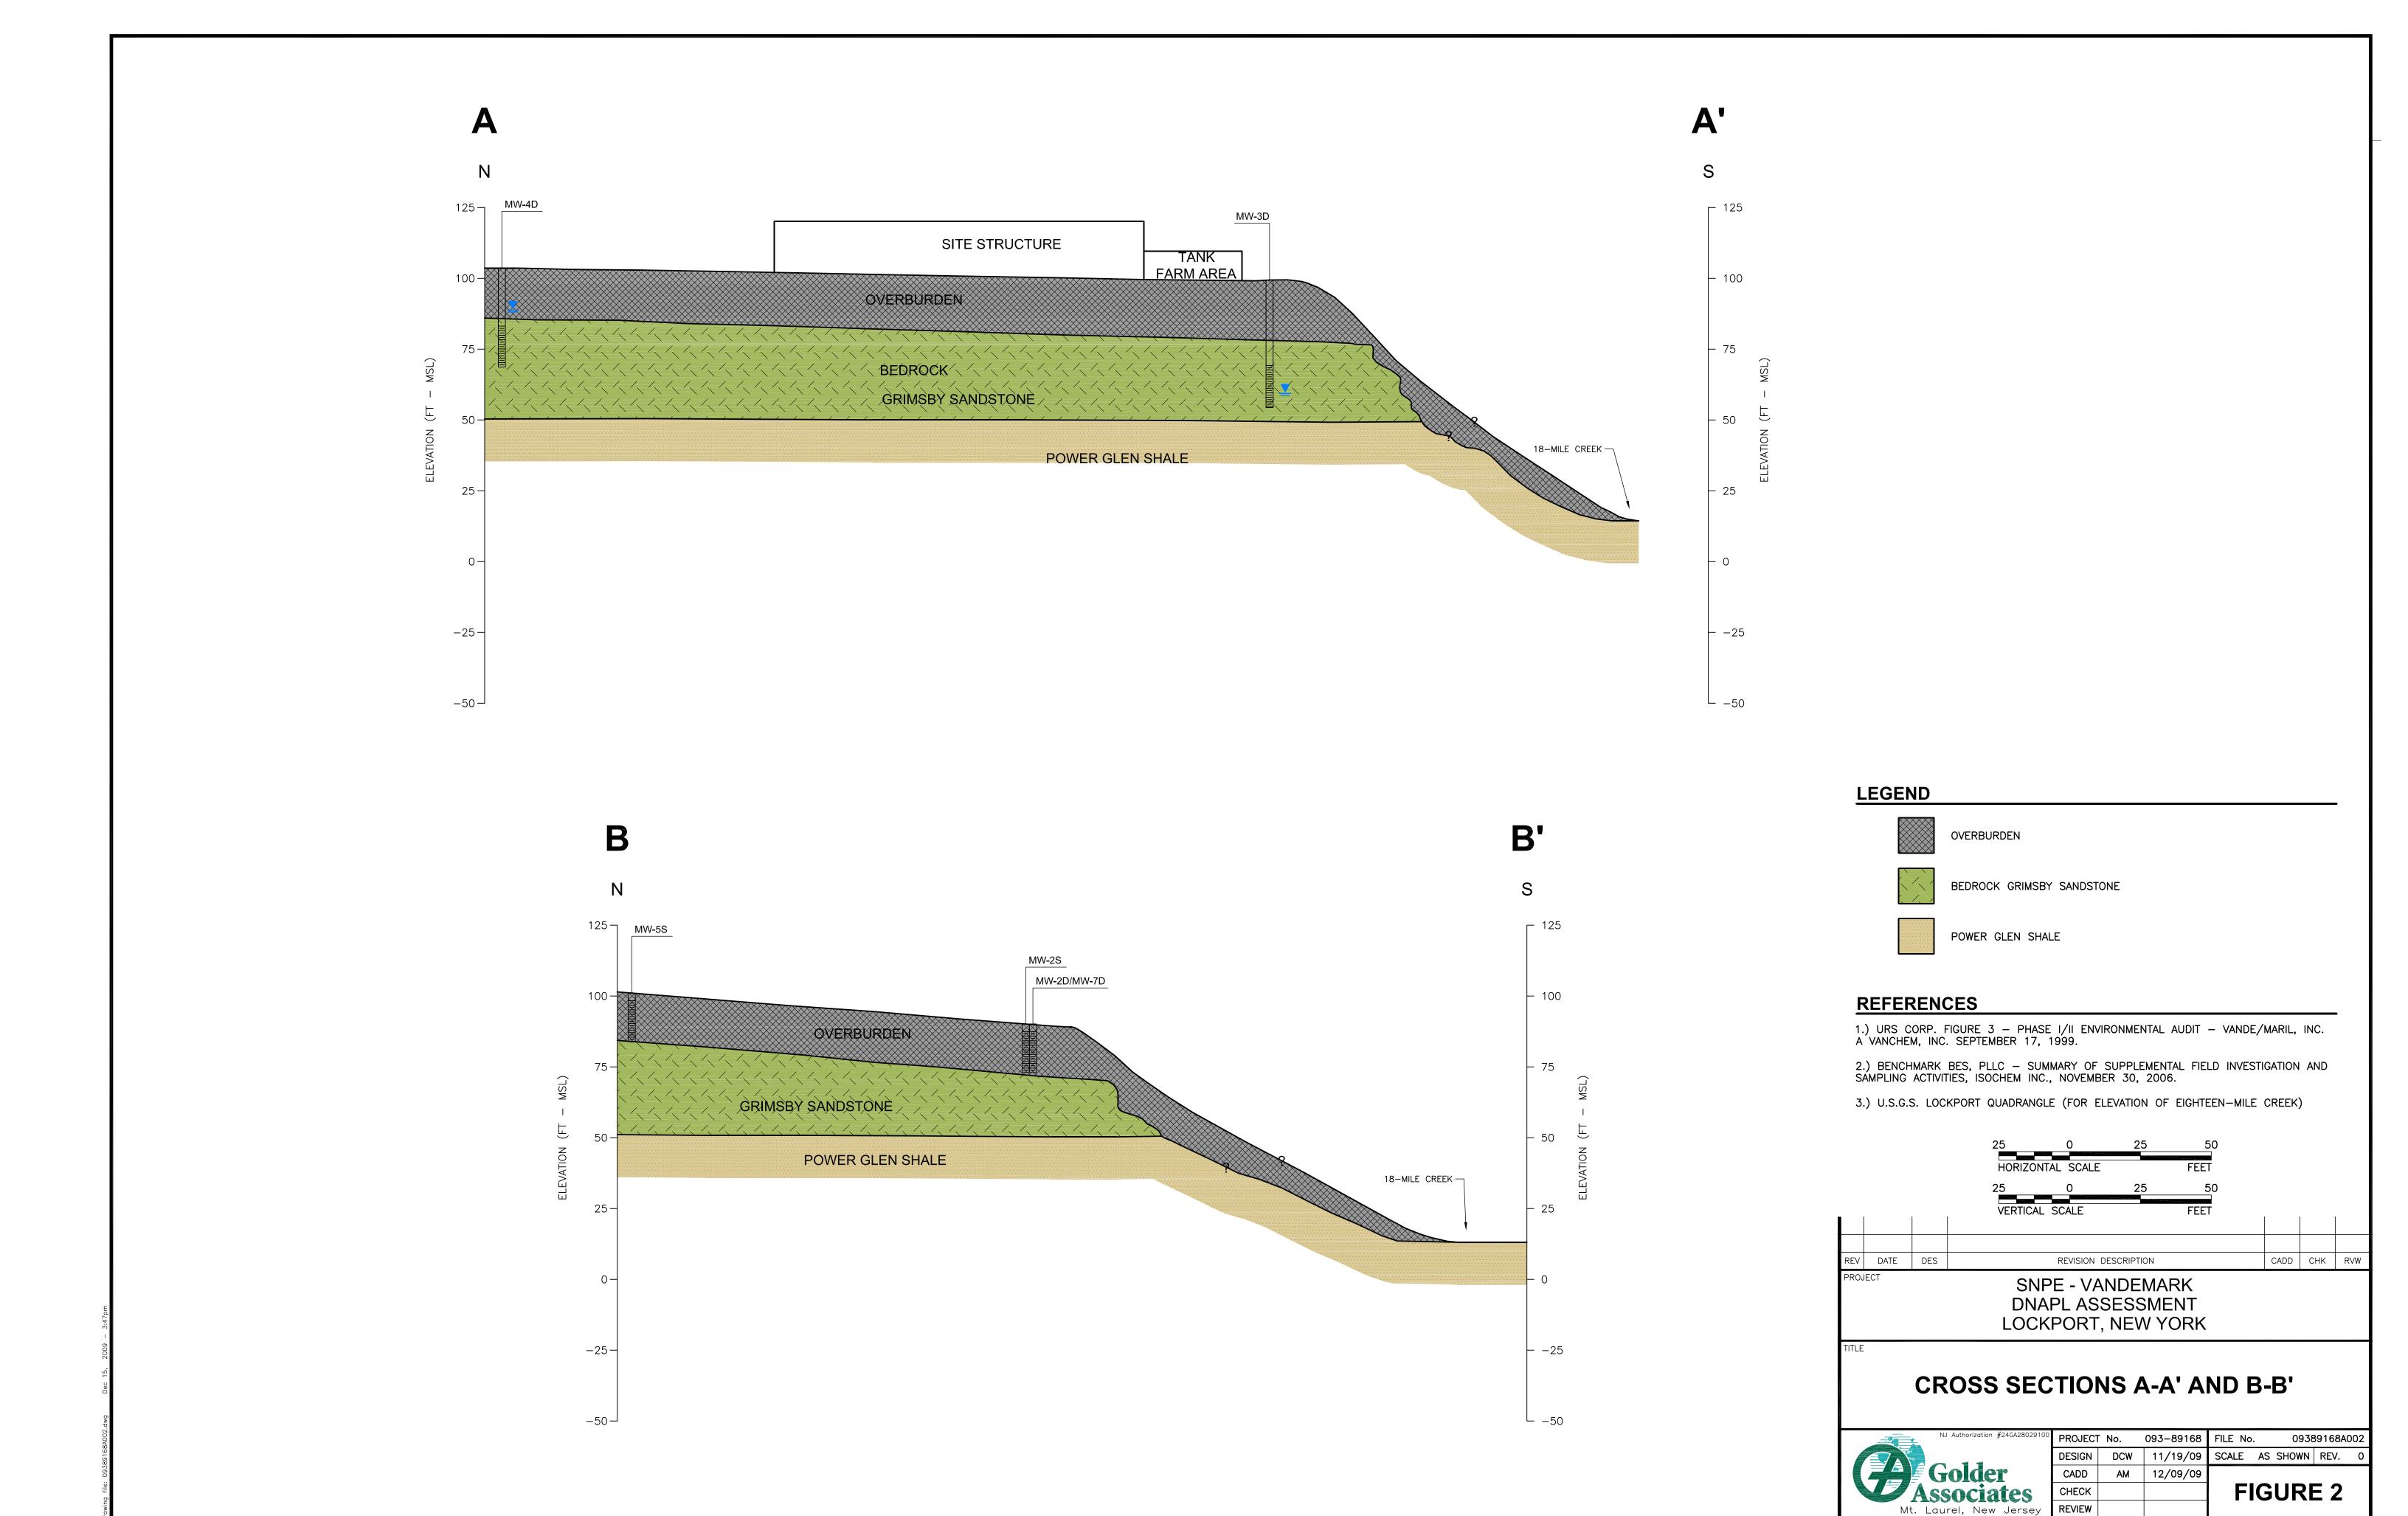
The unit underlying the Grimsby Sandstone is the Power Glen Shale, described in MW-7D as a dark gray with light to medium gray banded, horizontally bedded, very hard, shale. Also noted were clay filled horizontal fractures. These units are both part of the Lower Silurian age Medina Group. Both units are shown in cross sections of the site, shown in Figure 2.
