# ENVIRONMENTAL ASSESSMENT

## FOR BRAC 05 RECOMMENDATION FOR CLOSURE, DISPOSAL AND REUSE OF U.S. ARMY RESERVE CENTER AND ARMY MAINTENANCE SUPPORT ACTIVITY #76, NIAGARA FALLS, NEW YORK

**May 2012**

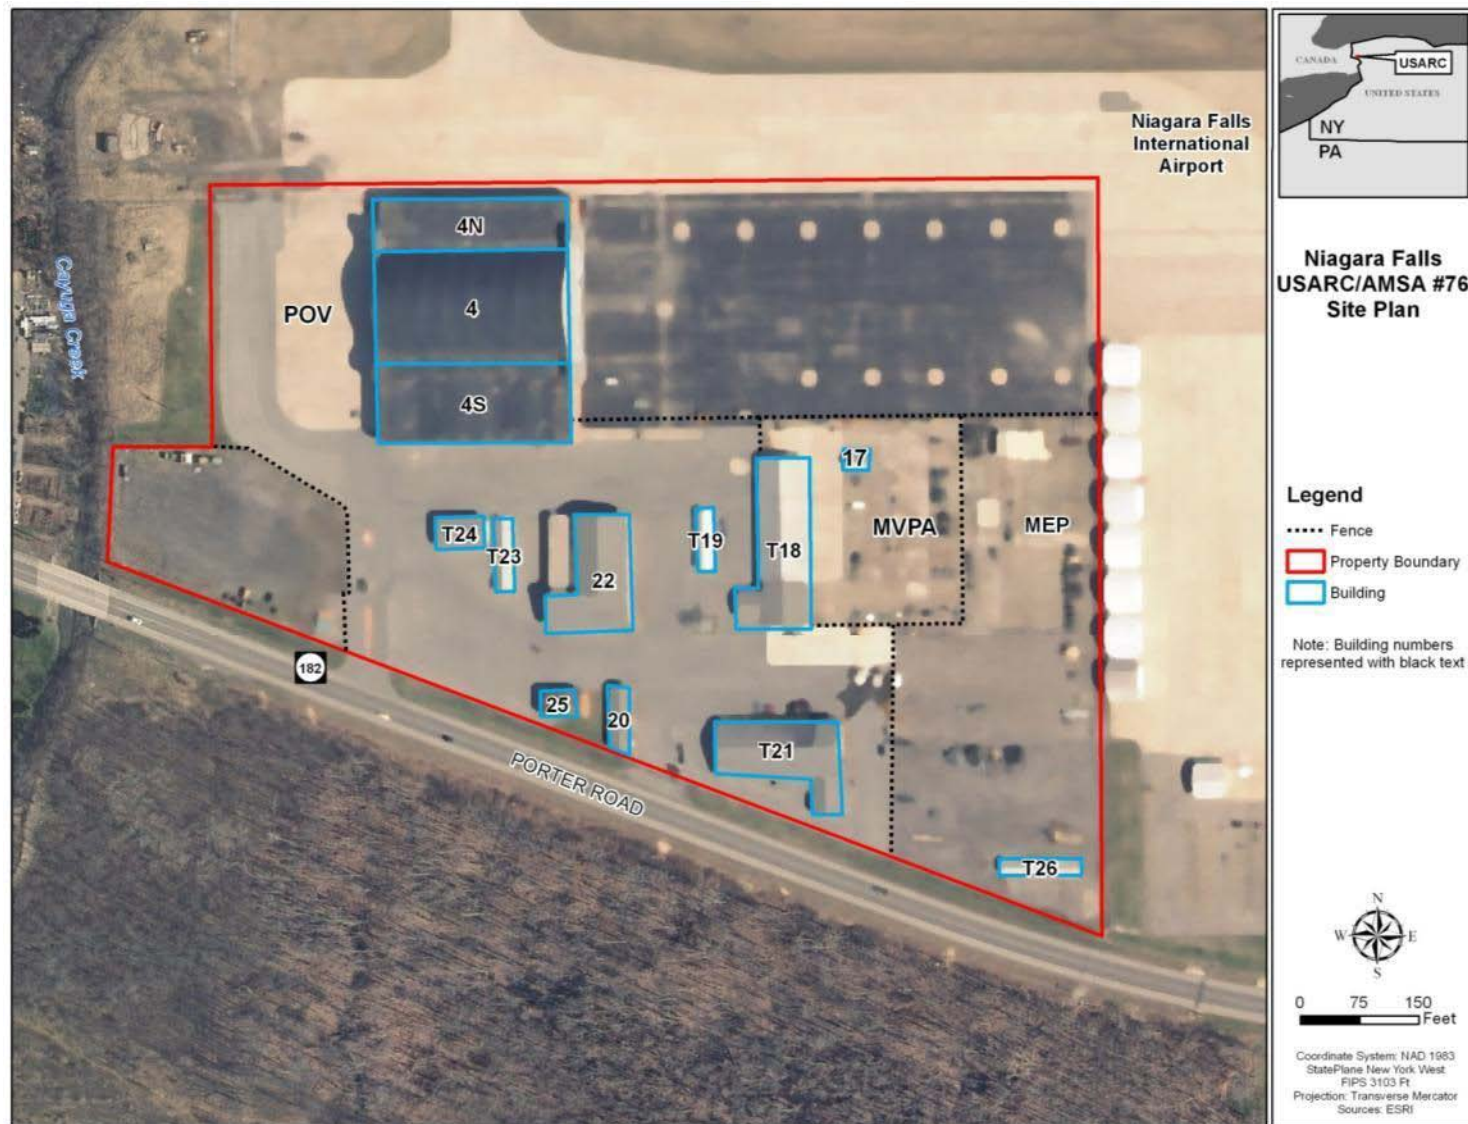
**Figure 2-1. Niagara Falls Site Plan**

Currently the property consists of 14 structures, including ancillary structures such as a guardhouse, hazardous material sheds, and an electrical building, and three parking/equipment storage areas (Figure 2-1). The property is almost entirely covered by impervious surfaces such as building footprints, asphalt parking areas, and driveways. Small areas are grass covered (south-central area) or have a mix of grass and gravel, such as in the southwestern corner of the Property. Buildings on site include:

- Building T24 is a single story, 2,400 SF storage shed with two metal roll-up vehicular doors. The building has electricity and heat but no plumbing.
- Building 25 is a single story, 1,750 SF building originally constructed as the heating plant for the property. It is currently used as a storage building.
- Building T26 is a single story, 2,000 SF building constructed of a metal frame as well as metal siding and roof. It is primarily used to store equipment.
- There is also a one-story, one bay wide and one bay deep electrical building on the property and a small guard shed at the entrance to the property.

In addition to the buildings there is a vehicle wash rack outside of Building 18 (the AMSA) and three OWS on the property.

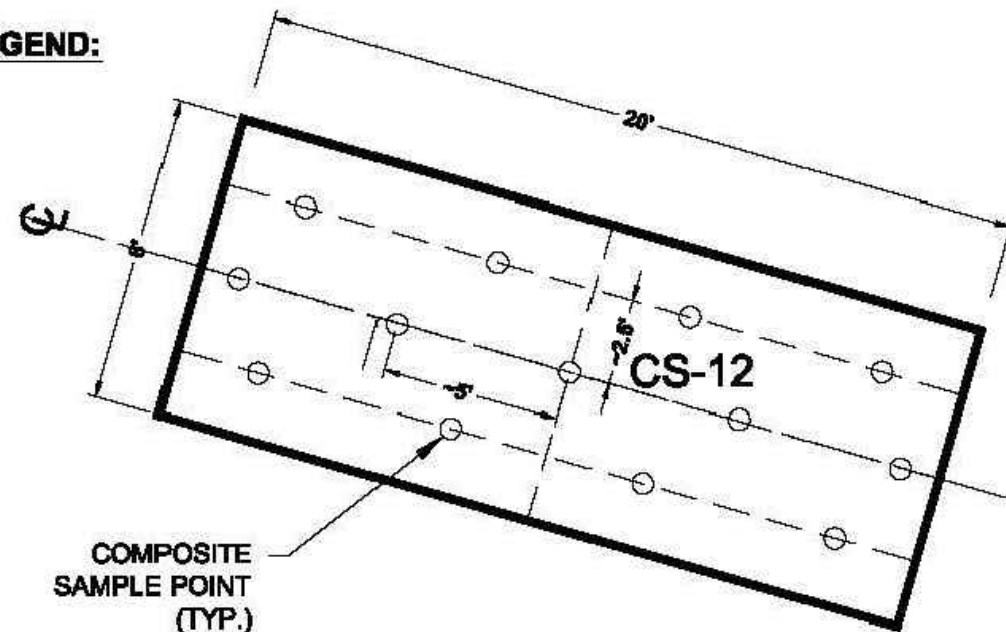
POST-EXCAVATION COMPOSITE SAMPLE TEMPLATE  
NOT TO SCALE

IMPACTED SOIL EXCAVATED TO APPROXIMATELY 2-FOOT TOTAL DEPTH

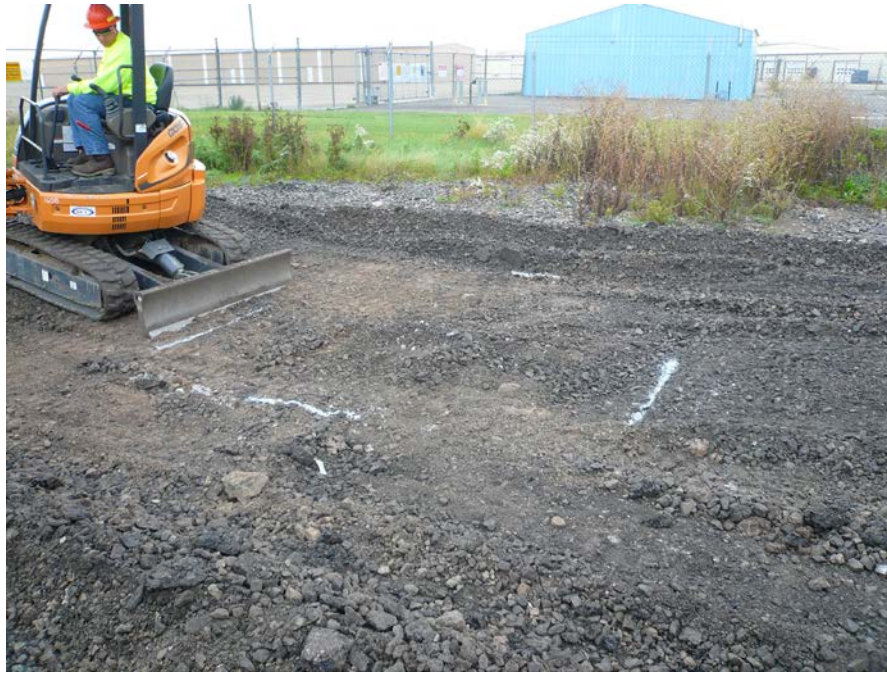
**Photograph 1** – Area of IRA prior to excavation as viewed from the west.

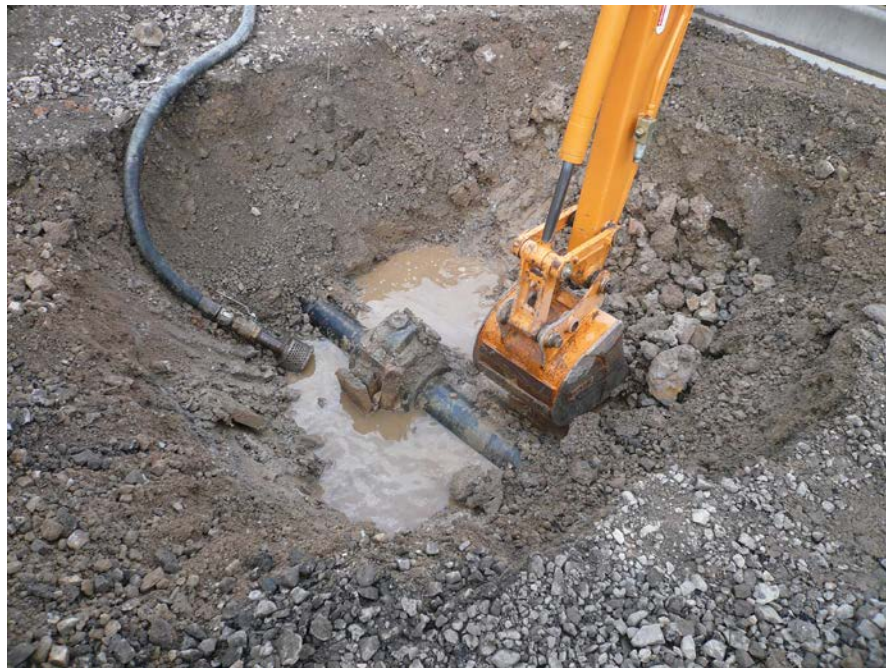
**Photograph 2** – Excavation and 6" Fire Protection Main as viewed from the southeast.

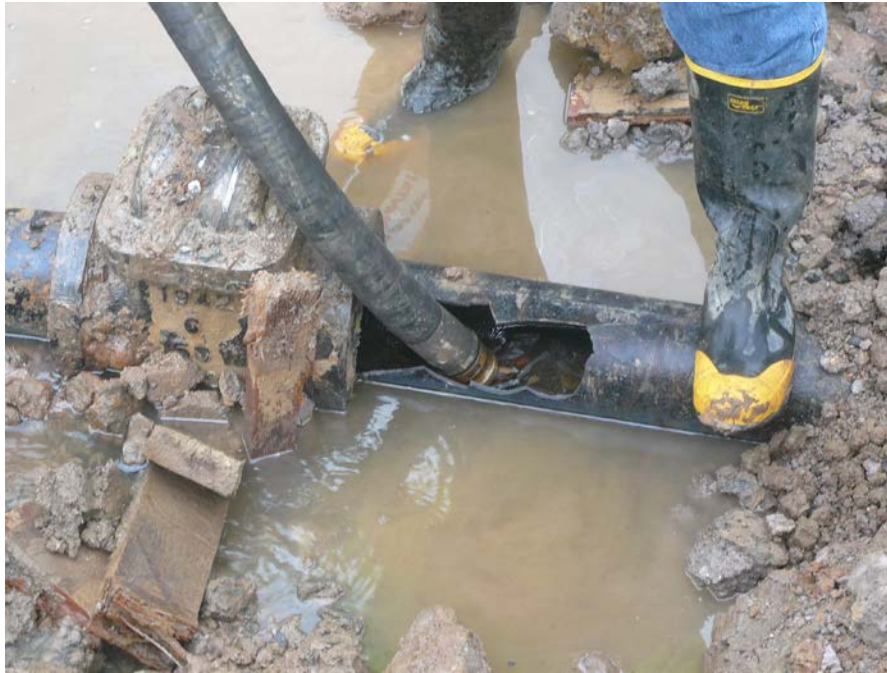
**Photograph 3** – Pumping of Fire Protection Main prior to removal.

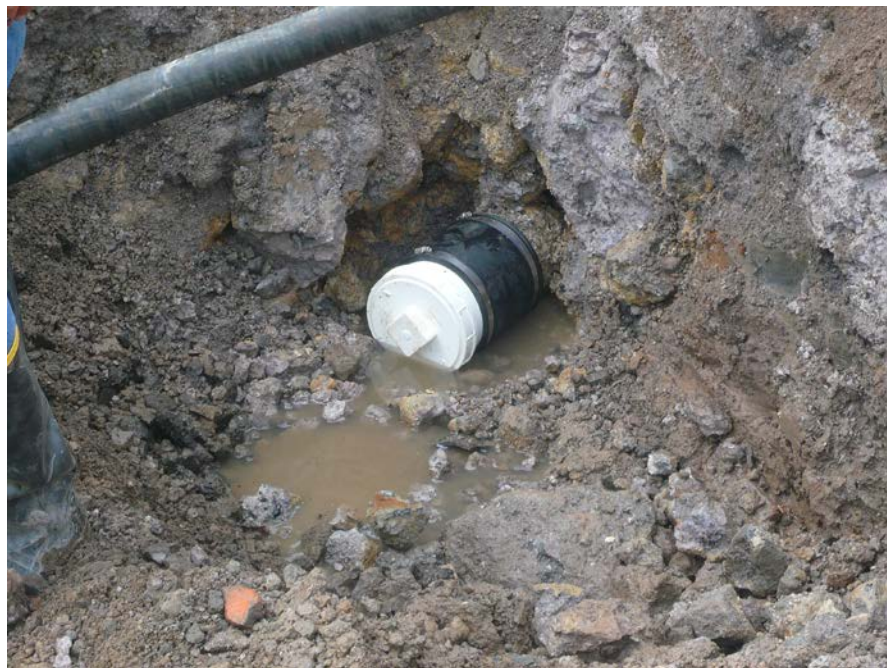
**Photograph 4** – Capped end of the Fire Protection Main.

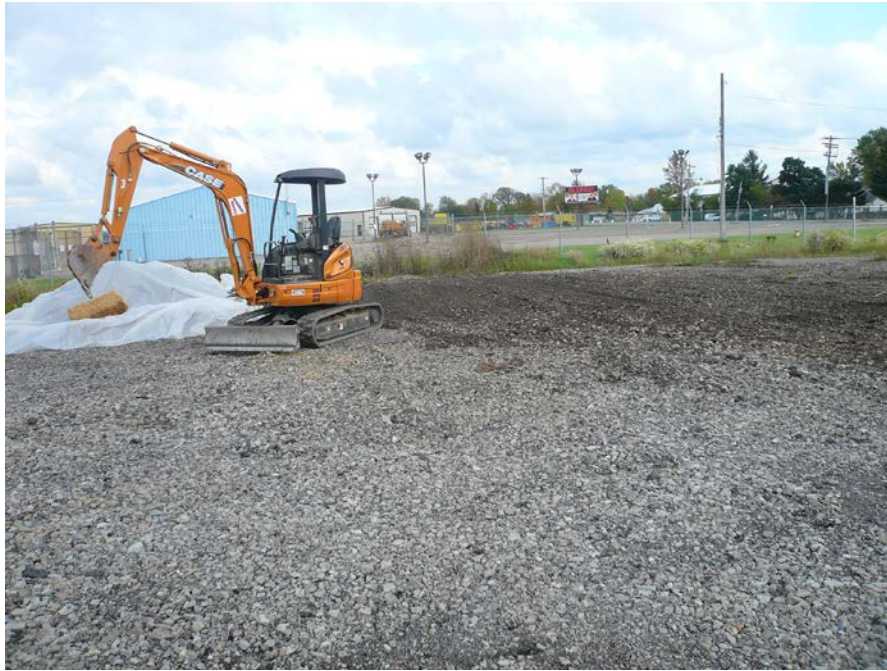
**Photograph 5** – Backfilled excavation as viewed from the west.

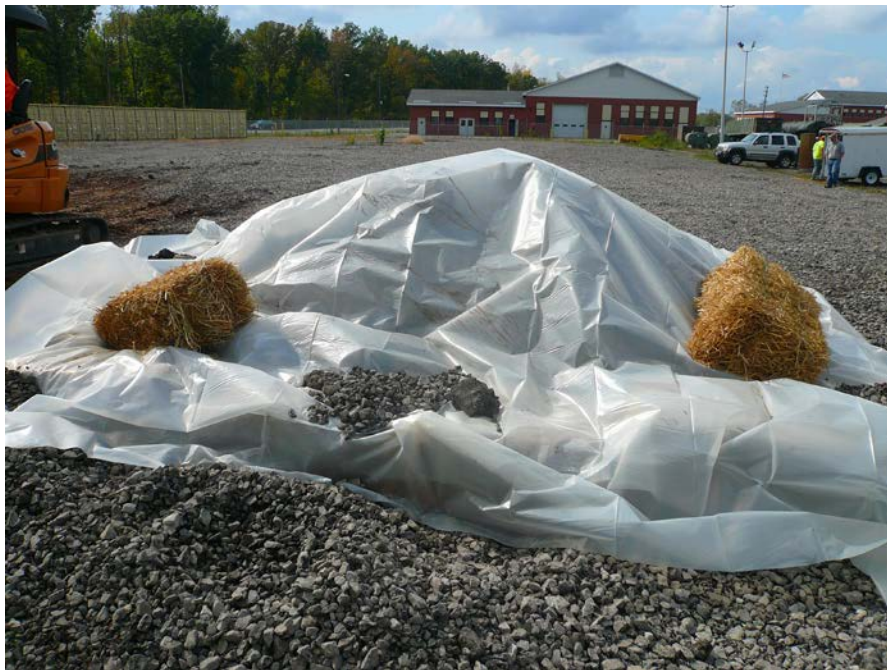
**Photograph 6** – Stockpiled and covered soil as viewed from the east.
