PHASE II ENVIRONMENTAL SITE ASSESSMENT (ASTM E1903-97)
And
VAPOR ENCROACHMENT SCREEN

Commercial/Residential Structure (FNB Project No. 11-000666-02-2)
2526 Pine Avenue
Niagara Falls, New York

Project No. 11RJS226.5

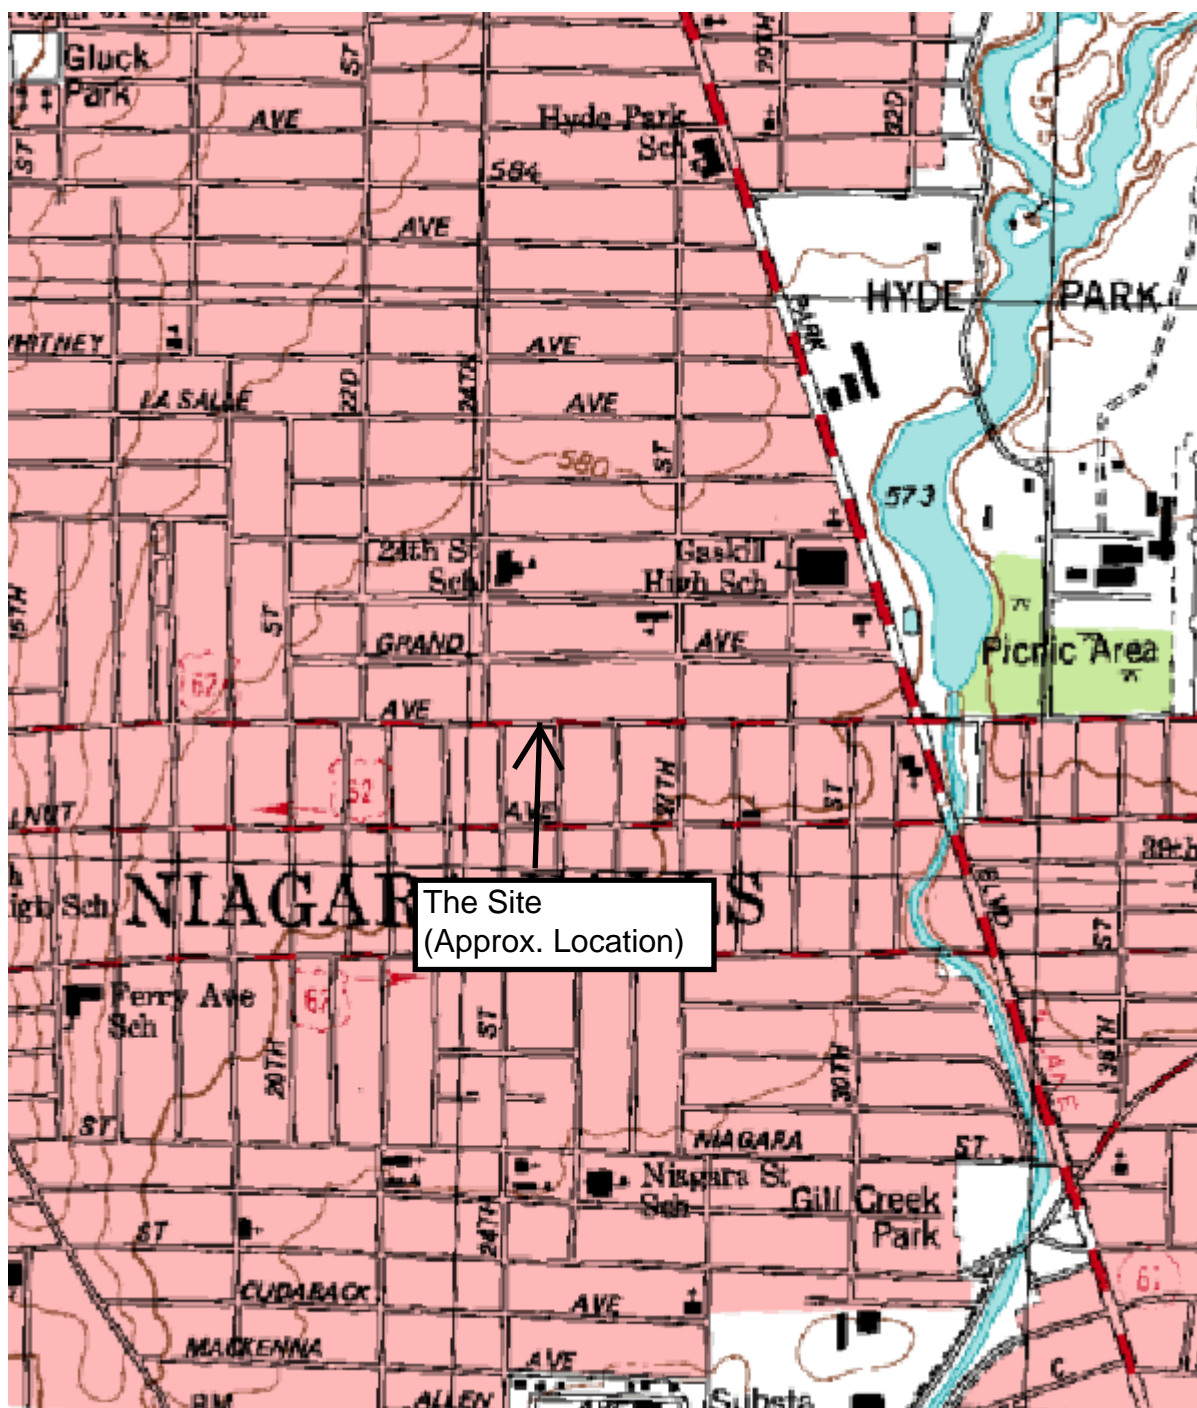
FIGURE 2
 Topographic Map
 11RJS226.5
 2526 Pine Ave
 Niagara Falls, NY

Center: 43.0952°N 79.031°W
 Elevation at center: 577 feet (176 meters)
 Quad: USGS Niagara Falls

The Site is located approximately 575 feet above mean sea level. Groundwater flow would be anticipated to the east or southeast, toward Gill Creek. However, localized subsurface variations and man-made structures can modify flow directions, a site-specific study would be required to confirm groundwater flow direction. A topographic map is provided as Figure 1.

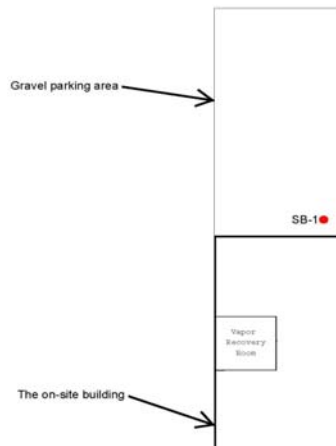
Boring Location Sketch

DRILLING LOG OF WELL/BORING NO. SB-1

Note: A temporary well was installed, however, such did not produce a sufficient amount of groundwater for sampling.

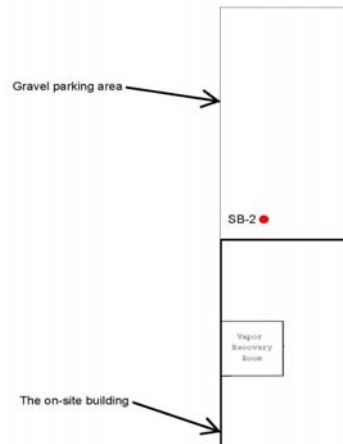
Boring Location Sketch

DRILLING LOG OF WELL/BORING NO. SB-2
