PERIODIC REVIEW REPORT

ETE Sanitation and Landfill

Site Number: 961005

September 21, 2020

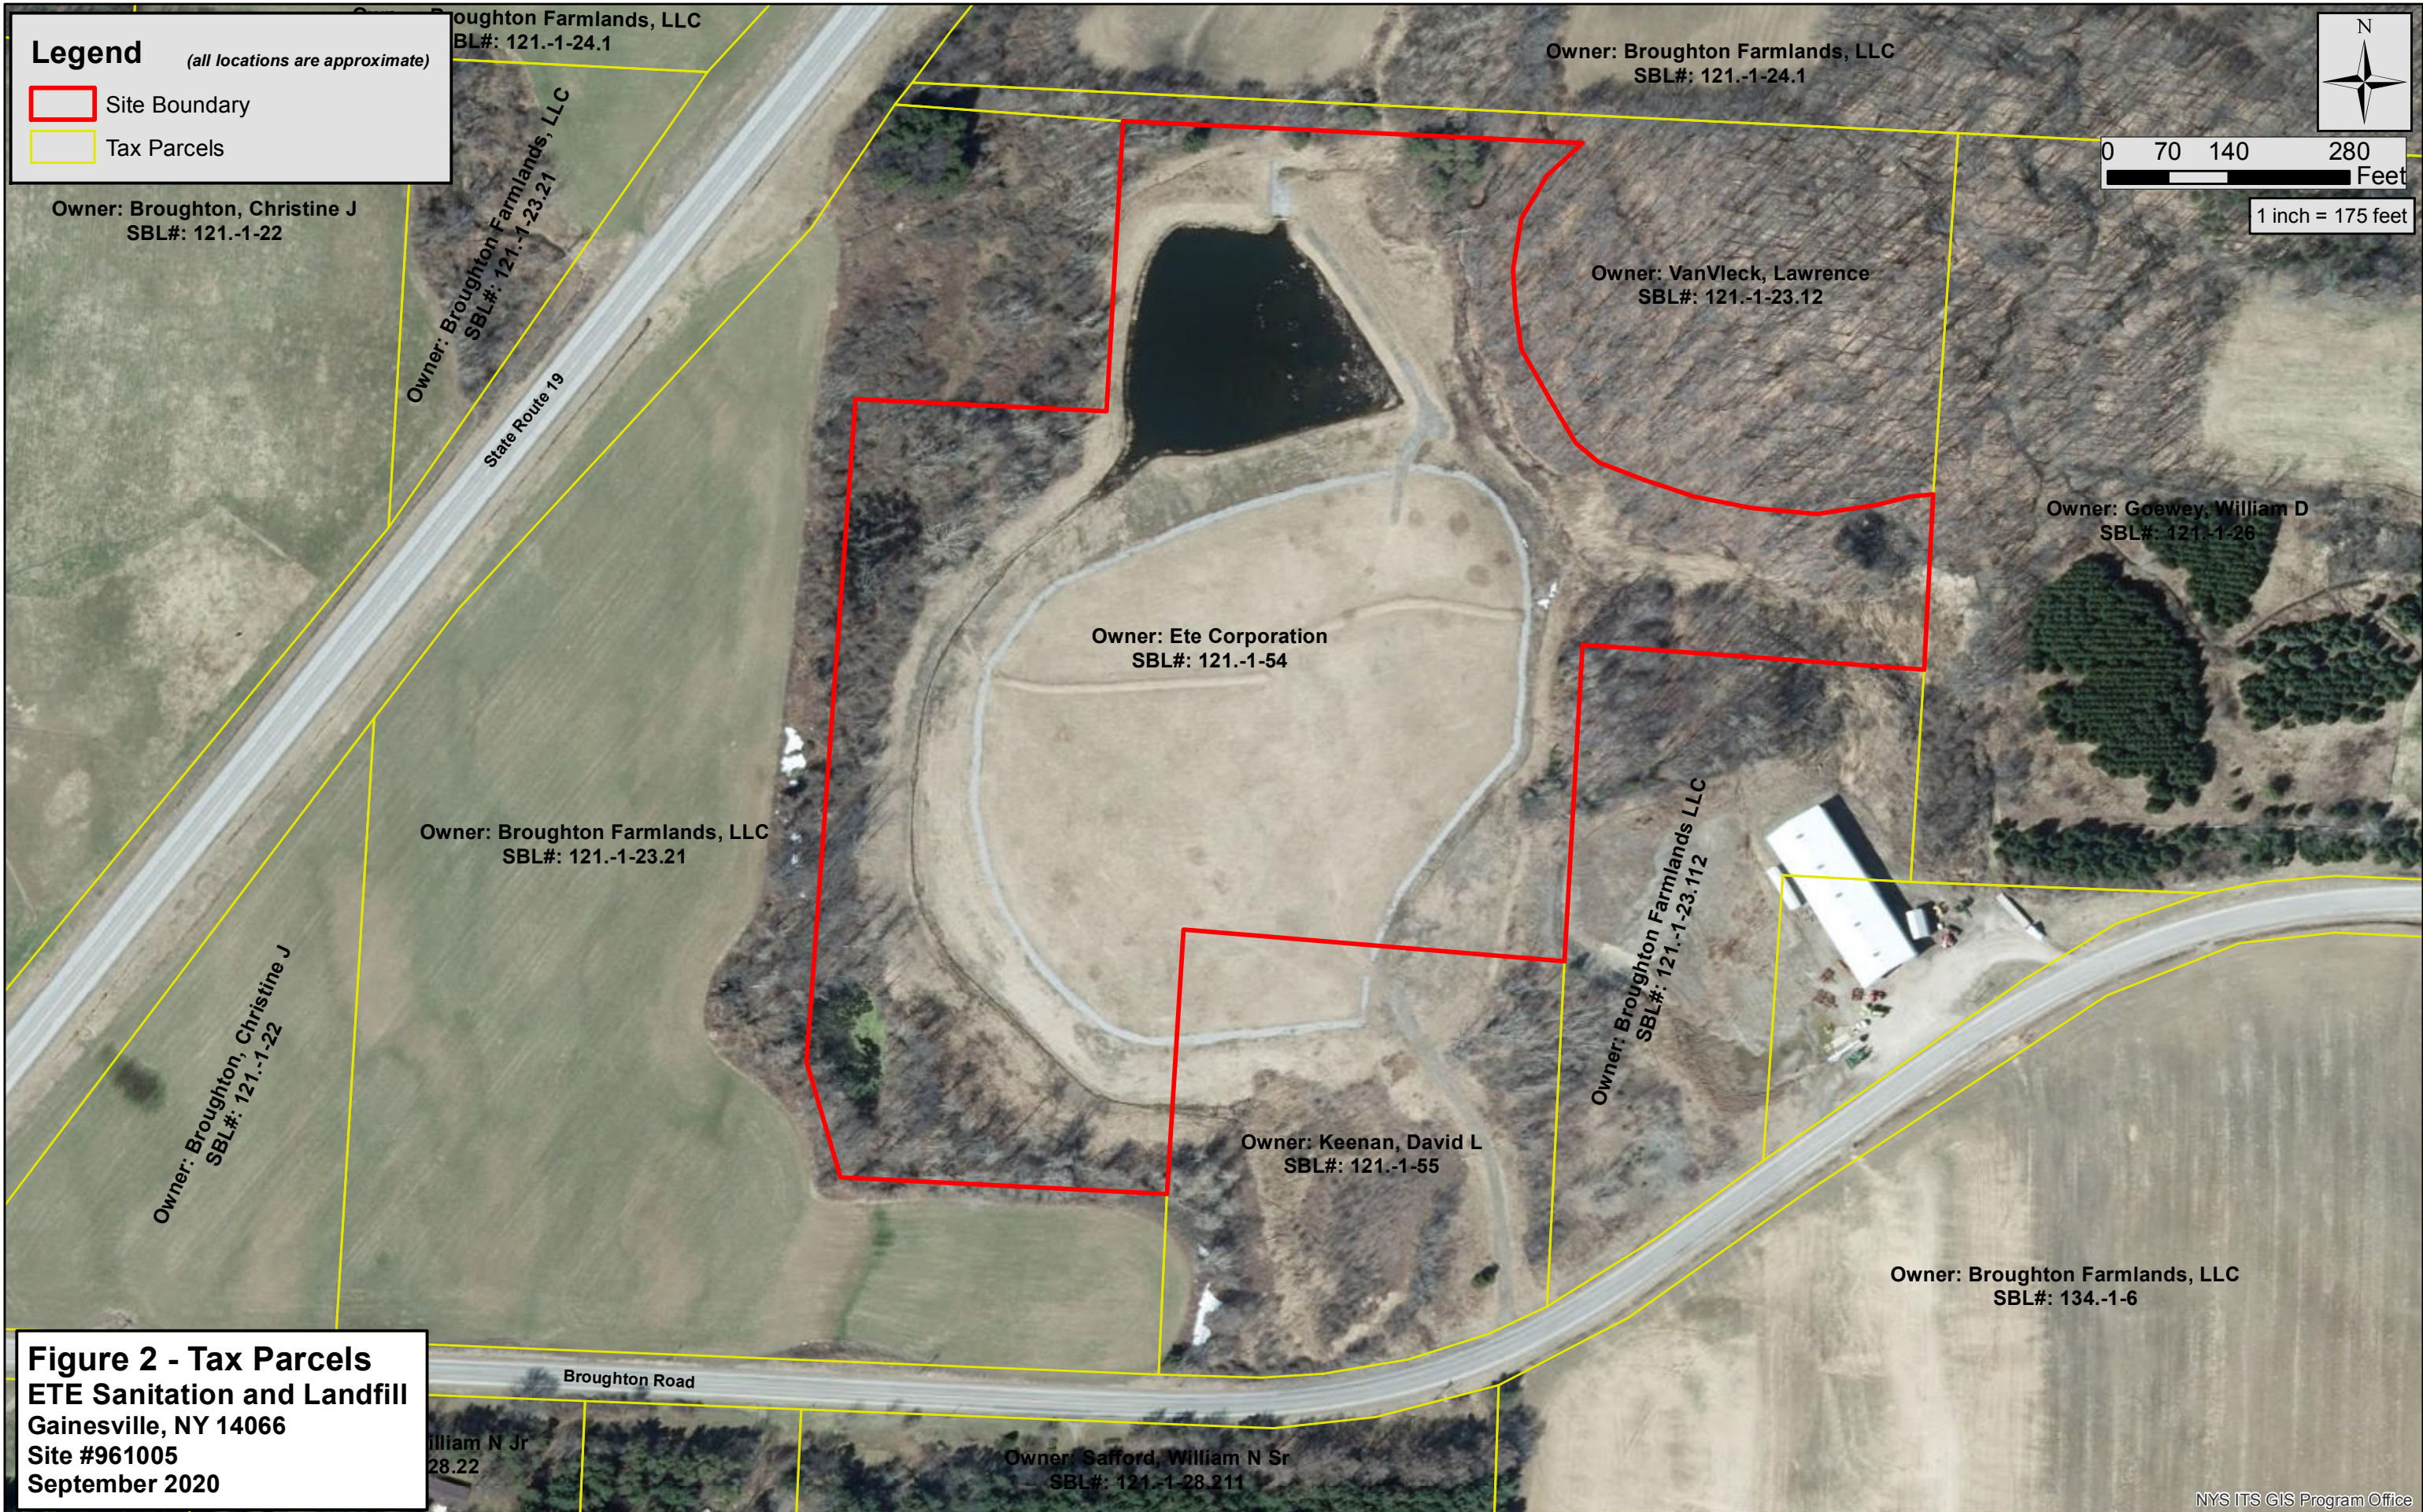
Figure 2 - Tax Parcels
ETE Sanitation and Landfill
 Gainesville, NY 14066
 Site #961005
 September 2020

The site occupies an approximately 25.48-acre area, and consists of a 7-acre landfill area situated on two parcels: (1) 20.57-acre parcel SBL121-1-54 owned by the estate of the defunct ETE Sanitation and Landfill Corporation to the north, east and west and (2) 5.495-acre parcel SBL 121-1-55 owned by a local private resident to the south (Figure 2).

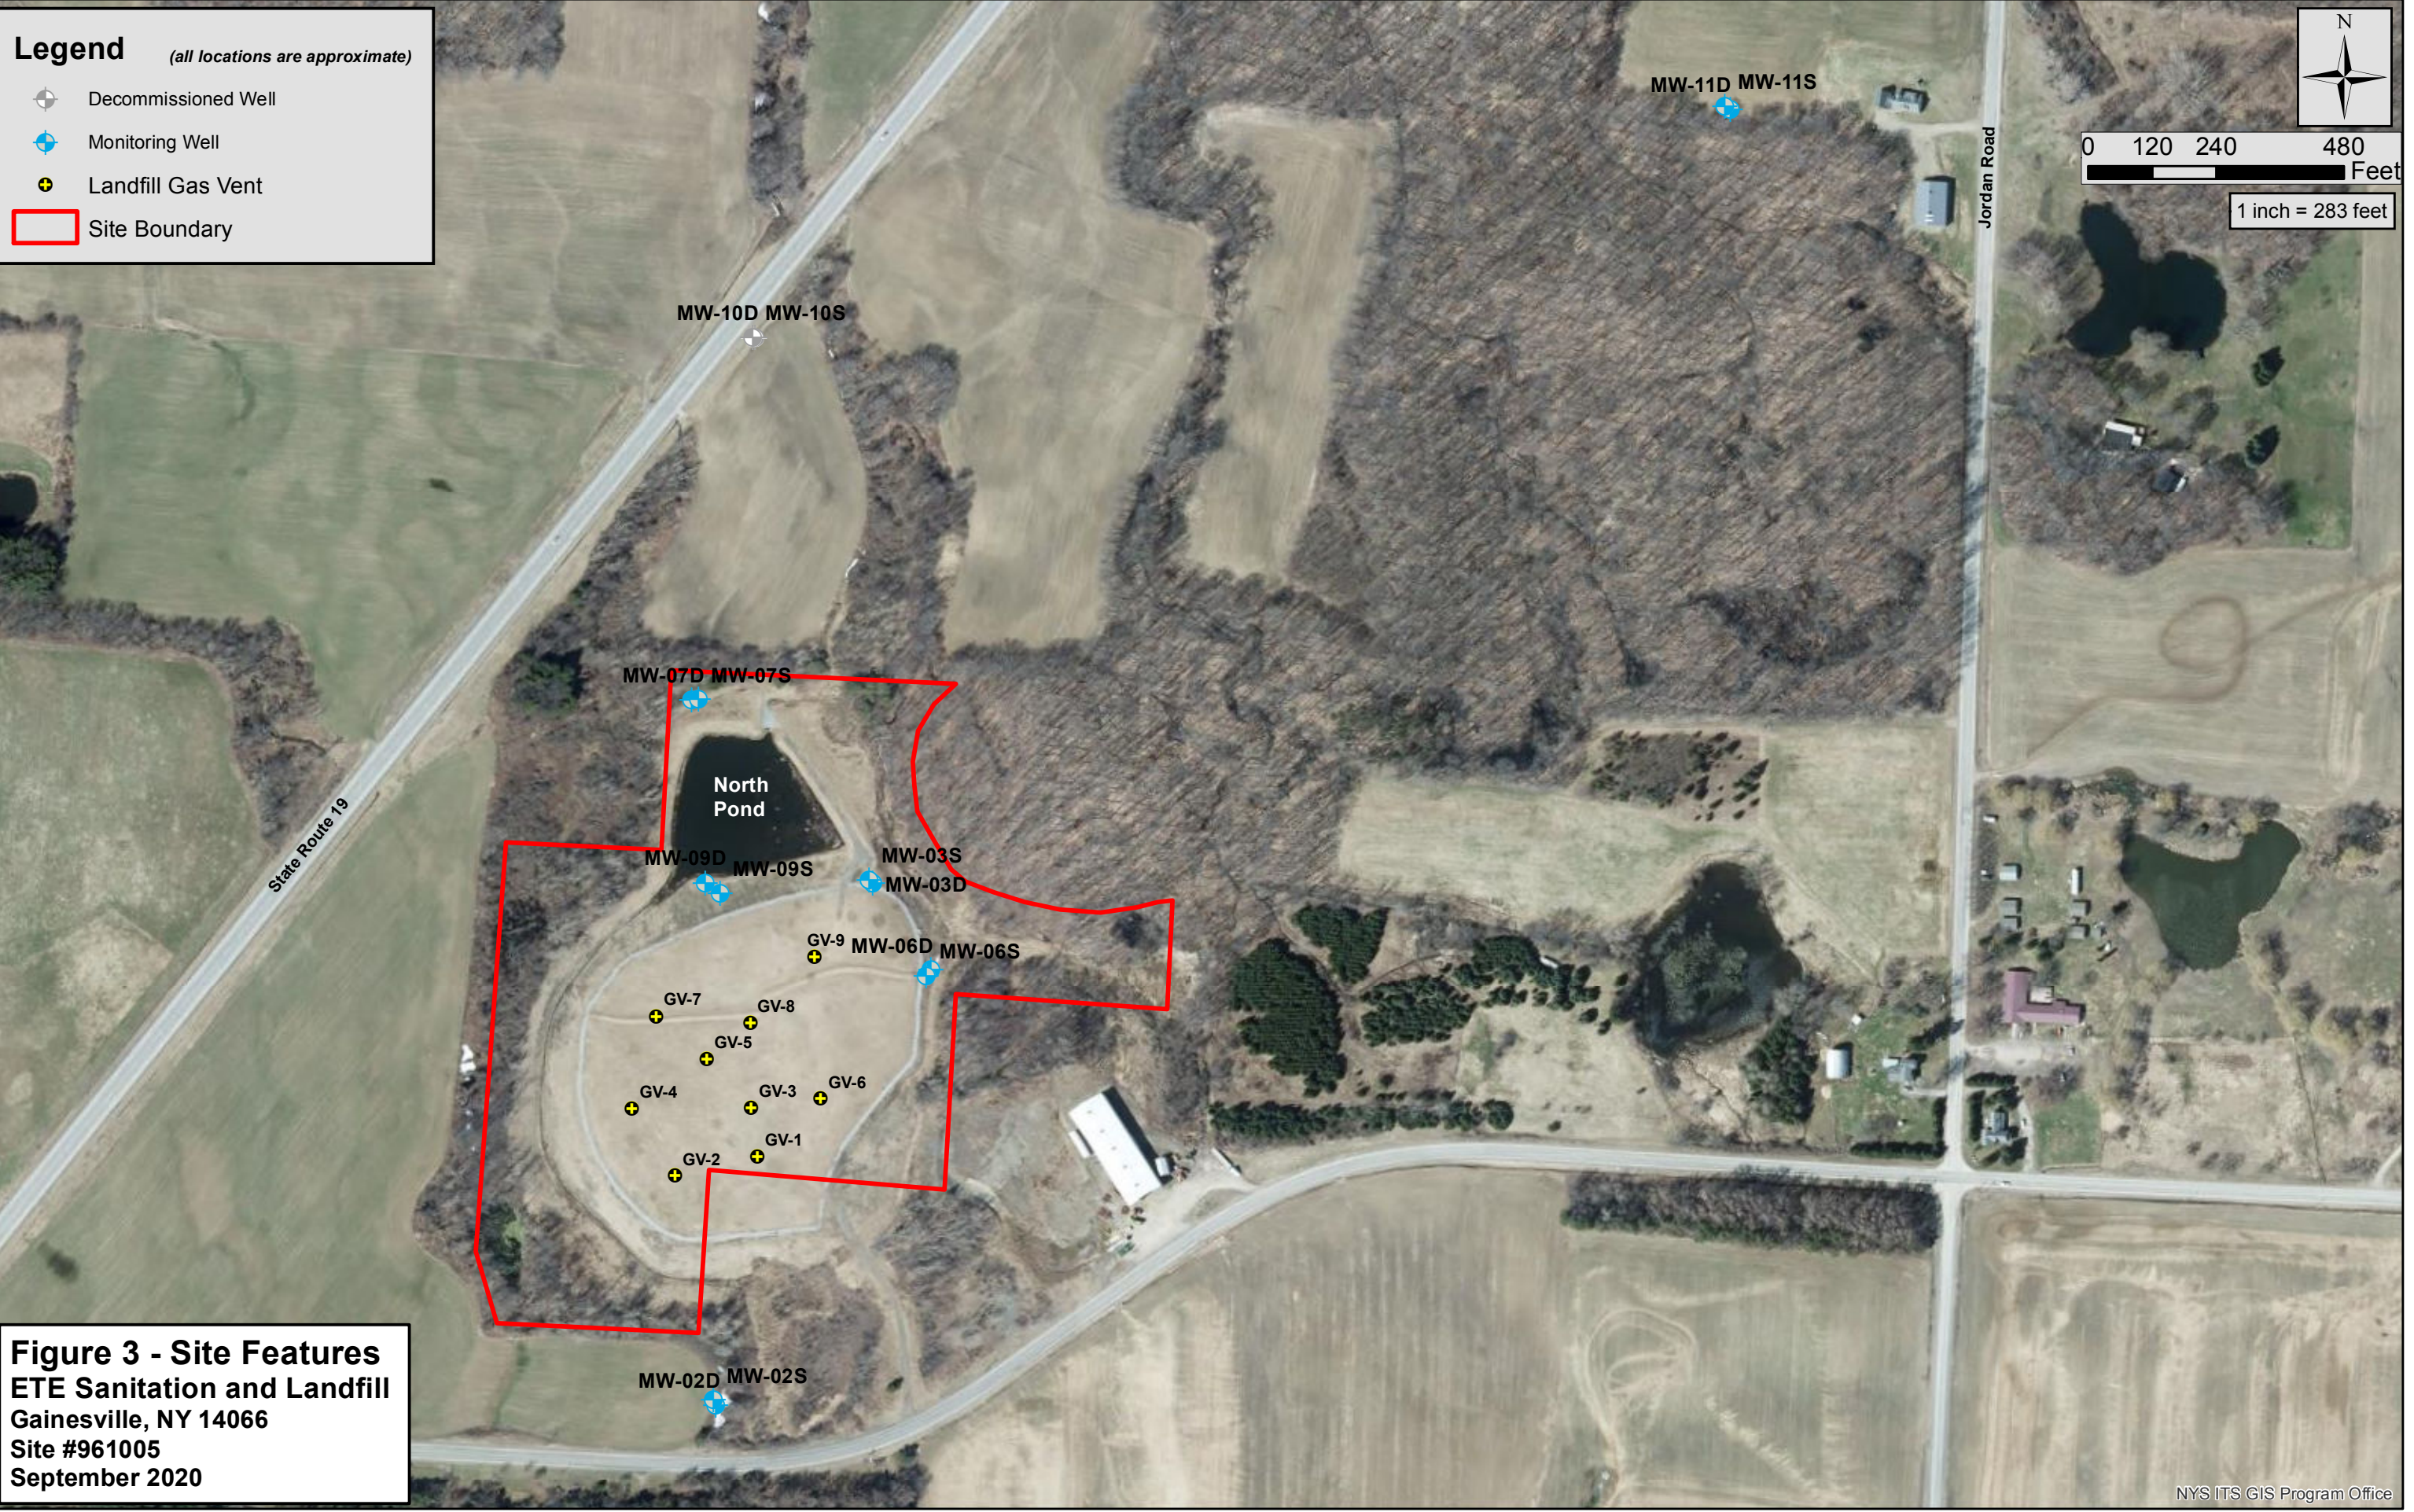
Figure 3 - Site Features
ETE Sanitation and Landfill
 Gainesville, NY 14066
 Site #961005
 September 2020

- Decommissioned Well
- Monitoring Well
- Landfill Gas Vent
- Site Boundary

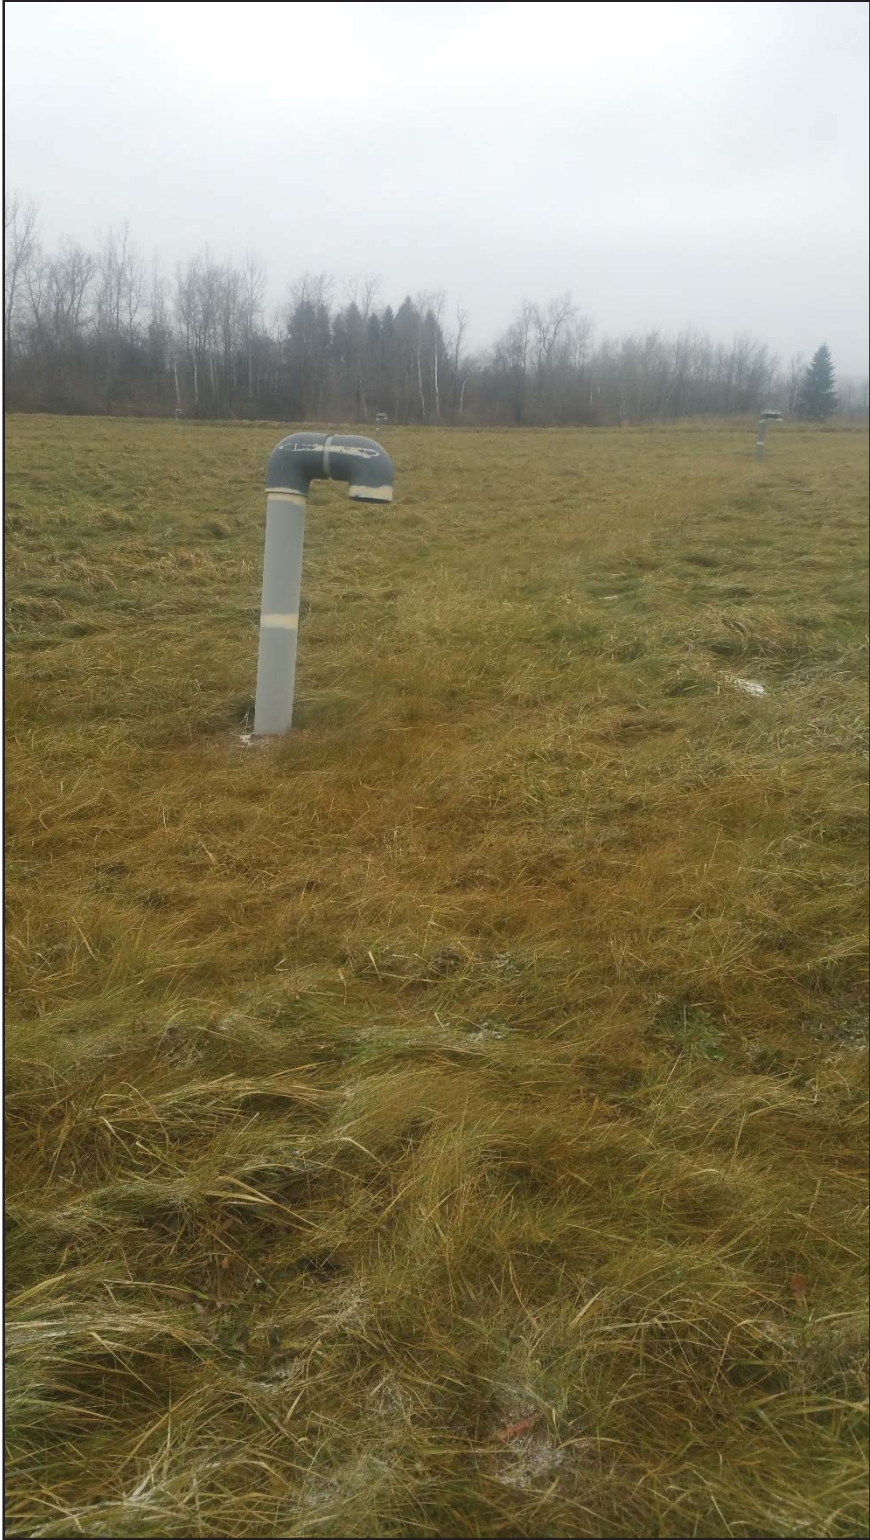
Photo 1: Gasvent#2.jpg

During the 2019 inspection GV-6 could not be located. The remaining gas vents were all found to be in good condition. Based on field monitoring none of the gas vents appear to be producing landfill gas or releasing other VOCs. This is consistent with gas vent monitoring completed in 2015.

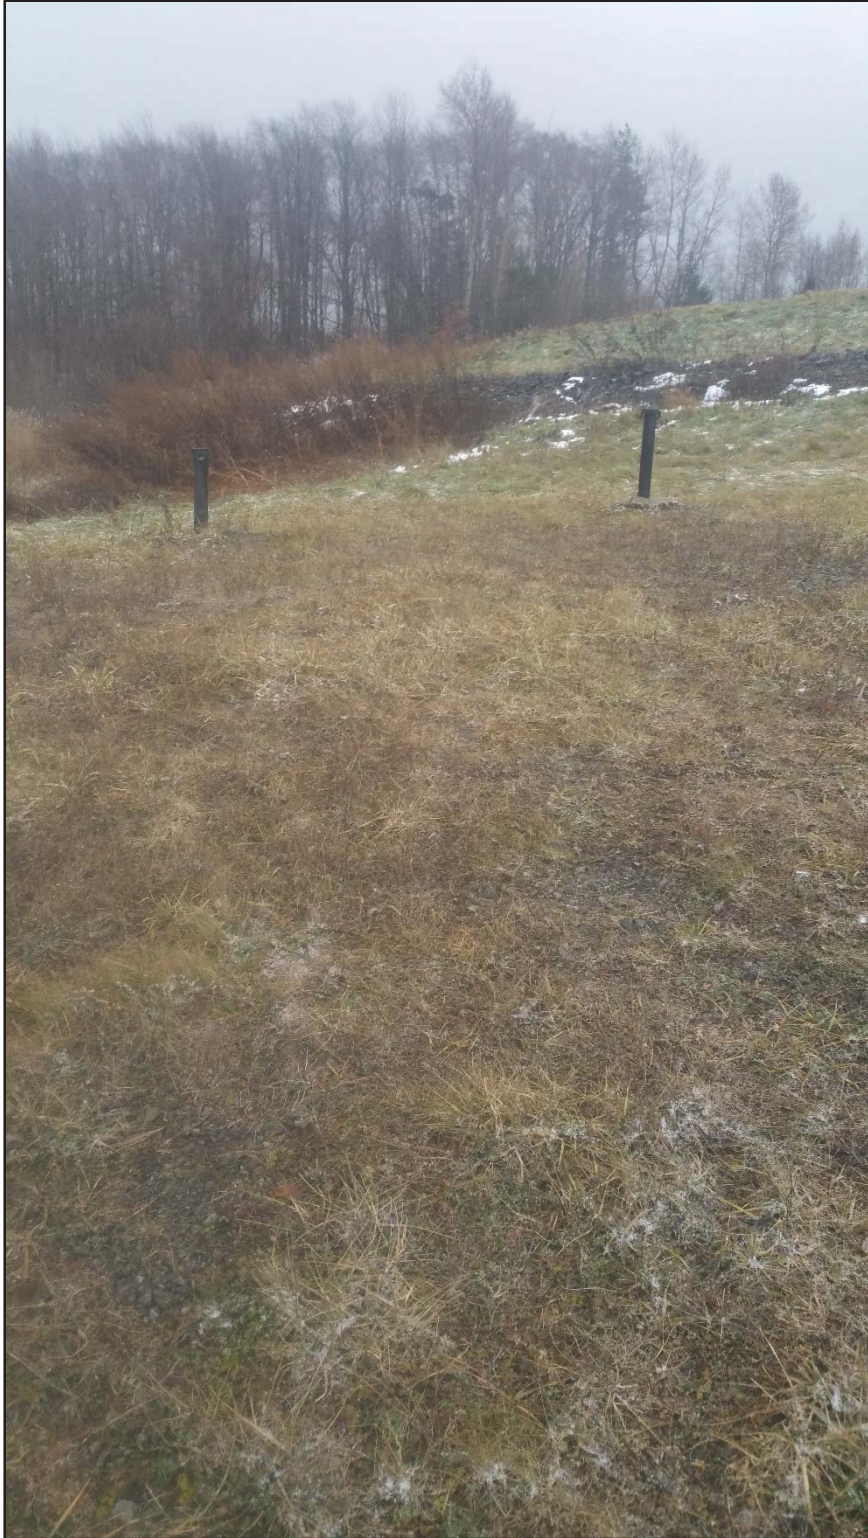
Photo 4: MW3SD.jpg

Monitoring well cluster 3 have a new type of protective casing than other wells. Both in good shape and locked. Monitoring well cluster 6 are in good physical condition, but the locks were cut off and left on top of protective casing. Monitoring well cluster 7 protective casing in good shape, could not open lock on 7S. Monitoring well cluster 9 the top of both protective casings are broken and unable to lock.

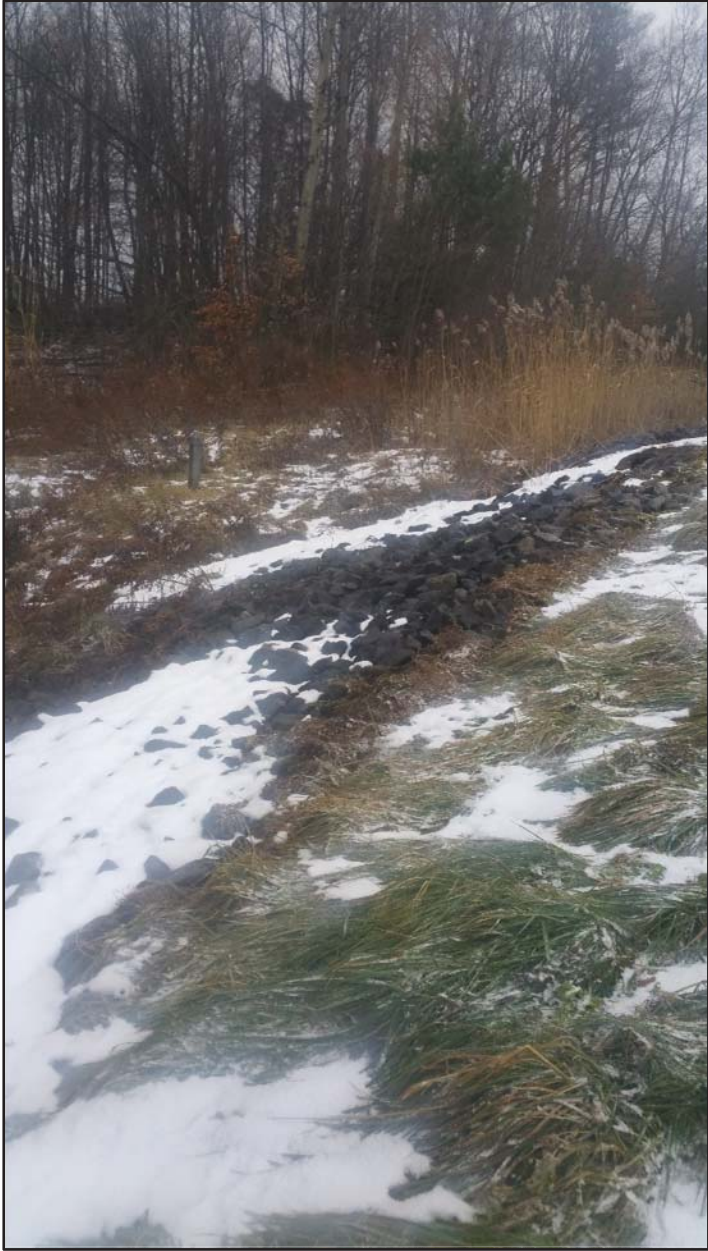
Photo 6: MW6SD.jpg

During the 2019 inspection all monitoring wells inspected were usable, though MW-7S could not be unlocked. Both wells in the MW-6 cluster had their locks cut, and both of the protective casings in the MW-9 cluster were damaged and cannot be locked.

Minor damage or missing locks were reported at several monitoring wells during the December 2019 site inspection. The locks should be replaced during the next site inspection and/or groundwater sampling event. The damaged wells should be further assessed to determine if they are still usable monitoring points or require repair.
