ENGINEERING INVESTIGATIONS AT INACTIVE HAZARDOUS WASTE SITES

PRELIMINARY SITE ASSESSMENT

Warsaw Village Landfill Site
Warsaw Village

Site No. 961006
Wyoming County

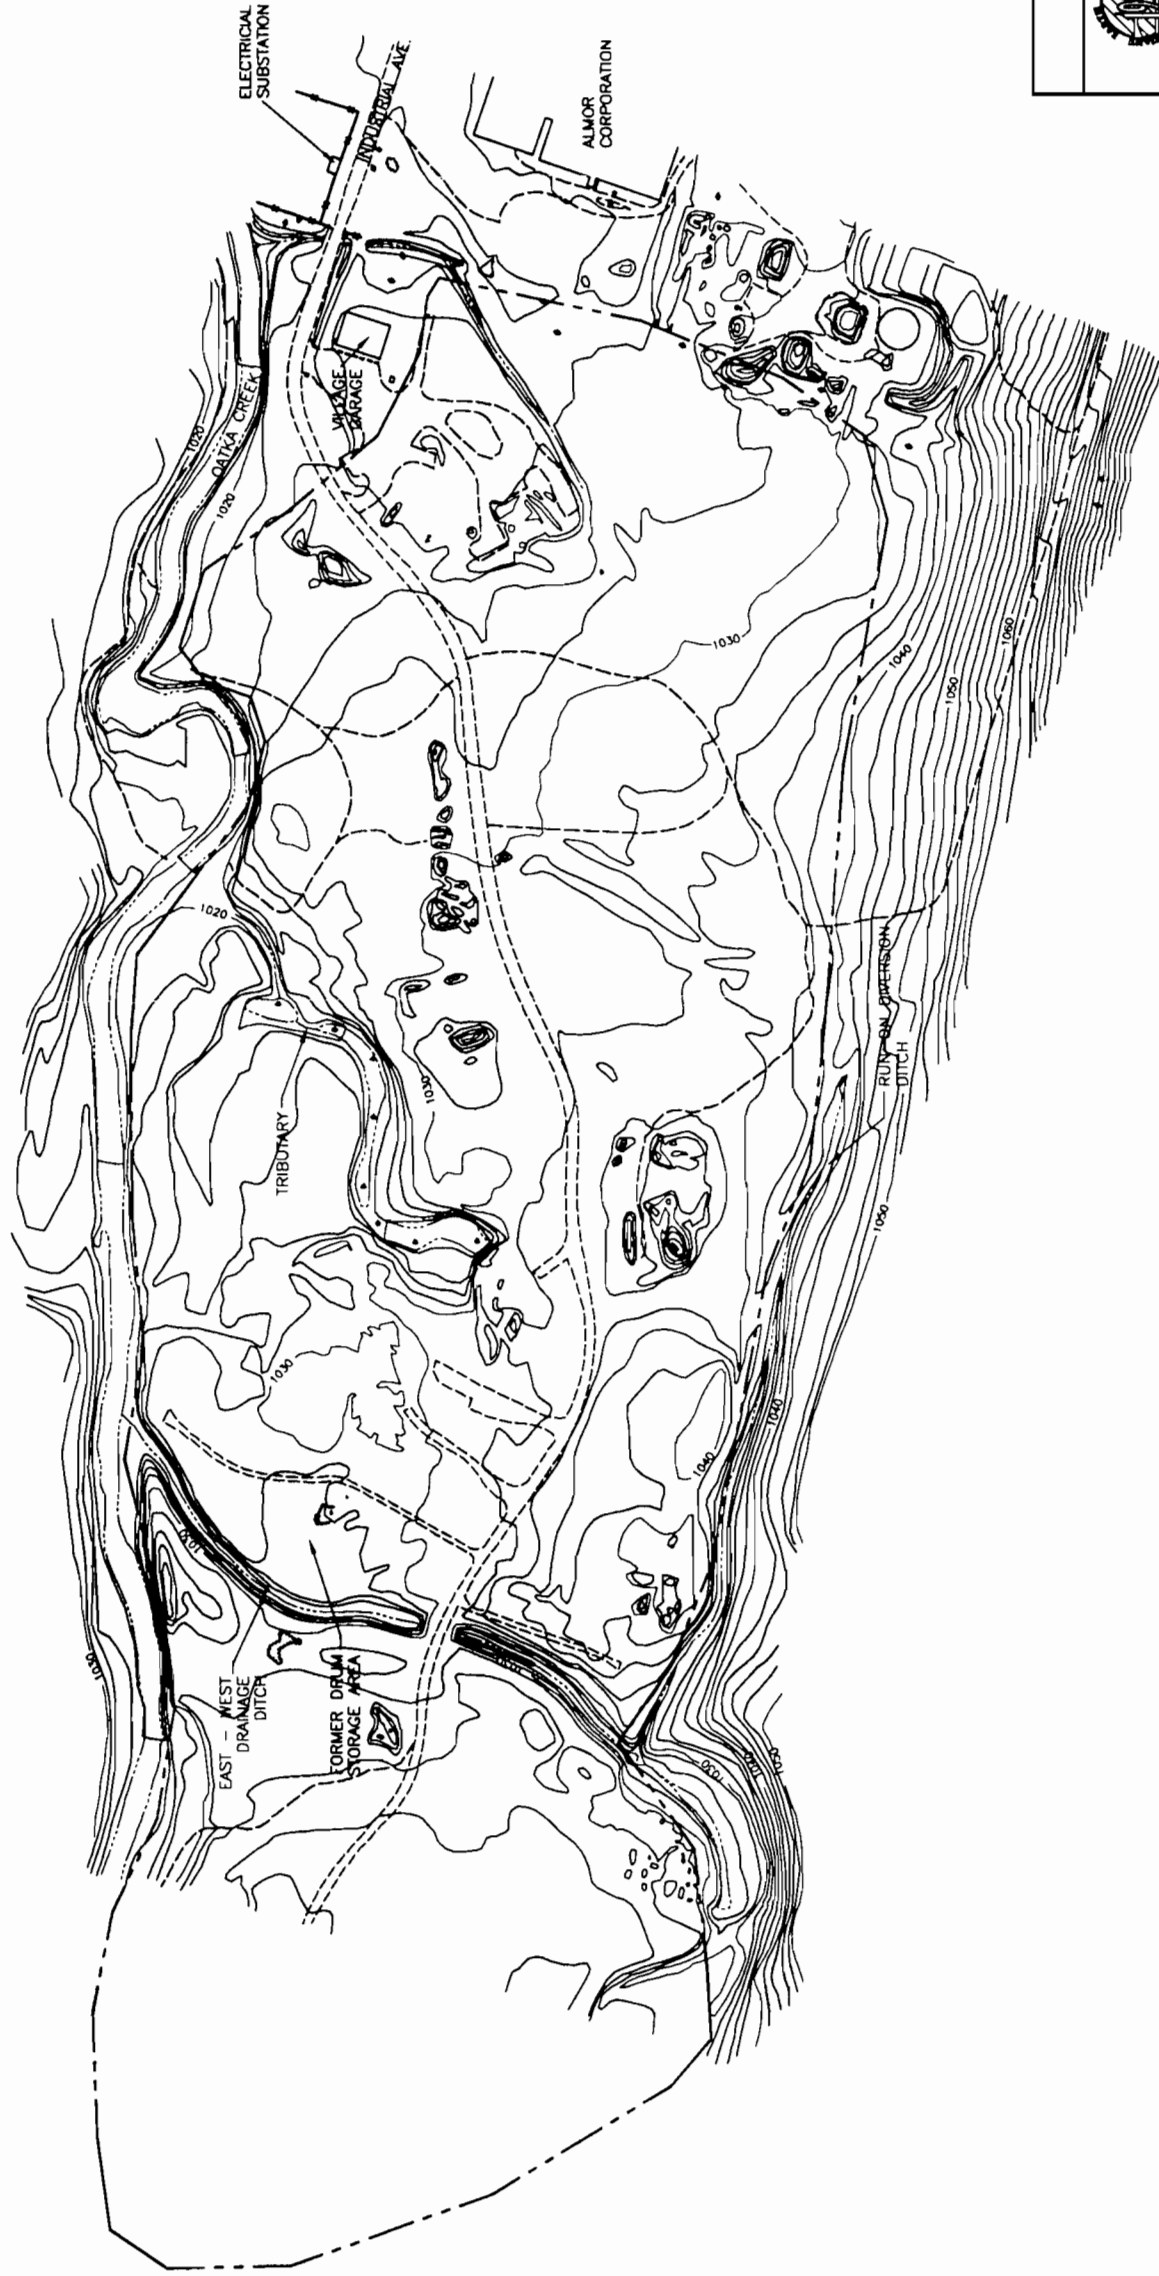
LEGEND
 - - - - - APPROXIMATE LANDFILL
 BOUNDARY

CONTOUR INTERVAL: 2'
 MAPPING COMPILED BY STEREOPHOTOGRAMMETRIC METHODS
 FROM 1" = 400' SCALE AERIAL PHOTOGRAPHY FLOWN 05/10/93.
 MAPPING COMPILED WITHOUT BENEFIT OF A FIELD EDIT.
