**Site Investigation and  
Remedial Alternatives Report  
Tract II Site  
Niagara Falls, New York**

**August 2000**

**CITY OF NIAGARA FALLS  
OFFICE OF ENVIRONMENTAL SERVICES  
Niagara Falls City Hall  
745 Main Street  
Niagara Falls, New York 14302**

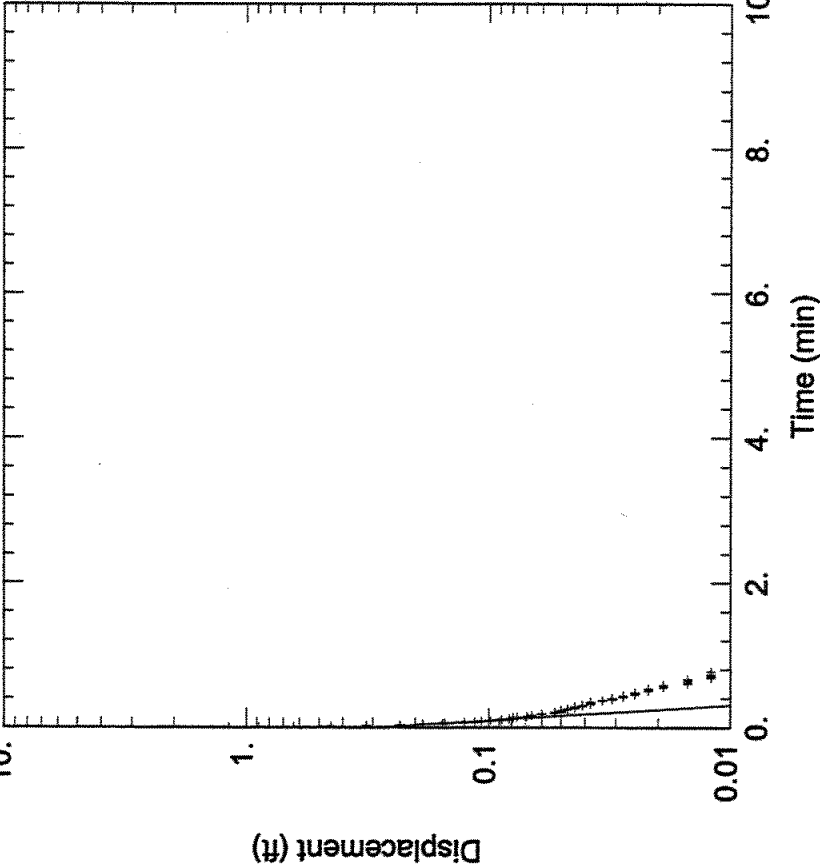
<p><u>TRACT II MW04 , RISING HEAD SLUG TEST</u></p> <p>Data Set: <u>A:\MW04.AQT</u>  Date: <u>01/28/99</u>      Time: <u>15:50:53</u></p>

<p><u>PROJECT INFORMATION</u></p> <p>Company: <u>Ecology &amp; Environment, Inc.</u>  Client: <u>City of Niagara Falls</u>  Project: <u>BP08</u>  Test Location: <u>Tract II, Niagara Falls, NY</u>  Test Well: <u>Tract II MW04</u>  Test Date: <u>12/10/98</u></p>	<p><u>SOLUTION</u></p> <p>Aquifer Model: <u>Unconfined</u>  Solution Method: <u>Bouwer-Rice</u>  <math>K = 0.01072 \text{ cm/sec}</math>  <math>y_0 = 0.2712 \text{ ft}</math></p>
<p><u>AQUIFER DATA</u></p> <p>Saturated Thickness: <u>10. ft</u></p>	<p>Anisotropy Ratio (<math>K_z/K_r</math>): <u>1.</u></p>
<p><u>WELL DATA</u></p> <p>Initial Displacement: <u>1.178 ft</u>  Casing Radius: <u>0.083 ft</u>  Screen Length: <u>10. ft</u></p>	<p>Water Column Height: <u>5.88 ft</u>  Wellbore Radius: <u>0.167 ft</u>  Gravel Pack Porosity: <u>0.4</u></p>

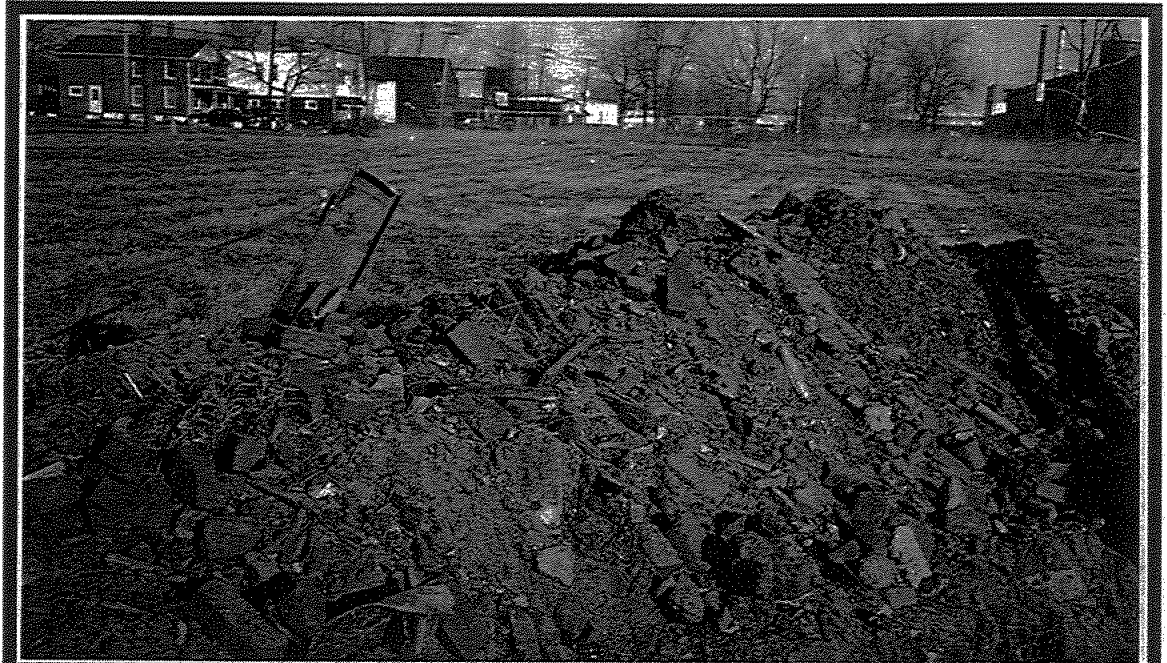
**Subject:** Construction and demolition (C&D) debris excavated and 0.6' to 2.8' below ground surface (BGS) at test pit TP-01 at southwest corner of site.

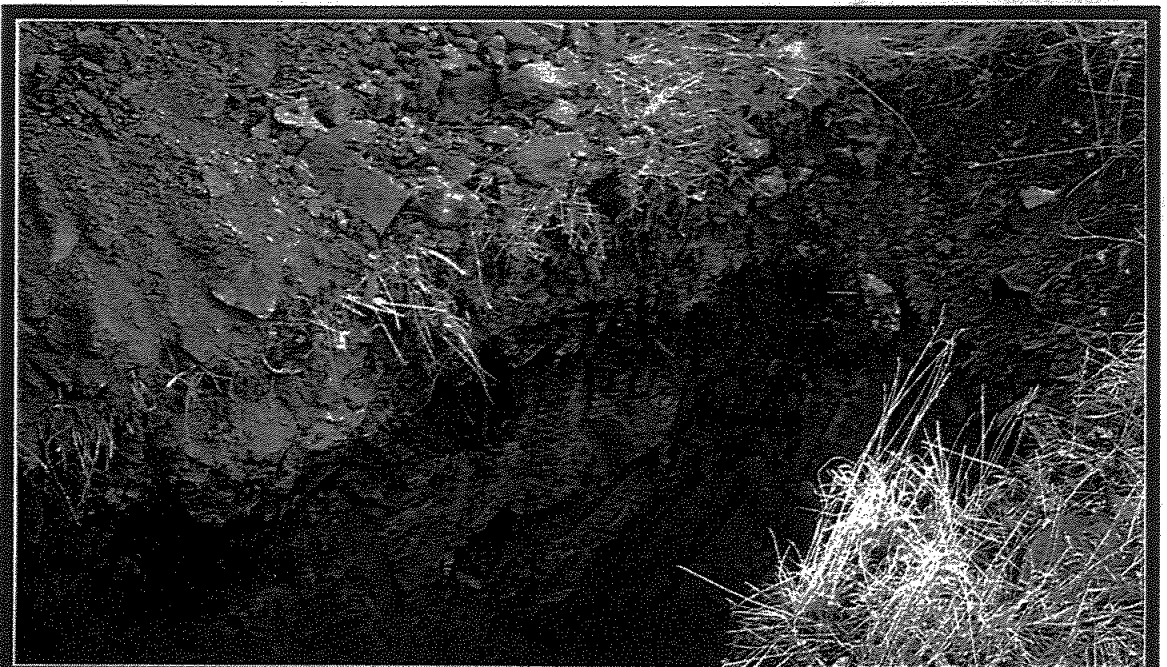
**Subject:** Charred wood and brick 0.7' to 1.9' BGS at test pit TP-02 west of concrete foundation.

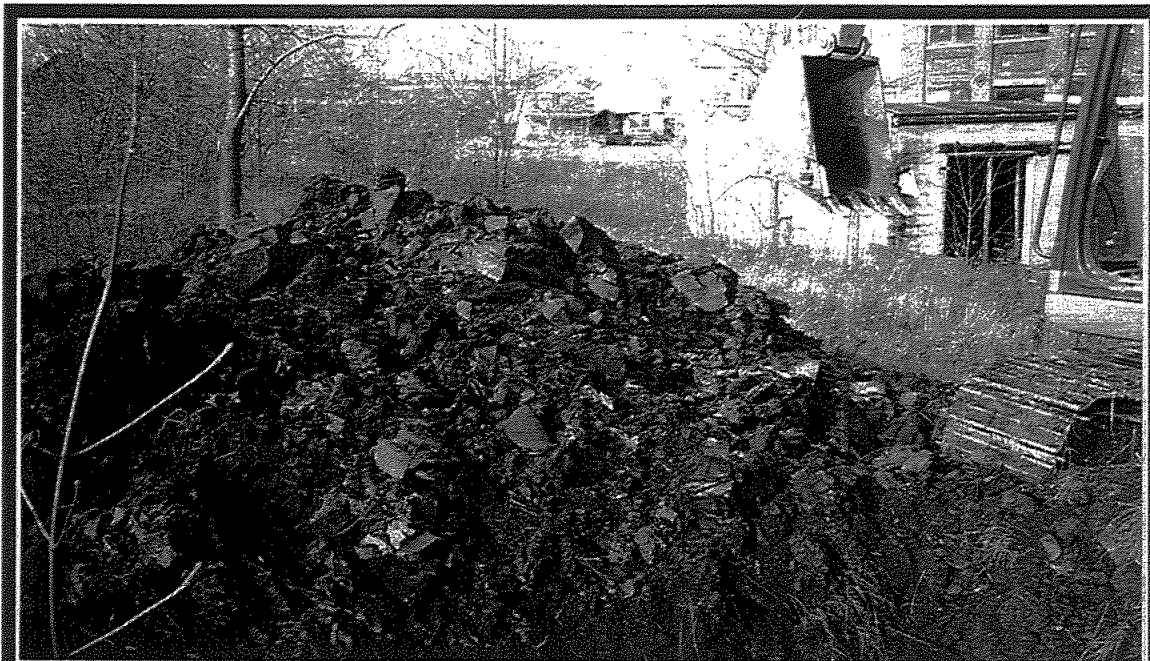
**Subject:** Burned cardboard and C&D fill from 0.3' to 4.4' below the surface of berm on northwest part of site.

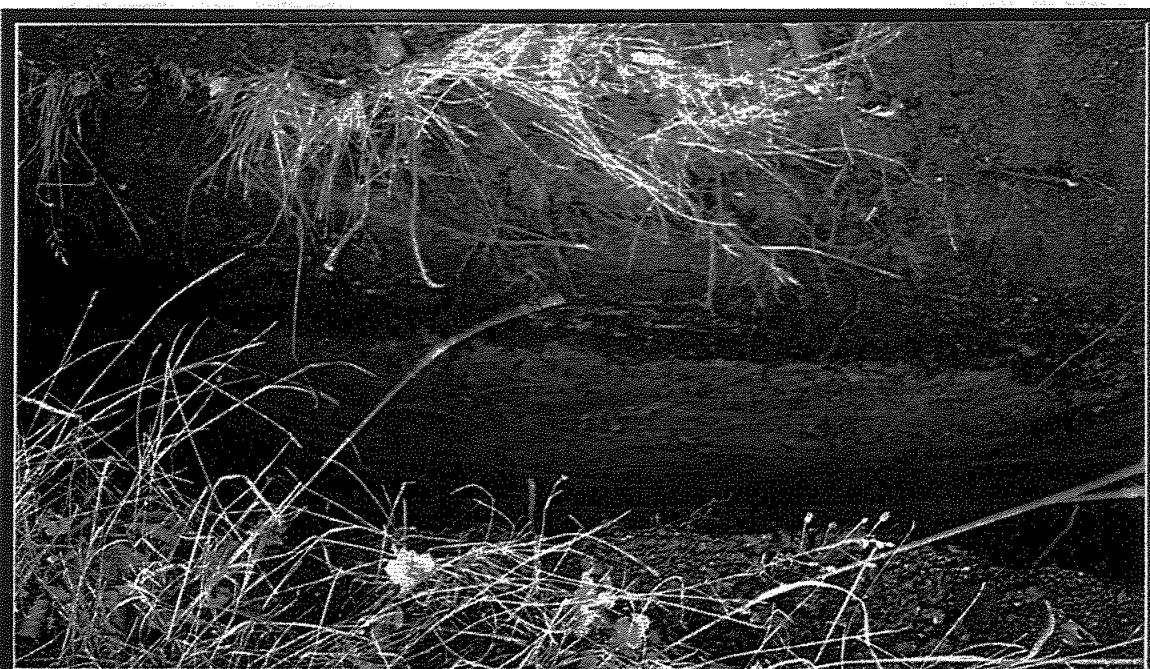
**Subject:** Cinders at ground surface and red brown clay with minor silt below 0.9' at test pit TP-04 at former railroad spur at north-central part of site.

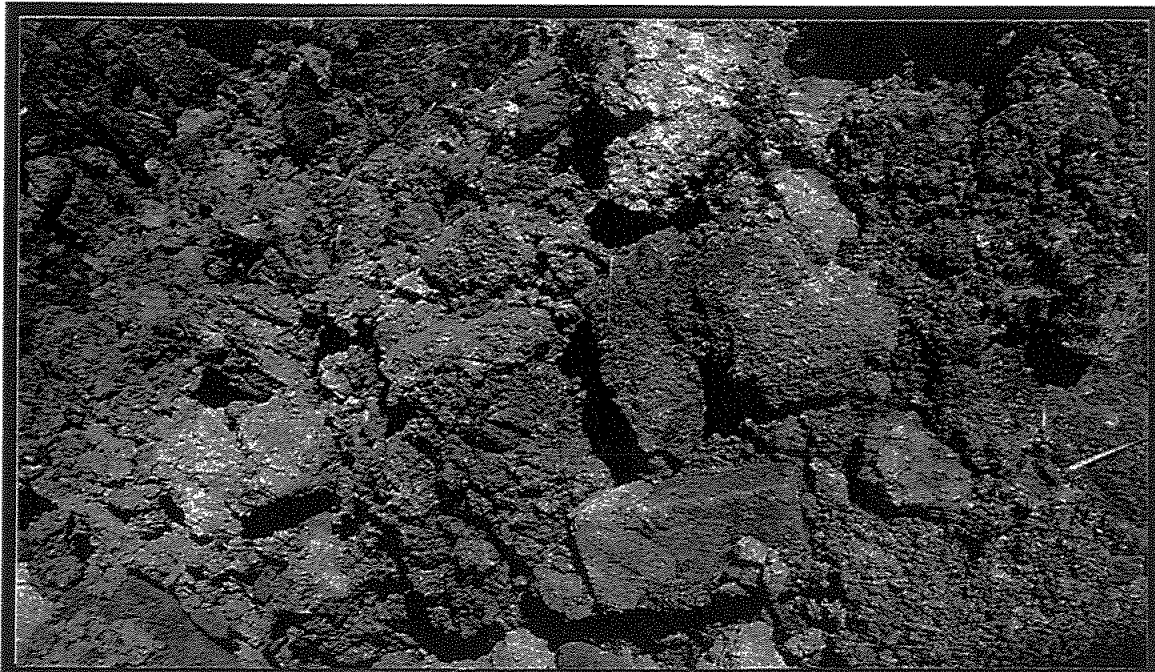
A black, tar-like substance with a strong organic odor was found in a Test Pit TP-05 sample in front of the dilapidated building located on the northeast side of the site. Laboratory analysis of sample SST2-05-BSO, collected from 4 to 6 feet BGS in this test pit, indicates that naphthalene and 2-methyl-naphthalene are present in tar substance at concentrations below respective screening criteria. In Test Pit TP-08 located at the west-central part of the site, a white, paste-like substance was observed. Laboratory analysis of sample SST2-08-BSO, collected from 4 to 6 feet BGS in this test pit, indicates that PAH compounds are present at concentrations exceeding in-screening criteria.

**Subject:** C&D debris from 0.5' to 5.4' BGS in test pit TP-5 on south (west) side of dilapidated building. Strong organic odor and OVA response of  $\leq 300$  ppm observed here.

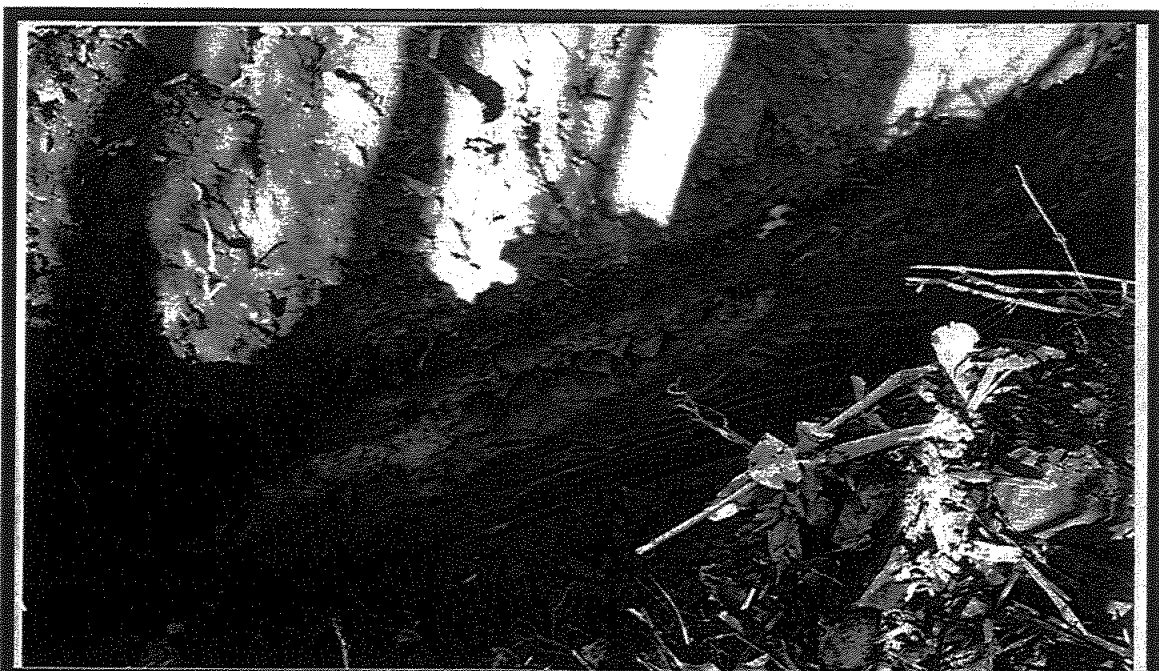
**Subject:** Cinder and brick from 0.5' to 3.5' BGS at test pit TP-06 on east side of dilapidated building.

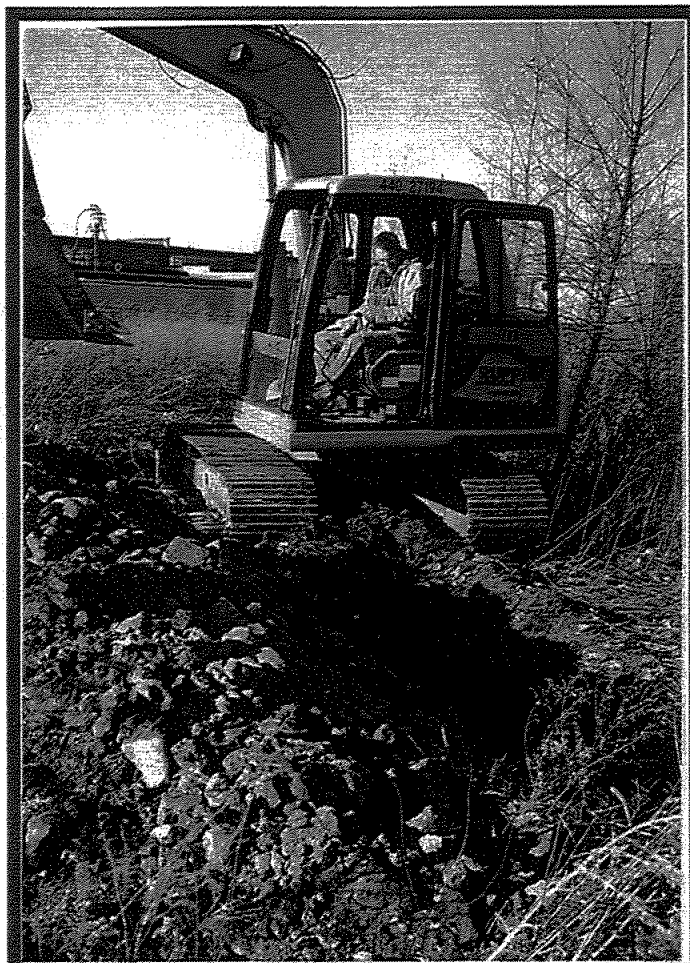
**Subject:** C&D debris removed from 0.5' to 4.7' BGS at test pit TP-07 at east-central part of site.

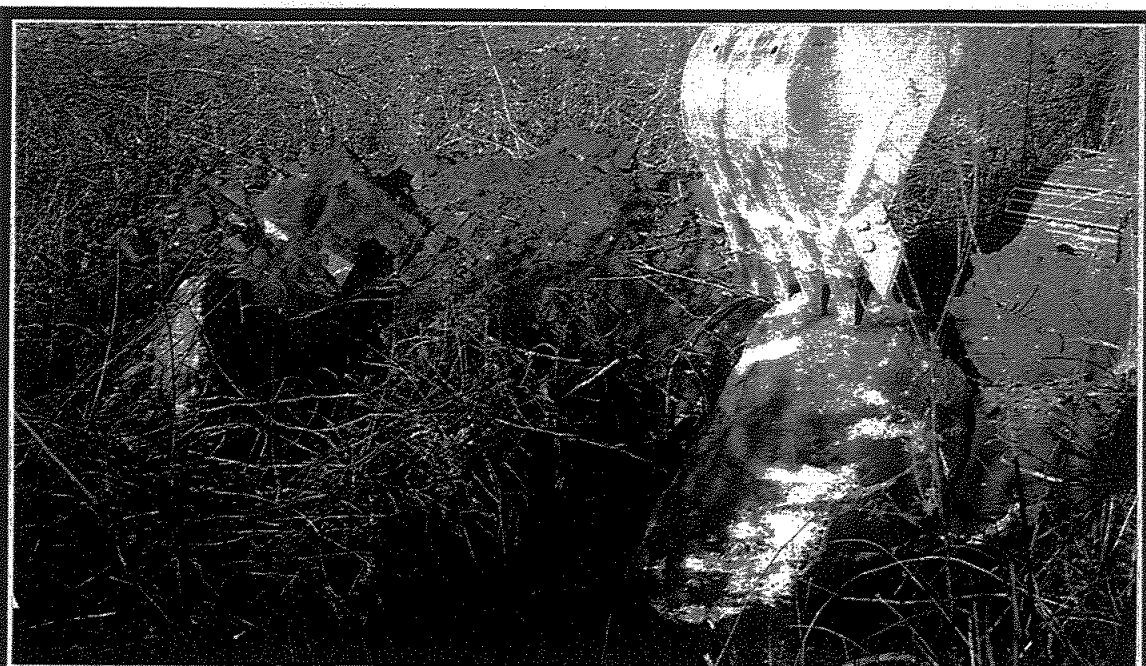
**Subject:** Large block of concrete and other C&D fill removed from 0.5 to 4.0' BGS at test pit TP-09 at east-central part of site.

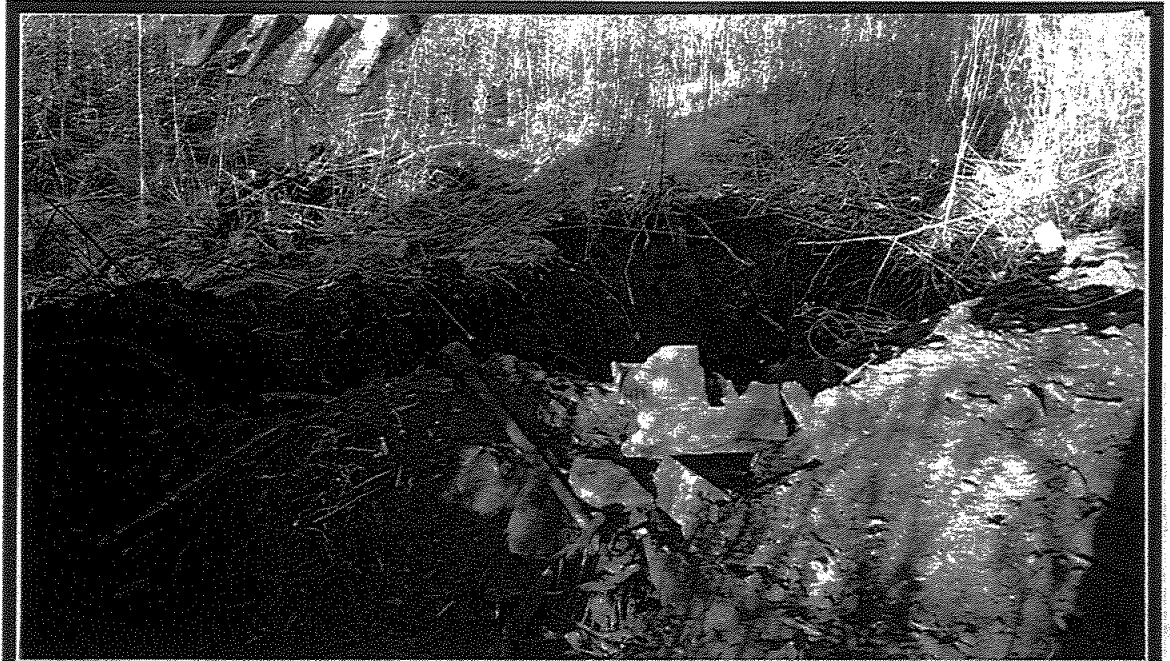
Elevated concentrations of lead were found in five test pit soils samples at levels exceeding the OSWER screening criterion. Four of these test pits were located on the east side of the site. Old battery casings were also observed on the east side of the site in Test Pits TP-10 and TP-12.

**Subject:** Broken battery casing and electrical conduit removed from 0.5' to 7.3' BGS in test pit TP-10 on east side of site.

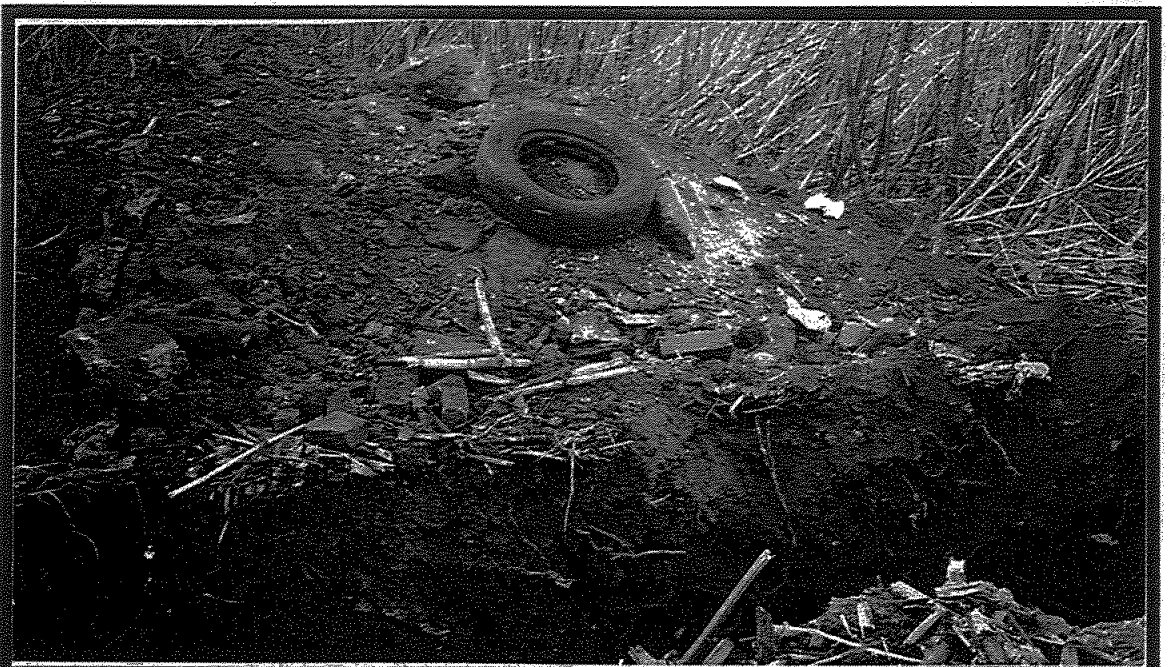
**Subject:** Tire and C&D debris removed from 0.5' to 4.6' BGS in test pit TP-11 at southeast corner of site.

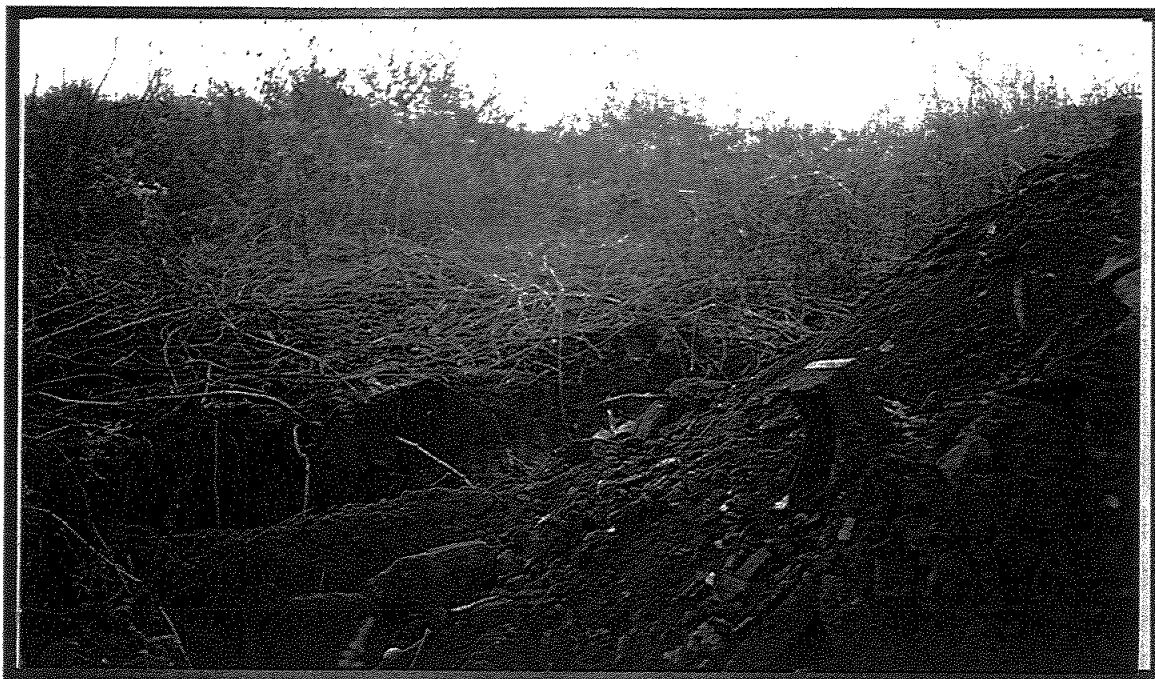
**Subject:** Broken battery, casings, C&D debris, and dark brown foundry sand removed from 1.7' to 7.4' BGS in test pit TP-12 at east-central part of site.
