**PERIODIC REVIEW REPORT**

**PORT-GREENBELT  
SHORELINE IMPROVEMENT PROJECT  
CITY OF BUFFALO, ERIE COUNTY, NEW YORK**

**SITE No. B-00149-9**

**AUGUST 2013**

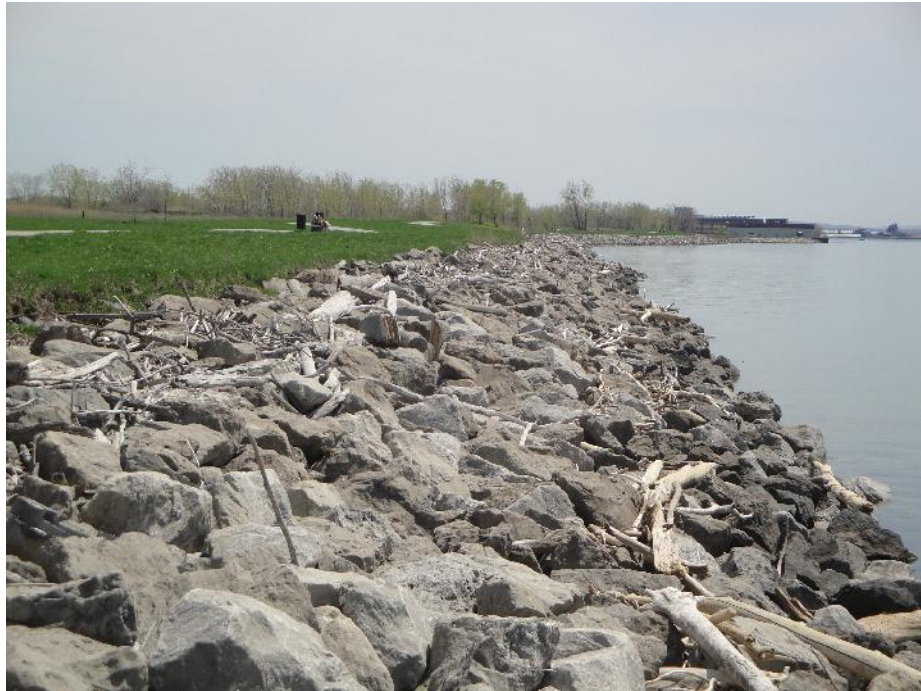
<b>Exhibit:</b>	<b>Date:</b>
1	5/3/2013

The armor stone revetment was in very good condition and showed no signs of failure or slipping. No stones were displaced or showed any signs of disintegration.

Revetment

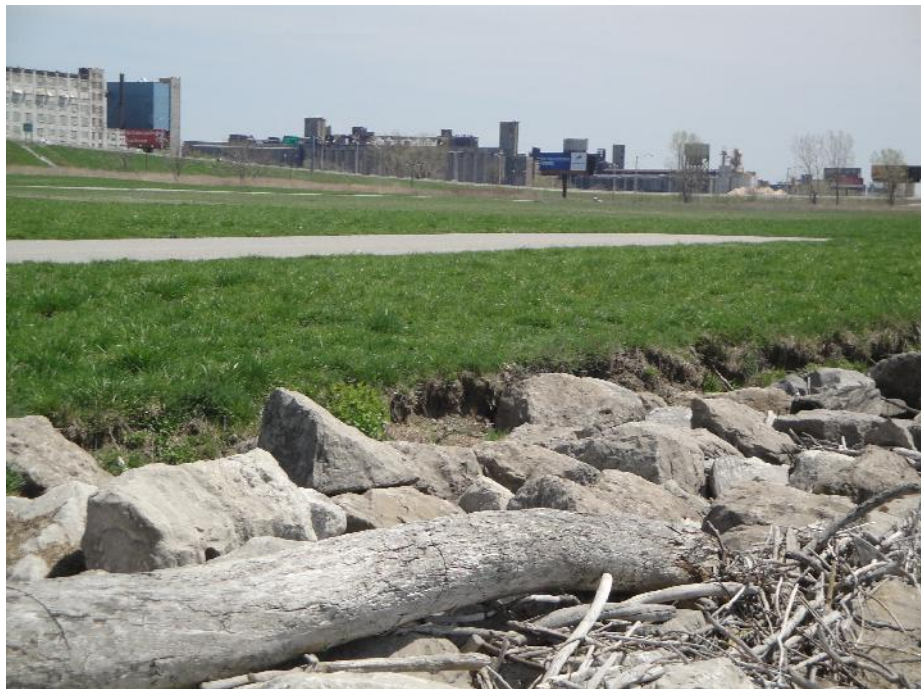
<b>Exhibit:</b>	<b>Date:</b>
2	5/3/2013

The northernmost extent of the shoreline, a short stretch of soil cover at the top of the revetment, shows signs of erosion in minor areas. Follow-up site visits showed no additional erosion and vegetation along this slope.

Minor erosion at the top of the revetment

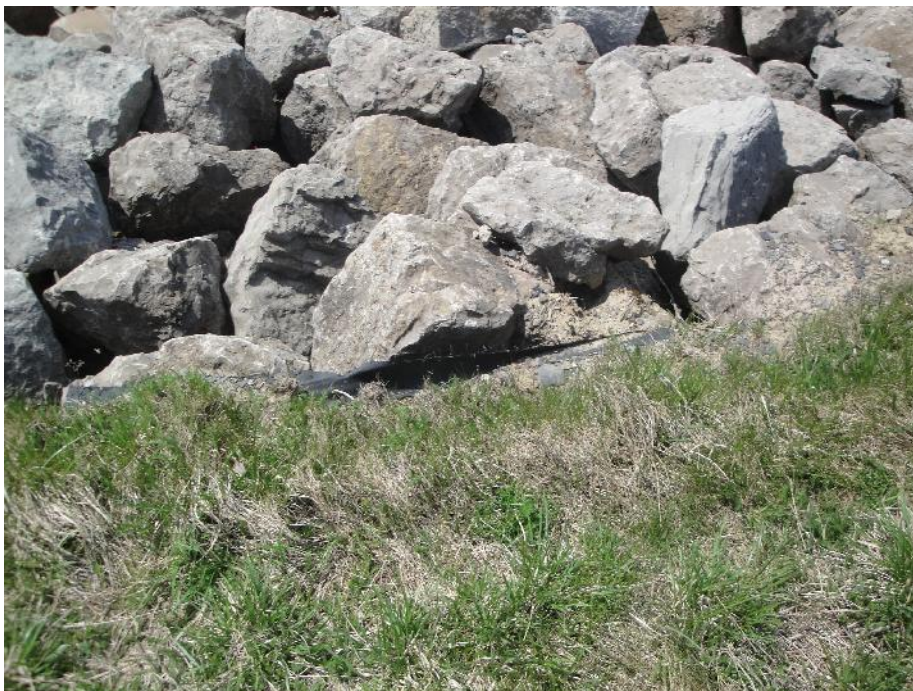
3

There were a few sites along the edge of the revetment where geotextile fabric is visible; this is similar to the as built condition and is not considered to have an impact of the effectiveness of the controls.

Exposed Fabric at top  
of revetment

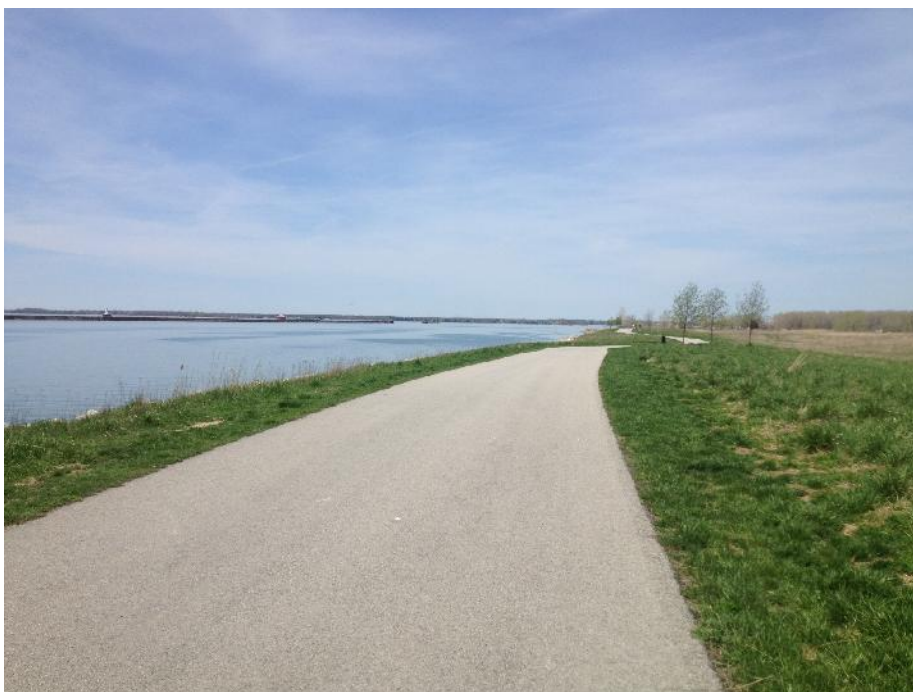
4

The asphalt path is in good condition and is not showing any signs of wear.

Asphalt Path

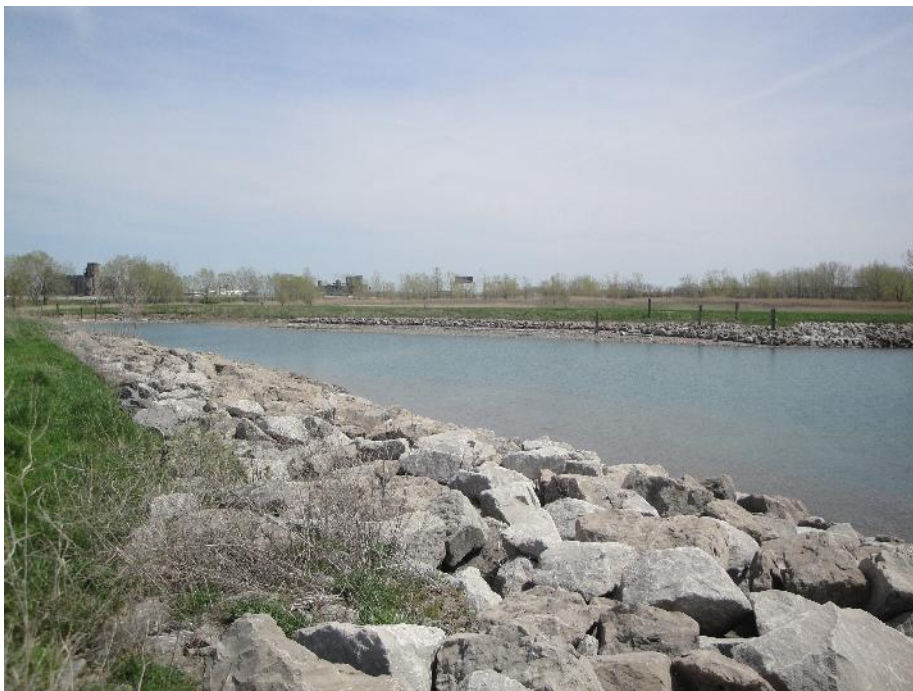
5

Generally the slip looked to be in good condition with significant portions of the area covered with stones and grass cover.

Bell Slip

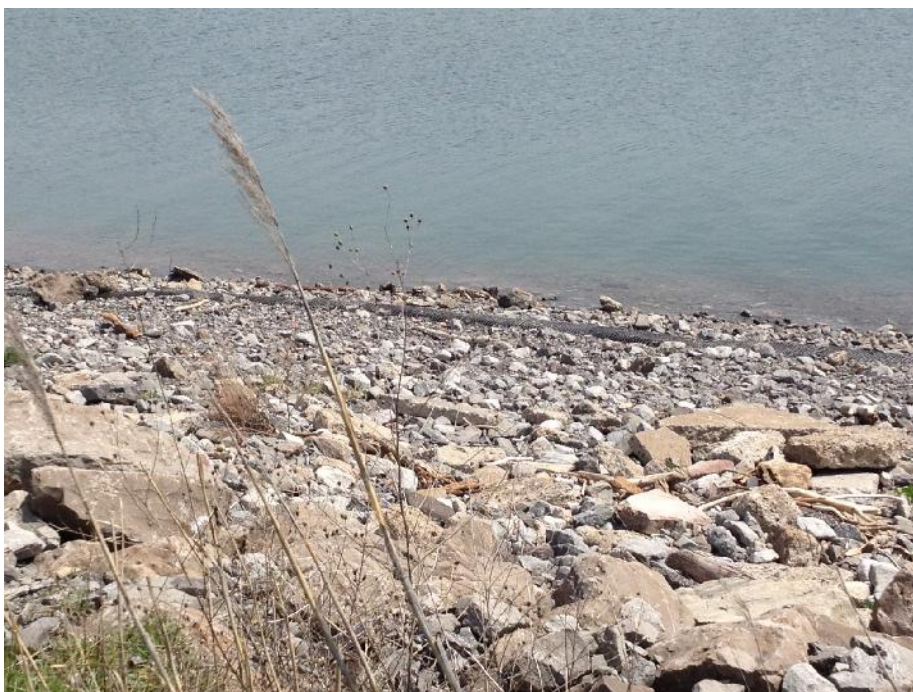
6

The geotextile sock along the water's edge showed some signs of damage. However, the contents of the sock were still in place and no erosion was observed adjacent to the sock. Therefore, the sock is considered to be acting as designed.

Exposed Sock in Bell Slip

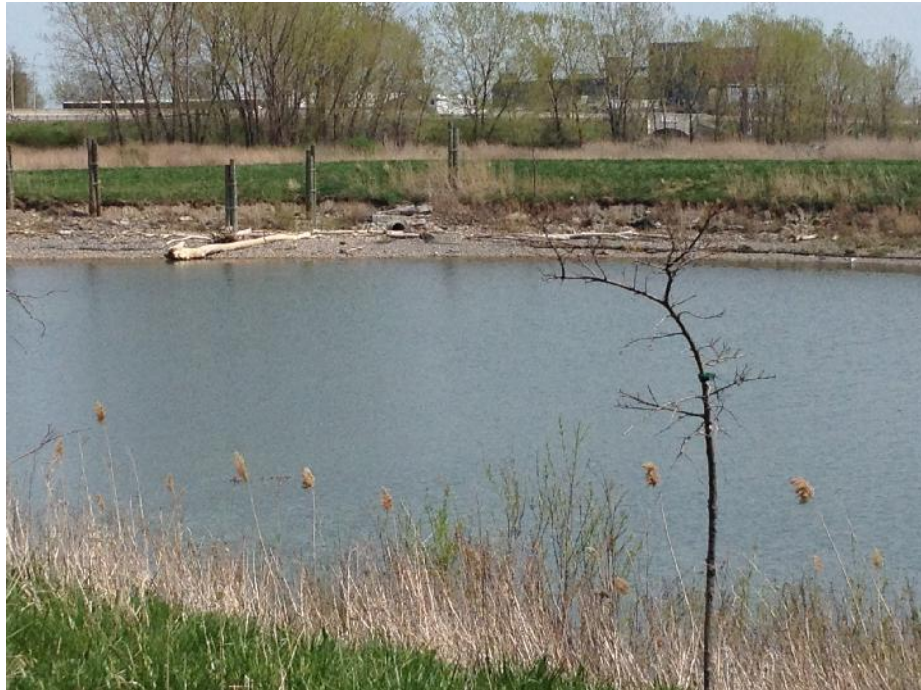
7

Some of the slopes show minor signs of erosion; portions of the slope have a short drop where there is no soil or vegetation and before the area where stone was used to stabilize the slope. Follow-up site visits showed no additional erosion and vegetation along this slope.

Erosion along Bell  
Slip
