**Re: Port-Greenbelt Shoreline Improvement Project Site – Corrective Measures Work Plan
NYSDEC Site No. B-00149-9**

PORT-GREENBELT SHORELINE EROSION AND REPAIR
SECTION 1

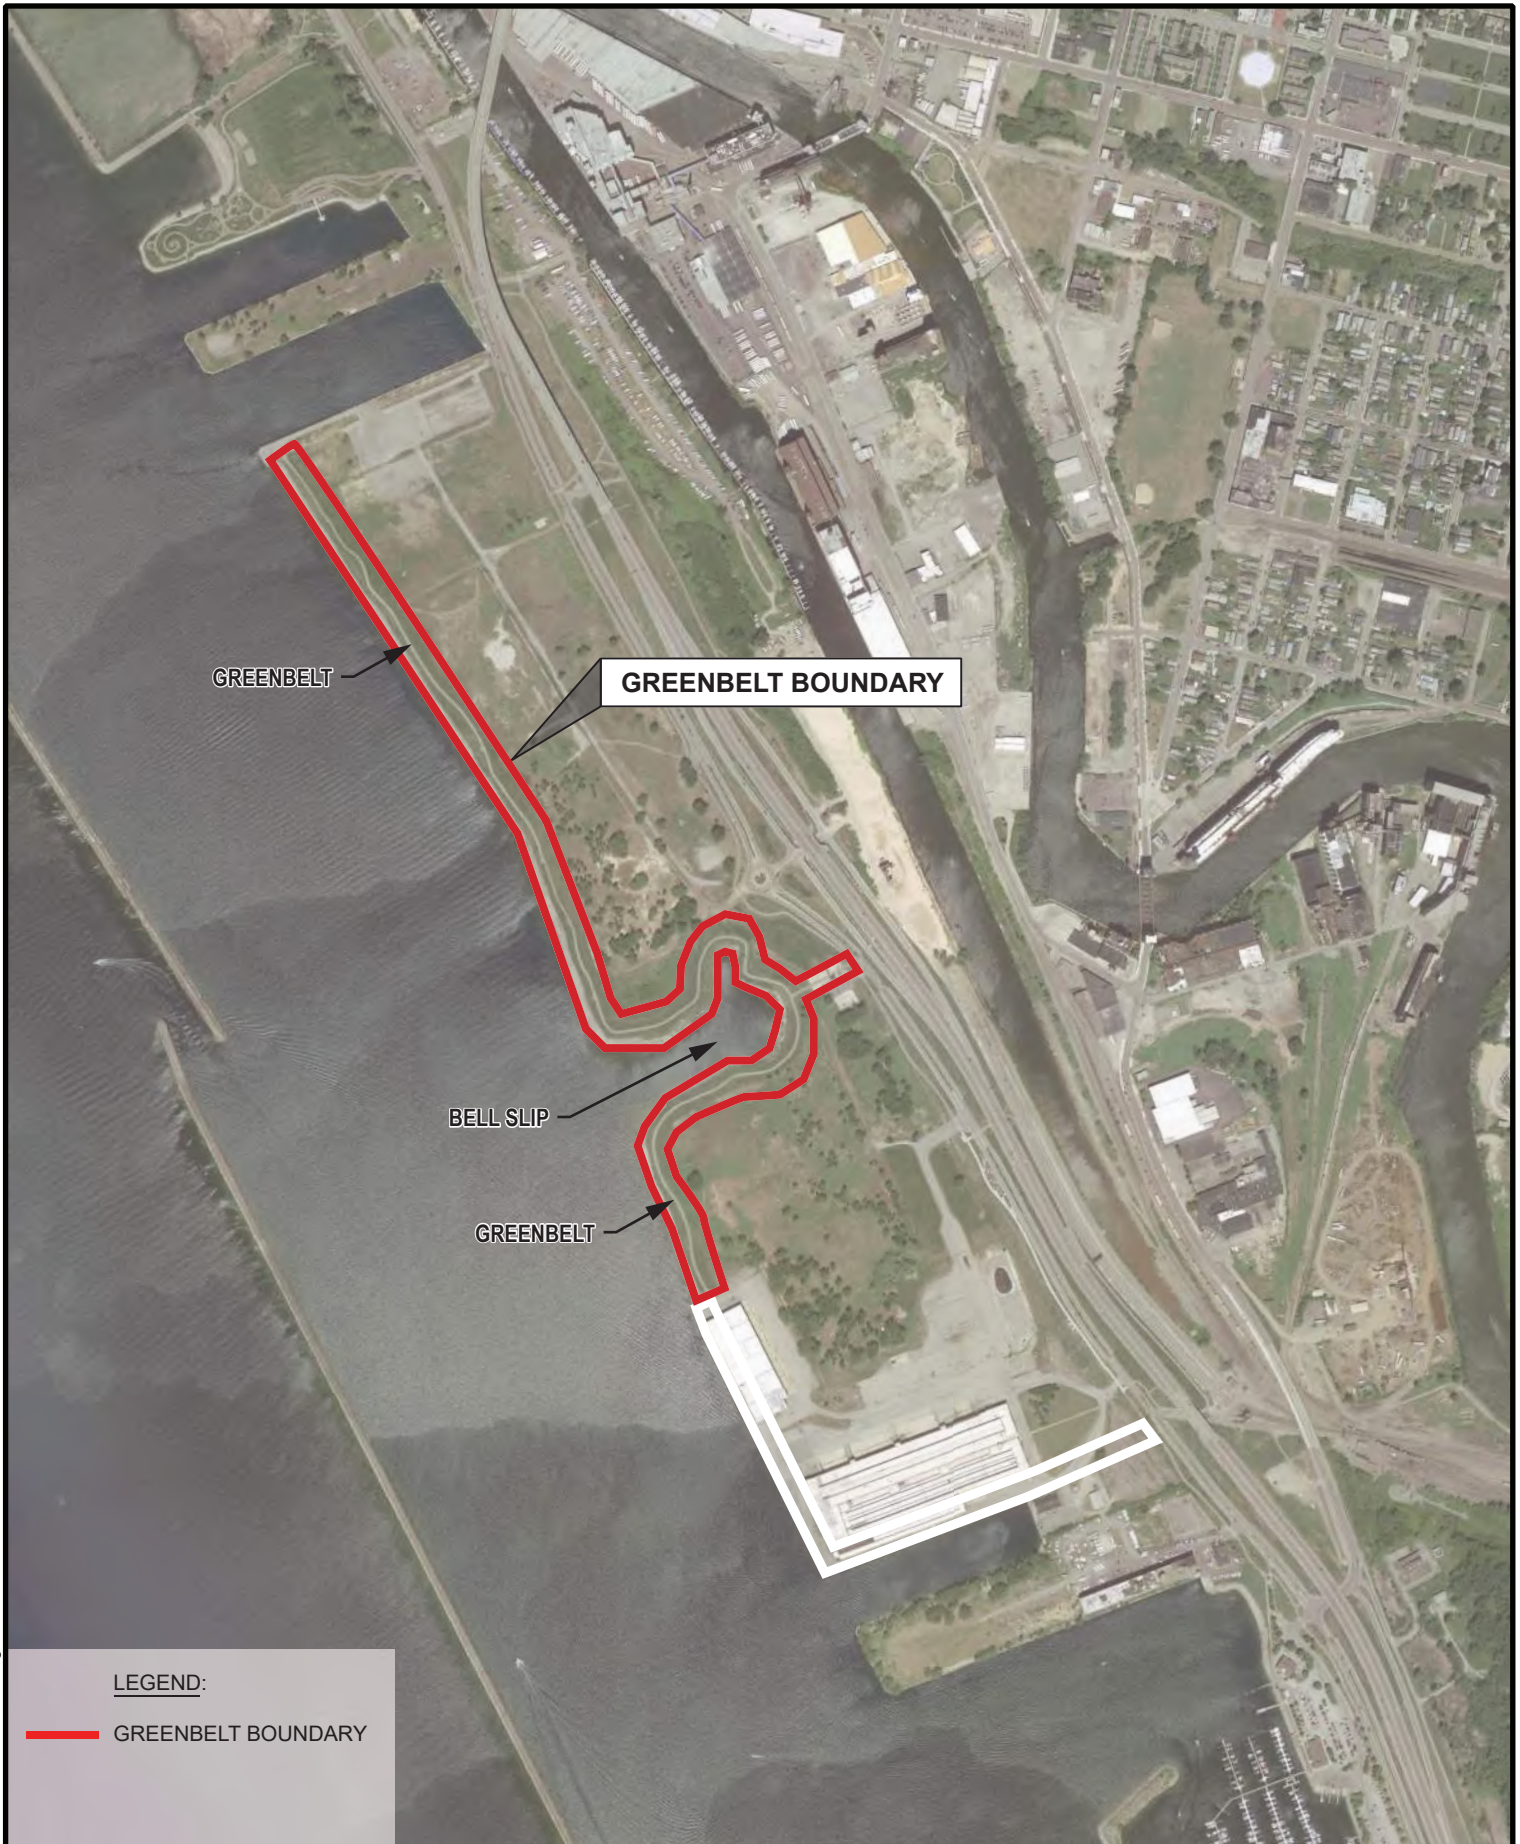
Typical photos of the erosion damage along with the proposed repair cross-sections are provide on Figures 3-11. The photo location and direction along with the cross-sections are keyed to the damaged areas on Figure 2 for reference.

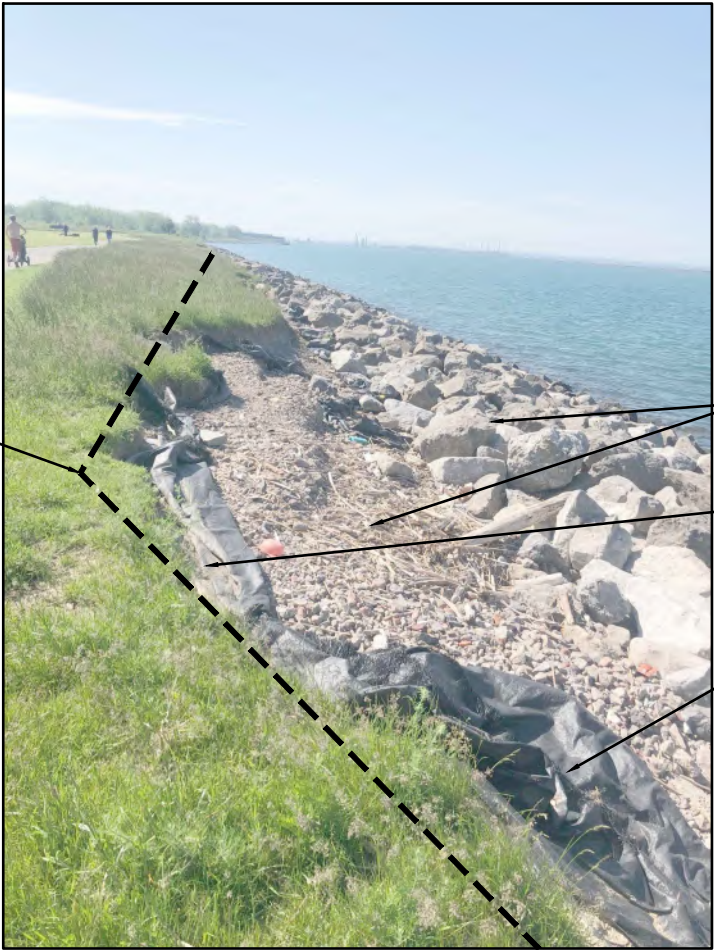
PHOTO 1

EDGE OF EROSION TO BE CUT BACK TO PROVIDE UNIFORM EDGE

Eroded areas will be cut back as needed to provide a uniform edge. In areas where the filter fabric is intact but has been displaced, the fabric will be laid out flat to its original extents. In areas where the filter fabric is missing or deteriorated, new filter fabric will be placed. New filter fabric shall meet the specs of Mirafi 600X geotextile. A manufacturer cut sheet is provided in appendix A.
