Site Investigation Report

Environmental Restoration Project
Clean Water/Clean Air Bond Act of
1996

Independent Leather
321-333 South Main Street
City of Gloversville
Fulton County, New York

ENVIRONMENTAL RESTORATION PROJECT
SITE INVESTIGATION REPORT
INDEPENDENT LEATHER
321-333 SOUTH MAIN STREET, GLOVERSVILLE, NEW YORK

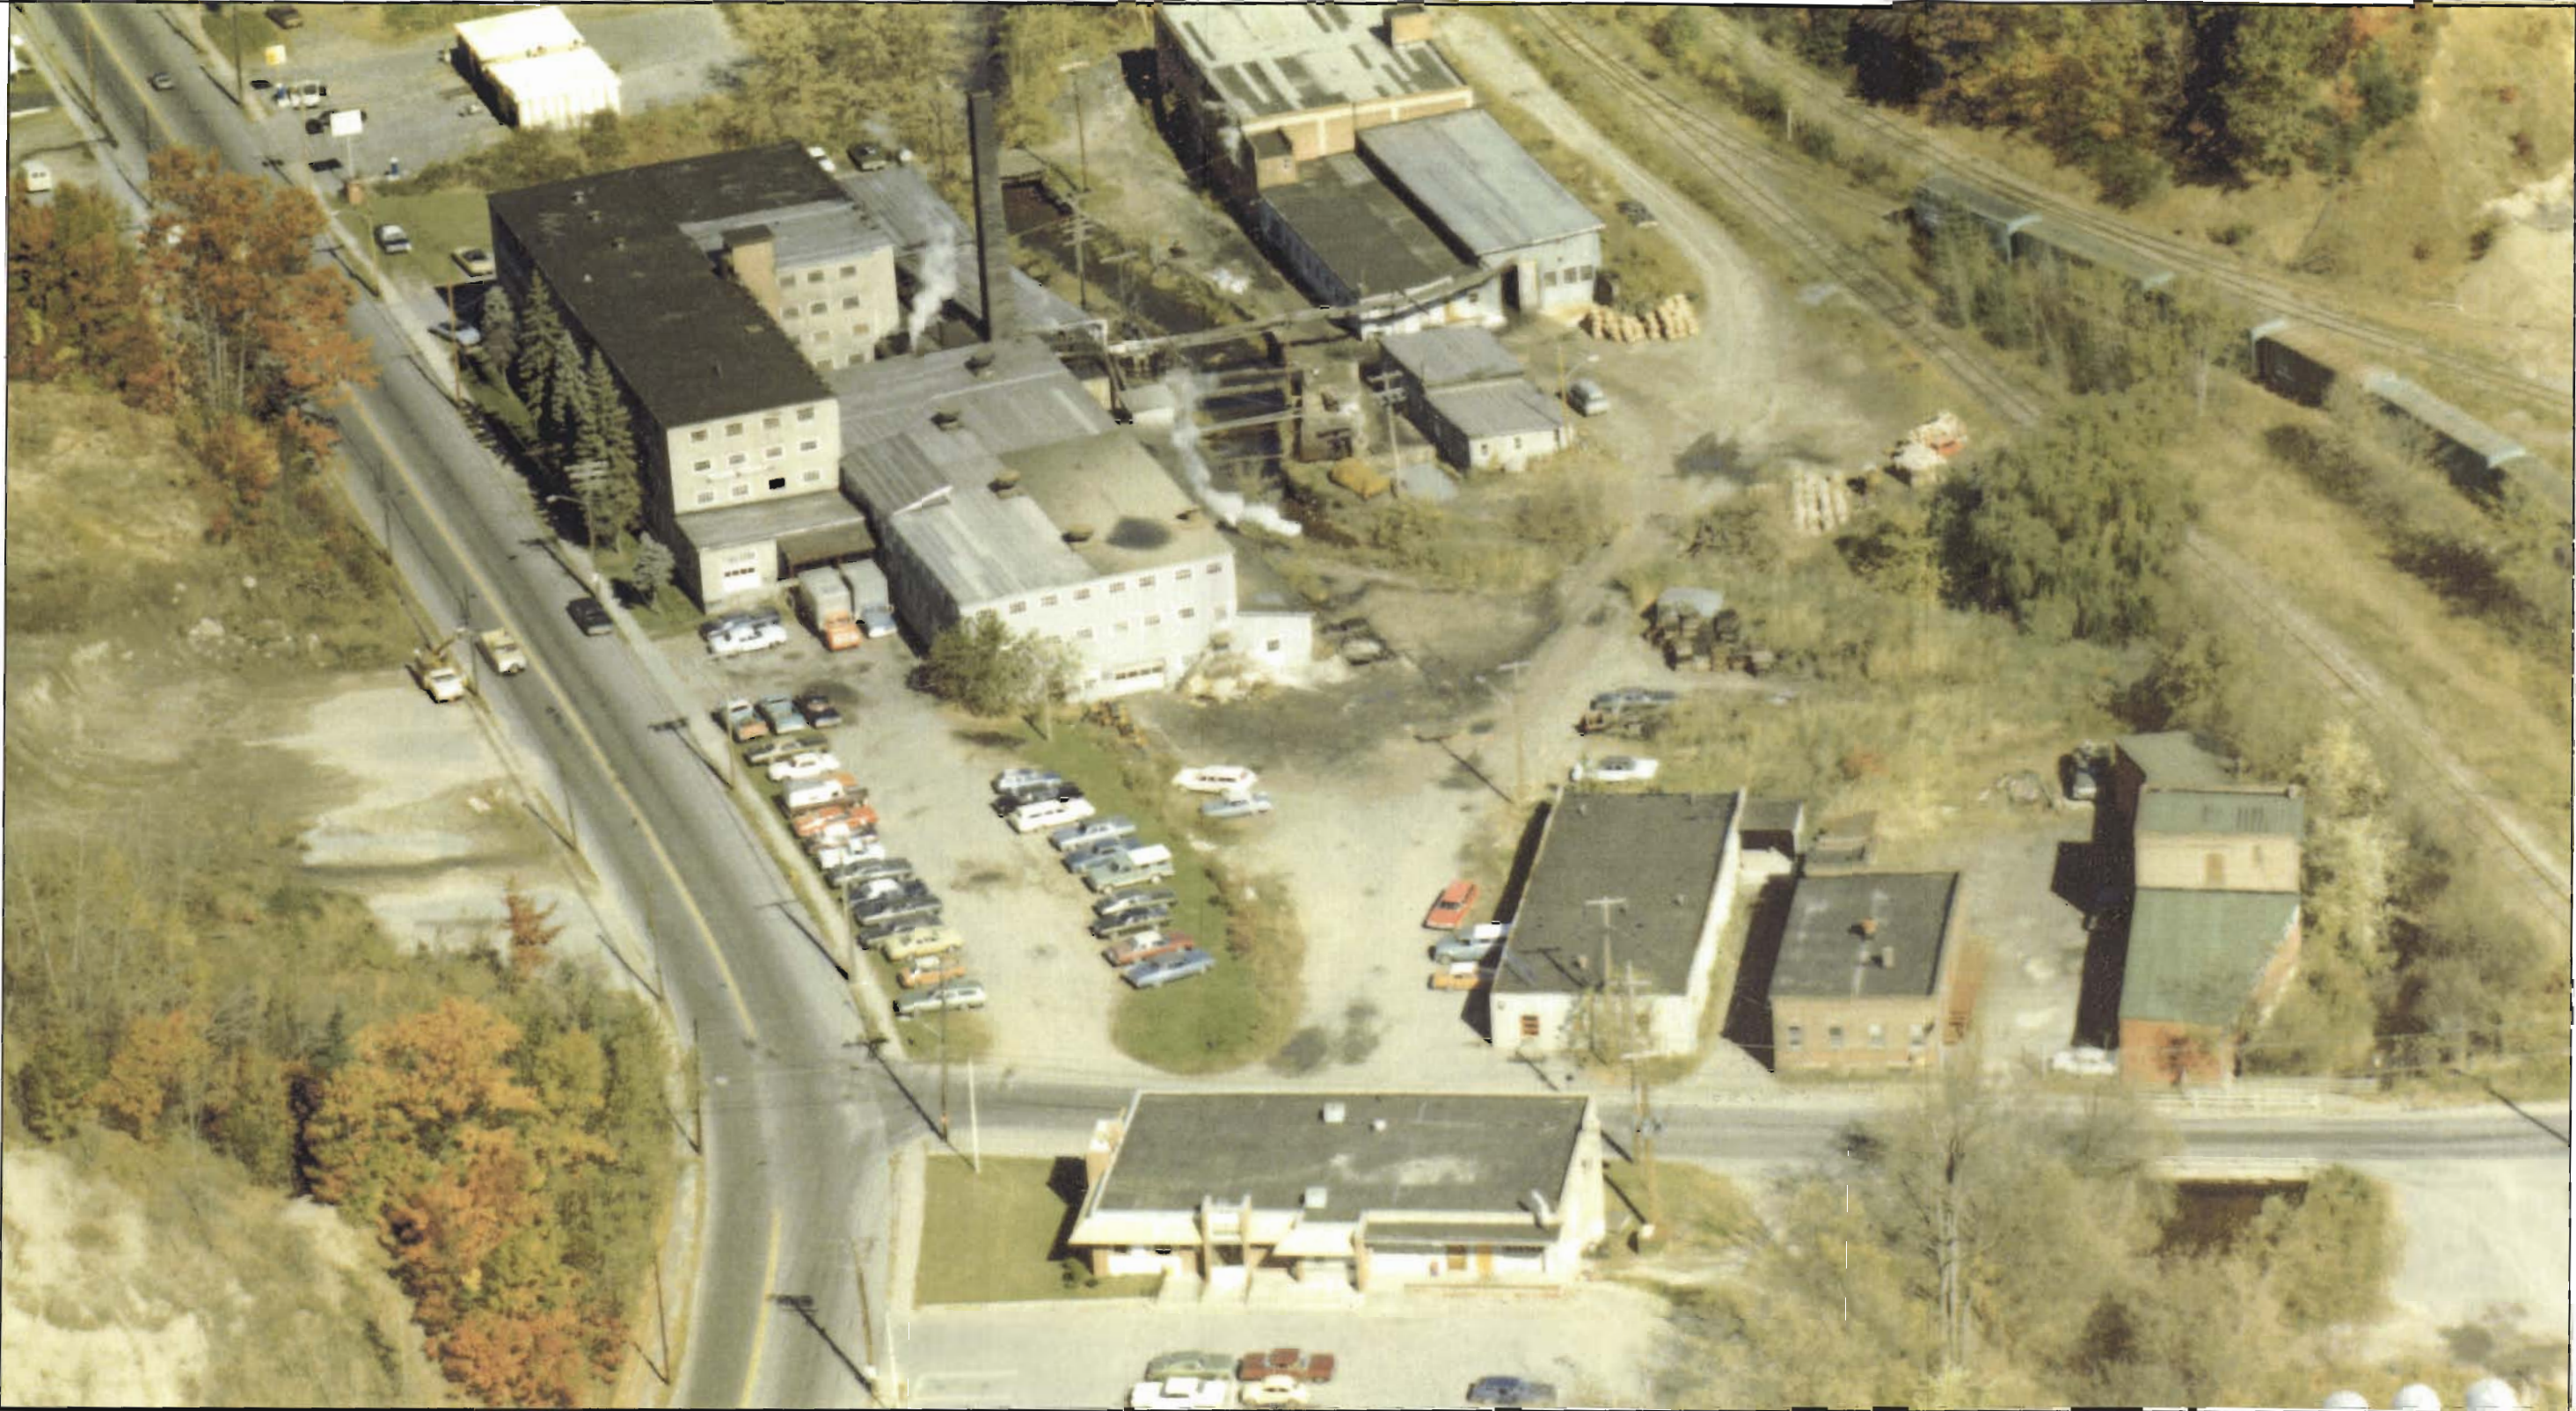
FIGURE 3
1970'S AERIAL PHOTOGRAPH

The site's property boundaries create an irregularly shaped parcel. The site is currently a defunct tannery complex. The Cayadutta Creek flows onto the site from the north and continues in a southerly direction through the middle of the parcel. At its peak, the site contained four separate buildings which were associated with the tannery process, and a sewage treatment plant. These buildings were located on both sides of the stream with steel/wooden bridges over the stream allowing access to each side of the stream as shown in the black and white aerial photograph presented in the Figure 3.

The surface features at the site have dramatically changed through the completion of this site investigation from early 2001 to late 2002. Historically (pre-2001), the western side of the site as separated from the eastern section of the site by Cayadutta Creek was improved with a four-story building with basement used as the main tannery building and a smaller detached maintenance building. There were loading docks on the south side of the building which lead to an upper and lower unpaved parking area. The parking lots were separated by a grassy gently sloping hill. The north side of the building provided another area of parking, a portion of which was paved (along road) and gravel surfaced (along creek). Limited landscaped areas of grass were also present on the north side of the building. There is and has always been a creek that flows through the site. There were three steel support wooden deck bridges crossing the creek. On the east side of the creek (pre-2001), there are two buildings, one being the secondary tannery building and the other is a smaller storage building. The balance of the land is relatively flat and either grass (generally the southeast corner of the site) or dirt covered (roadway around building). An aerial photograph (circa 1970's) of the site is presented as Figure 3 of this report, which shows the historical surface features of the site.

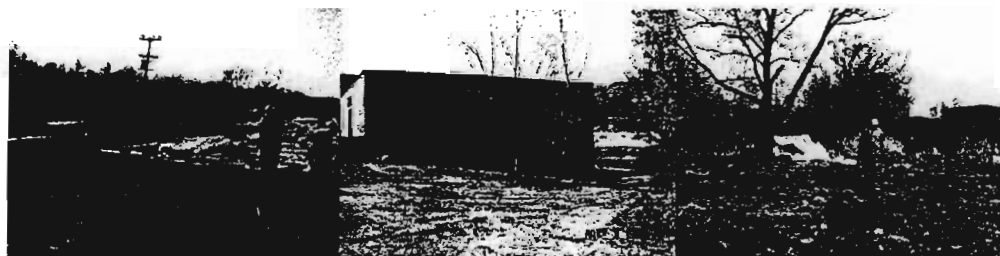
Area surveyed represented sectors shown in Attachment A-1 with this report. The sectors are as follows:

1. 220' north/south X 65' east/west (approximate)
2. 330' north/south X 40' east/west (approximate)
3. 120' X 120' (approximate)

Left - S-1 / Center - S-2 / Right - S-3
(Shows beginning of each sector)

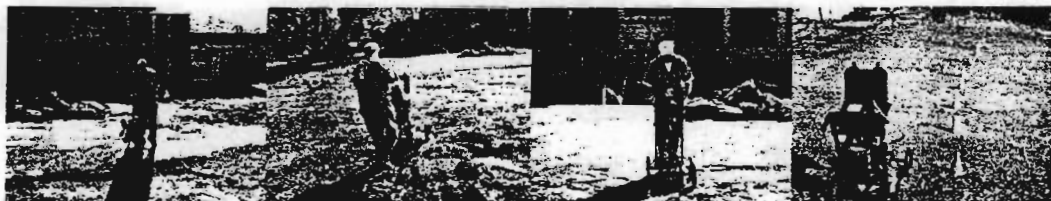
FILE214 represents an easterly traverse of approximately 80 linear feet. This is showing an equitable distribution of the subsurface signal to approximately 6.4' below the surface. No unusual features or hyperbolas. FILE215 through FILE217 represent parallel traverses at 4.0' intervals showing little change in this area of the survey. FILE225 and FILE226 represent parallel traverses south of SSW3. Unchanged in subsurface data.

Data collection in 1st sector (S-1) - Cones are at 4.0' intervals to maintain grid.

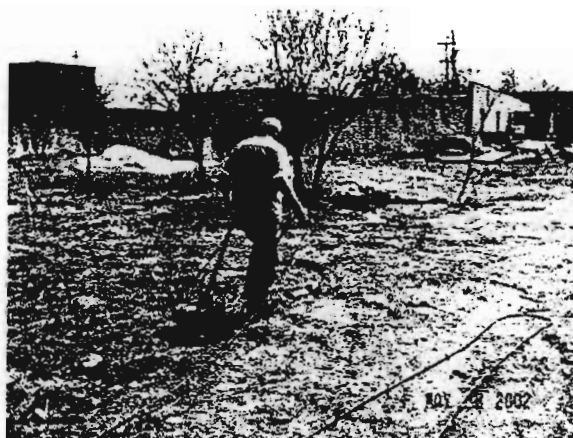
Hand pulling 500MHz w/handle & cable

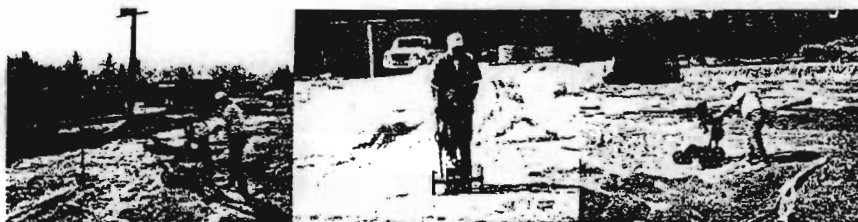
FILE239 through FILE245 represent multiple, short traverses over the plastic covered area of S-1. These profiles were selected based on the surface topography. Areas where the surface was flat, a profile was taken. No unusual anomalies in any of this data.

Data collection over plastic covered area in Sector 1

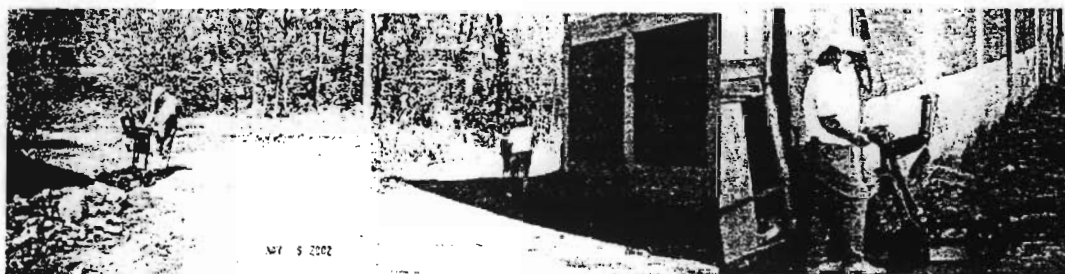
Sector 2 represented an area starting at the northwest corner of the property on the north side of the Secondary Tannery Building #2. Traverses were collected in both north/south and east/west directions along the western side of the building including the three sides of the storage building at the southern end of the corridor. No unusual anomalies were seen to indicate the presence of any underground storage tanks.

FILE249 through FILE257 represent data collected on the north and west sides of the Secondary Tannery Building. All shows a clear penetration to the base of the gpr window of 6.4' with no unusual hyperbolic features. The subsoil's appear to be similar throughout the entire data showing no metallic reflections or unusual subsurface features.

Collection of data in Sector 2

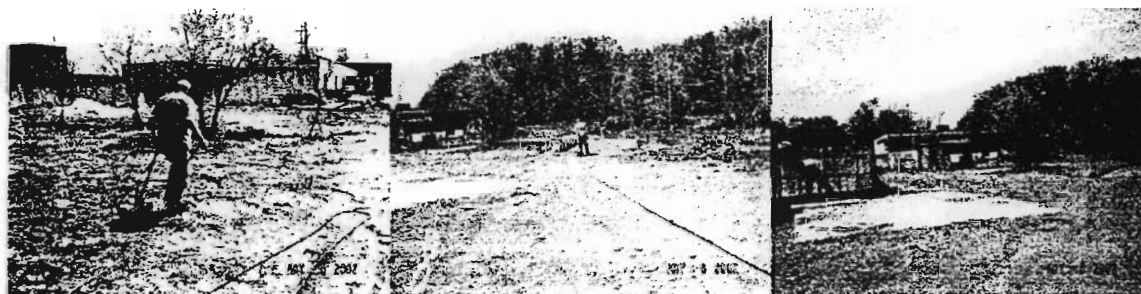
FILE288 through 297 represent data collection in Sector 3, southeast corner. All of the data collected in this area shows a high conductivity reading near the 7.0' depth which appears to be that of the water table. During the gpr investigation, the depth was varied from 33.5' nanoseconds to more than 60 nanoseconds looking for the optimal range. No parabolic features were found in this sector indicating the presence of any underground storage tanks and/or drums.

Sector 3 collection of data
