SAMPLING REPORT

UNION SHIP CANAL SITE

A.K.A. HANNA FURNACE CORPORATION SITE

June 7, 2001

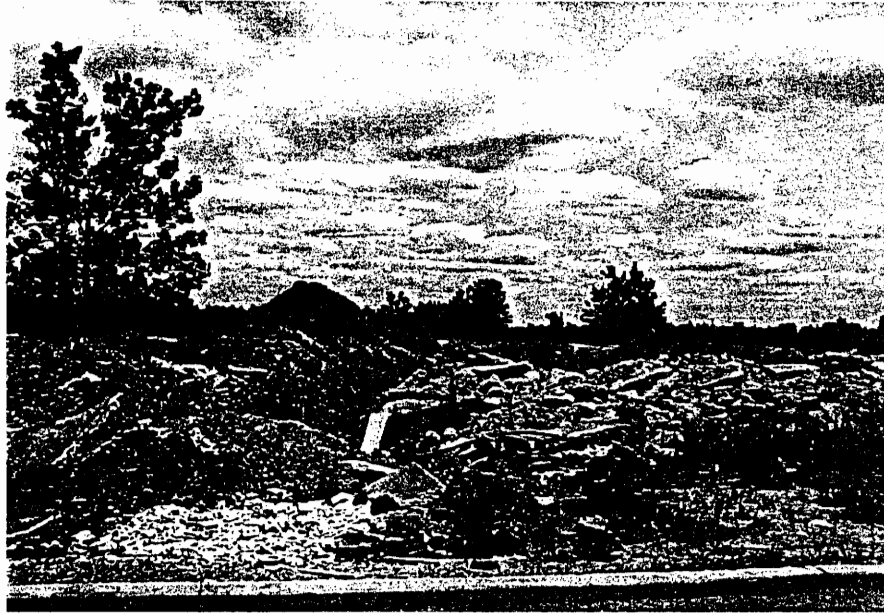
Figure 1: This photograph of the Union Ship Canal site was taken from Furhman Boulevard looking east at the property.

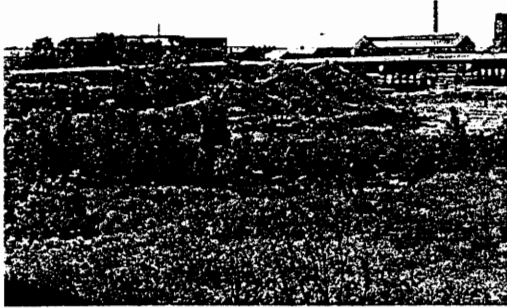
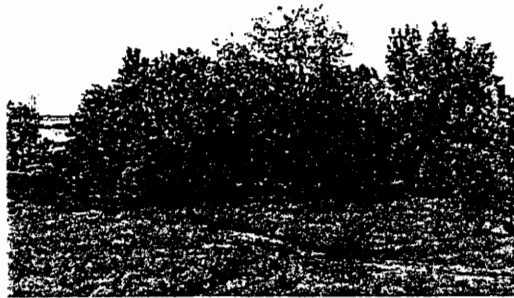
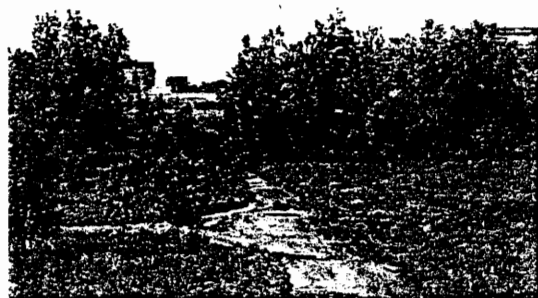
These are four panoramic pictures of the site from standing on the mountain landfill. The pictures are from west to east, while standing in the south portion of the site.

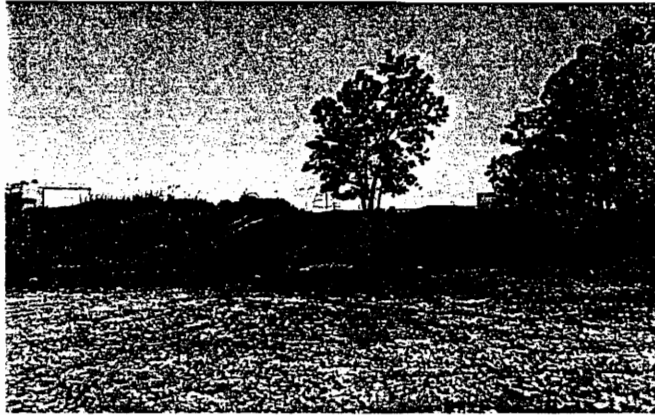
Figure 3: This is a picture of the southwestern side of the flu ash waste pile. See Figure A of Appendix A for a map of the following sample locations.

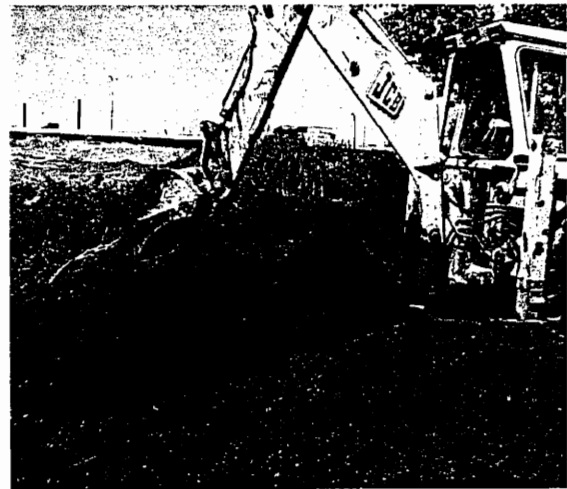
Figure 5: This is sample, US-FA-02 which is located on the canal side of the flu ash pile.

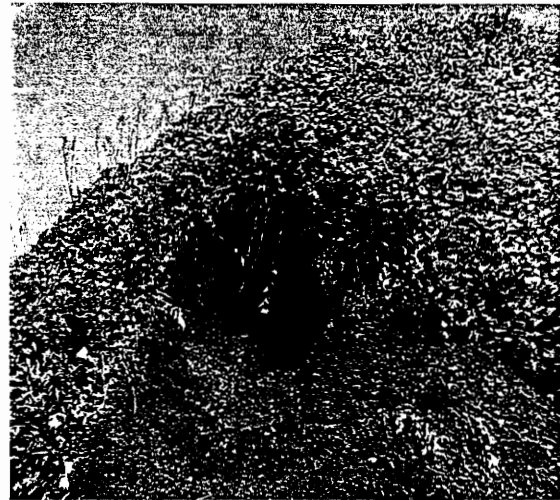
The next pile sampled was the iron ore (IO) pile. The backhoe began digging on the southwest side of the pile which is closest to the canal. At 1055 the EPA sampled US-IO-01 and duplicate US-IO-4 at 3.5 - 4.0 feet deep. The sample consisted of a light brown clay with numerous round stones. In the meantime the backhoe dug a hole on the southeast side of the pile. The OSC determined that the sample is homogenous throughout the entire pile. Therefore, no other samples will be collected from the iron ore pile. See picture : Figure 10 on page 9.

Figure 10: This is a picture of a proposed sampling location further to the east in the iron ore pile. It was decided in the field that this matrix is the same as US-IO-01 and therefore was not sampled.

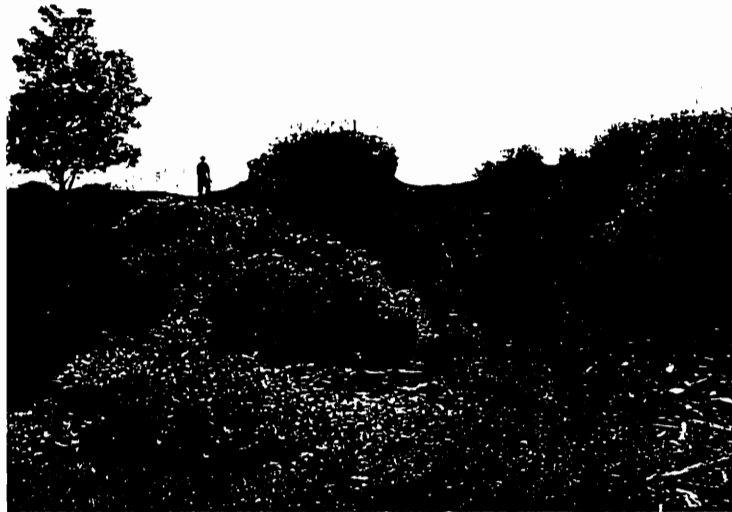
Figure 11: This is a picture of the mountain landfill pile and was taken from the west side of the pile. The following sample locations can be found on a map, called Figure A in Appendix A.

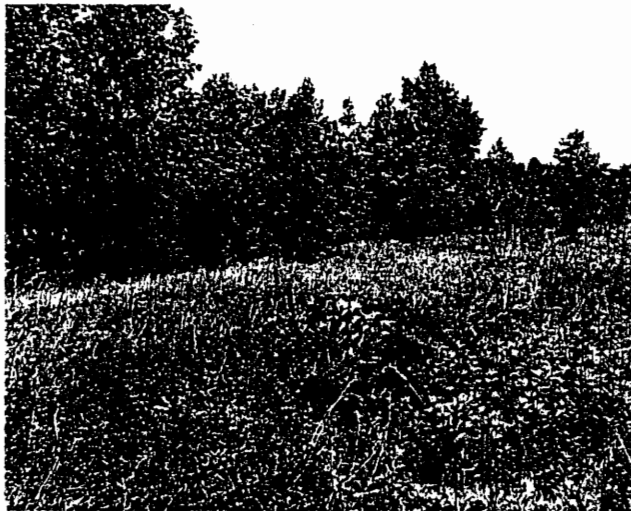
Figure 14: This is a picture of sampling location, US-ML-03 which is located on the top north side of the mountain landfill.
