**EPA CONTRACT NO: 68-W-00-113**  
**TECHNICAL DIRECTIVE DOCUMENT NUMBER: 02-04-08-0043**  
**DOCUMENT CONTROL NUMBER: RST-02-F-01652**  
**SUBJECT: OPERABLE UNIT 3B - SOIL SAMPLING AND**  
**XRF FIELD SCREENING TRIP REPORT**  
**ROBLIN STEEL SITE**  
**DUNKIRK, CHAUTAUQUA COUNTY, NEW YORK**

## **SAMPLING TRIP REPORT**

**SITE NAME:** Roblin Steel Site  
DCN No: RST-02-F-01652  
TDD No: 02-04-08-0043

**SITE LOCATION:** Roblin Steel Site  
320 South Roberts Road  
Dunkirk, New York (Figure 1)

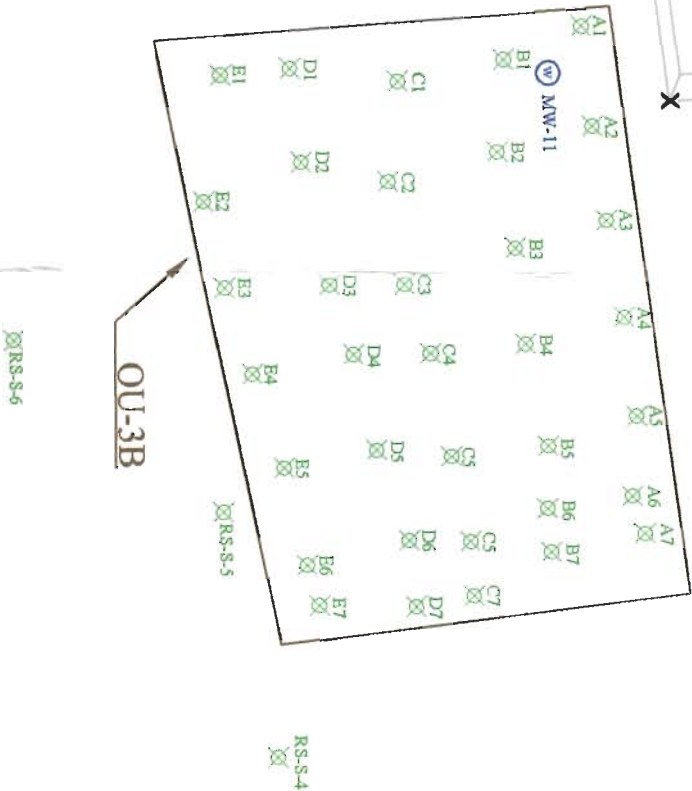
**FIGURE 2**

Site Map  
Roblin Steel

| | XRF Field Screening Location<br><small>(Location Documented Using GPS)</small> | |
| | Post Excavation Sample Locations<br><small>(Location Documented Using GPS)</small> | |

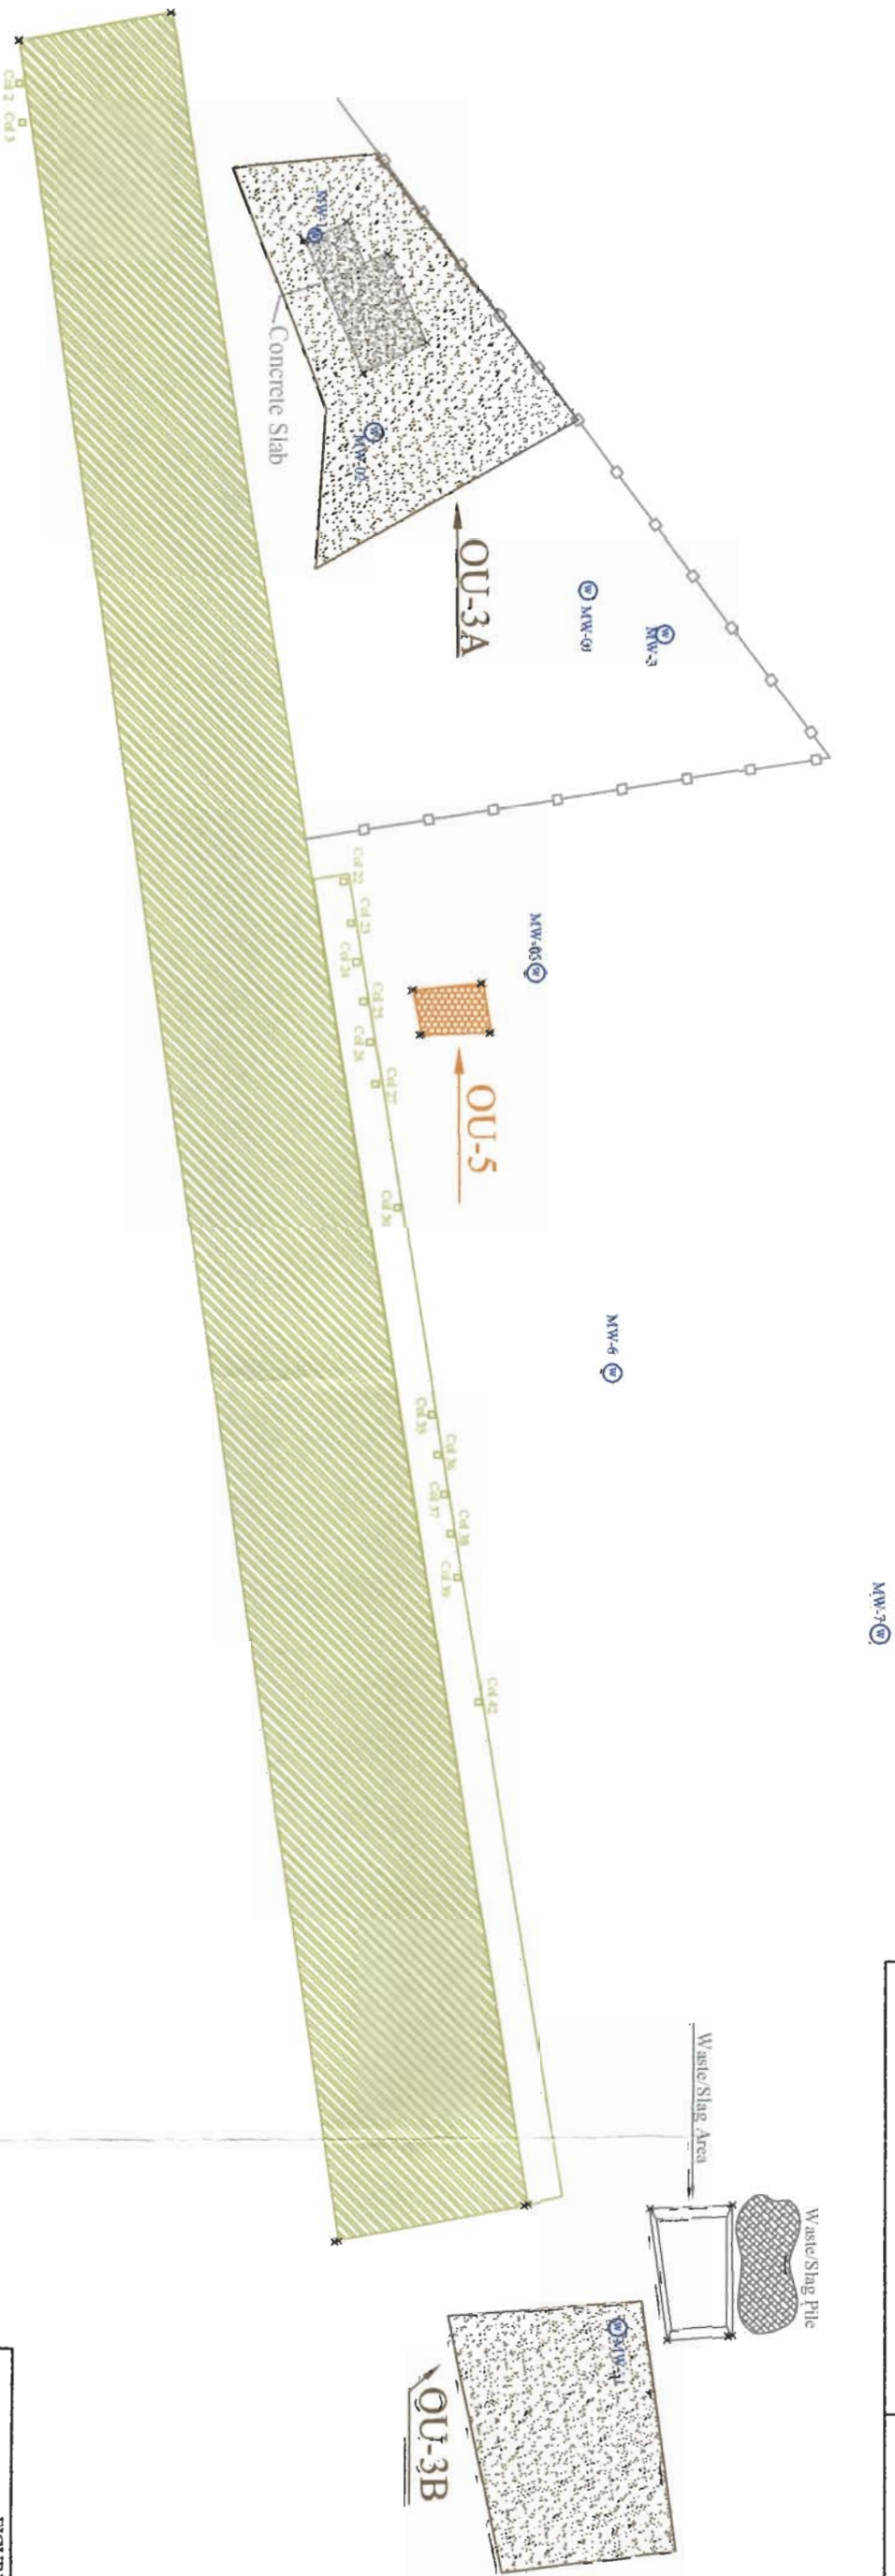
FIGURE 3  
OPERABLE UNIT 3B-SAMPLE LOCATION MAP

Three random screening locations positioned outside of the southern perimeter of OU-3B were screened with the XRF using the prepared cup method (see Figure 3). The areas tested showed signs of either soil disturbance, characterized by a reddish coloring of the soil (possibly indicating the presence of K061), or consisted of a mound of soil. All three characterizations indicate that possible dumping may have occurred, leading to contamination. The XRF screening results indicated lead concentrations below the site specific action level of 1,000 ppm (refer to Appendix F). The screening was done to roughly determine if OU-3B might consist of a larger area than was originally determined. After sampling was completed, all sample locations were logged using a Global Positioning System

Following the initial excavation of approximately four inches of soil, RST created a 20' x 20' grid covering the entire area. The grid was started on the northern perimeter of the area, and consisted of five transects, A-E (see Figure 3). After each sample location was established, a soil sample was collected, and analyzed with a Niton XLi 722 XRF using the prepared cup method for 60 seconds (refer to Appendix A). The purpose of the XRF screening was to determine if the concentration of lead in the soil was below the site specific action level of 1,000 parts per million (ppm).
