# **2019 Periodic Review Groundwater Monitoring and Sampling Annual Report**

815 River Road Site  
Site Number B00178  
City of North Tonawanda

Prepared for:  
City of North Tonawanda

**GHD** | 285 Delaware Avenue Suite 500 Buffalo New York 14202 USA  
11110868 | Report No 4 | February 28, 2020

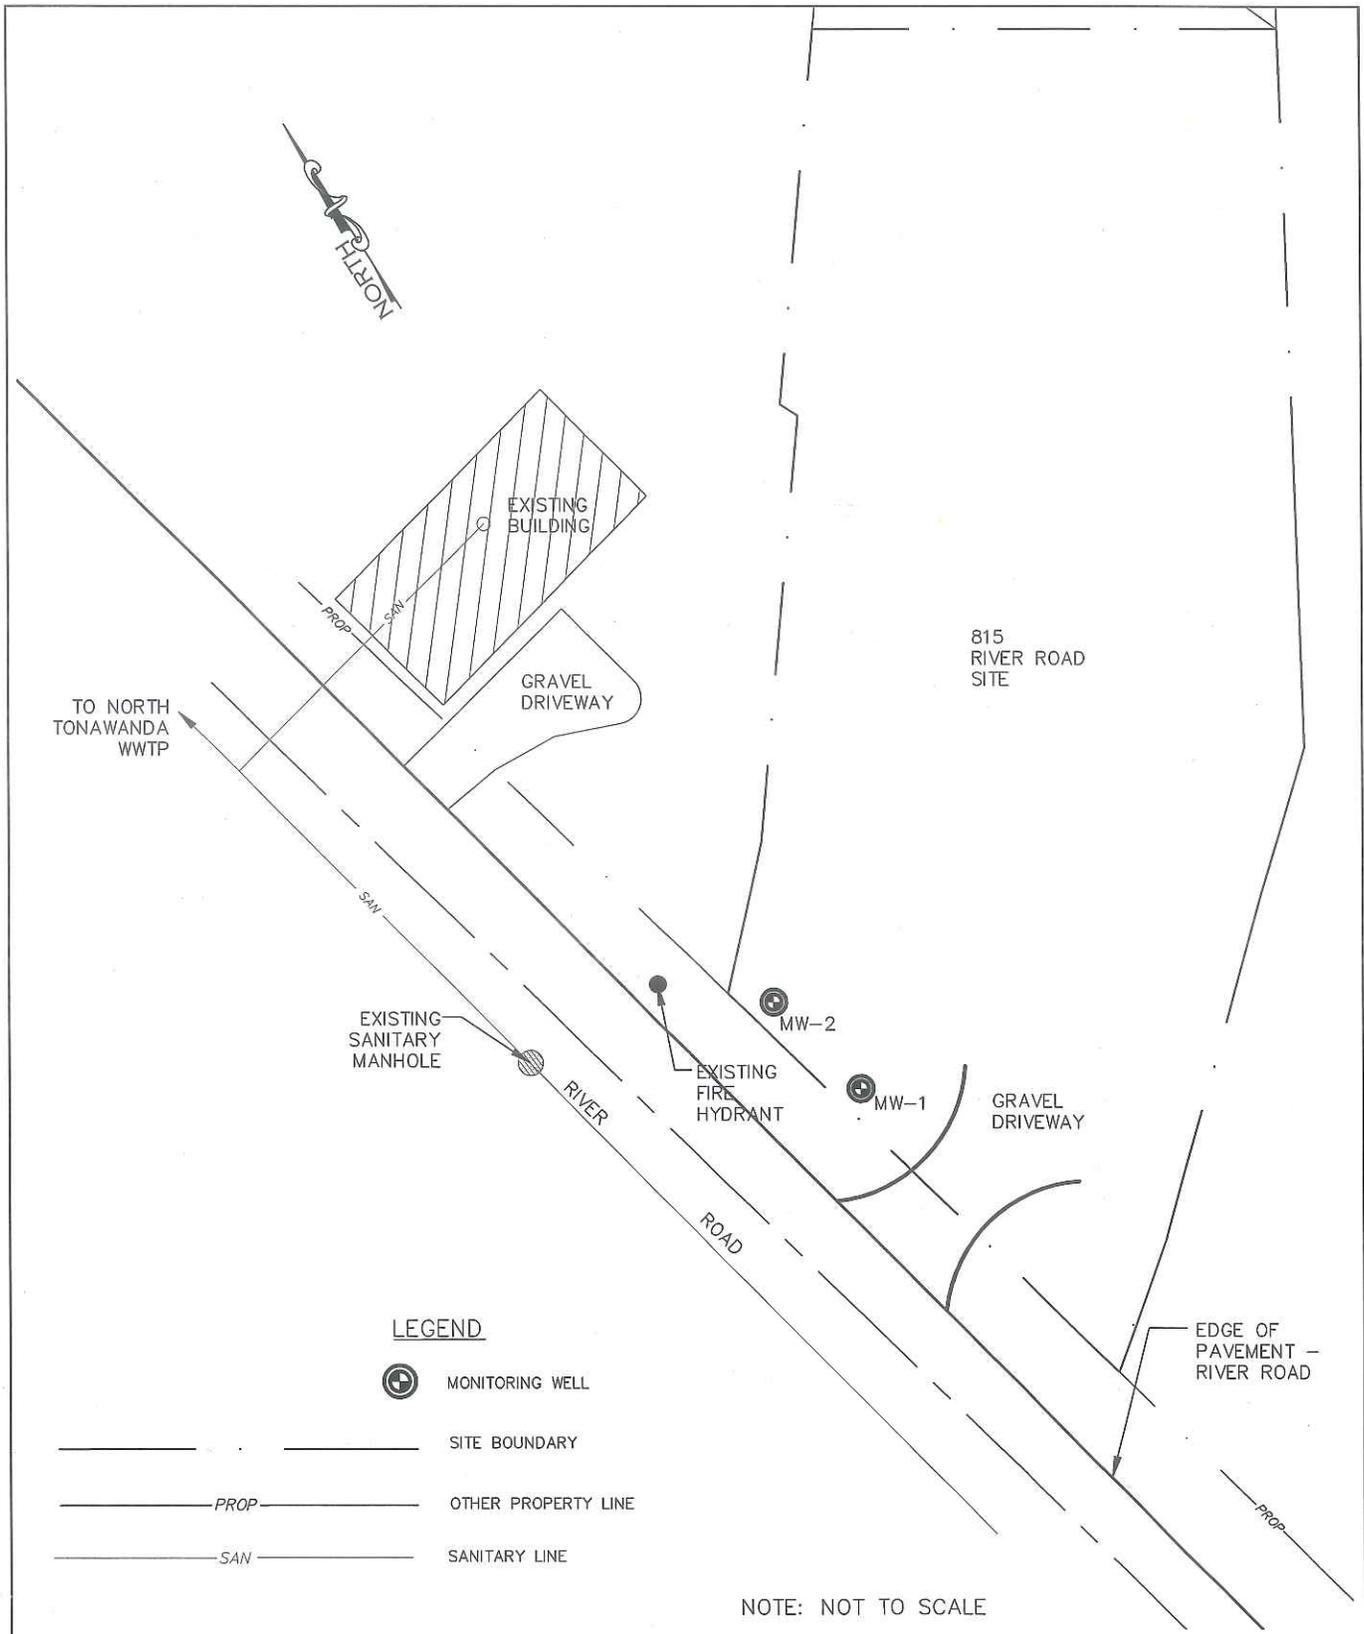
815 RIVER ROAD SITE NORTH TONAWANDA, NEW YORK
FIGURE 2 SITE PLAN

The 2019 monitoring program at the 815 River Road Site consisted of one annual sampling event. Groundwater was sampled from monitoring well MW-2 on January 28, 2020. Monitoring well MW-1 was found in a damaged condition with the well's protective casing bent to the extent that a bailer could not be advanced down the well casing. The location of groundwater monitoring wells MW-1 and MW-2 are approximately 10-feet from the River Road curb line at the 815 River Road property. This sampling event represents the 7<sup>th</sup> event of the groundwater monitoring program. A Site plan is presented on Figure 2.

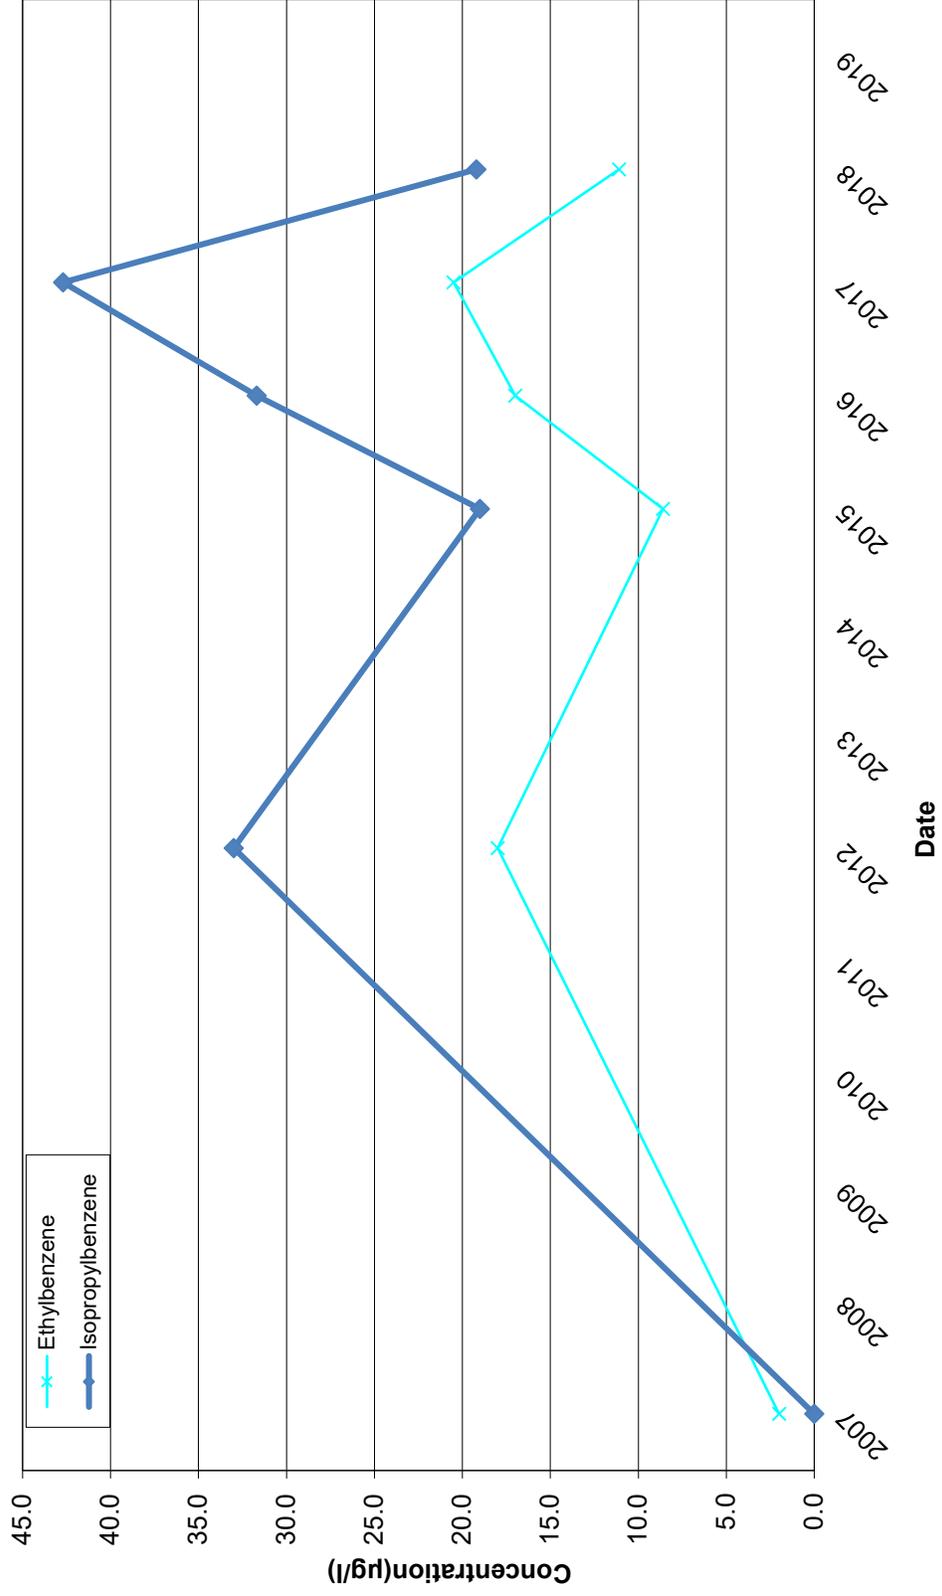
**FIGURE 3**  
**Groundwater VOC Concentrations in MW-1 vs. Time**  
**815 River Road Site - North Tonawanda, NY**  
**2019 Periodic Review Report**

Groundwater test results from monitoring well MW-1 detected the following total VOC concentrations from 2007, 2012, 2015, 2016, 2017, and 2018. No groundwater test results for 2019 from monitoring well MW-1 is available.

2007	6.0 µg/L
2012	148.0 µg/L
2015	28.0 µg/L
2016	57.3 µg/L
2017	112.8 µg/L
2018	74.3 µg/L

Groundwater monitoring for the reporting years of 2012, 2015, 2016, 2017 and 2018 detected VOC concentrations that exceeded the groundwater standard for the following parameters: ethylbenzene and isopropylbenzene. A trending graph shows an upward trend since 2015 to 2017 and a decreasing trend for 2018 of detected VOCs as presented on Figure 3.

Concentrations of cyclohexane were detected in 2012, 2016, 2017, and 2018. Concentrations of methylcyclohexane were detected in 2012 and 2017. No groundwater quality standard is established for cyclohexane and methylcyclohexane.

During 2019 groundwater sampling, monitoring well MW-1 was found in a damaged condition with the well's protective casing bent to the extent that a bailer could not be advanced down the well casing. Groundwater sampling for 2019 could not be collected. No test data is available for 2019.

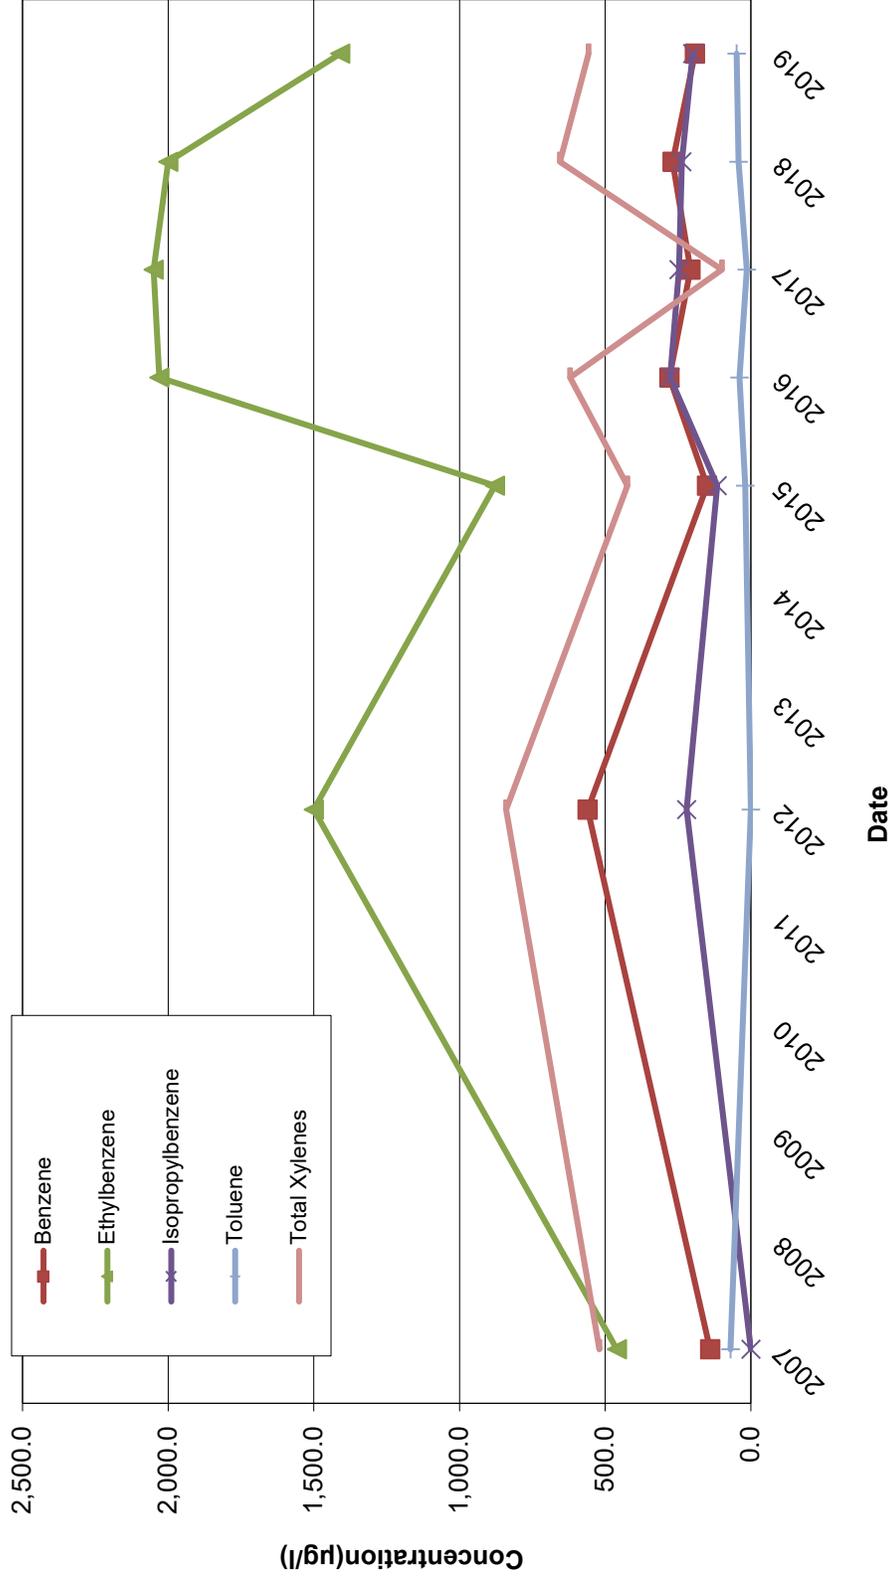
**FIGURE 4**  
**Groundwater VOC Concentrations in MW-2 vs. Time**  
**815 River Road Site - North Tonawanda, NY**  
**2019 Periodic Review Report**

Groundwater test results from monitoring well MW-2 detected the following total VOC concentrations from 2007, 2012, 2015, 2016, 2017, and 2018.

2007	1,230.0 µg/L
2012	3,345.0 µg/L
2015	1,866.1 µg/L
2016	3,474.3 µg/L
2017	2,771.1 µg/L
2018	3,539.7 µg/L
2019	2,407.3 µg/L

Groundwater monitoring for the reporting years of 2012, 2015, 2016, 2017, 2018, and 2019 detected VOC concentrations that exceeded the groundwater standard. A trending graph shows a generally stationary trend from 2016 to 2019 of detected VOCs with the exception of total xylenes and ethylbenzene as presented on Figure 4. Total xylenes is decreasing in 2019. Ethylbenzene decreased in 2017 and increased back in 2018 to concentrations observed in recent years.

- Compounds that exceeded the groundwater standard in 2015, 2016, 2017, 2018, and 2019 included: benzene, ethylbenzene, isopropylbenzene, toluene, total xylenes. Compounds that exceeded the groundwater standard from the 2012 sampling event included: benzene, ethylbenzene, isopropylbenzene, and total xylenes.
- Detected compounds from 2019 groundwater monitoring that decreased in concentrations from the 2018 sampling event included: benzene, ethylbenzene, isopropylbenzene, and total xylenes.
- Detected compounds from the 2019 sampling event that increased in concentrations from the 2018 sampling event included: toluene.
