CONSTRUCTION COMPLETION REPORT

FOSTER REFRIGERATION SITE

**119 North 2nd Street
Hudson, Columbia County, New York
NYSDEC Site No. B-00184**

July 26, 2019

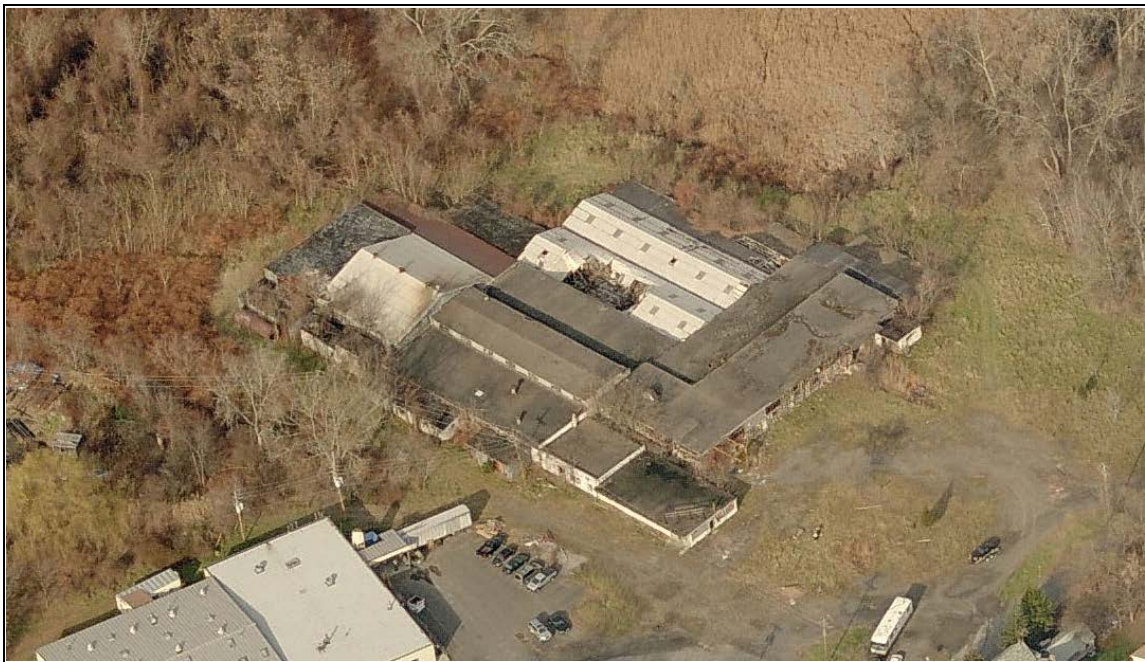
Historic aerial image of the Foster facility sometime after 1994

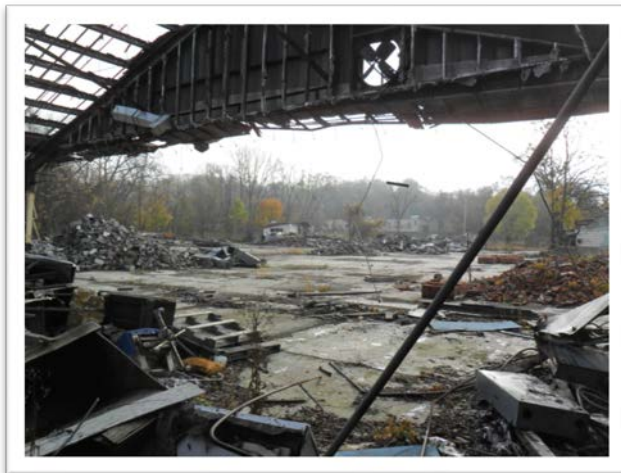
Pre-demolition view of site

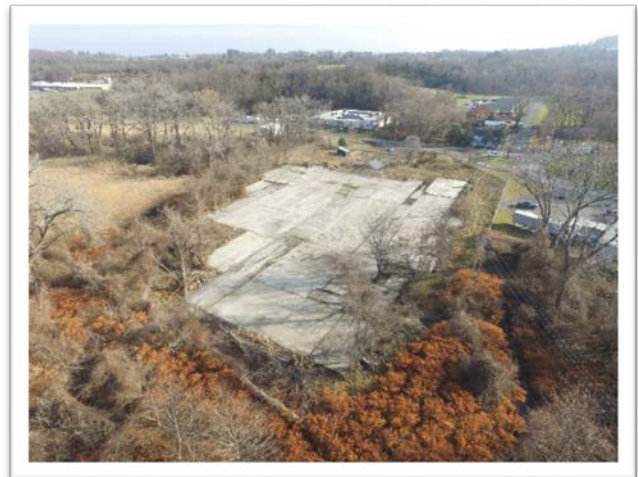
Post demolition aerial view of site

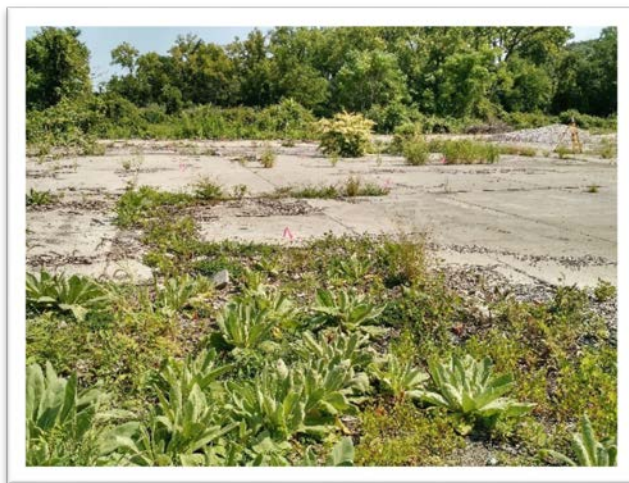
Concrete slabs penetrated during SI work

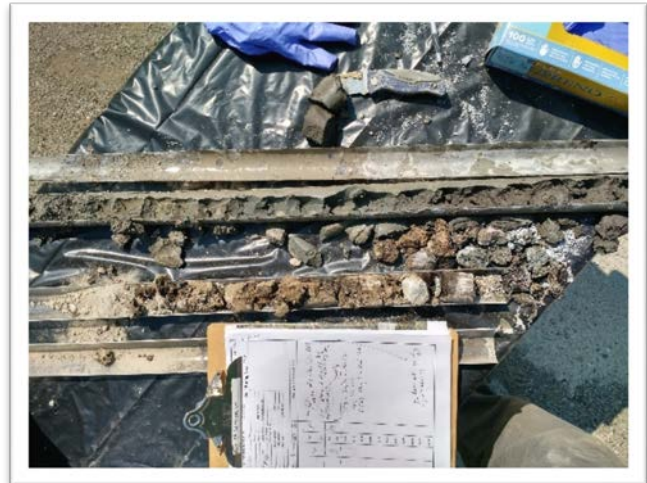
Classifying soils during SI work

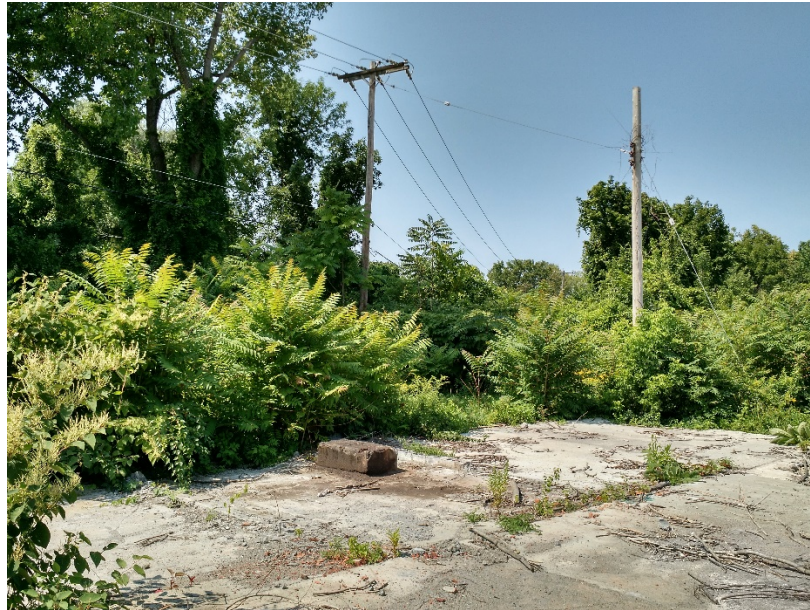
Surficial staining present at Surface Pedestal sample location where PCBs were detected

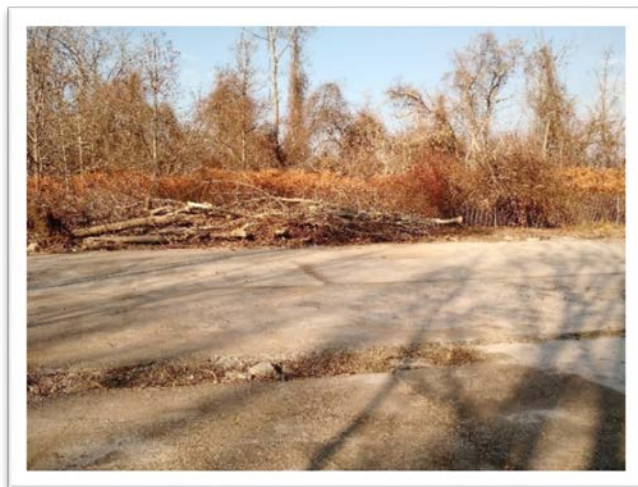
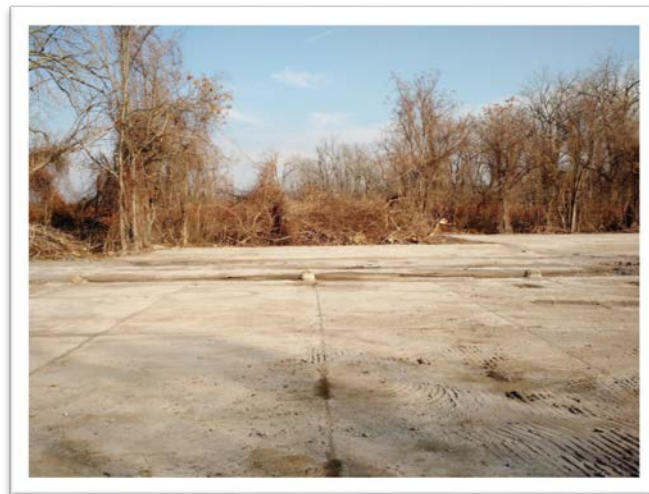
Trees, brush and woody debris that required processing and relocating to facilitate excavation work

From 12/17/17 to 12/21/17 PES performed site clearing work including cutting down and processing trees and woody vegetation. PES cut and processed all accessible trees within the area designated for access and/or excavation. The site was grubbed of all trees and undergrowth using chain saws, a bobcat loader and an excavator equipped with a hydraulic thumb. Tree trunks and limbs were cut into manageable sizes for on-site chipping. Resulting wood chips were used at various areas of the site.

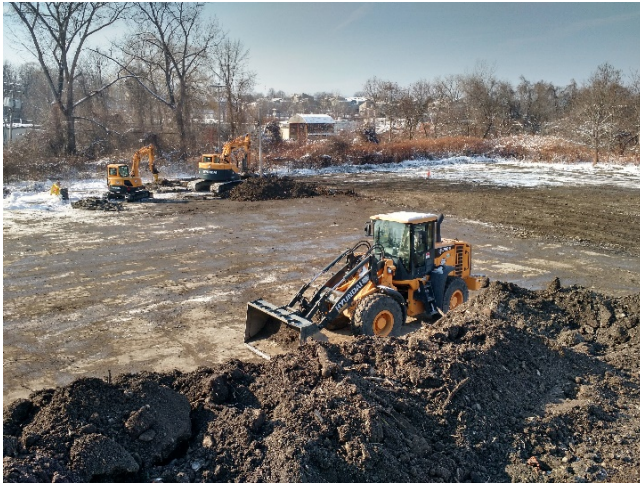
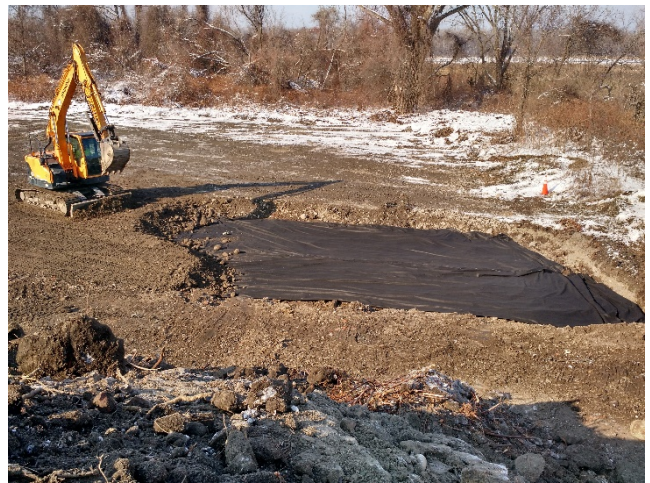
Employing cut and fill methods to remove the top 2-ft of existing soil and apply 1.5-ft of select fill over Demarcation layer and beneath topsoil cover

PES used traditional “cut and fill” method to accomplish the removal effort. In general, the excavation proceeded from the rear (northwest) to the front (southeast) of the site in a windrow pattern from west to east. Target soil was first removed by the excavator then subsequently transported by a frontend articulated loader to the staging area. Groundwater was not encountered in the shallow excavation.

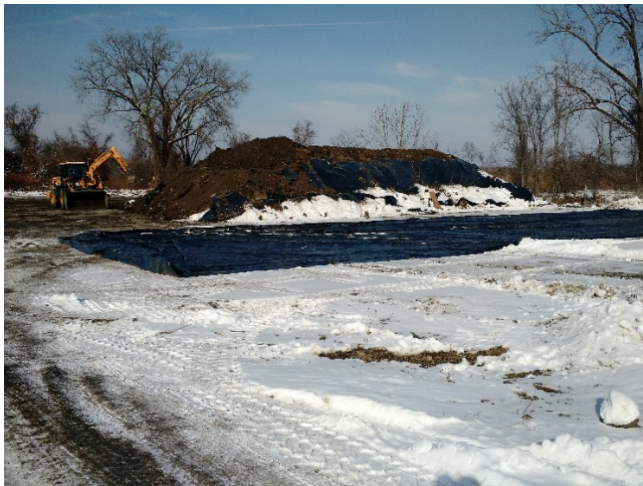
Cut soil staging area

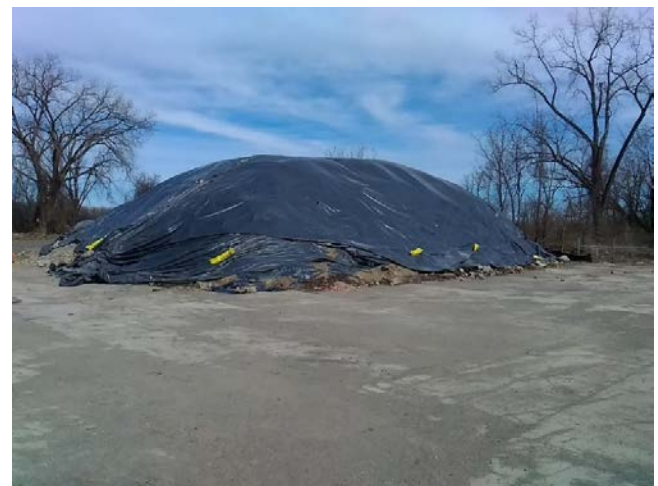
Poly-encapsulated cut soils

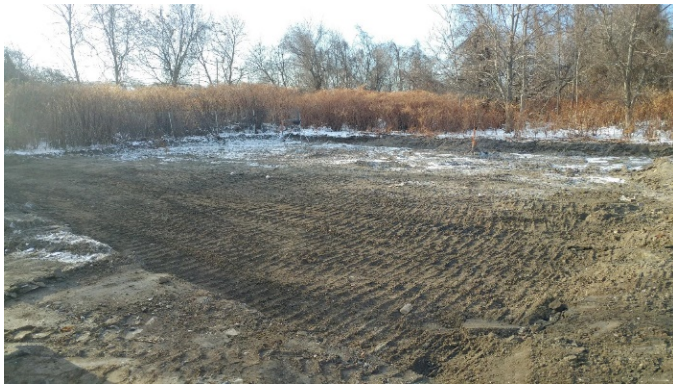
Initial 2-ft cut at SW corner of site

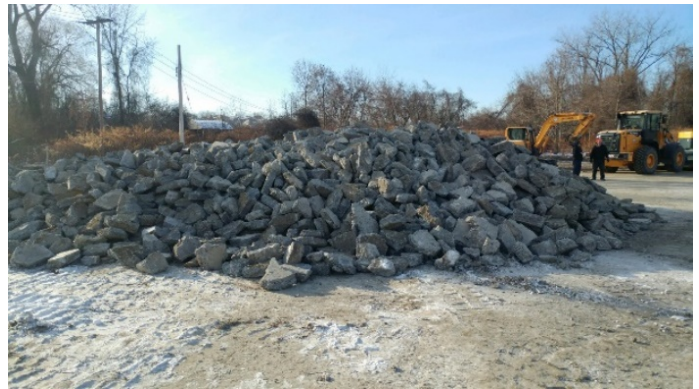
Processed concrete

To facilitate concrete removal and sizing from areas targeted for excavation, PES used hydraulic pin hammers. The removed concrete was sized maximum 2' X 2' dimensions to meet disposal requirements.

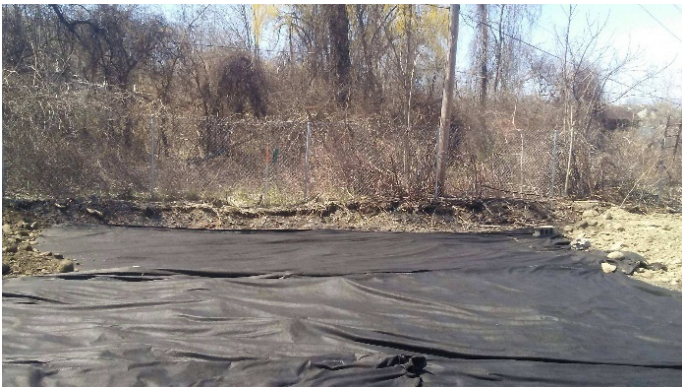
Demarcation layer placed along the southwest Perimeter at the excavation and removal area

As indicated previously, PES utilized “cut and fill” methods during the removal action at the rear of the site where excavation work was planned. A physical demarcation layer consisting of black, permeable, woven geotextile was emplaced along the floor of the excavation prior to the application of select fill. This same demarcation layer was also spread at existing grade and beneath 12-inches of topsoil at areas in the front of the site in between the security fence and building slabs that remain.

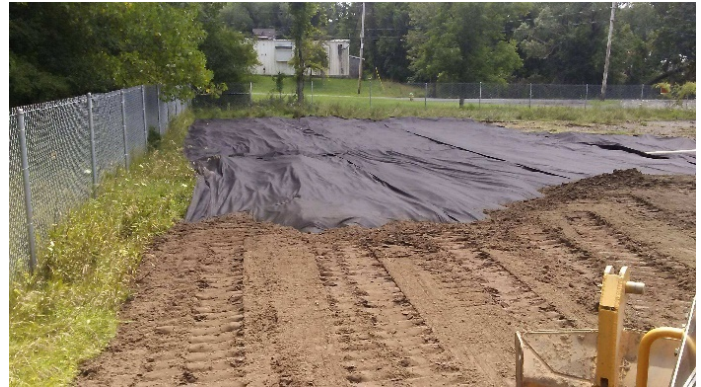
Demarcation layer placed beneath topsoil and on top of existing grade in the NE corner of the site

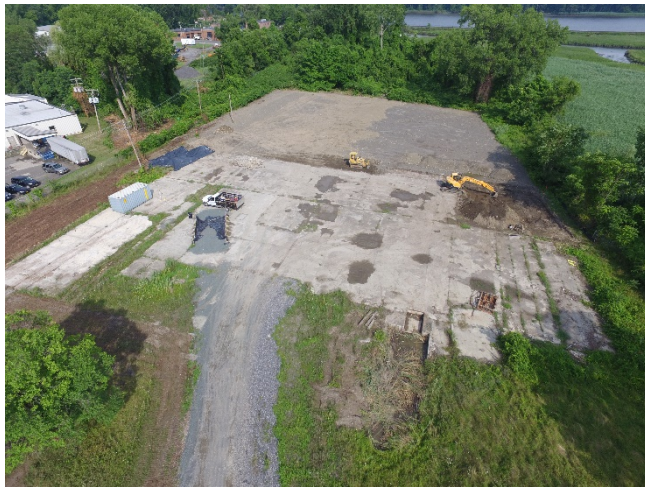
Final cut and select fill application at rear cut area

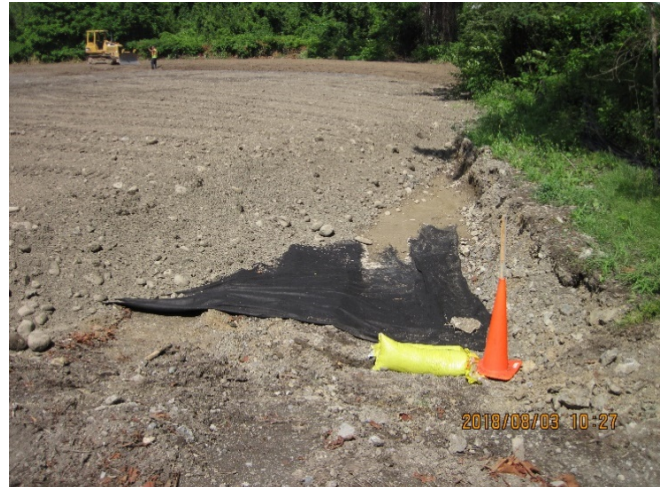
Select fill applied over demarcation layer

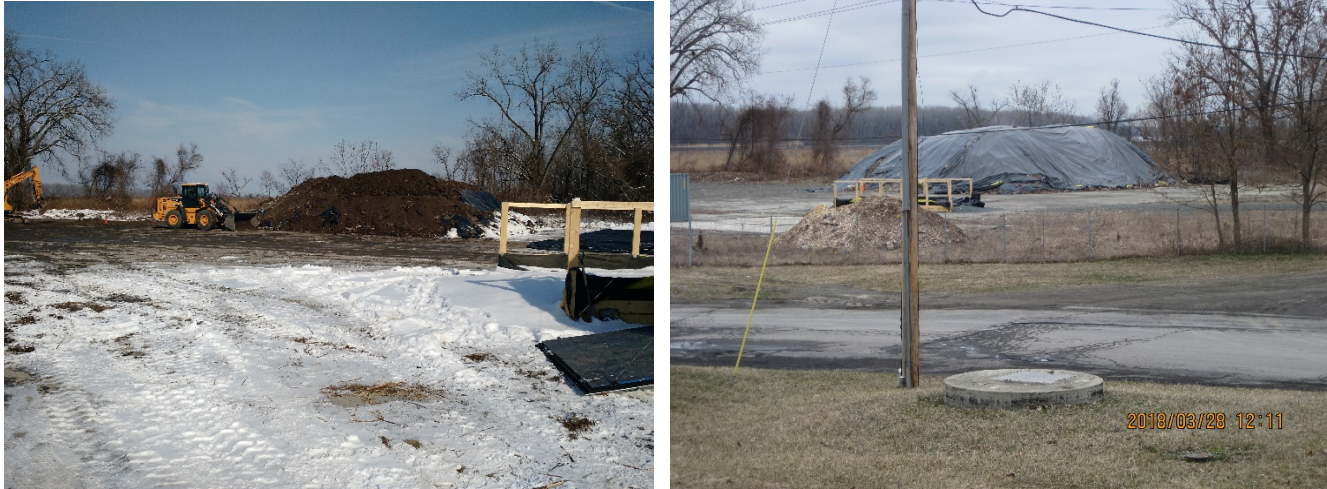
Soil removed from the main excavation was staged on-site on the existing concrete pad and was secured on and covered with poly sheeting.

The resulting staged soil cell was sampled for characterization to obtain disposal approval. Representative samples were collected from the soil cell and submitted for analyses for: TCLP Metals (EPA Method 6010 and 7470), TCLP VOCs (EPA Method 8260), TCLP SVOCs (EPA Method 8270), PCBs (EPA Method 8082), TCLP Pesticides (EPA Method 8081), TCLP Herbicides (EPA Method 8151) & general chemistry parameters paint filter, pH, and flashpoint. Samples were collected by PES professional staff and placed in clean glass sample jars supplied by the analytical facility. Representative samples were labeled, sealed, and placed immediately in iced storage for transport to Test America Laboratories, Inc. (Test America) of Amherst, NY. Resulting analytical is summarized in Table 4 and associated lab reports are included as Attachment D.

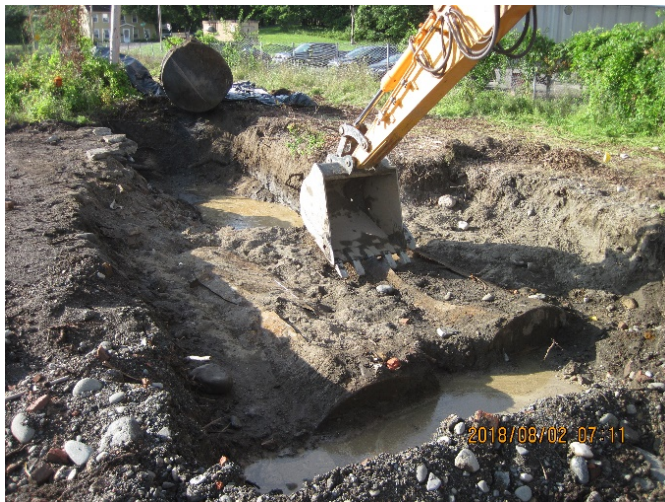
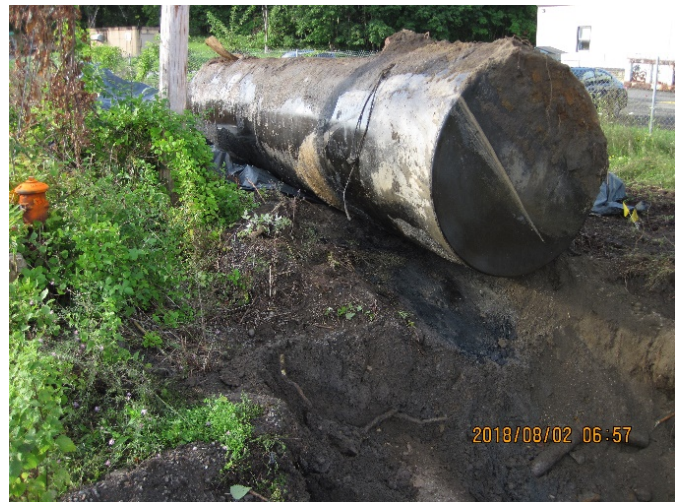
UST Ref. #	Product	Capacity (Gallons)	Construction	Residual Product (Inches/gallons)	UST Condition
TK-001	Fuel Oil	4,000	Single Wall Bare Steel	5.25/196	Advanced Rusting/Pitting – holes noted
TK-002	Unknown – reported (EPA) as petroleum	2,000	Single Wall Bare Steel	Previously removed - filled with sand	Advanced Rusting/Pitting – holes noted
TK-003	Unknown – reported (EPA) as petroleum	2,000	Single Wall Bare Steel	Previously removed - filled with sand	Advanced Rusting/Pitting – holes noted

On July 26, 2018, PES field construction staff performed excavation of surficial soil to expose the tops of the USTs to allow for dismantling of associated piping and access for cleaning. PES professional staff provided oversight and documentation for the closure process. As stated previously, the EPA and their contractors performed decommissioning of TKs – 002 & 003. In contrast, TK-001 required access and cleaning for proper closure. Oversight tasks performed by PES in association with the decommissioning of TK-001 included: supervision of the removal of residual fluids, tank atmosphere monitoring, vapor purging and interior access/cleaning. The closure of the USTs was performed in accordance with 6 NYCRR 613 -2.6.

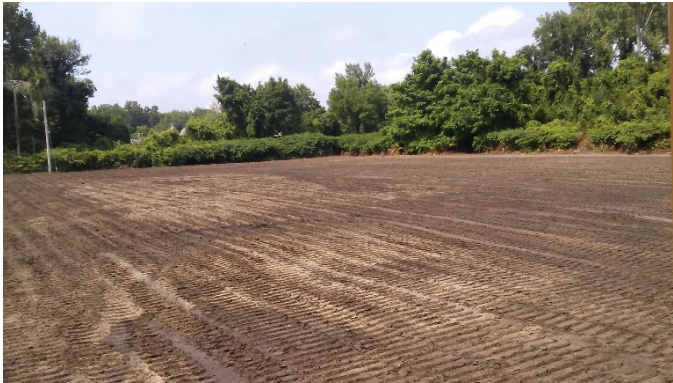
Topsoil applied to rear of site at cut areas

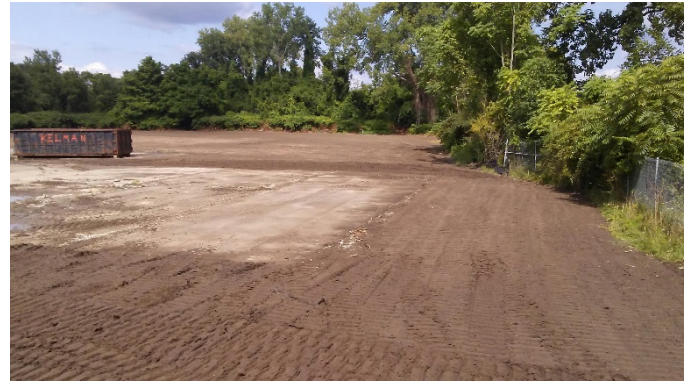
Topsoil applied to north side and front of site

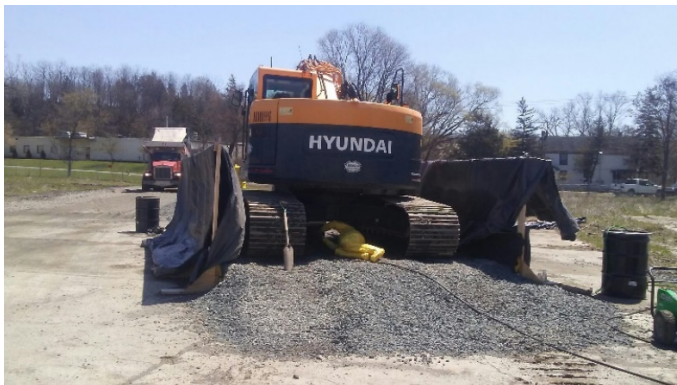
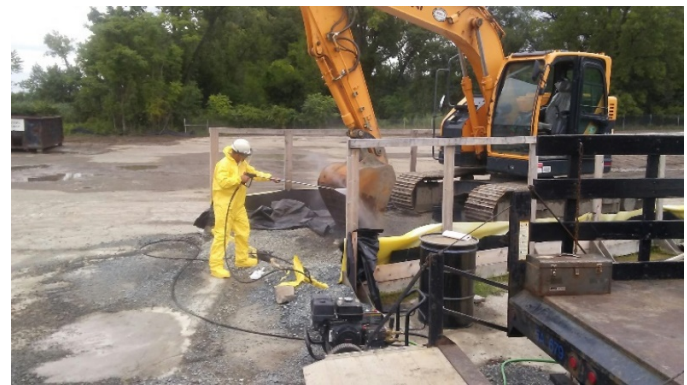
Decontamination involved the physical removal of all sediment from machinery surfaces followed by an alconox/potable water rinse. Rinse fluids were captured and containerized for contaminant assessment. Representative samples were collected from the containerized fluids for Metals (EPA 6010 and 7470), VOCs (EPA 8260) and PCBs (EPA Method 8082). Samples were collected by PES professional staff and placed in clean glass sample jars supplied by the analytical facility. Representative samples were labeled, sealed, and placed immediately in iced storage for transport to Test America Laboratories, Inc. (Test America) of Amherst, NY. Resulting analytical lab reports are included as Attachment D. With the exception of a single constituent of concern (barium at 0.098 mg/l), non -detect responses were obtained for all compounds of concern. The residual water was

PES performed decontamination of all equipment prior to demobilization from the site. An equipment decontamination pad was constructed at the beginning of the project to facilitate equipment cleaning.

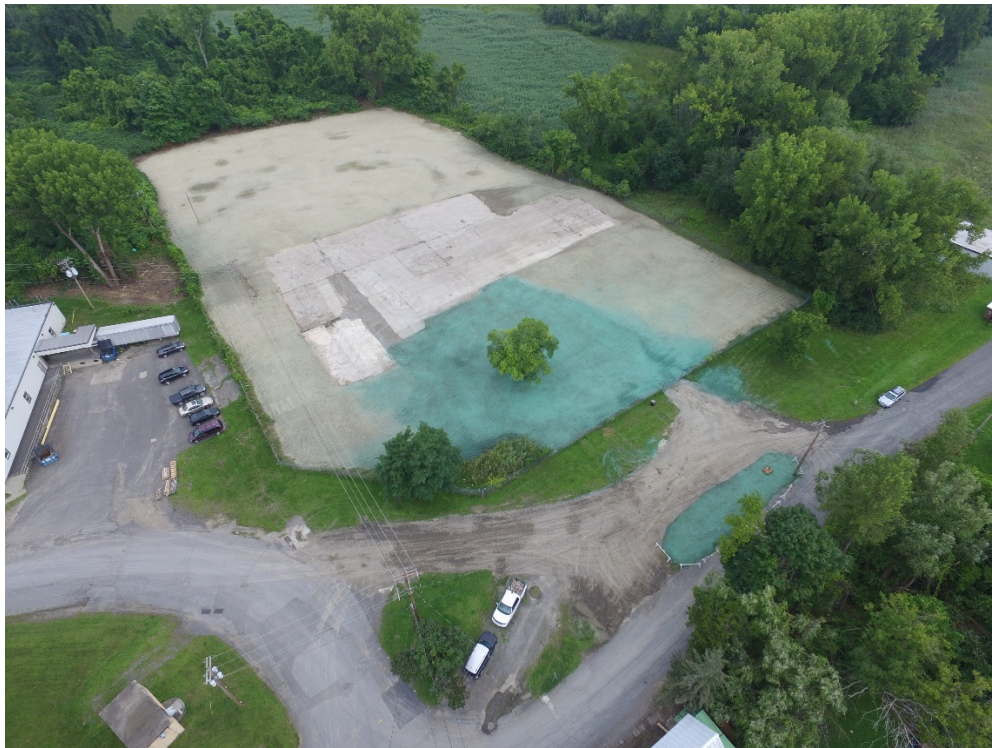
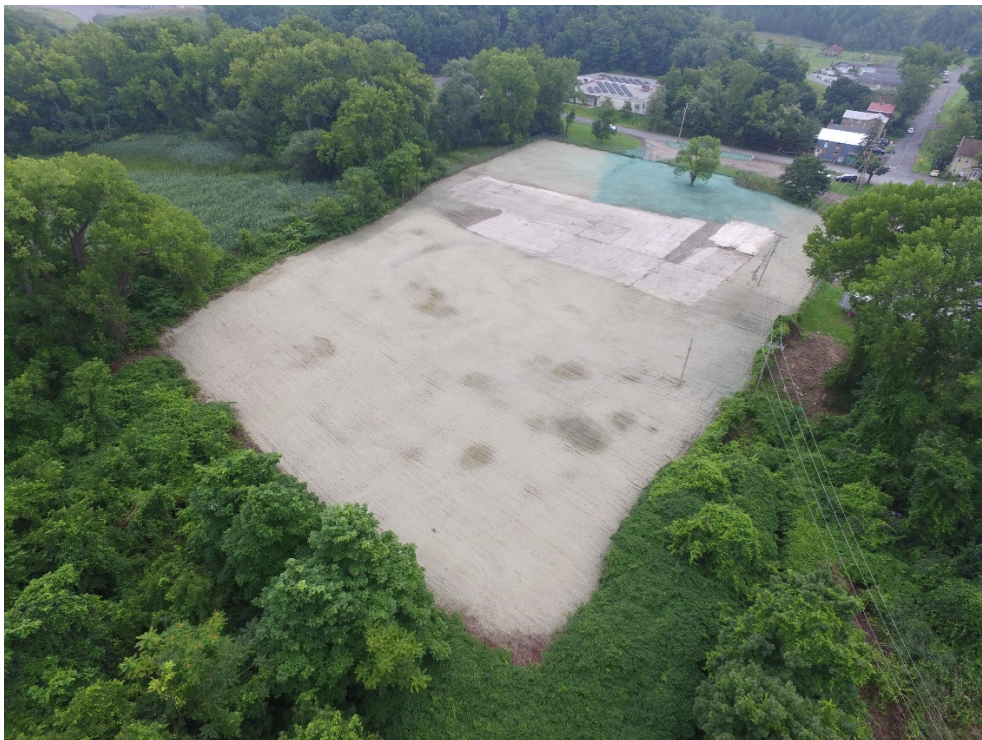
Select site-specific aerial images taken by PES to document the site subsequent to the ROD implementation are included below.
