# SUPPLEMENTAL INVESTIGATION SUMMARY REPORT

**The DeLaval Property  
Rinaldi Boulevard  
City of Poughkeepsie, New York**

**January 2005**

**CLOUGH HARBOUR & ASSOCIATES LLP**

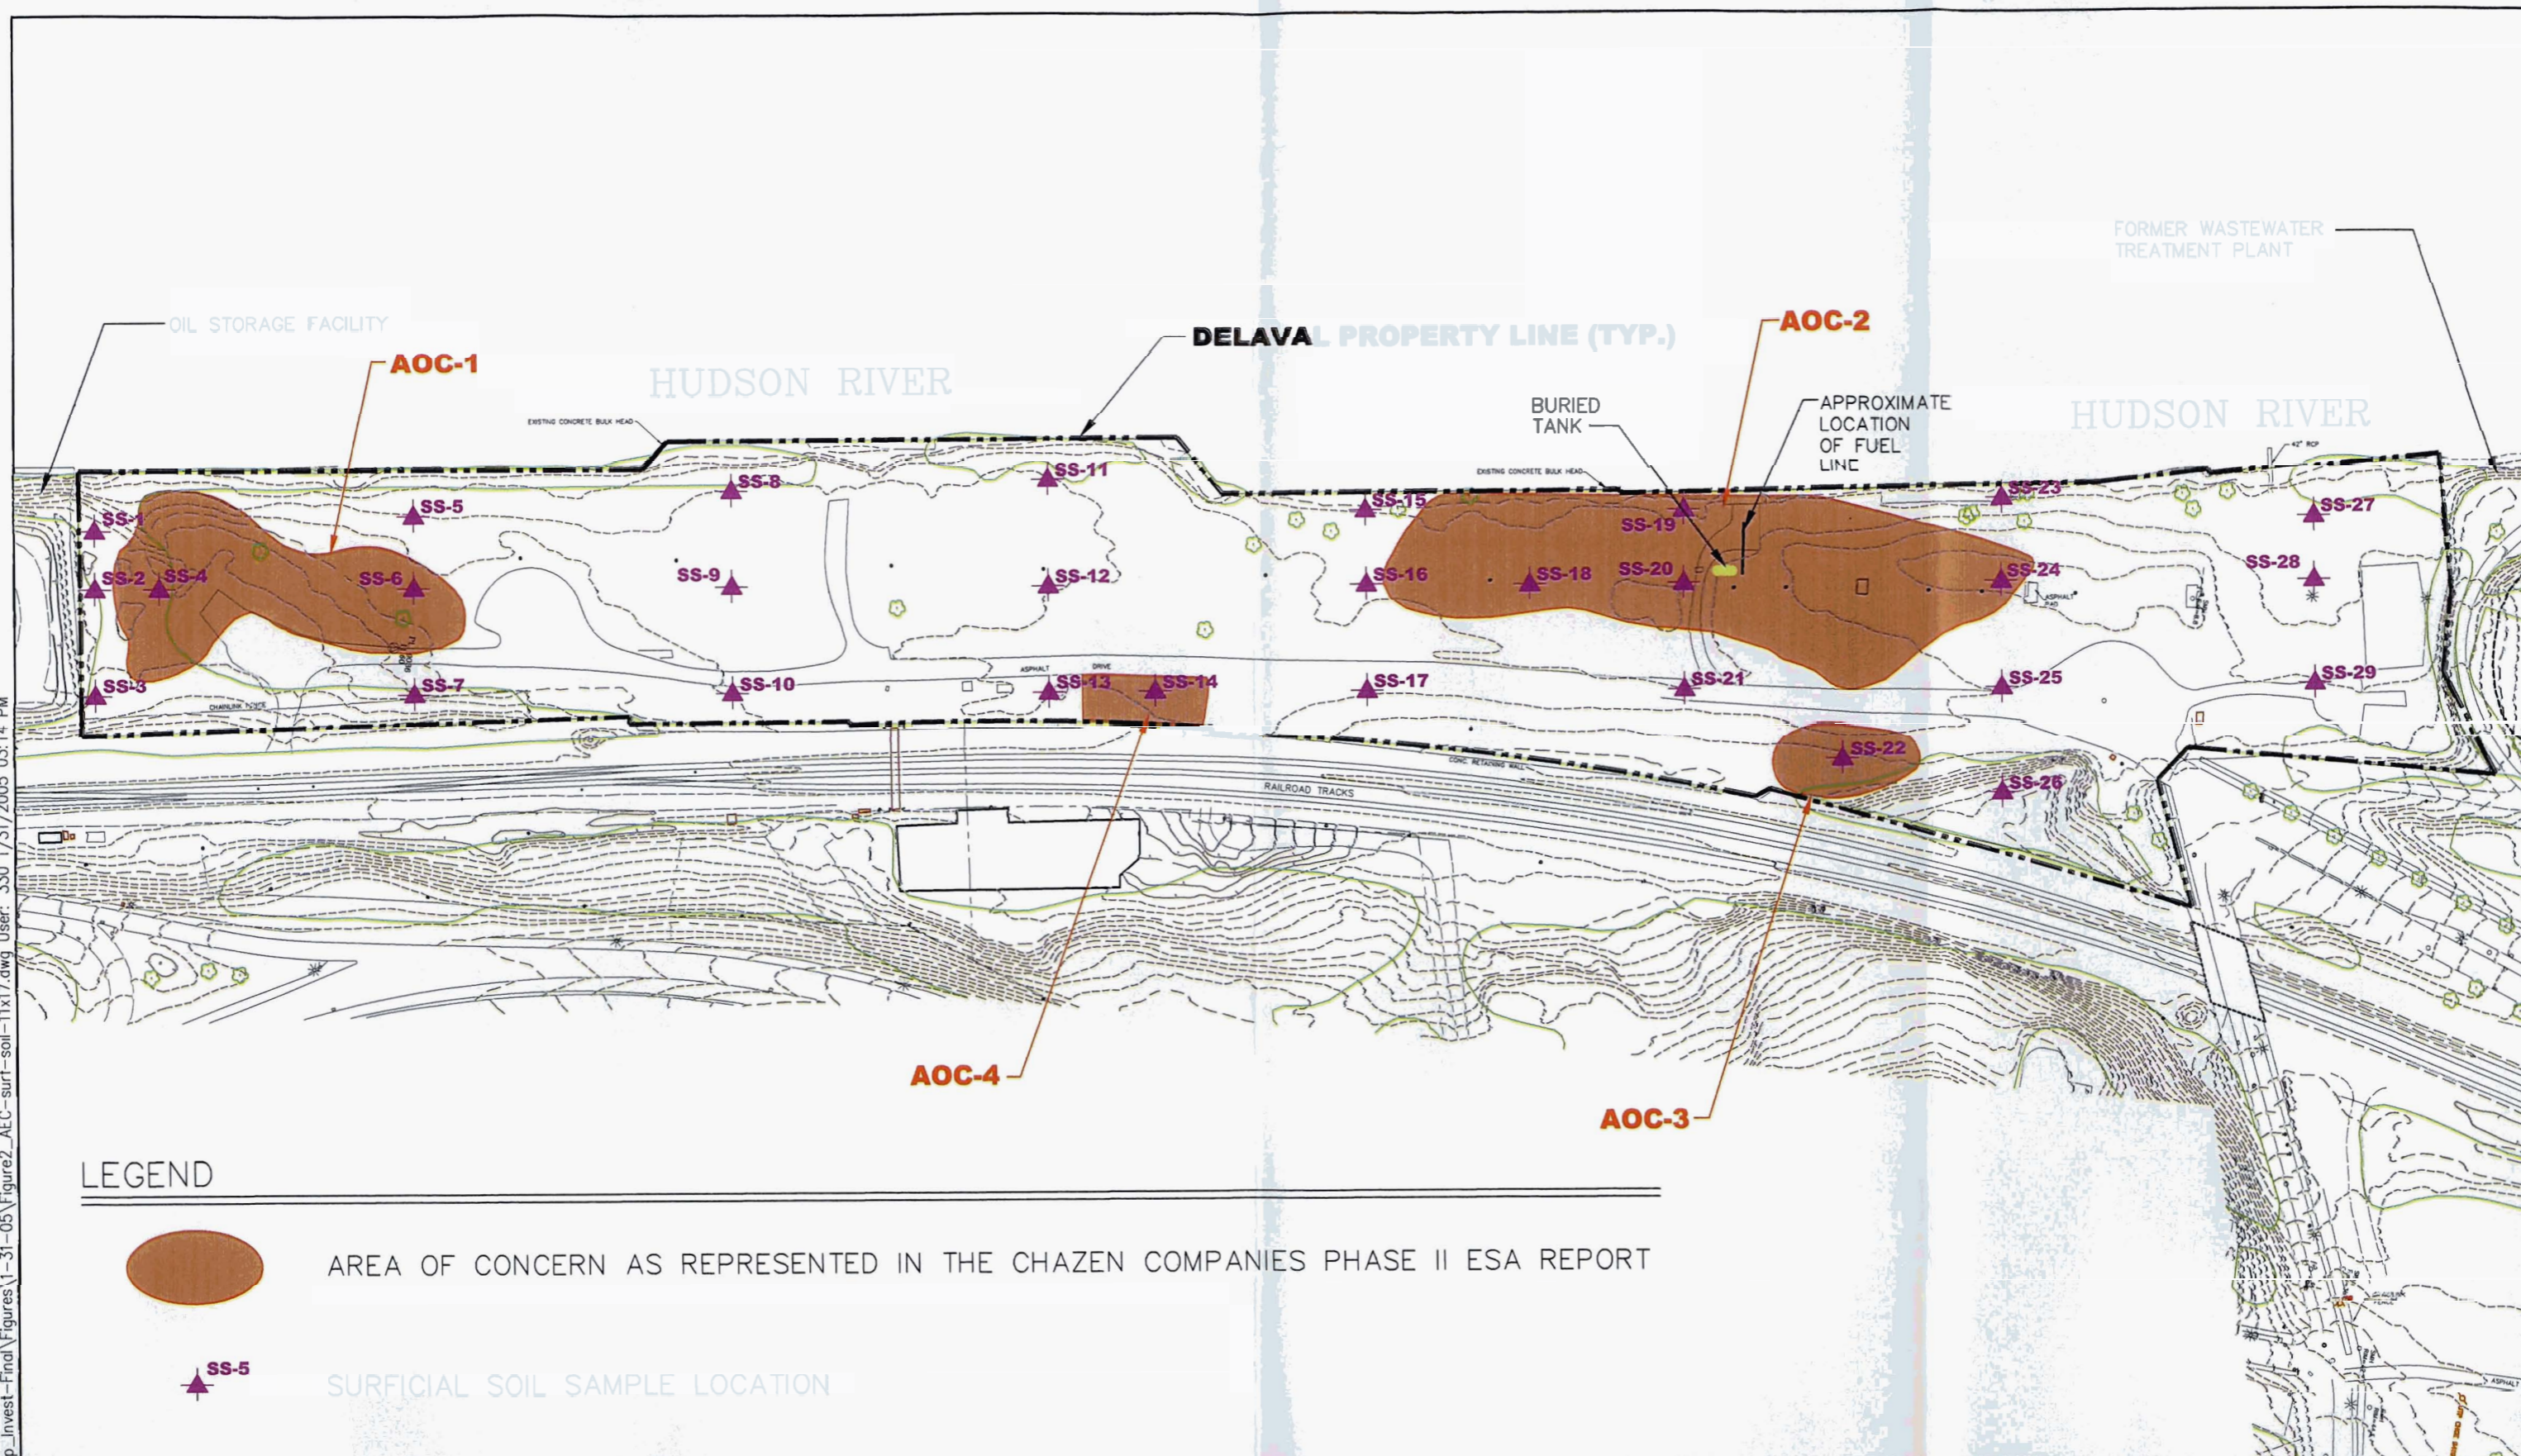
Table 1 provides a summary of the analytical results for all surface soil samples and Figure 2 illustrates the sampling locations at which each surface soil sample was collected from. All compounds detected at concentrations in excess of the NYSDEC's Recommended Soil Cleanup Objective concentrations listed in Technical and Guidance Memorandum (TAGM) No. 4046 have been shaded. As previously indicated, the surface soil samples were not analyzed for the presence of VOCs. The results of the surface soil sample analyses are discussed below and are summarized in the following table.

Aroclor-1260 was the only PCB congener detected in the surface soils on the DeLaval property. It was detected in eleven of the thirty surface soil samples collected from the DeLaval property, mainly along north side of AOC-1 and the northern one-third of the property. However, Aroclor-1260 was only detected at concentrations in excess of NYSDEC recommended soil cleanup objectives along the north end of AOC-1. Given that site is currently vacant and there are no current sources of PCBs on the ground surface, the origin of the PCB contamination in the surface soils is not clear.

With the exception of the background sample SS-29 and surface soil sample SS-25, approximately three-hundred feet south of the background sample, there were at least three metals in excess of the background concentrations in all of the surface soil samples on the DeLaval property. In fact, all RCRA-8 metals were found in excess of the background concentrations in the surface soil samples collected from sampling locations SS-1, SS-4, SS-7, SS-10, SS-20, SS-22, SS-26, and SS-27. All but one of the RCRA-8 metals was found in excess of the background concentrations in surface soil samples SS-2, SS-3, SS-5, SS-6, SS-9, SS-17, SS-19, SS-23, and SS-24.

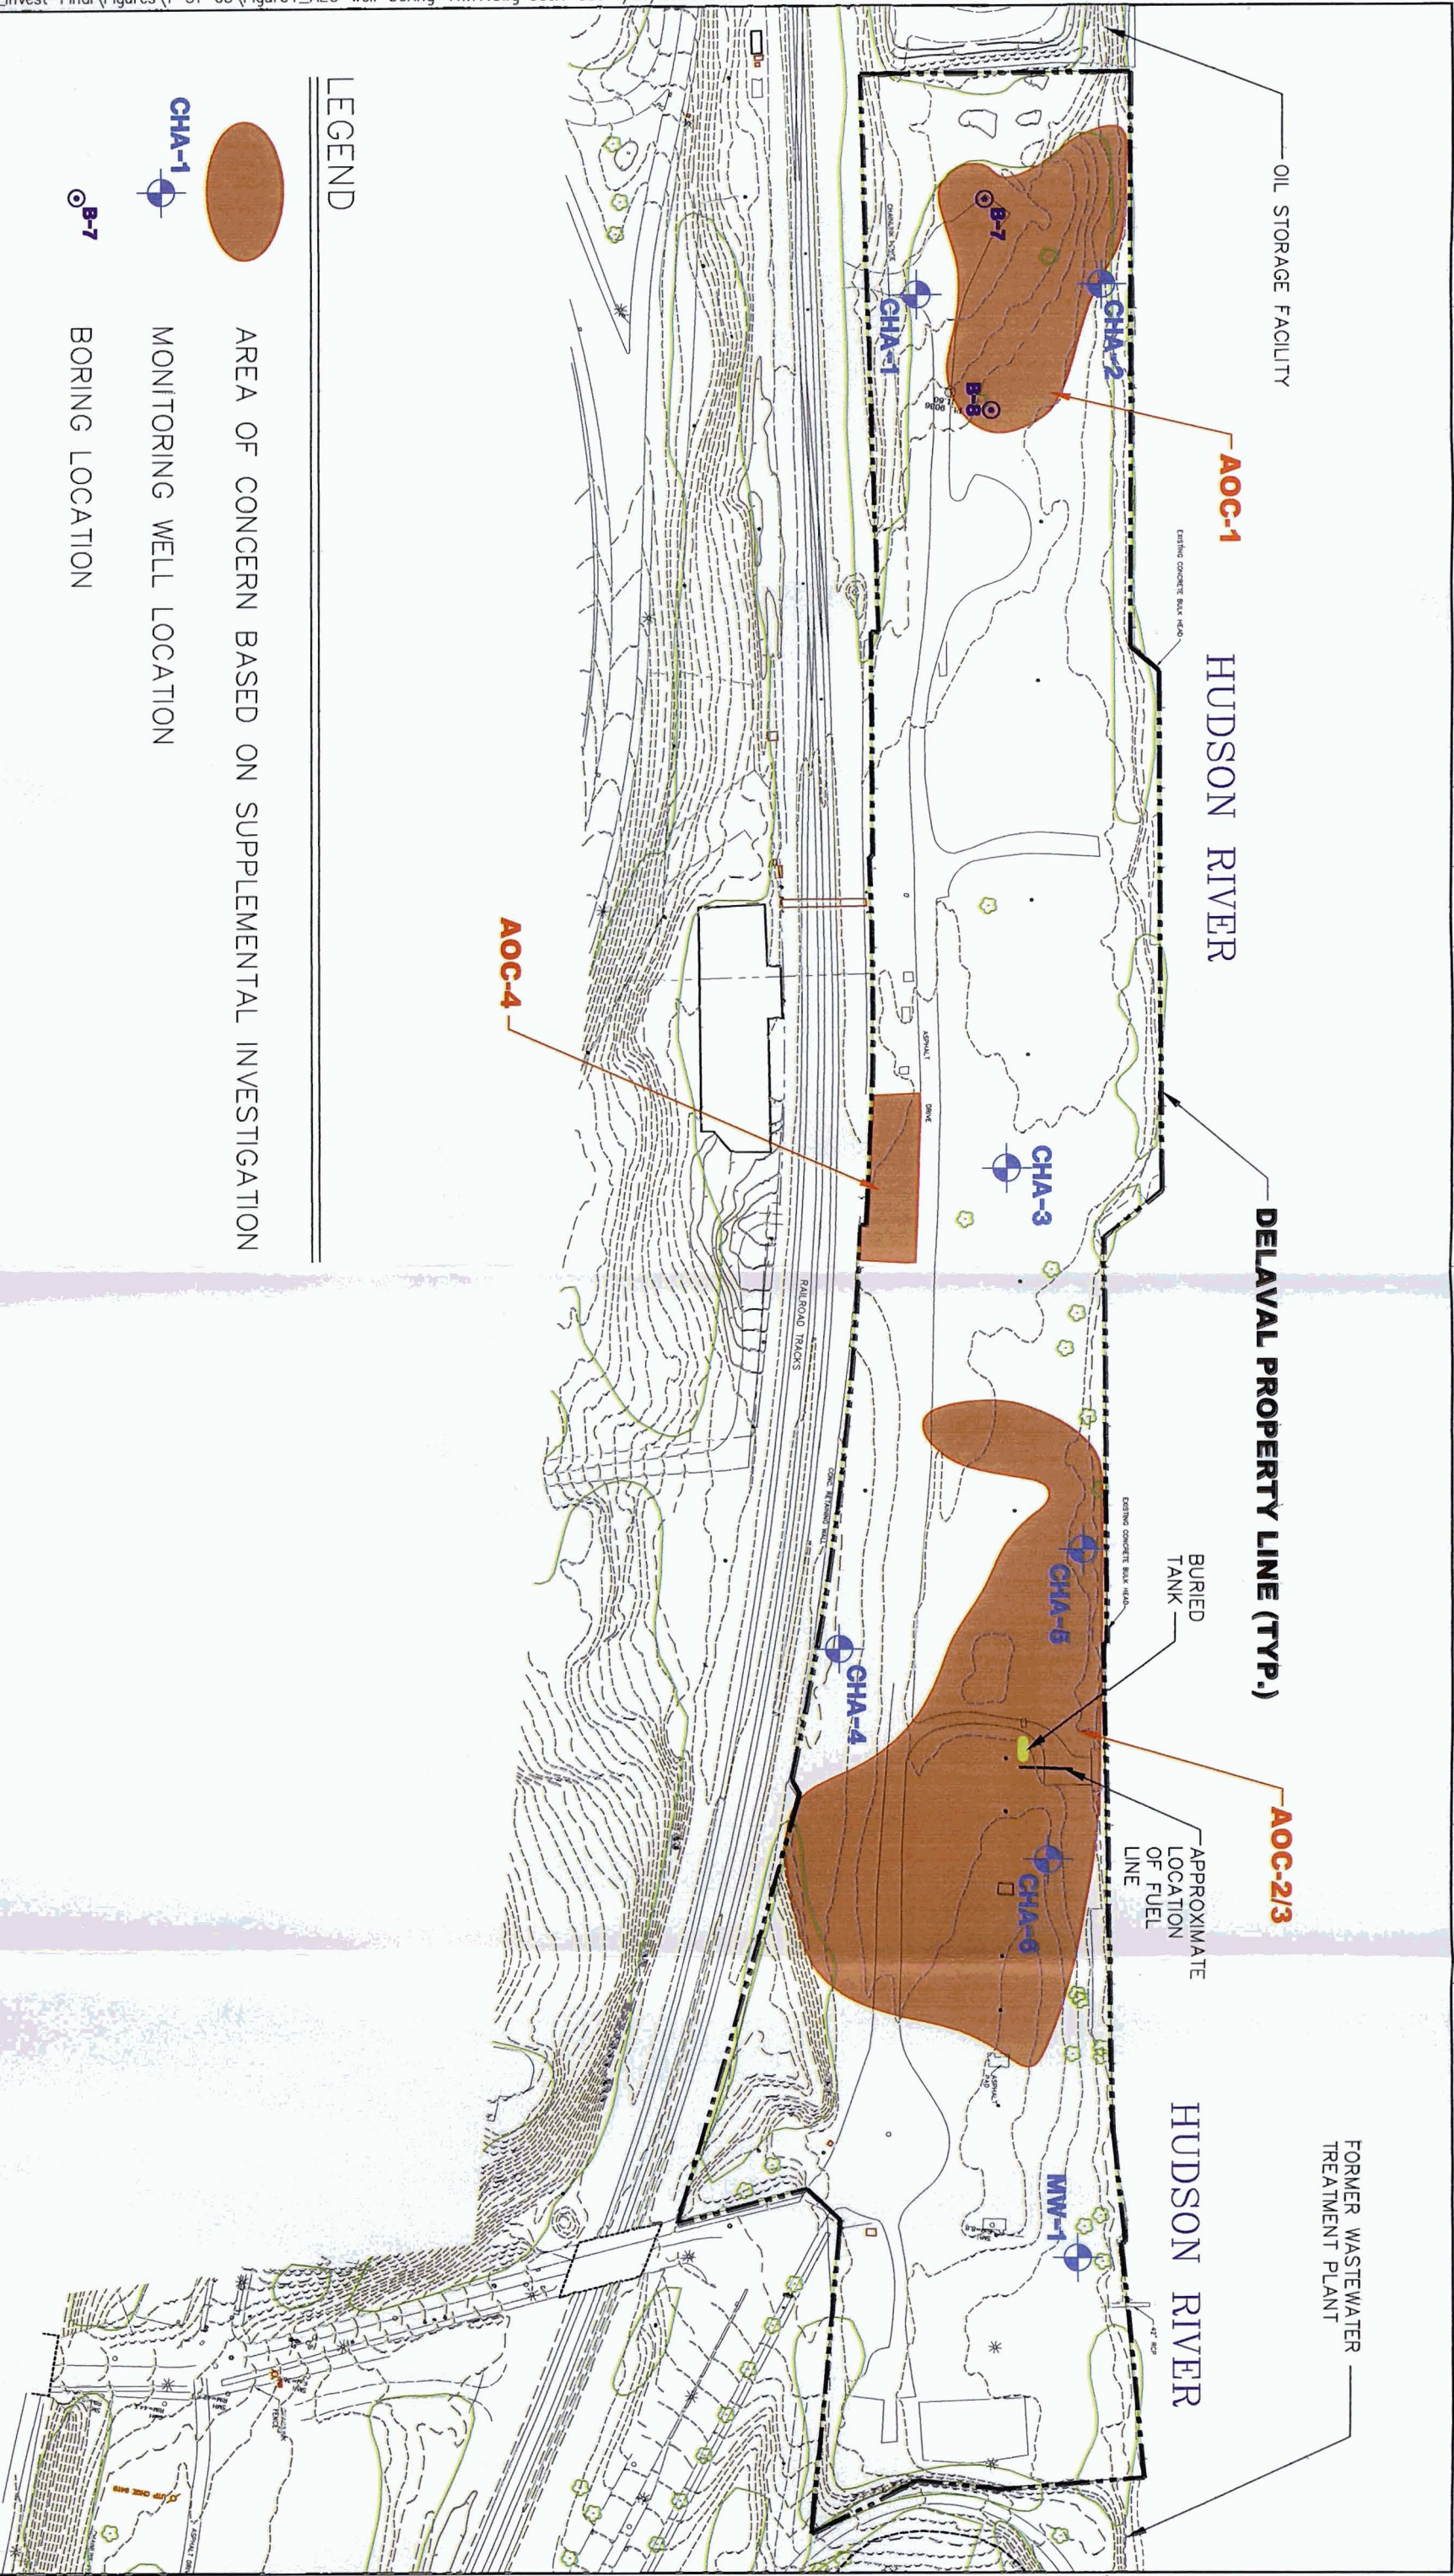
FIGURE 3

As previously mentioned, test pits were used to further delineate the extent of petroleum contamination on the DeLaval site as well as to verify the contents of the fill material. While CHA had initially intended to delineate the limits of the petroleum contamination using a Geoprobe® drilling system, CHA decided that the Geoprobe® system would be ineffective in areas where structural walls and foundations or large construction and demolition (C&D) debris was encountered. Each environmental test pit location has been identified on Figure 3 and associated test pit logs are included as Appendix A.

A variety of fill and waste materials were encountered in AOC-1, including silt, sands, cobbles, metal lathe millings, brick, fire brick, concrete, scrap metal, glass, ceramic tile, wood, asphalt roofing material, slag, and tires. While most of the materials were considered relatively inert, the most significant evidence of waste disposal was encountered at the north end of AOC-1 in test pits TP-8 and TP-17. Concrete, tires, steel tire rims, plastic, glass, scrap metal, a rusted and crushed drum, a plastic pool liner, wood, and metal shavings covered with a white grease-like lubricant were encountered in TP-8 at a depth of 0.7 to 14 feet below the ground surface. Wood, scrap metal, tires, pipes, plastic, and bricks were encountered from a depth of 1 to 19 feet below the ground surface in TP-17.

The most significant evidence of petroleum contamination was encountered along the western edge of AOC-1. CHA noted strong petroleum odors, heavy black staining of the soils, and PID readings

ranging up to 58 PPM in test pits TP-8, TP-9, TP-10, and TP-11. CHA also noted a petroleum odor and sheen on the groundwater observed in some of these test pits.

Black groundwater with a moderate to strong petroleum odor and with sheen on the surface was encountered in a number of the test pits in AOC-2 and AOC-3. The sheen ranged from discoloration on the groundwater surface to the formation of small oil droplets on the water surface. It is unclear whether the black color observed in the groundwater was attributable to the petroleum contamination, the presence of slag and other fill materials in the subsurface or septic conditions associated with potential anaerobic breakdown of the contaminants. However, a petroleum odor typically coincided with the presence of the sheen.

TEST PIT LOCATION PLAN AND  
AREAS OF ENVIRONMENTAL CONCERN  
DEVALVA PROPERTY  
CITY OF POUGHKEEPSIE  
DUTCHESS COUNTY, STATE OF NEW YORK

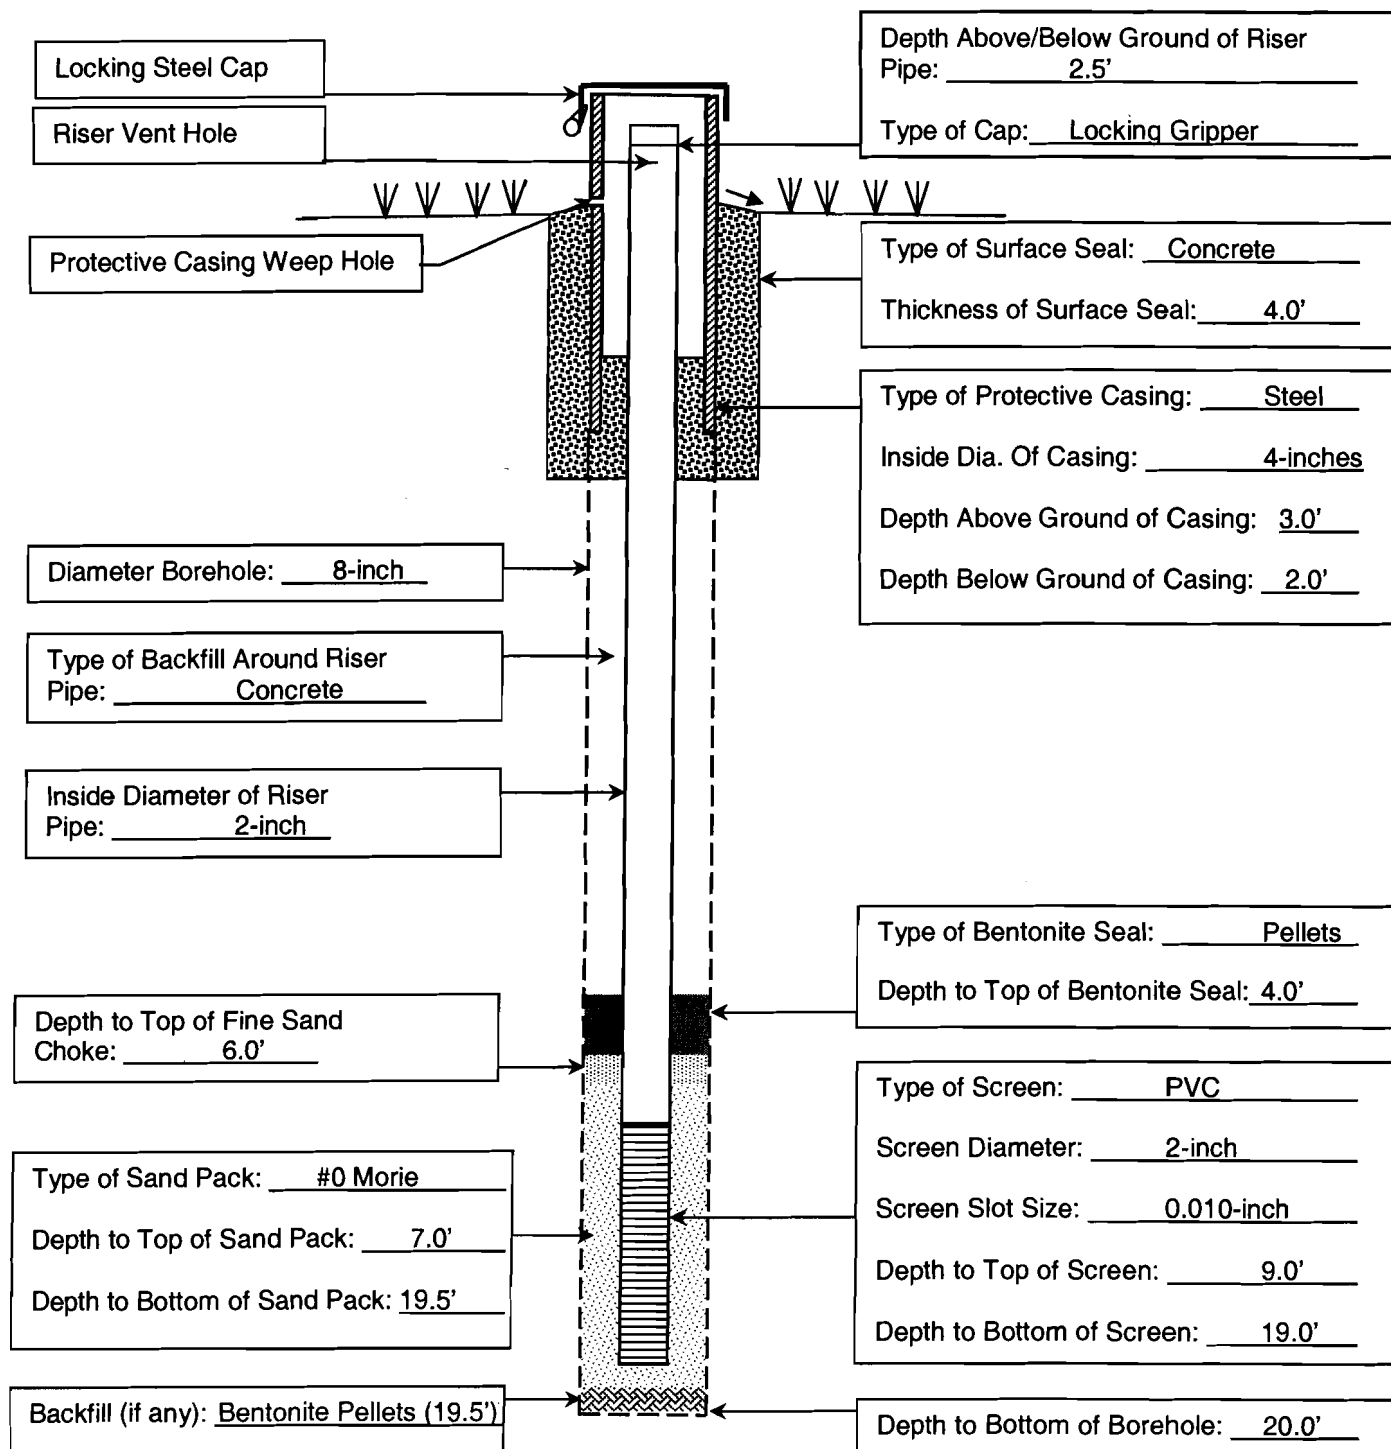
The diagram illustrates the vertical construction of a well. At the top, a 'Locking Steel Cap' is shown with a 'Riser Vent Hole'. Below the cap, a 'Protective Casing Weep Hole' is indicated. The casing is made of 'Steel' and has an 'Inside Dia. Of Casing' of 4-inches. The 'Depth Above Ground of Casing' is 3.0', and the 'Depth Below Ground of Casing' is 2.0'. The borehole has a 'Diameter Borehole' of 8-inch. The 'Type of Backfill Around Riser Pipe' is 'Concrete'. The 'Inside Diameter of Riser Pipe' is 2-inch. A 'Bentonite Seal' made of 'Pellets' is located 4.0' below the casing. Below the seal, the 'Depth to Top of Fine Sand Choke' is 6.0'. A 'Sand Pack' of '#0 Morie' is located 7.0' below the choke, extending to a 'Depth to Bottom of Sand Pack' of 19.5'. The 'Backfill (if any)' is 'Bentonite Pellets (19.5')'. The 'Type of Screen' is 'PVC' with a 'Screen Diameter' of 2-inch and a 'Screen Slot Size' of 0.010-inch. The 'Depth to Top of Screen' is 9.0', and the 'Depth to Bottom of Screen' is 19.0'. The 'Depth to Bottom of Borehole' is 20.0'.

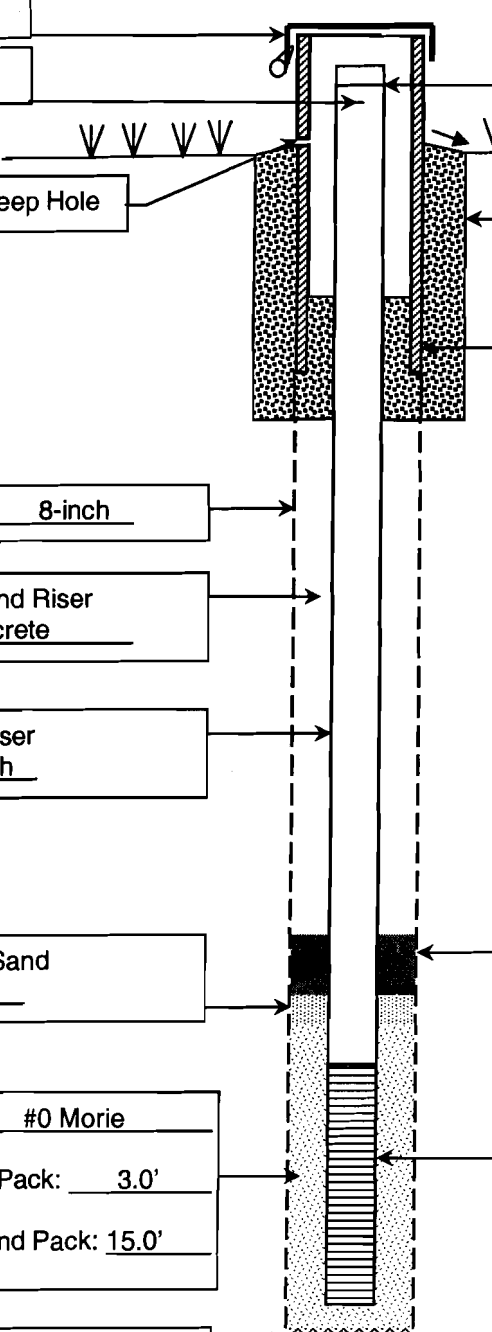
The diagram illustrates the vertical construction of a well. At the top, a 'Locking Steel Cap' is shown with a 'Riser Vent Hole'. Below the cap, a 'Protective Casing Weep Hole' is indicated. The casing is made of 'Steel' and has an 'Inside Dia. Of Casing' of 4-inches. The casing extends 3.0' above ground and 2.0' below ground. The borehole has a 'Diameter Borehole' of 8-inch. The space around the riser pipe is filled with 'Concrete'. The riser pipe has an 'Inside Diameter of Riser Pipe' of 2-inch. A 'Bentonite Seal' made of 'Pellets' is located 2.0' from the top of the screen. The screen is made of 'PVC' with a 'Screen Diameter' of 2-inch and a 'Screen Slot Size' of 0.010-inch. The screen extends 4.0' from the top and 14.0' from the bottom. The sand pack is made of '#0 Morie' and extends 3.0' from the top and 15.0' from the bottom. The bottom of the borehole is filled with 'Bentonite Pellets'. The total 'Depth to Bottom of Borehole' is 16.0'.

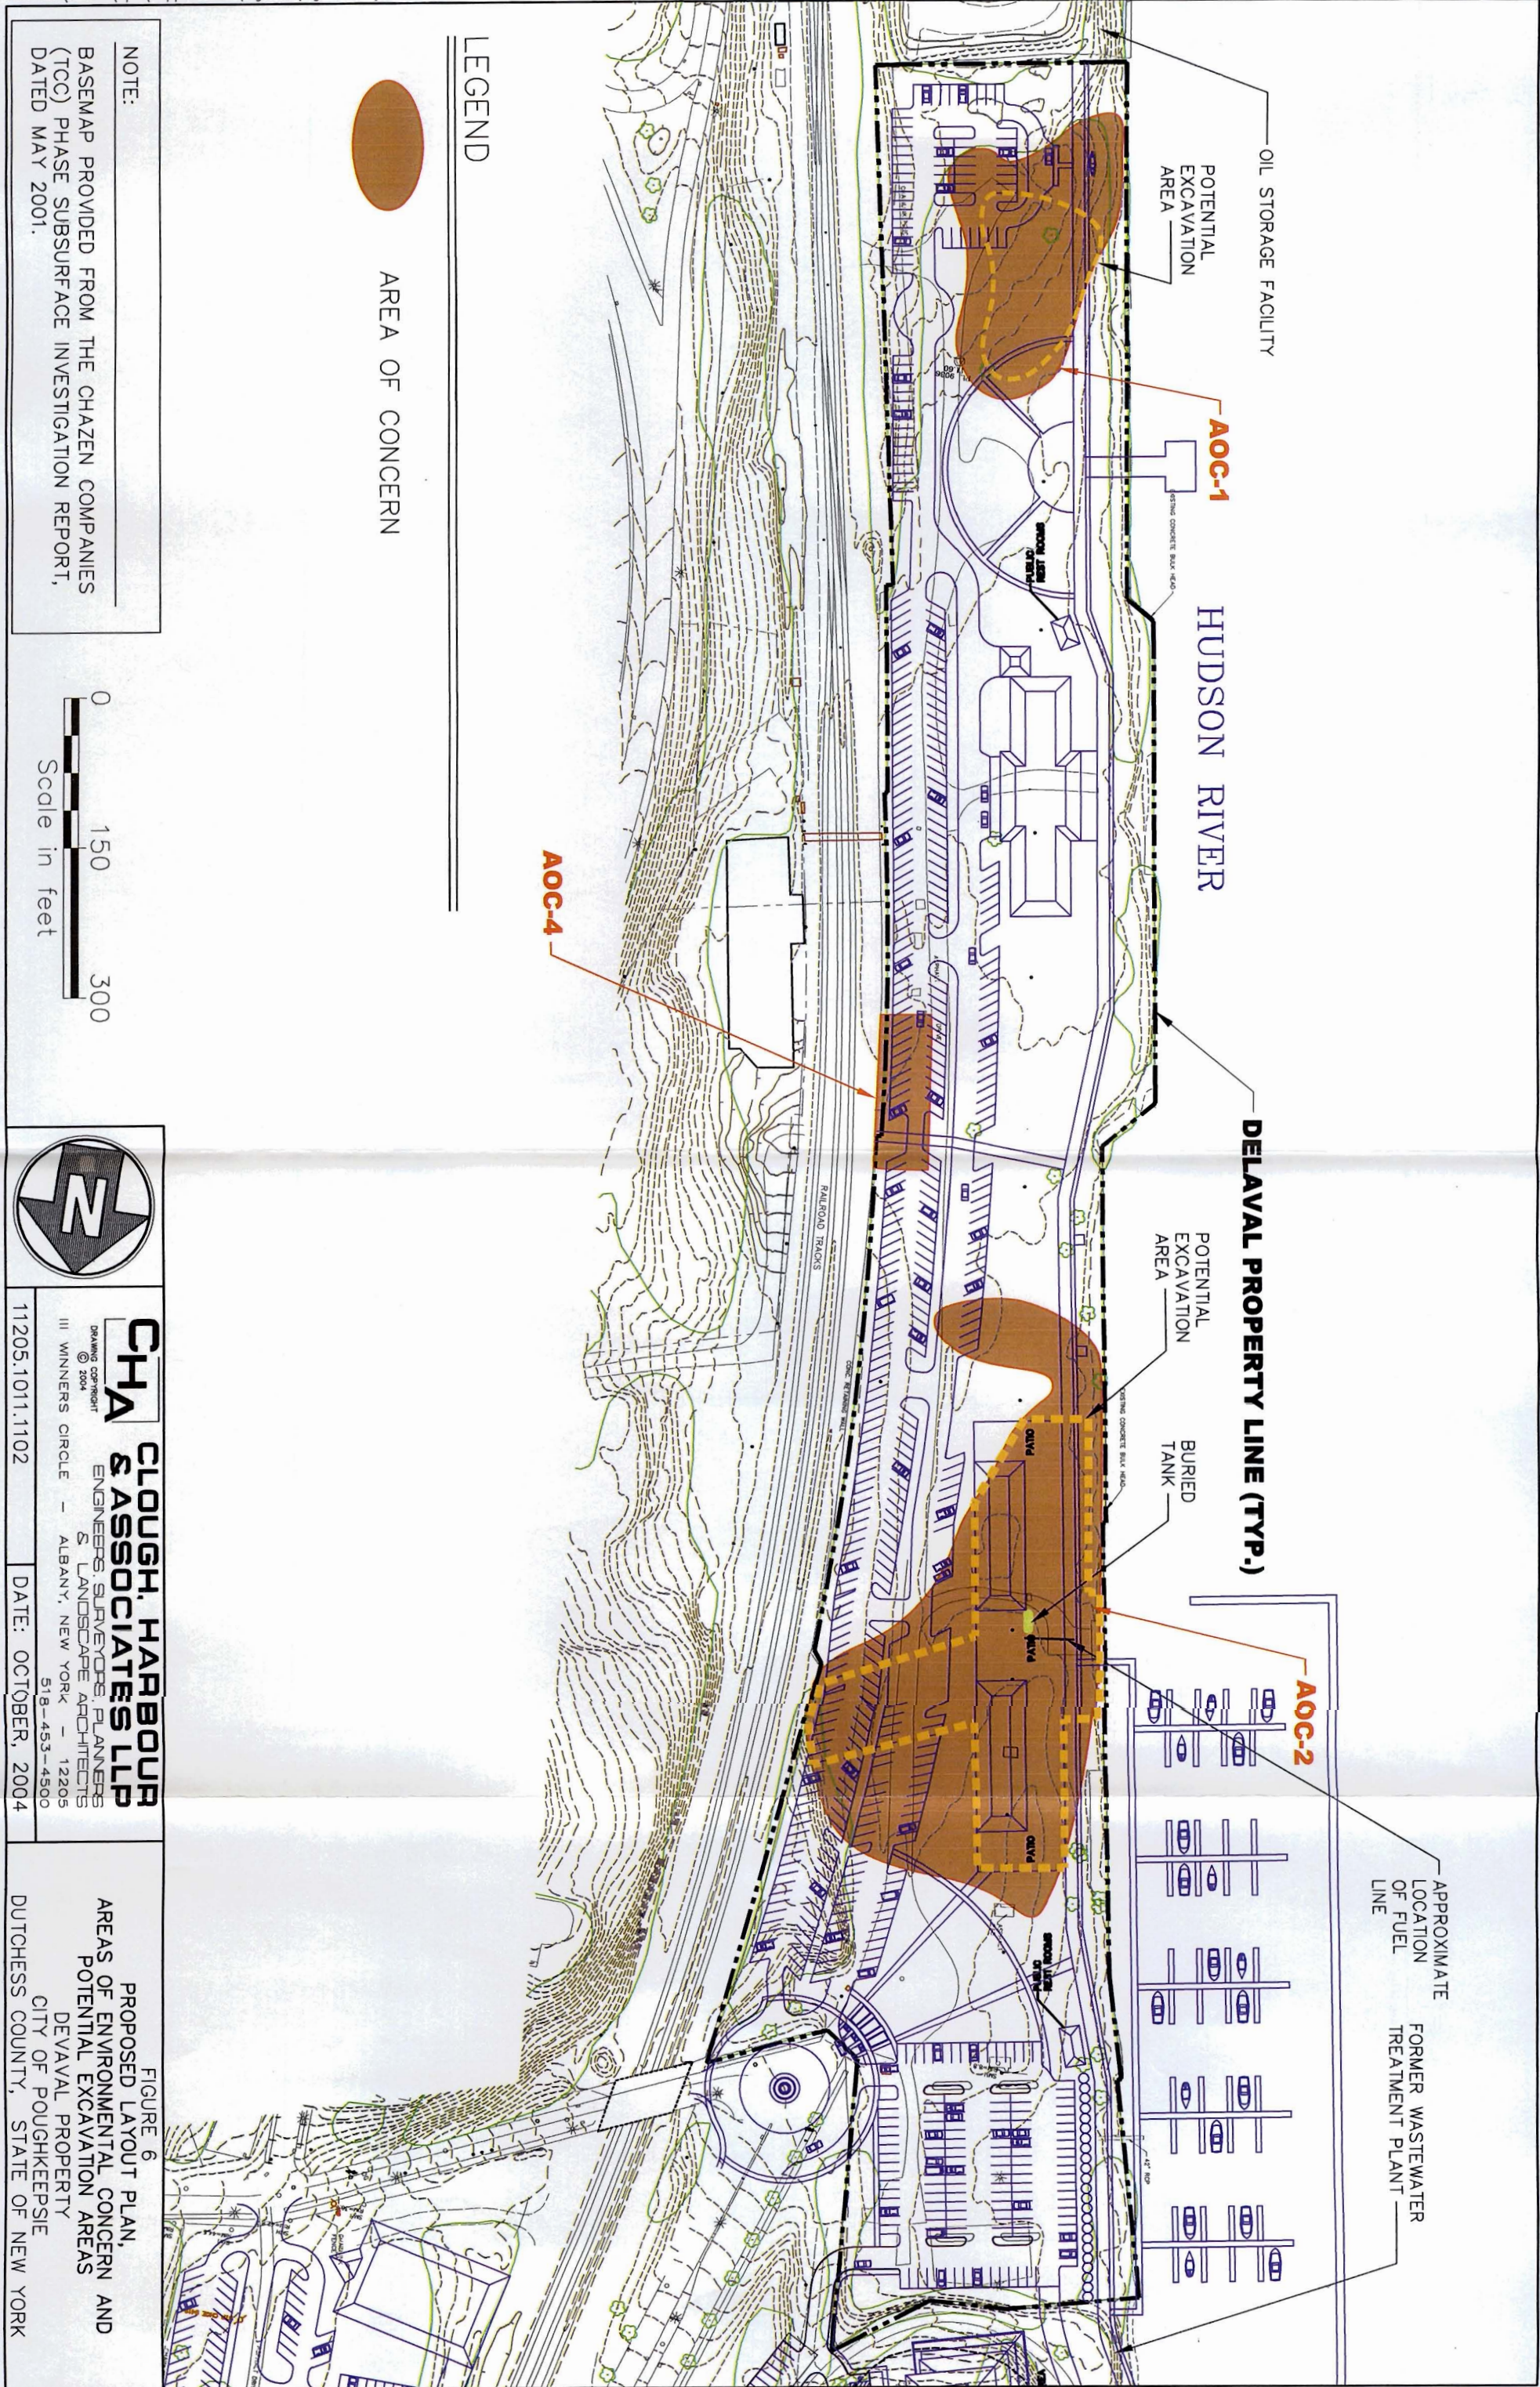
FIGURE 5  
GROUNDWATER CONTOUR MAP AND  
AREAS OF ENVIRONMENTAL CONCERN  
DEVAL PROPERTY  
CITY OF POUGHKEEPSIE  
DUTCHESS COUNTY, STATE OF NEW YORK
