Phase II Environmental Site Assessment

Limited Subsurface Investigation

48 Sewell Street

Hempstead, New York

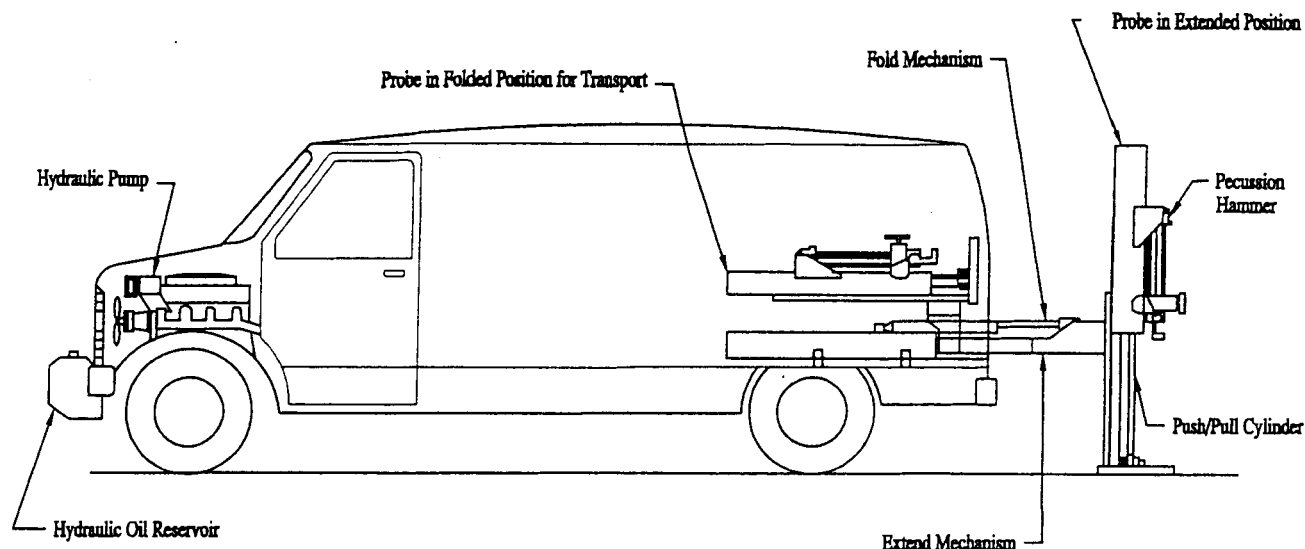
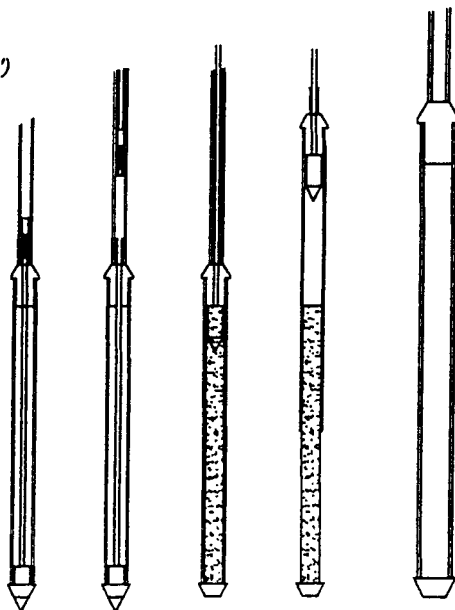
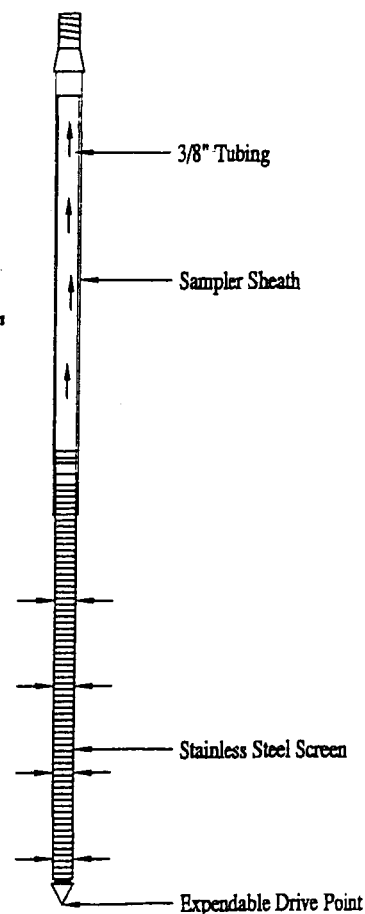
Diagram 1: Geoprobe Operating System

Basics

- ◆ Hydraulic powered probe unit is operated from a engine driven pump.
- ◆ Remote vehicle ignition allows operator to start engine from probe unit.
- ◆ Belt driven hydraulic pump supplies 10 gpm @ 2000 rpm, 3000 psi operating pressure
- ◆ Probe unit folds for transport
- ◆ Unit utilizes static weight of vehicle and pecussion hammer to advance probing tools.
- ◆ Hydraulic hammer delivers pecussion rate of 30 Hz.
- ◆ Probes have greater than 18,000 lbs of down force and 25,000 lbs of retraction force.
- ◆ Drives multiple diameter probes (1", 1.25" and 2.25") to depths over 100 feet.

Soil Probing Tool

The tools are advanced and a sample is acquired in a non-reactive plastic sheathing. The system offers two sizes of sample retrieval:

- Large bore - 1.5" x 2'
- Macro - 2.25" x (2', 3' & 4')

Groundwater SP-15 Sampler

The tool allows a stainless steel, 4" screen to be delivered to the underlying groundwater. At the desired depth, the screen is retracted and samples are obtained via a check valve assembly.

Subsurface probes were installed using a *Geoprobe* hydraulically powered probing tool (see **Diagram 1: Geoprobe Operating System**). Mechanized, vehicle mounted probe systems apply both static force and hydraulically powered percussion hammers for tool placement (static down forces up to 3,000 pounds combined with percussion hammers of eight horsepower continuous output). Recovery of large sample volumes was facilitated with a probe-driven sampler. The probe-driven sampler consisted of a hollow probe which opened via a remote control mechanism at the selected sampling depth in the soil profile to allow soil to enter as it was advanced. Discrete media samples were secured at the desired depths and were contained within a non-reactive transparent plastic sleeve that lined the hollow probe. The plastic sleeves were removed for subsequent inspection and sample aliquot acquisition.

The groundwater sampling system used was the *Geoprobe* Screen Point 15, which is designed to accurately collect grab samples of groundwater. The Screen Point 15 uses a screen with a standard slot size of 0.004 inches that is sealed inside a 1.5-inch ID alloy steel sheath as it is driven to depth. The screen is sealed inside the sheath with Neoprene O-rings which prevent infiltration of formation fluids until the desired depth is attained. When the screen has been driven to the depth of interest in the formation, extension rods are used to hold the screen in position as the driving rods are retracted approximately 4 feet. The 4-foot long sampler sheath forms a seal above the screen as it is retracted. A total of 41.5 inches of slotted screen is placed into contact with the formation. The Screen Point 15 groundwater sampler has a total boring diameter of 1.5 inches, the outside diameter of the screen is 1.0 inch. This provides for a maximum of 0.25 inches between the screen and the natural formation as the sampler sheath is retracted. These conditions approach the ideal for natural formation development, which can be conducted when lower turbidity samples are required.

The groundwater sample was collected from the sampler utilizing 3/8 inch diameter disposable tubing equipped with a bottom check valve. The tubing extended from the surface down to the sampler. The tubing was oscillated until the process had achieved proper development.
