BROWNFIELD CLEANUP PROGRAM

SITE INVESTIGATION & INTERIM REMEDIAL MEASURE WORK PLAN

48 SEWELL STREET, LLC.

BERNINGER ENVIRONMENTAL, INC.

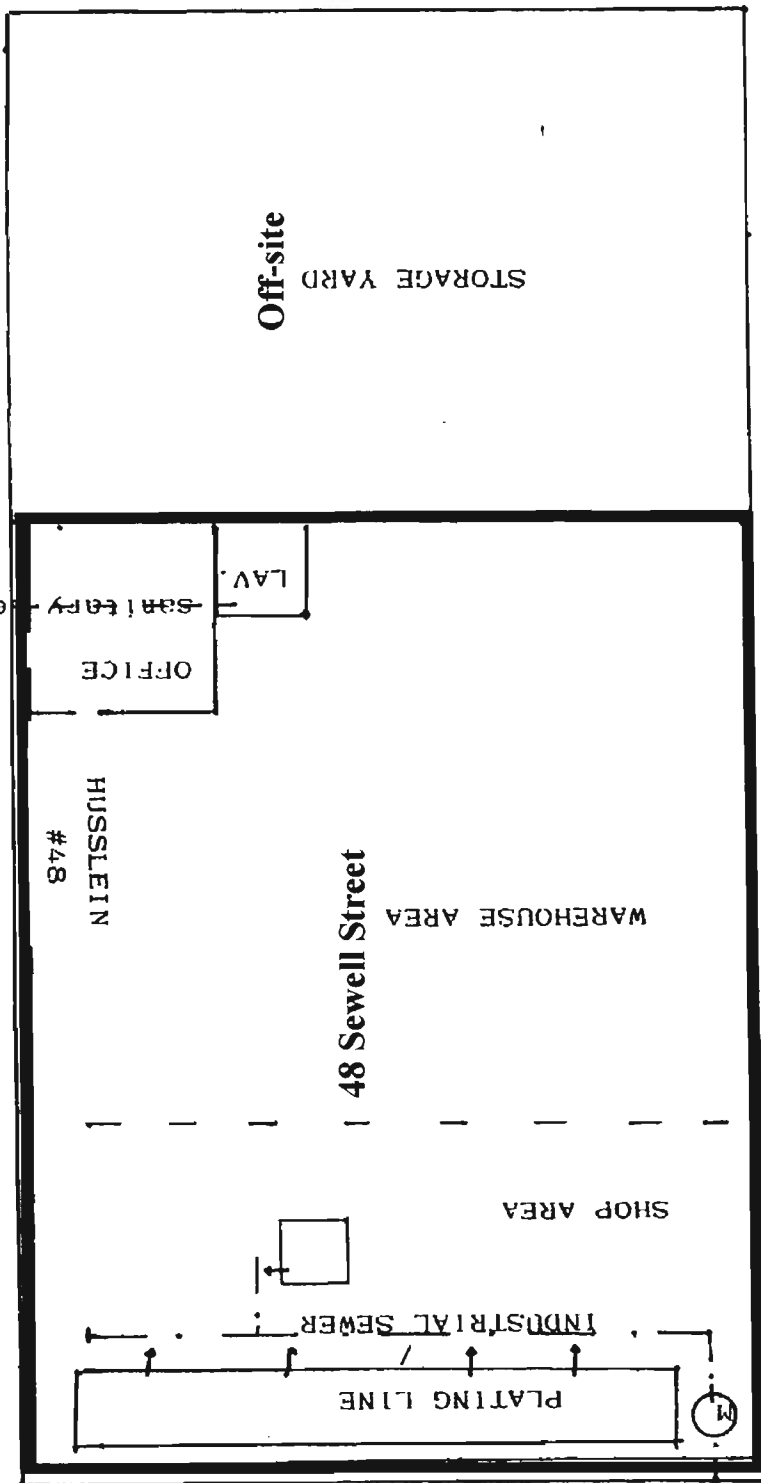
Figure 4 - Former Property Use

Source: Nassau County Department of Health Records

subject parcel, the eastern 2/3rd of the property was used for office space and warehousing/storage only. A separate municipal wastewater sewer connection was present that served this portion of the property. Sanitary flow was noted to be in the order of 600 gallons per day (gpd) and discharges were to a separate wastewater line depicted at the northeast corner of the property. The remaining western portion of the property was used as the shop area and contained the holding tanks for the plating line.(see Figures 4 to5).

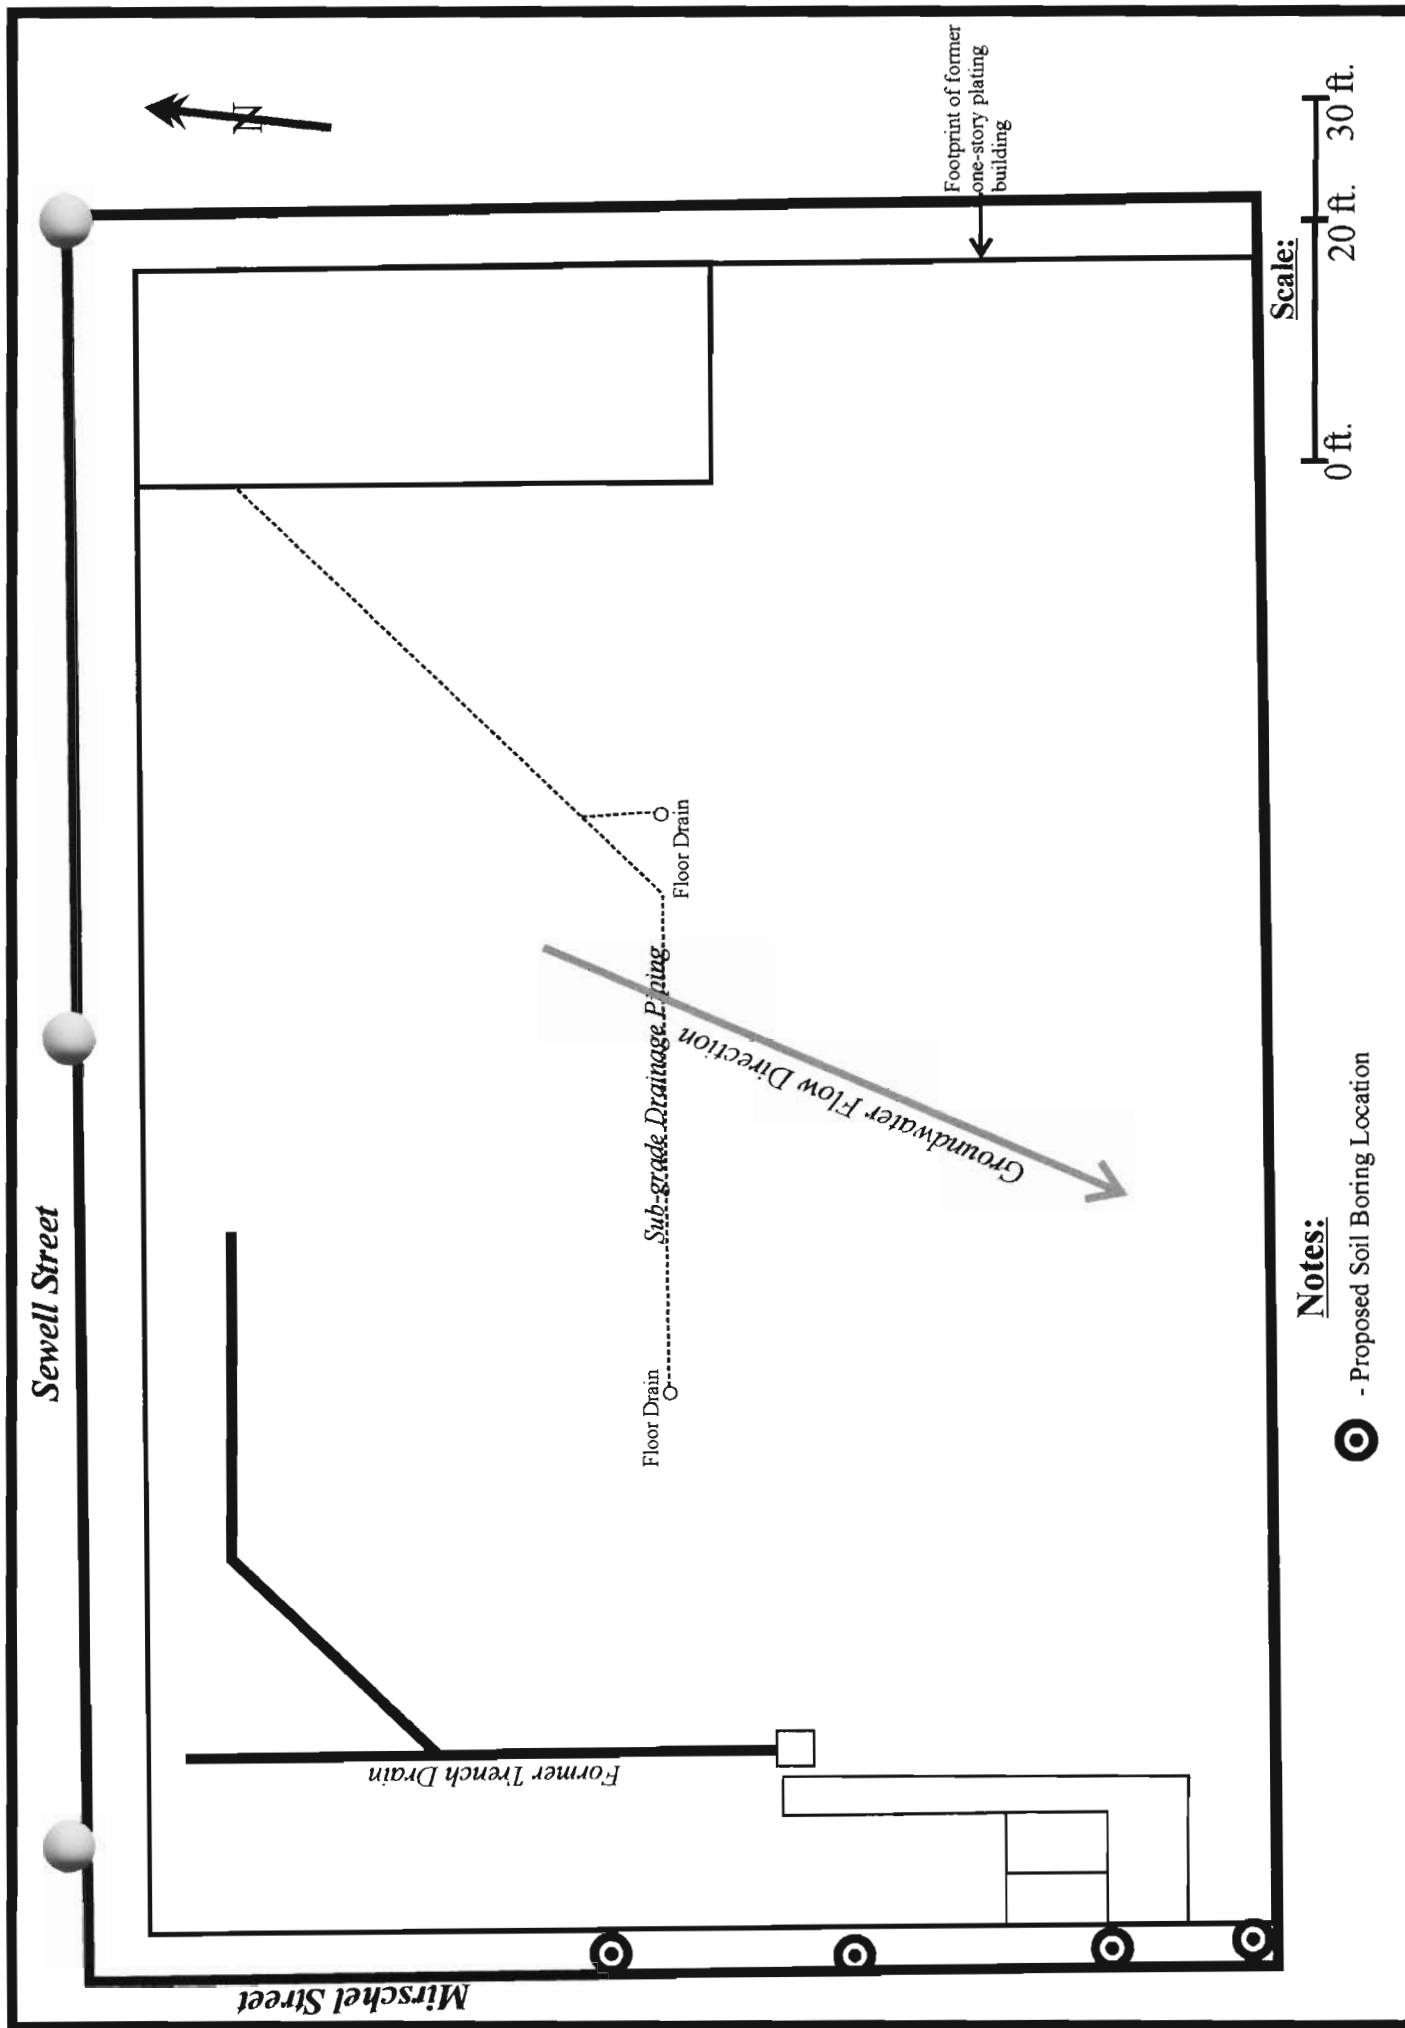
Notes:
 - Proposed Soil Boring Location

<p>Berninger Environmental, Inc. 90-B Knickerbocker Avenue Bohemia, New York 11716 (631) 589-6521 Fax (631) 589-6528</p>	<p>Former Husslein Plating, Corp. 48 Sewell Street Hempstead, New York</p>	<p>Figure 12 - Proposed Soil Borings</p>
--	---	---

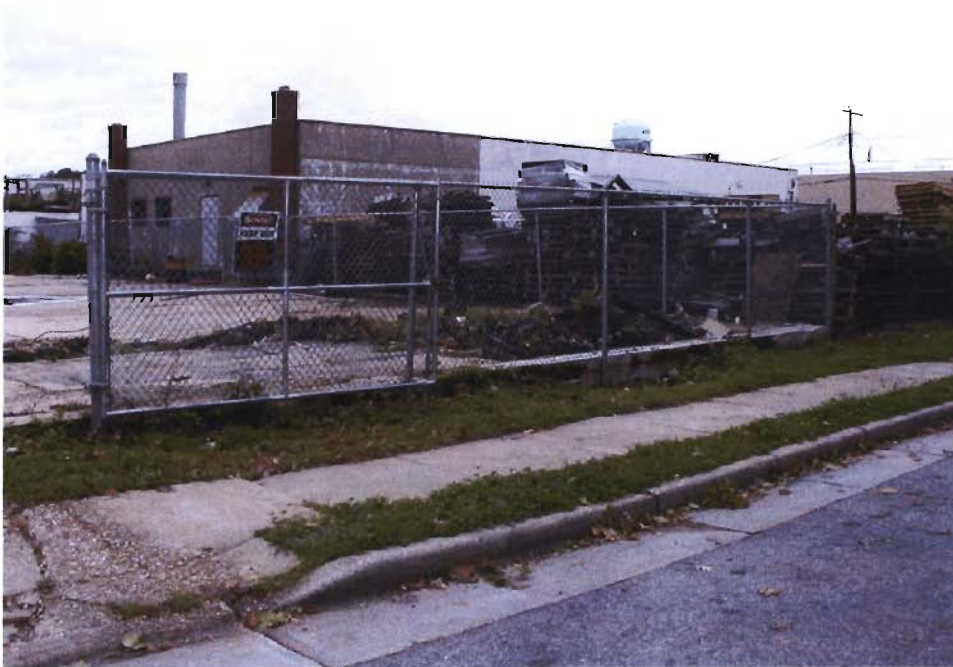
Photograph No. 1 - View of southwest corner of the property, along Mirschel Street. Location of former wastewater treatment pits and former municipal sewer connection.

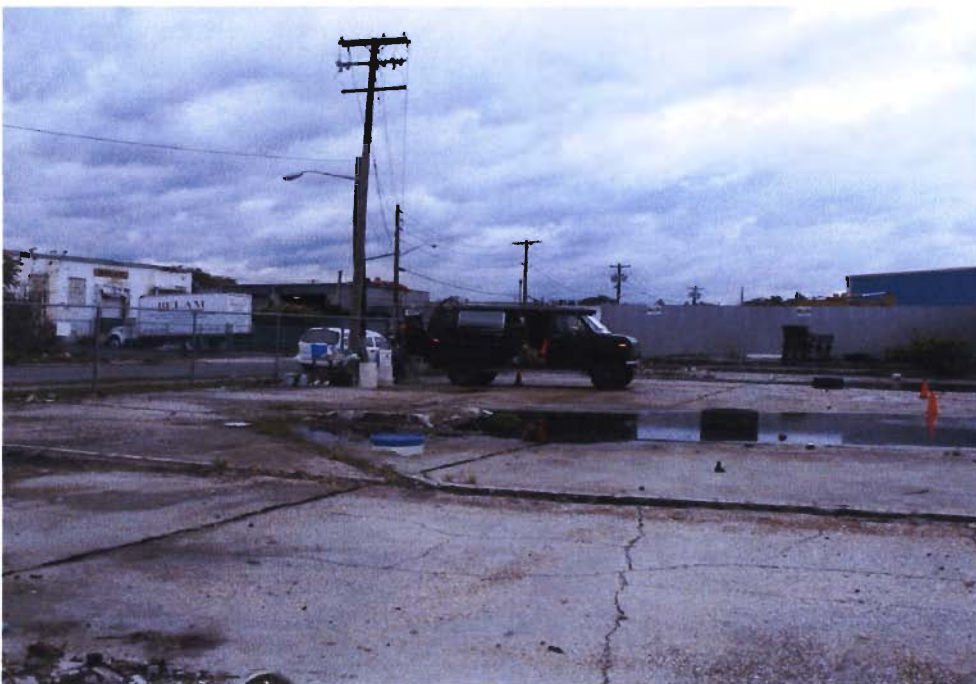
Photograph No. 2 - View of interior of the property, former trench drain is depicted in foreground. Installation of soil borings and monitoring wells.

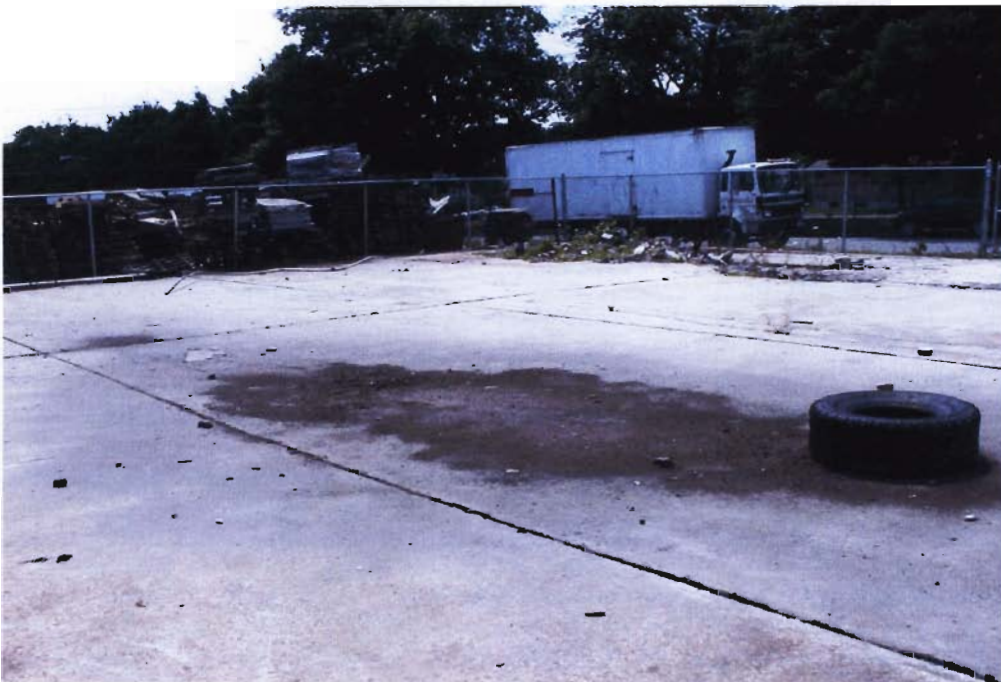
Photograph No. 4 - View of the western portion of the property, location of former plating operations and wastewater treatment.

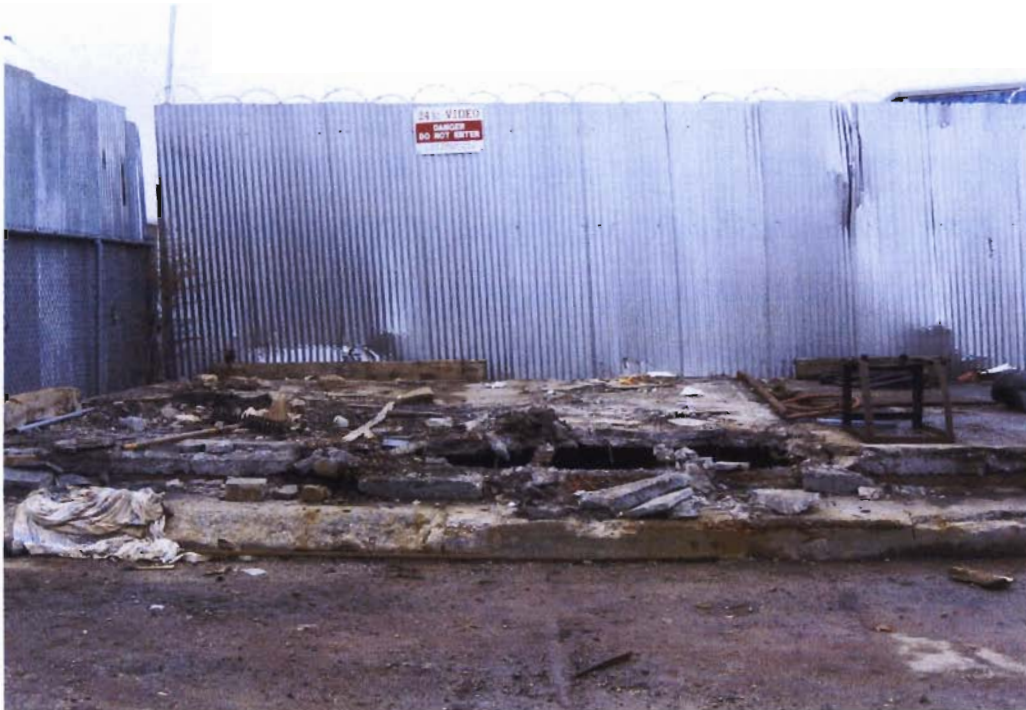
Photograph No. 5 - View of northeast corner of the property, location of former office and basement structure with old heating system; No. 2 fuel oil UST was located at this area, prior to its removal.

system that was present in a limited basement structure (underlying the former office area) on the east side of the property. Evidence of remnant heating system was observed within the basement remains. The fill ports for two former gasoline USTs that were remnant site features from the former Semke operation (prior to 1972, never used by Husslein Plating) were noted to be present along the sidewalk with piping leading into the interior of the facility along Sewell Street. All three of these USTs were removed in January 2006 under the scrutiny of the NCDH and NCFM as preliminary activities to those required compliance activities under the BCP (see Section 3.0).

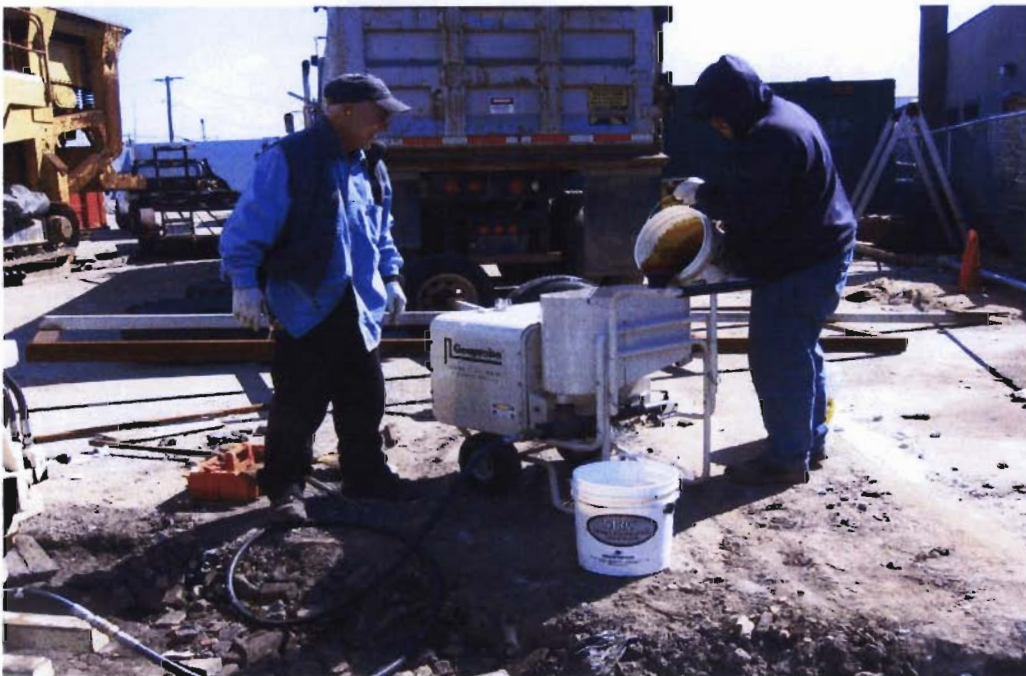
Photograph No. 6 - Injection of Metals Remediation Compound in April/May 2005 at subgrade impacted soil source areas and at southwest property perimeter.

implemented during April-May 2005 and included the injection of MRC into both an interior source area on-site and along the downgradient property perimeter to create a groundwater contaminant reduction flow barrier (see Figure 10) Furthermore, a low-permeability sealing material (cement) was installed in areas of open penetrations (former trench drain) within the concrete foundation at the western portion of the property to limit rainfall infiltration in these areas.

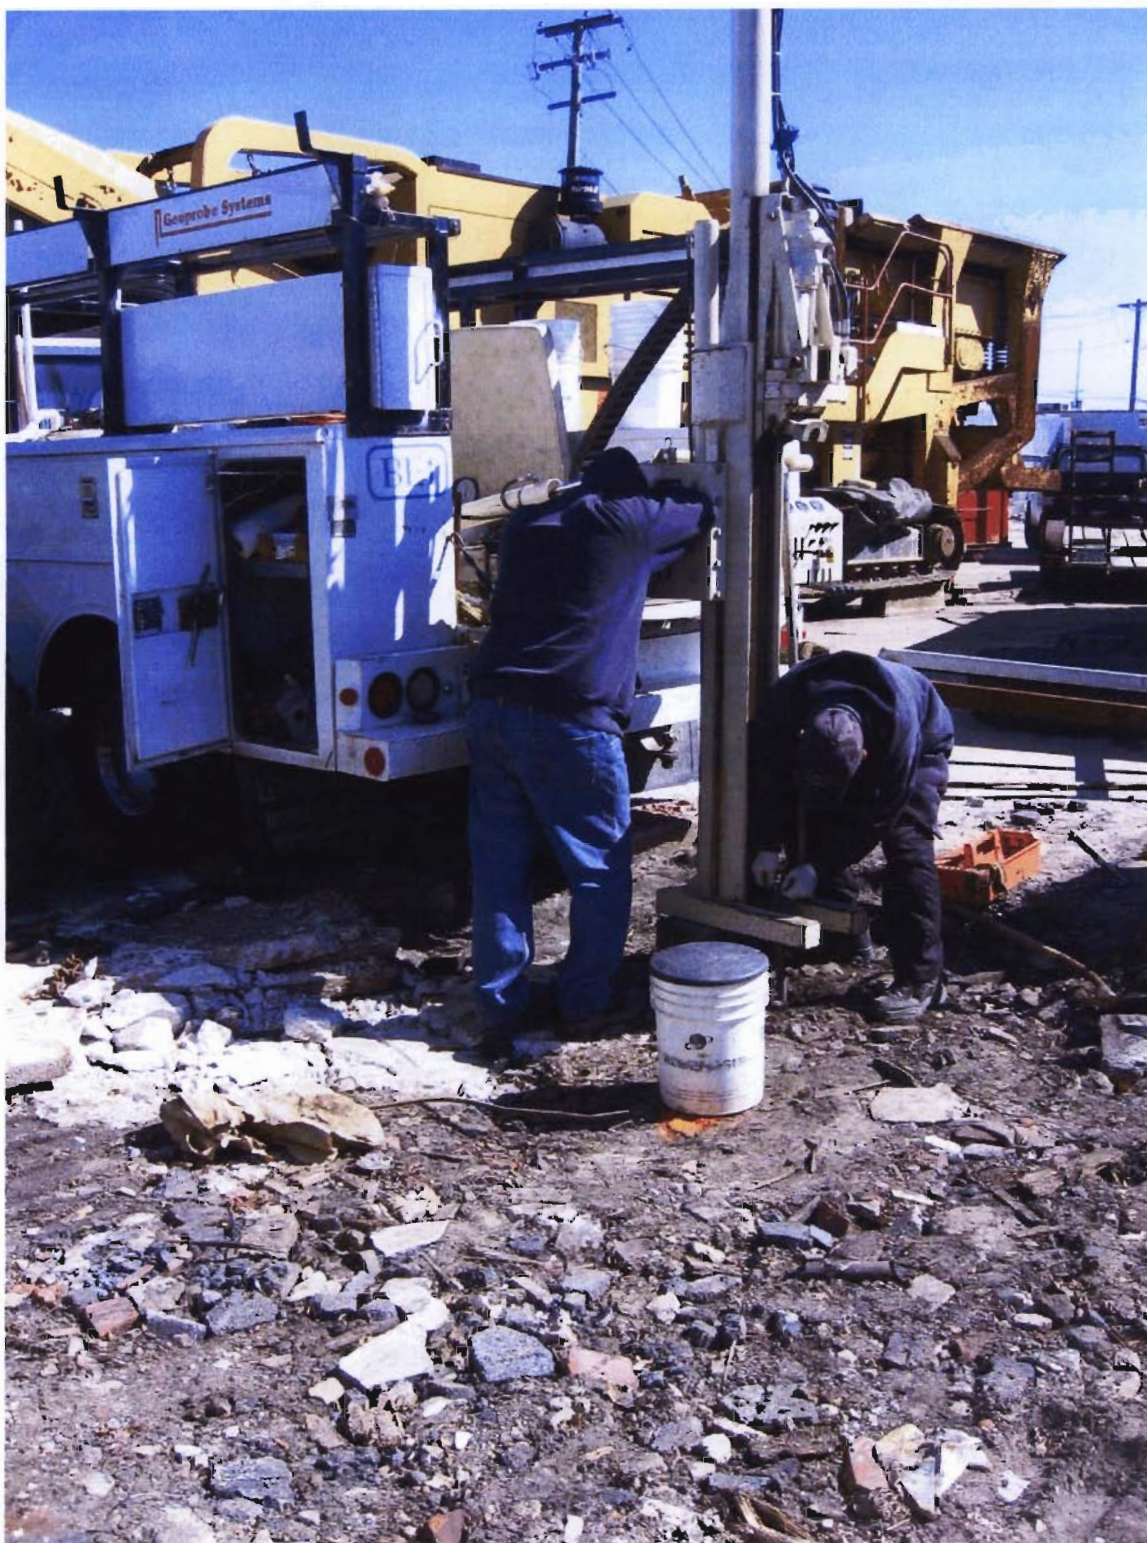
Photograph No. 7 - Supplemental soil sampling in subgrade soil source areas to collect samples for pre-disposal characterization for the IRM.

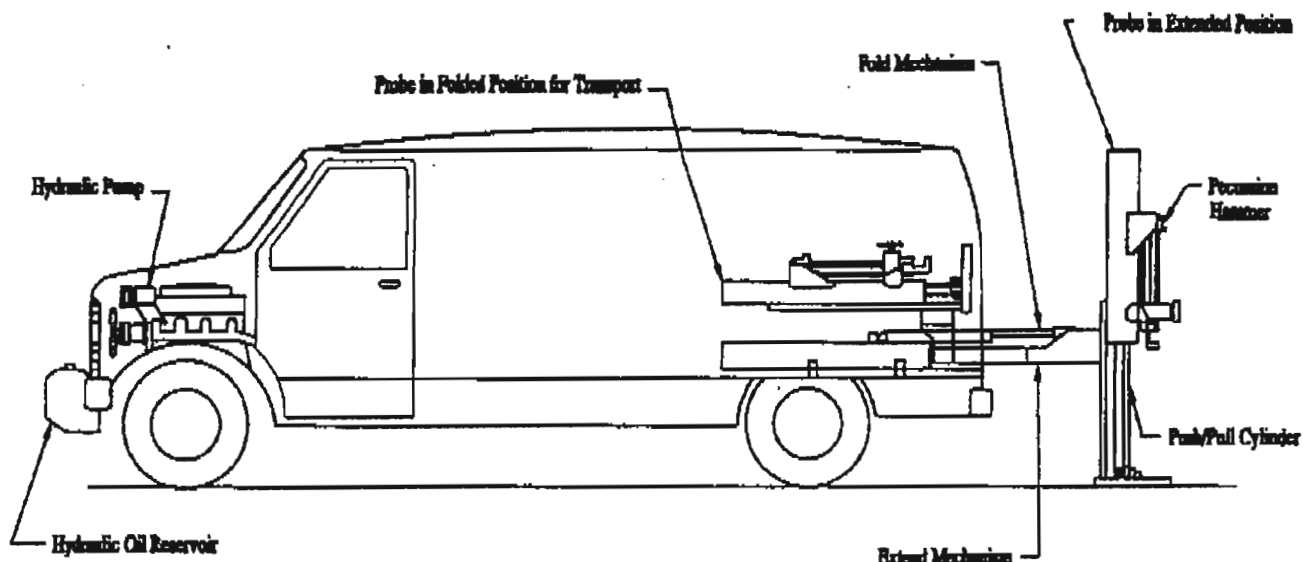
Subsurface probes were installed using a *Geoprobe* hydraulically powered probing tool (see **Diagram 1: Geoprobe Operating System**). Mechanized, vehicle mounted probe systems apply both static force and hydraulically powered percussion hammers for tool placement (static down forces up to 3,000 pounds combined with percussion hammers of eight horsepower continuous output). Recovery of large sample volumes was facilitated with a probe-driven sampler. The probe-driven sampler consisted of a hollow probe which opened via a remote control mechanism at the selected sampling depth in the soil profile to allow soil to enter as it was advanced. Discrete media samples were secured at the desired depths and were contained within a non-reactive transparent plastic sleeve that lined the hollow probe. The plastic sleeves were removed for subsequent inspection and sample aliquot acquisition.

- ◆ Hydraulic powered probe unit incorporated from a engine driven pump.
- ◆ Remote vehicle ignition allows operator to start engine from probe unit.
- ◆ Belt driven hydraulic pump supplies 10 gpm @ 2000 rpm, 3000 psi operating pressure
- ◆ Probe unit folds for transport
- ◆ Unit utilizes static weight of vehicle and percussion hammer to advance probing tools.
- ◆ Hydraulic hammer delivers percussion rate of 30 Hz.
- ◆ Probes have greater than 18,000 lbs of down force and 25,000 lbs of retraction force.
- ◆ Drives multiple diameter probes (1", 1.25" and 2.25") to depths over 100 feet.

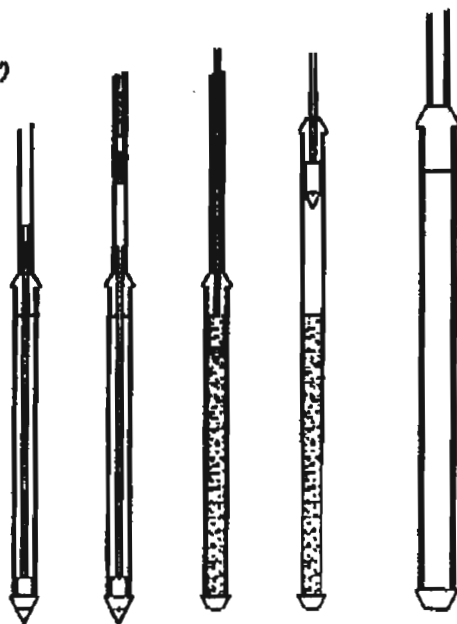
The tools are advanced and a sample is acquired in a non-reactive plastic sheathing. The system offers two sizes of sample retrieval:

- Large bore - 1.5" x 2'
- Macro - 2.25" x (2', 3' & 4')

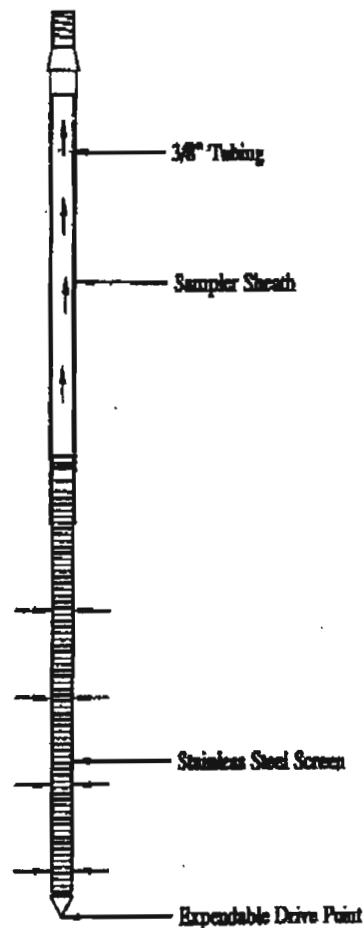
- ▲ **Groundwater SP-15 Sampler**
The tool allows a stainless steel, 4' screen to be delivered to the underlying groundwater. As the desired depth, the screen is retracted and samples are obtained via a check valve assembly.
