Re: Revised Off Site Sediment Sampling
Former Cibro Terminal Site ID: 13015
7 Washington Ave, Island Park NY 11558

November 2018
Former Cibro Petroleum Terminal Site
Brownfield Cleanup Site C130153
Island Park, New York

PHOTO LOG – Former Cibro Terminal Site

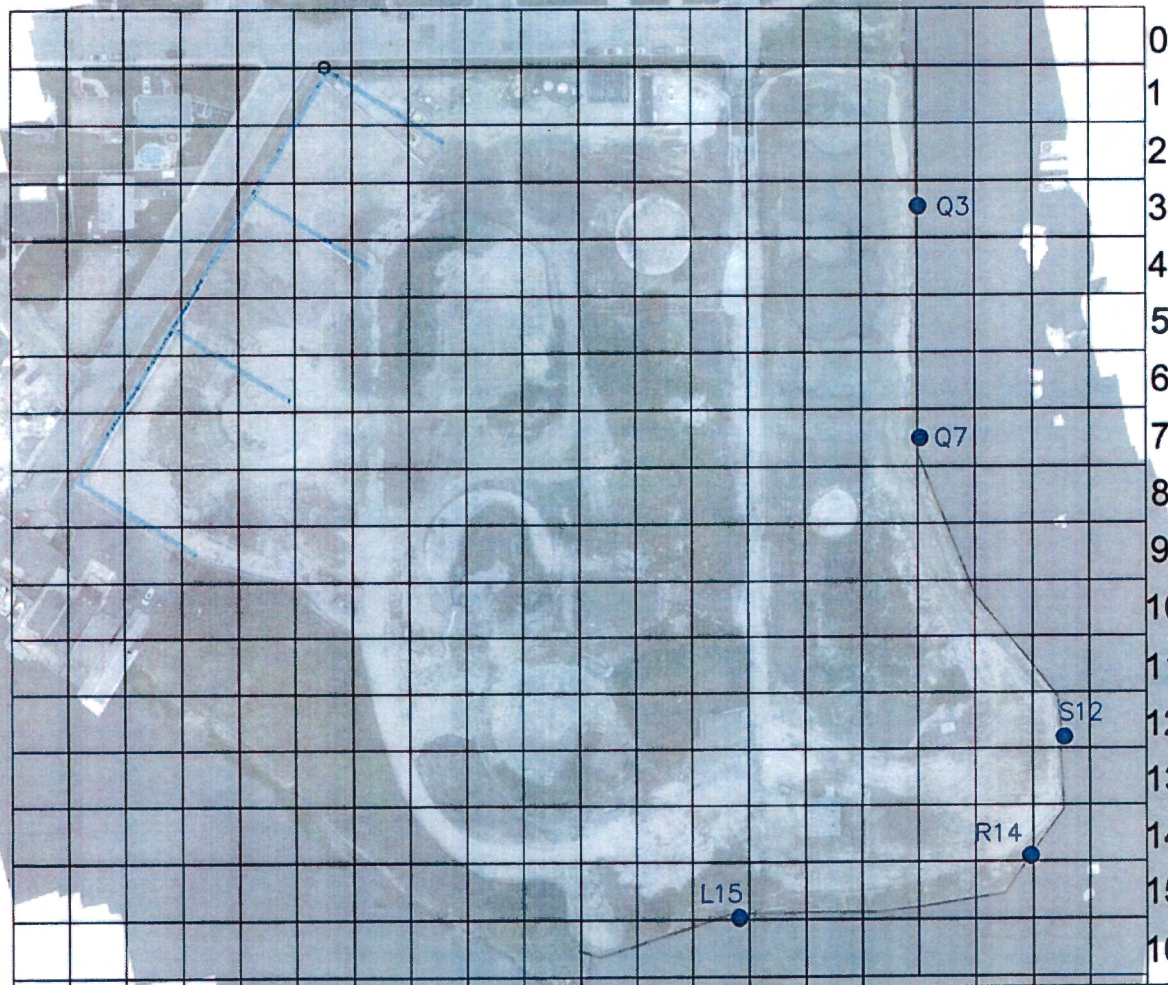
Five sediment samples were collected in the locations shown on Figure #1.

Posillico contracted AARCO Environmental to assist in the collection of the sediment samples on September 26 and September 27, 2018. Per the NYSDEC approval on July 31, 2018, samples were collected using direct-push pneumatically driven sampler in-lieu of using a Vibracore sampler. Sample cores were advanced to 10' below mudline in the five locations tabulated above and shown on Figure #1.

1. SAMPLE LOCATIONS

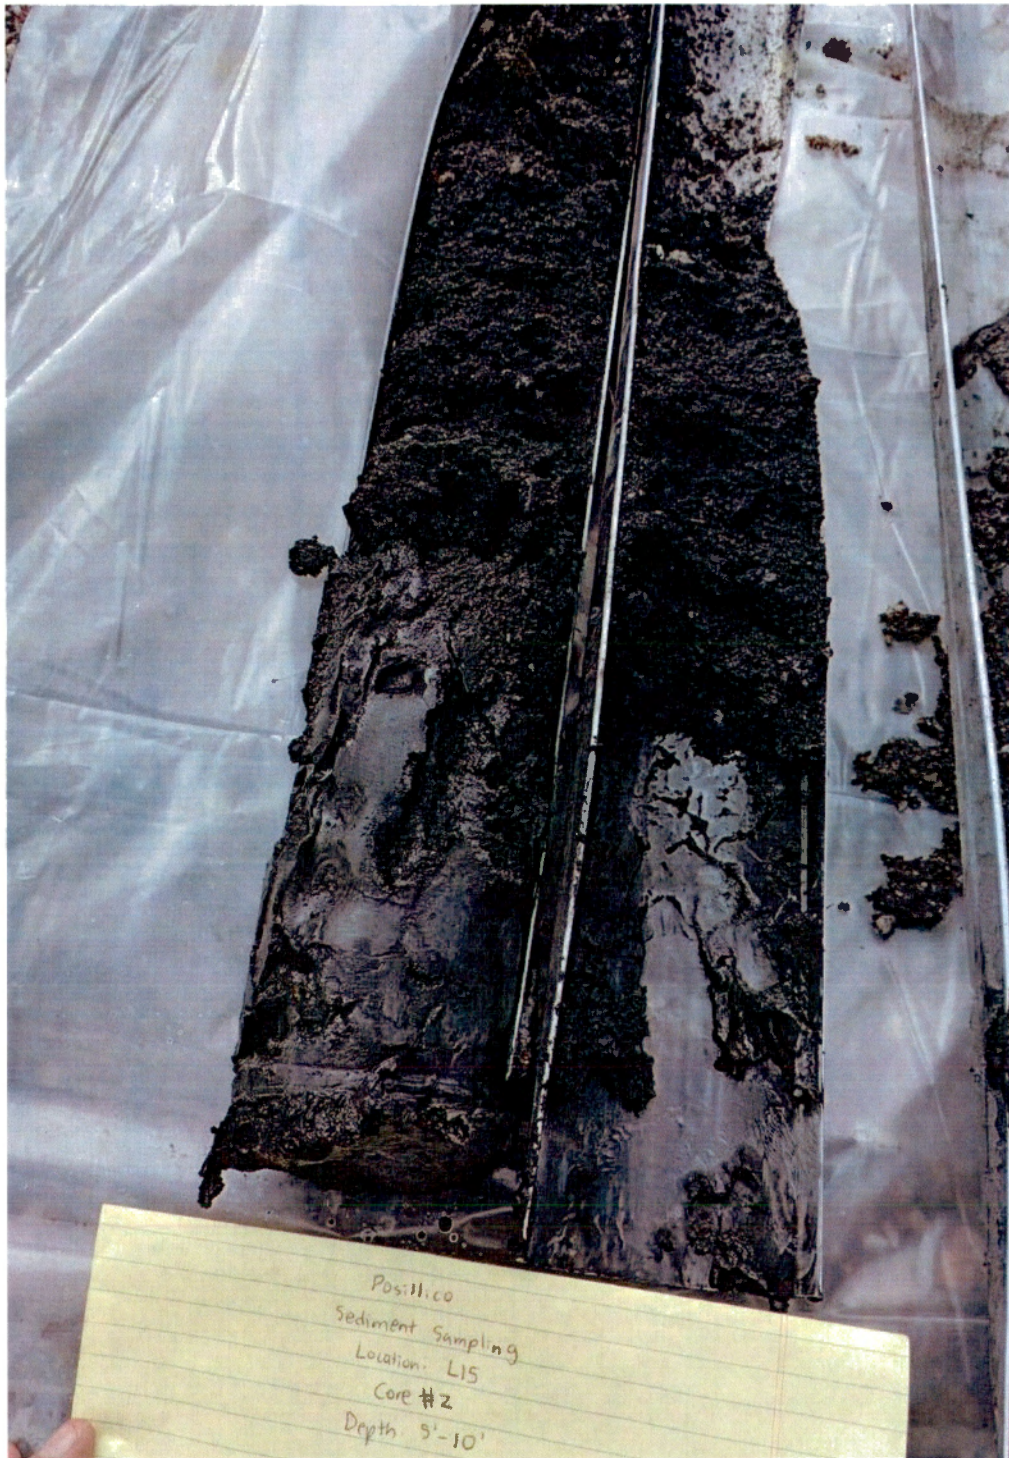
Sample Location L15 Core #2- 5'-10'

There was one slight exceedance of Class A guidance values for arsenic with a detected concentration of 9.1 ppm at location L15 from 5-10’ below the mudline. Although this concentration slightly exceeds the Class A guidance value of 8.2 ppm it falls on the low end of the Class B guidance range of 8.2-70. There were no other exceedances detected of Class A guidance values for metals.

The slight exceedance of Class A guidance values for arsenic is not considered indicative of an anthropogenic impact of the subject site. Based on the depth of the sample, the marginal nature of the exceedance, and review of the NYSDEC Screening and Assessment of Contaminated Sediment Guidance, the exceedance is not anticipated to pose a potential risk to aquatic organisms.
